Preliminary Roost Assessment and  
Nocturnal Bat Survey Report

Fieldhouse Industrial Estate, Rochdale

Reference: 80-955-R1-1

Date: August 2022

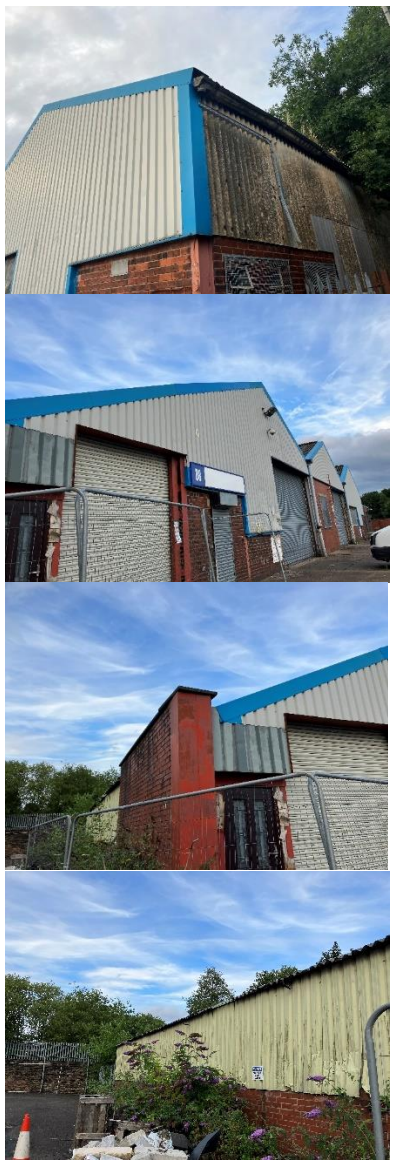
| BUILDING REF. | DESCRIPTION | ASSESSMENT | PHOTOGRAPH |
|---|---|---|---|
| D8 | <p>A red brick building with a pitched roof, comprising corrugated steel sheets on the western aspect and asbestos on the northern and southern aspects. The brick was well-sealed throughout. Roller shutter doors and security lighting were located on the western aspect, meanwhile two caged windows were found on the southern aspect. The east of the building was inaccessible due to heavy foliage and fencing. The inside of building was also inaccessible due to health and safety restraints. No features were identified which could support roosting bats.</p> | Negligible | |

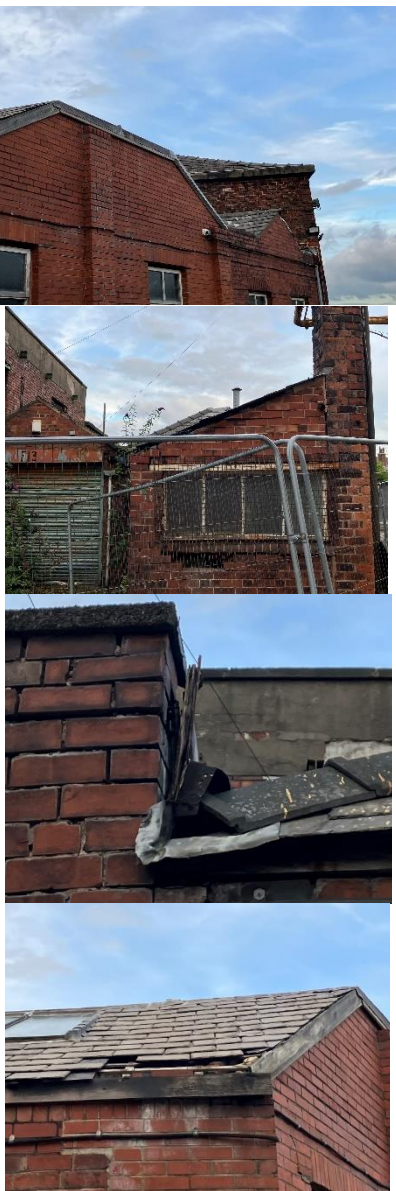
| BUILDING REF. | DESCRIPTION | ASSESSMENT | PHOTOGRAPH |
|---|---|---|---|
| F13 | <p>A red brick-built building with a pitched slate roof. Slipped roof tiles were present which could provide occasional opportunities for crevice dwelling bat species. Brickwork was well sealed, except on the northern aspect, where some crevices around the window were located. Internal access to the building could not be gained due to health and safety restrictions. The building provided opportunities for crevice dwelling bat species on an occasional basis.</p> | Low | |

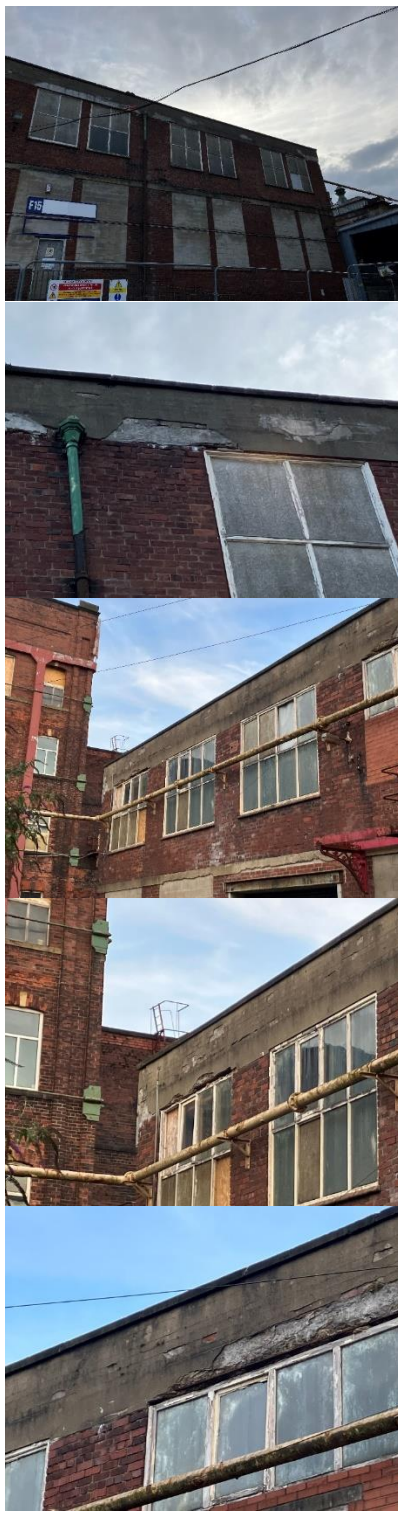
| BUILDING REF. | DESCRIPTION | ASSESSMENT | PHOTOGRAPH |
|---|---|---|---|
| F14-15 | <p>A red brick building with a parapet roof. The brickwork was well sealed throughout and windows on the eastern aspect had been sealed with breezeblock. Some cement had chipped around the windowpanes on the eastern and northern aspects. This provided no roosting potential on the eastern aspect as gaps were only superficial, whereas on the northern aspect, gaps were larger and deeper and hence could provide some bat roosting potential. Internal access to the building could not be gained due to health and safety restrictions. Overall the building could support crevice dwelling bat species on an occasional basis.</p> | Low | |
