## Bat Emergence and Re-Entry Surveys (BERS)

Canal Side Works, Fletcher Street, Rochdale, OL11 1AE

This report is prepared to inform a planning application for the proposal described as:  
“The erection of a new workshop”.

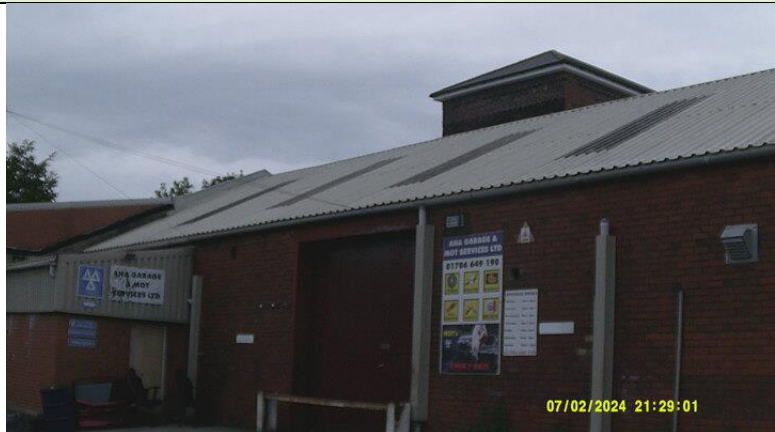
| David Hill-Chambers<br><br>Position 1 | No Emergences: No bat activity of any kind was observed during the survey period. | | | | | | |

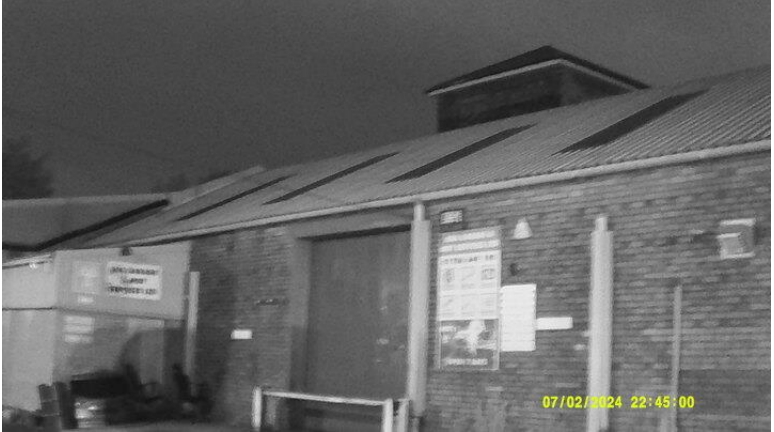
| <b>IR position 1</b> | <b>No Emergences Recorded:</b> IR footage recorded the view of position 1. IR confirms no bats emerged from the building during the survey period. No bat activity was recorded. | |

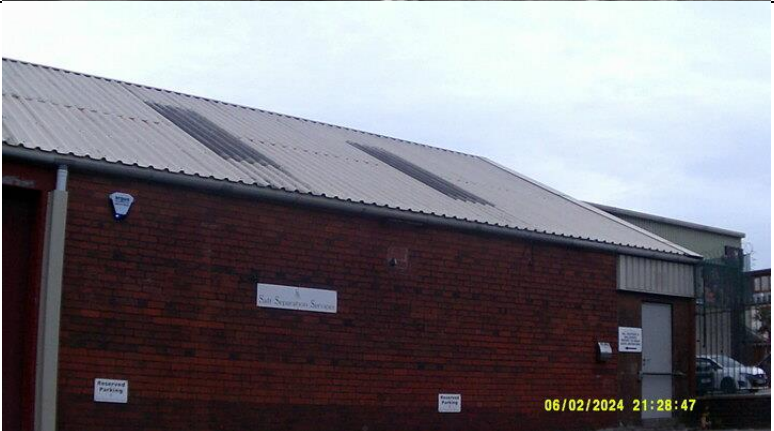
| <b>Nicola Baxter</b><br><b>Position 2</b> | <b>No Emergences:</b> No bats were observed emerging from B1 during the survey period. No bat activity was observed within the surrounding around. | |

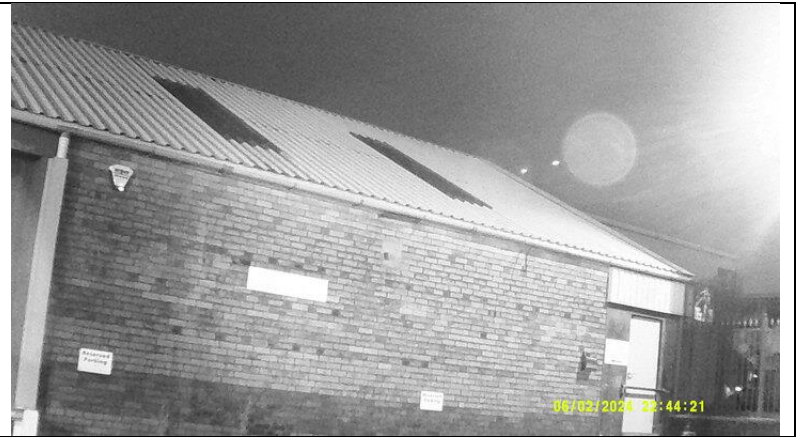
| <b>IR position 2</b> | <b>No Emergences Recorded:</b> IR footage recorded the view of position 2. IR confirms no bats emerged from the building during the survey period. No bat activity was recorded. | |
