**REPORT ON  
GROUND INVESTIGATION  
AT  
UNIT B, BIRCH BUSINESS PARK  
HEYWOOD**

| <b>Report Title:</b> | Report on Ground Investigation at Unit B, Birch Business Park, Heywood |
| <b>Report Number:</b> | AG3353-21-AN84 |
| <b>Date:</b> | March 2022 |

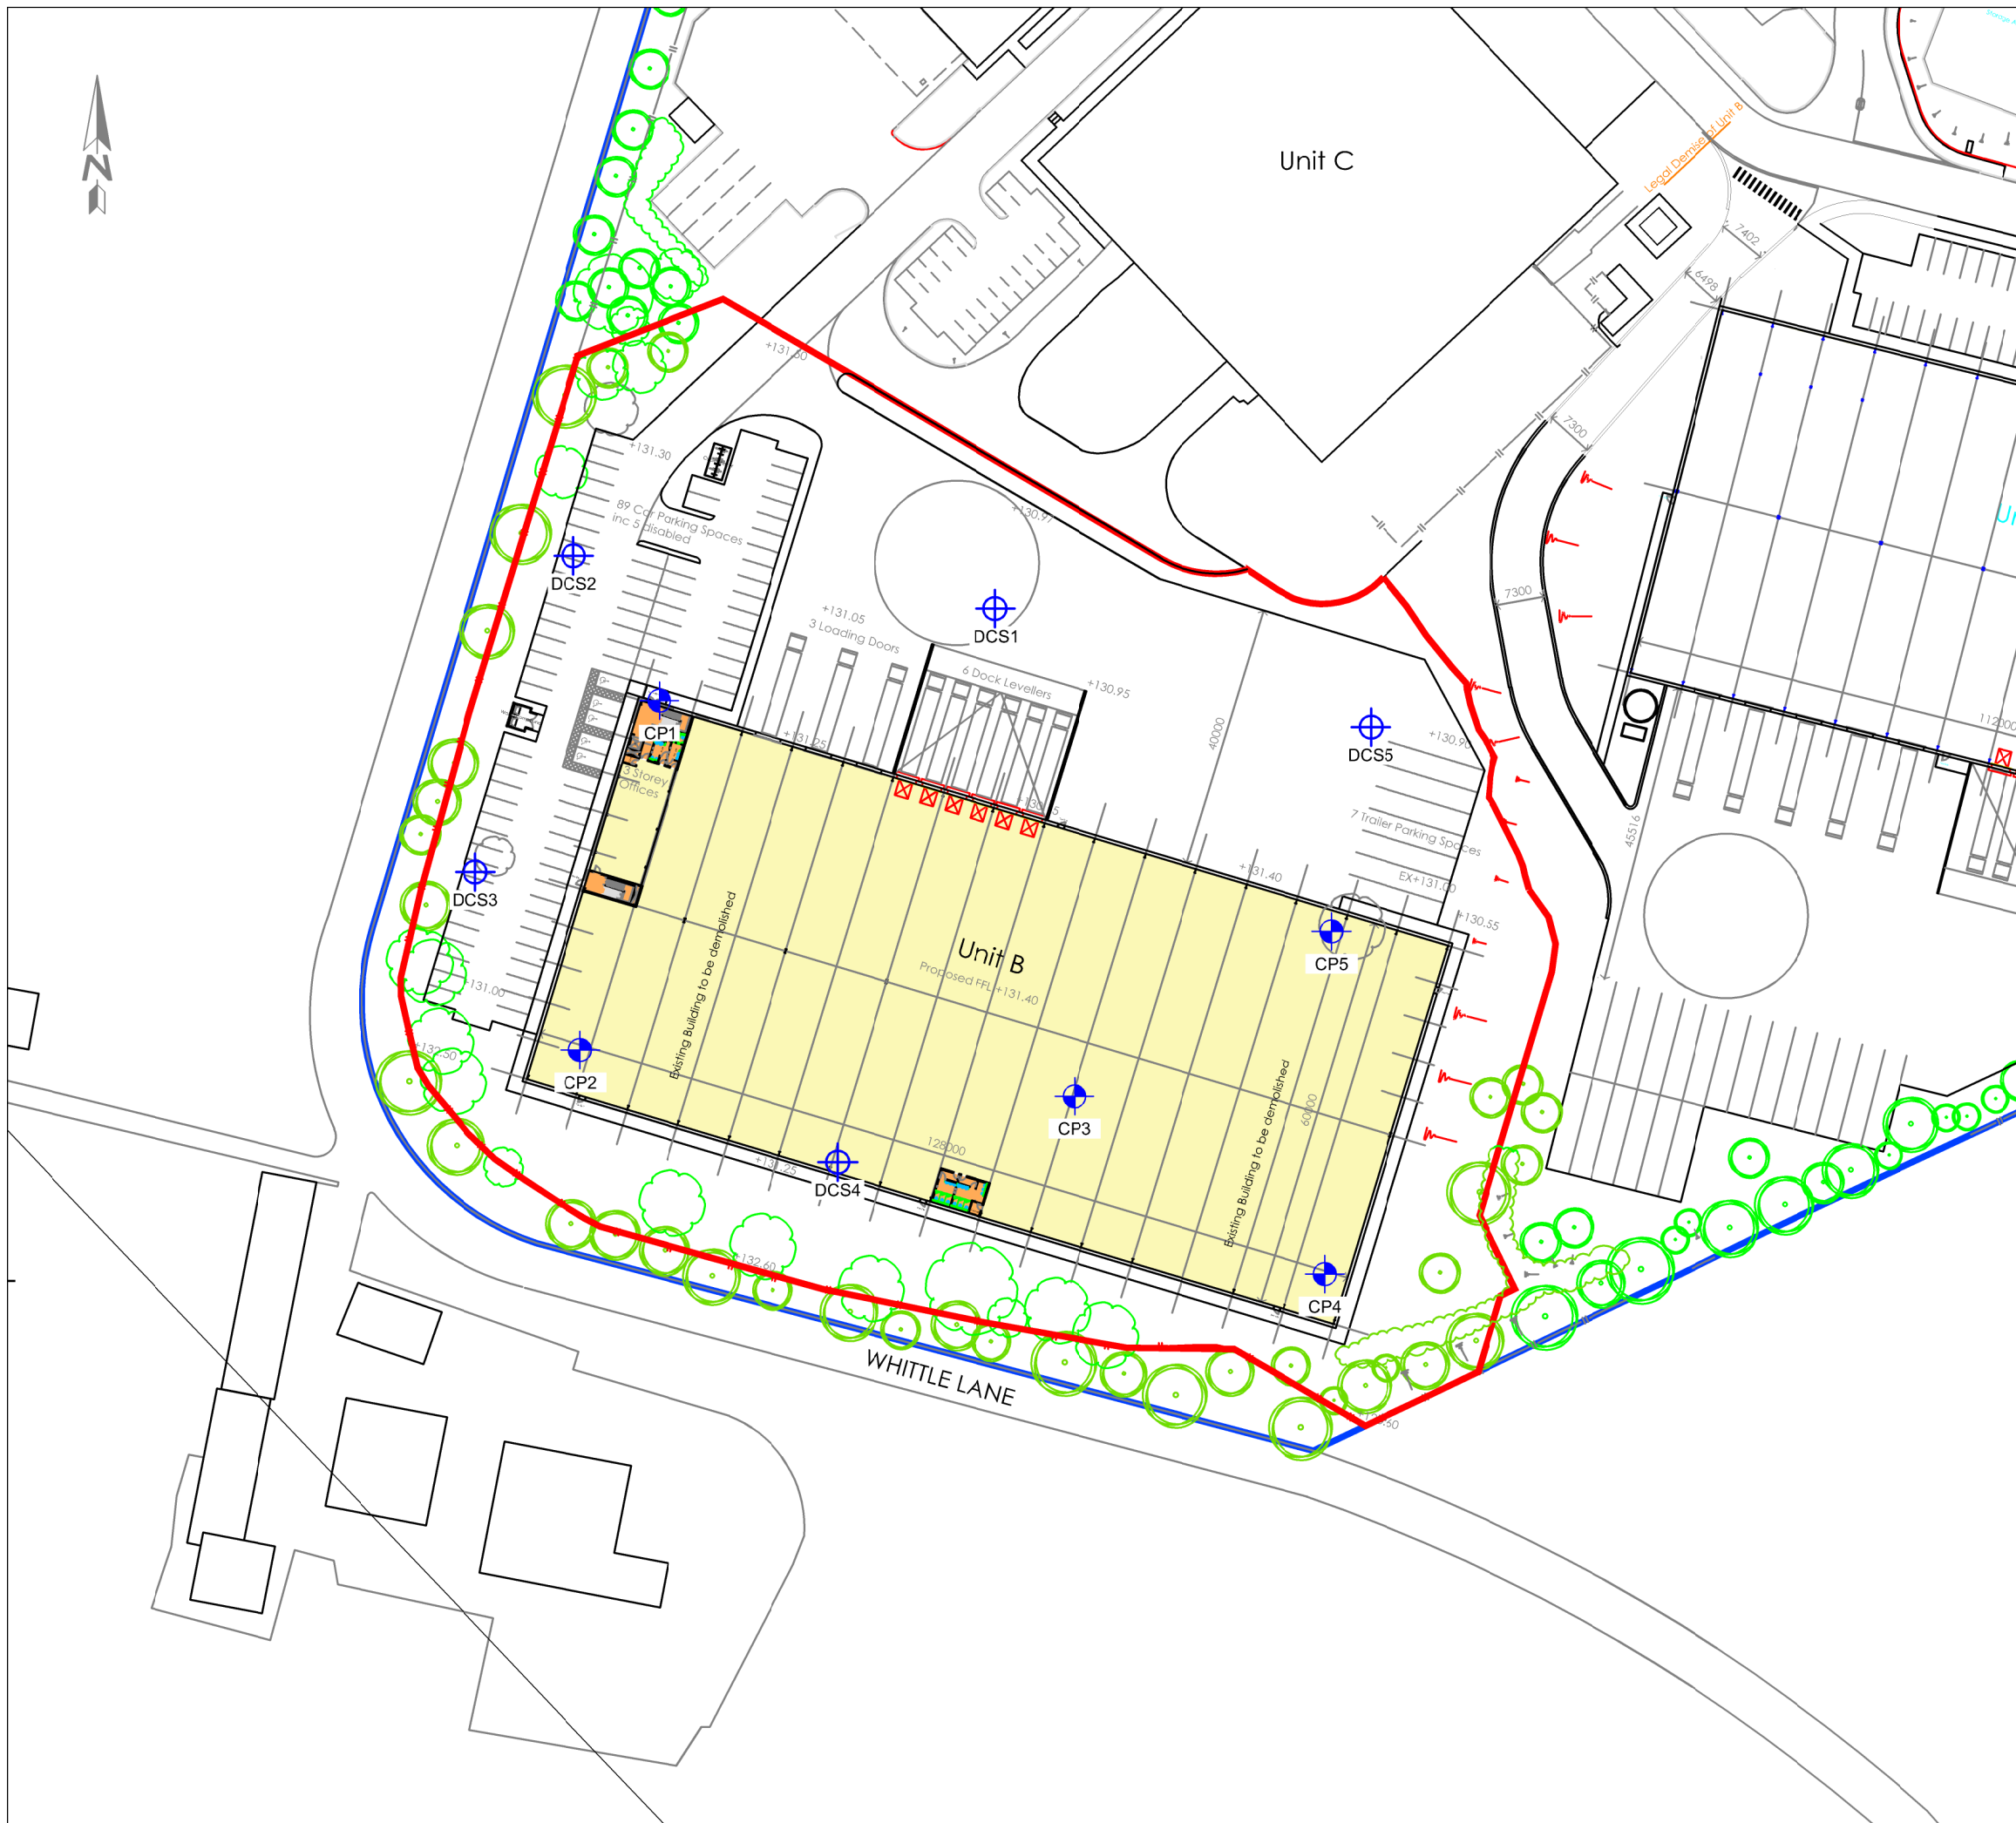
| Drawing No: AG3353-21-02 | Revision: 0 | |

| <b>KEY:</b><br><div><div>CP1</div><div>Cable Percussion Borehole</div></div> <div><div>DCS1</div><div>Driven Continuous Sampling Borehole</div></div> | | |

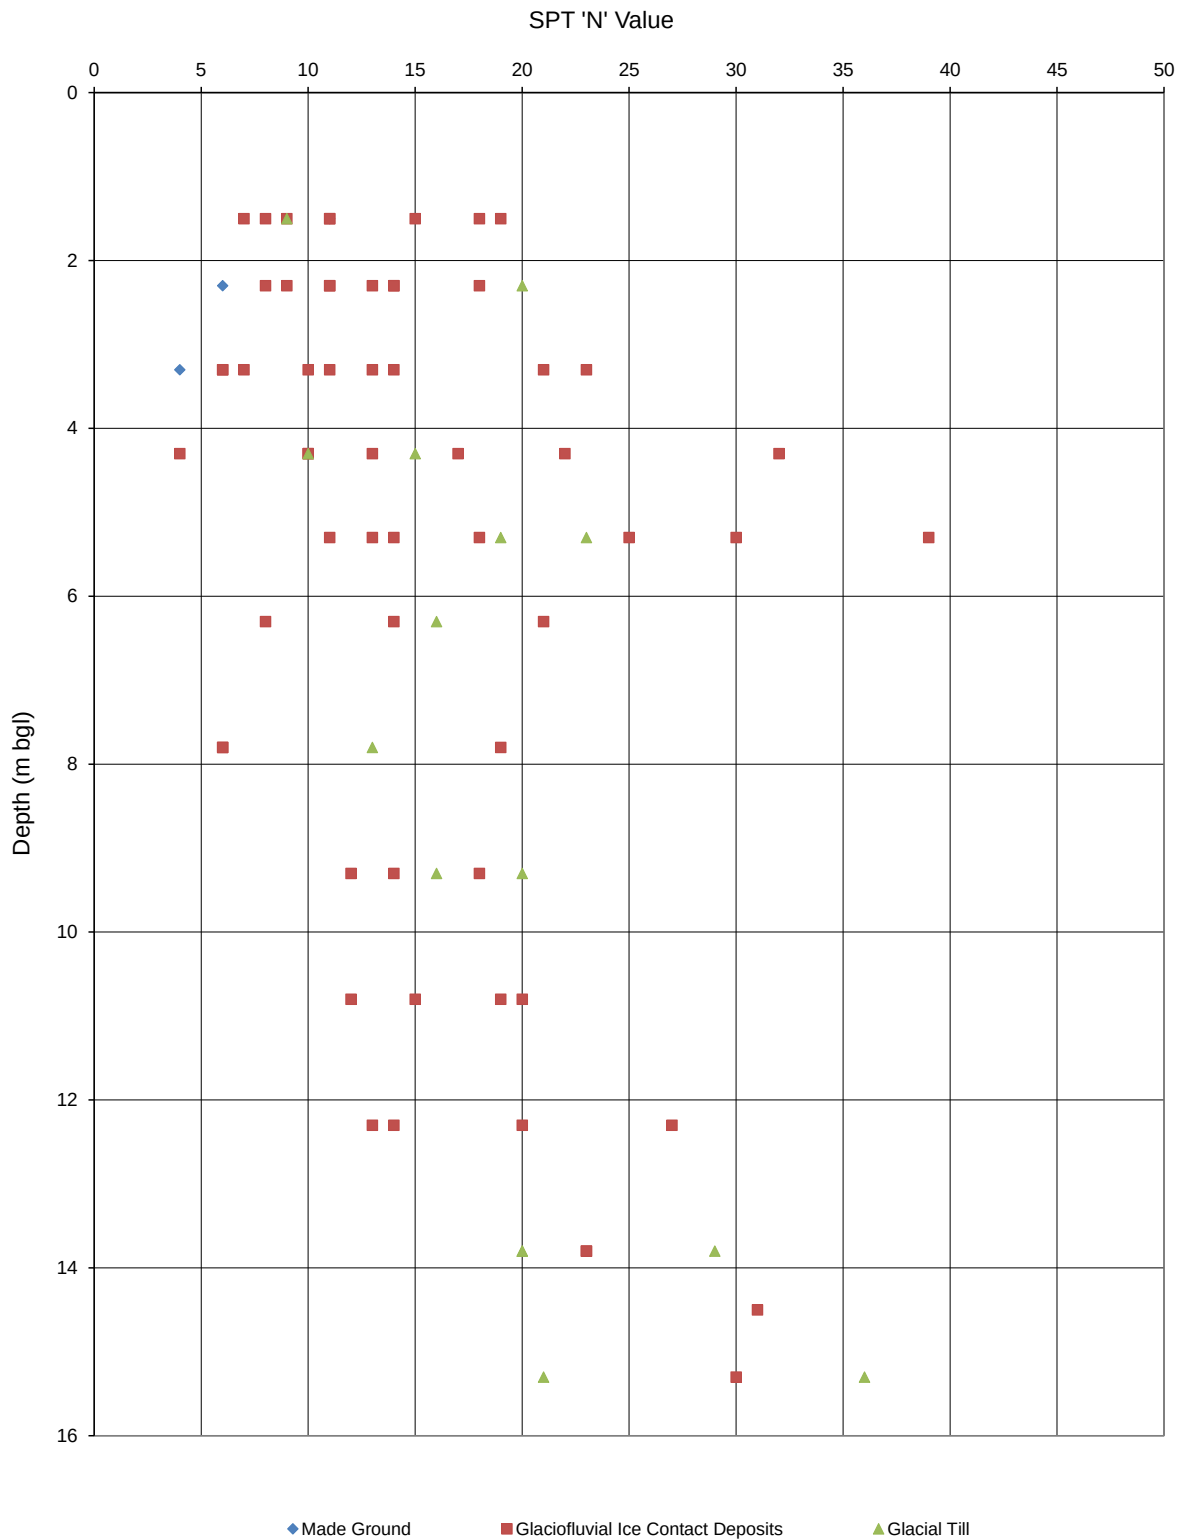
# Uncorrected SPT 'N' Value versus depth

Notes: 1. Uncorrected N values plotted

Alternatively, a piled foundation solution may be considered, founding within the deeper stiff/medium dense Glacial Till/Glaciofluvial Ice Contact Deposits. An SPT 'N' value versus depth plot is included in Appendix A and should be referred to along with the borehole logs when designing piles. However, attention is drawn to the ground conditions encountered in CP2 and CP5, where lower N values were recorded in the Glaciofluvial Ice Contact Deposits at c.7.5m bgl.

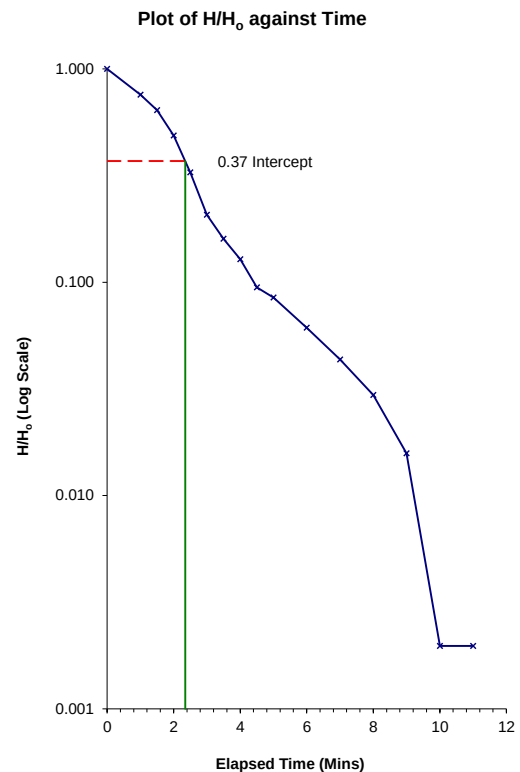
## Permeability Results

### Using BS EN ISO 2282-2 Equation B.7

Falling head permeability tests were undertaken within the standpipes of CP1 and CP5 to provide a preliminary indication of infiltration potential, the results of which are discussed further in Section 8.6.

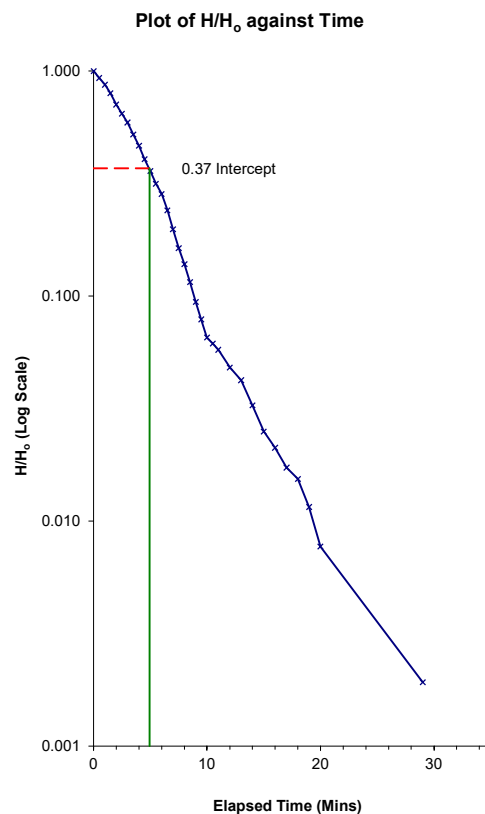
## Permeability Results

Using BS EN ISO  
22282-2 Equation B.7

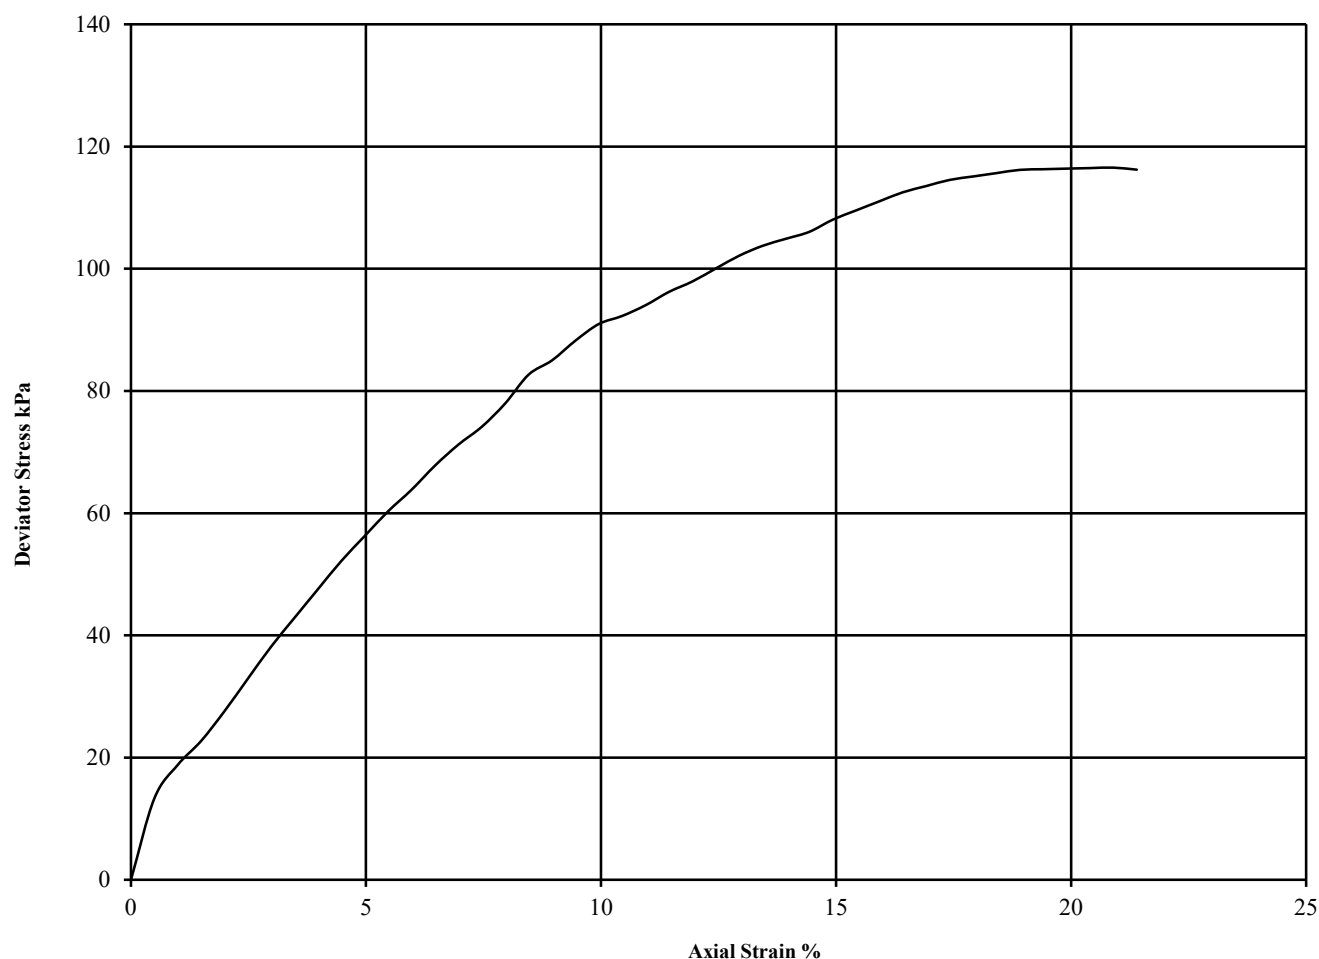
| Diameter (mm): | | 103 | Height (mm): | | 207 | Test: | UU Single Stage | | Remarks: |

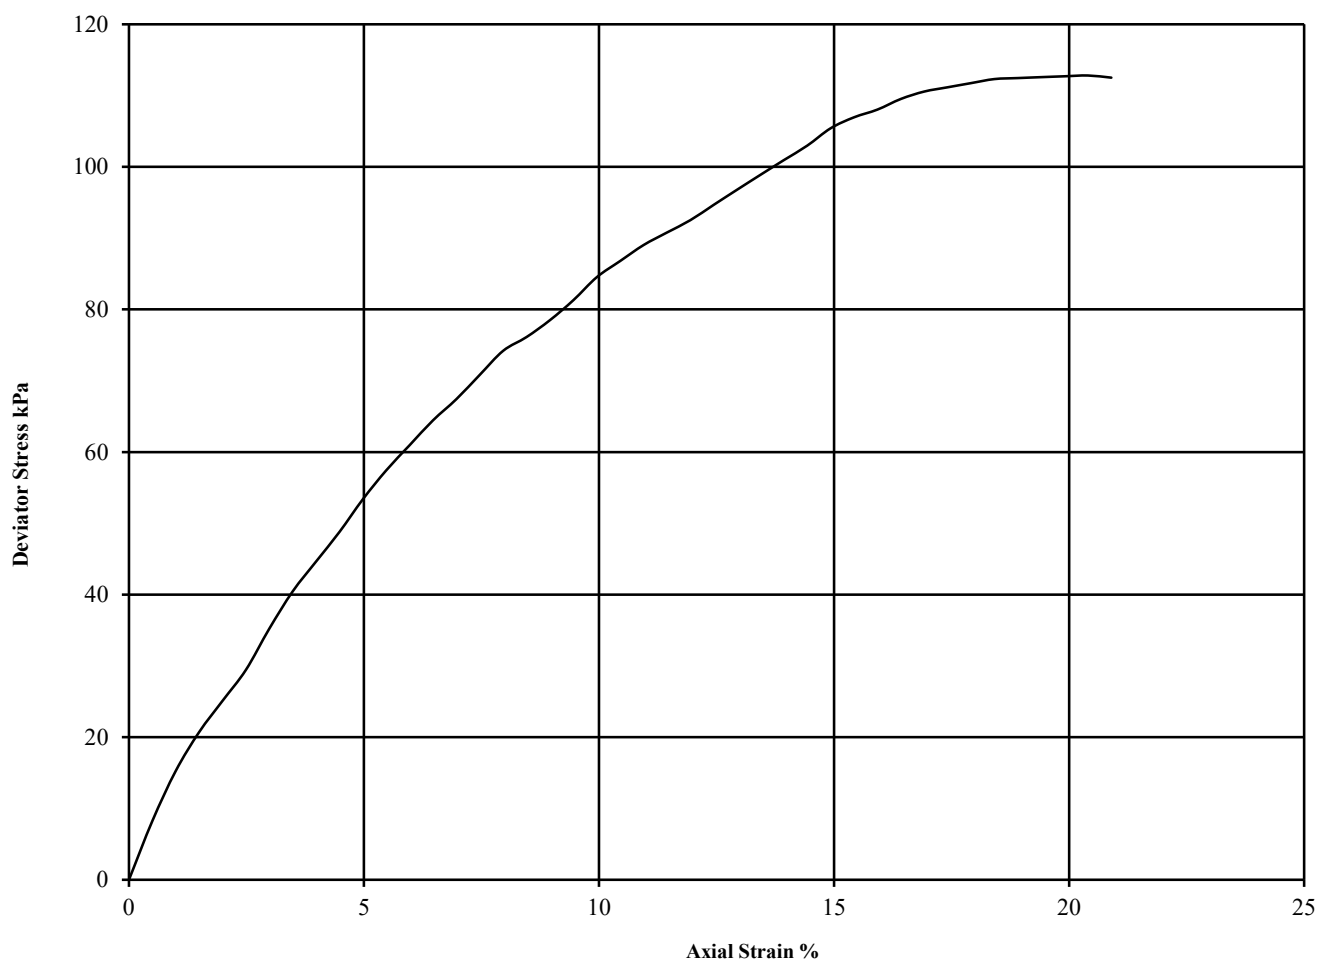
| Diameter (mm): | | 103 | Height (mm): | | 207 | Test: | UU Single Stage | | Remarks: |

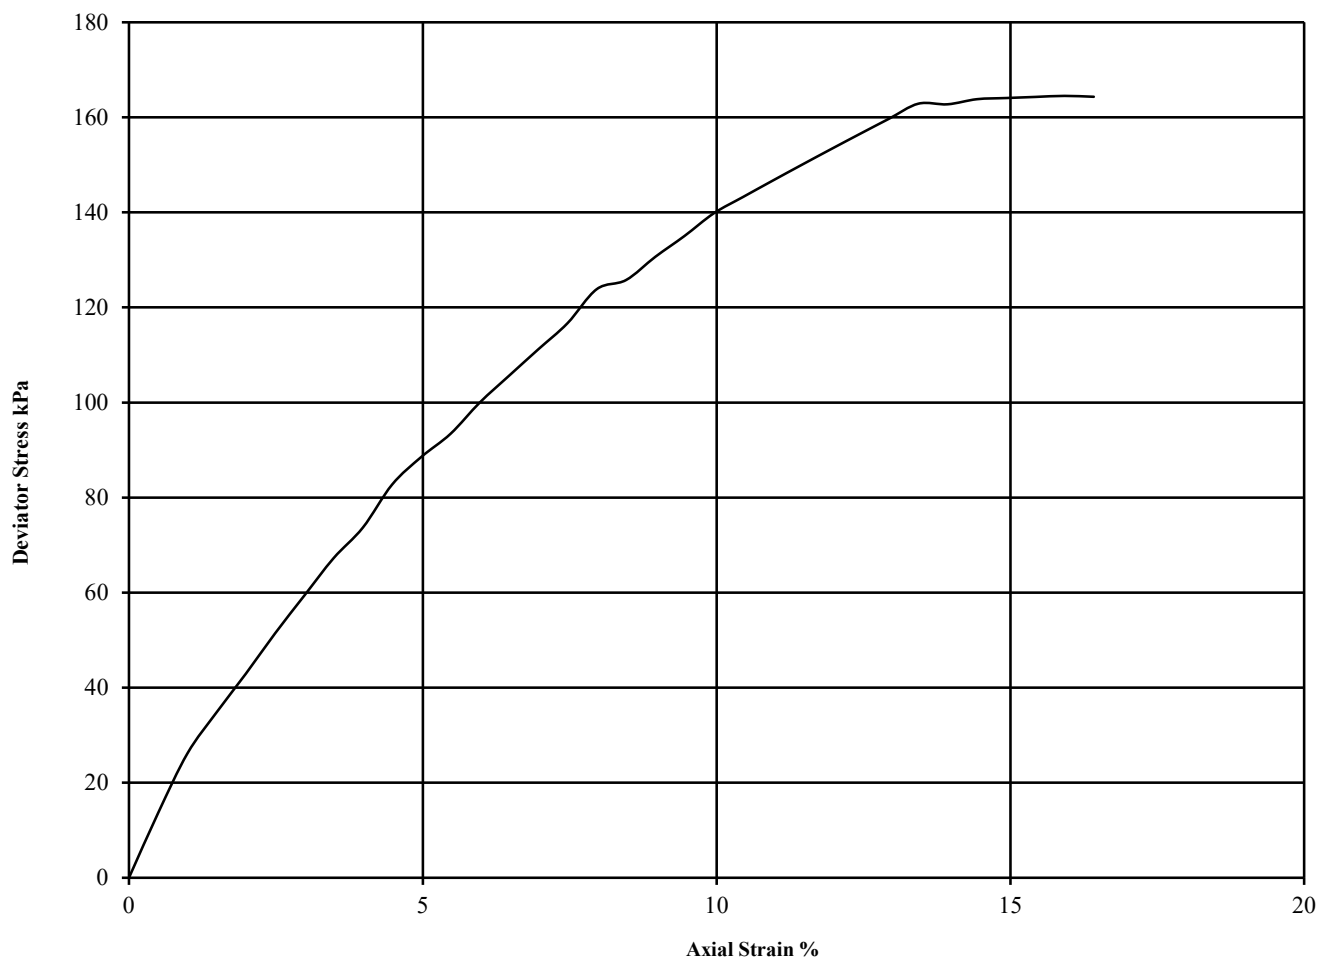
| Diameter (mm): | | 103 | Height (mm): | | 207 | Test: | UU Single Stage | | Remarks: |

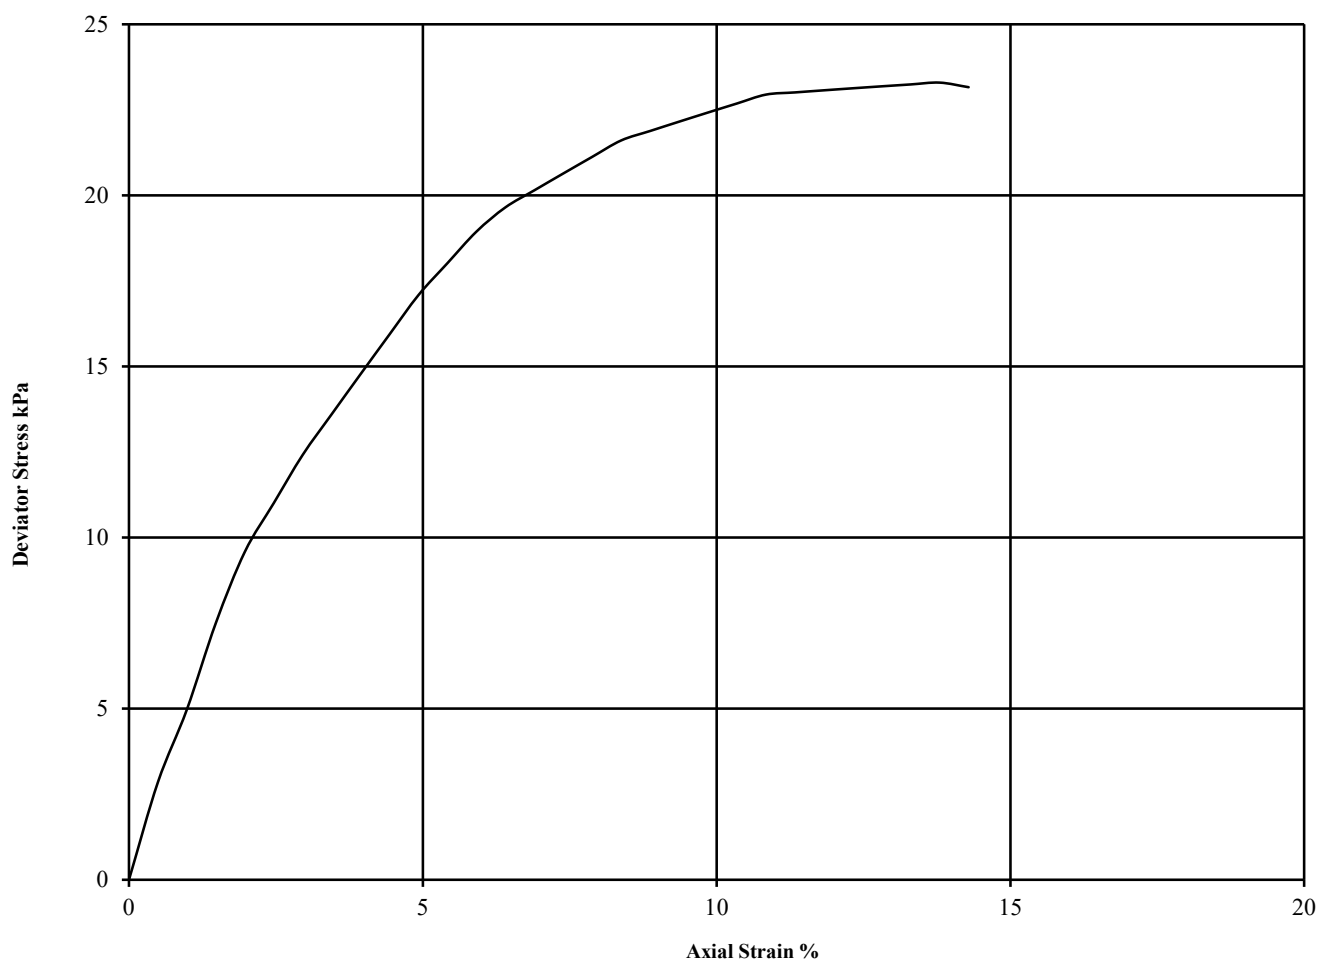
| Diameter (mm): | | 102 | Height (mm): | | 207 | Test: | UU Single Stage | | Remarks: |
