# Further Redlumb Farm

## Produced for Everhaus Limited

| Document Title | Condition C14 Discharge |
| Document Reference No. | 11171-D4S-ZZ-RP-CE-0001 |

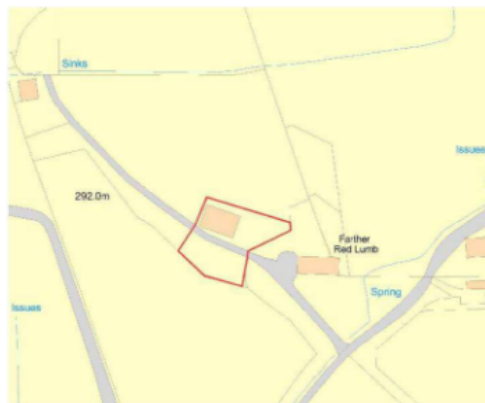
Figure 1 – Site Plan as Existing

The site is sloping with existing levels varying from 291.00 to 294.00 AOD (refer to the enclosed site topographical survey).

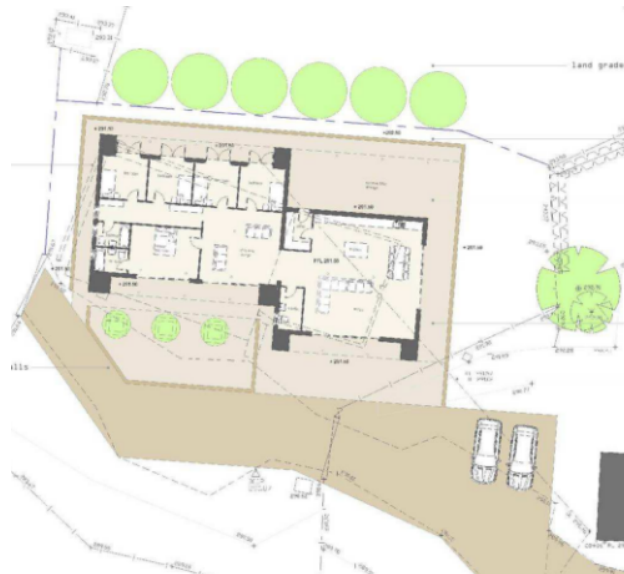
Figure 22 – Proposed Development

The proposed development consists of a new single storey residential building with an access road/driveway.

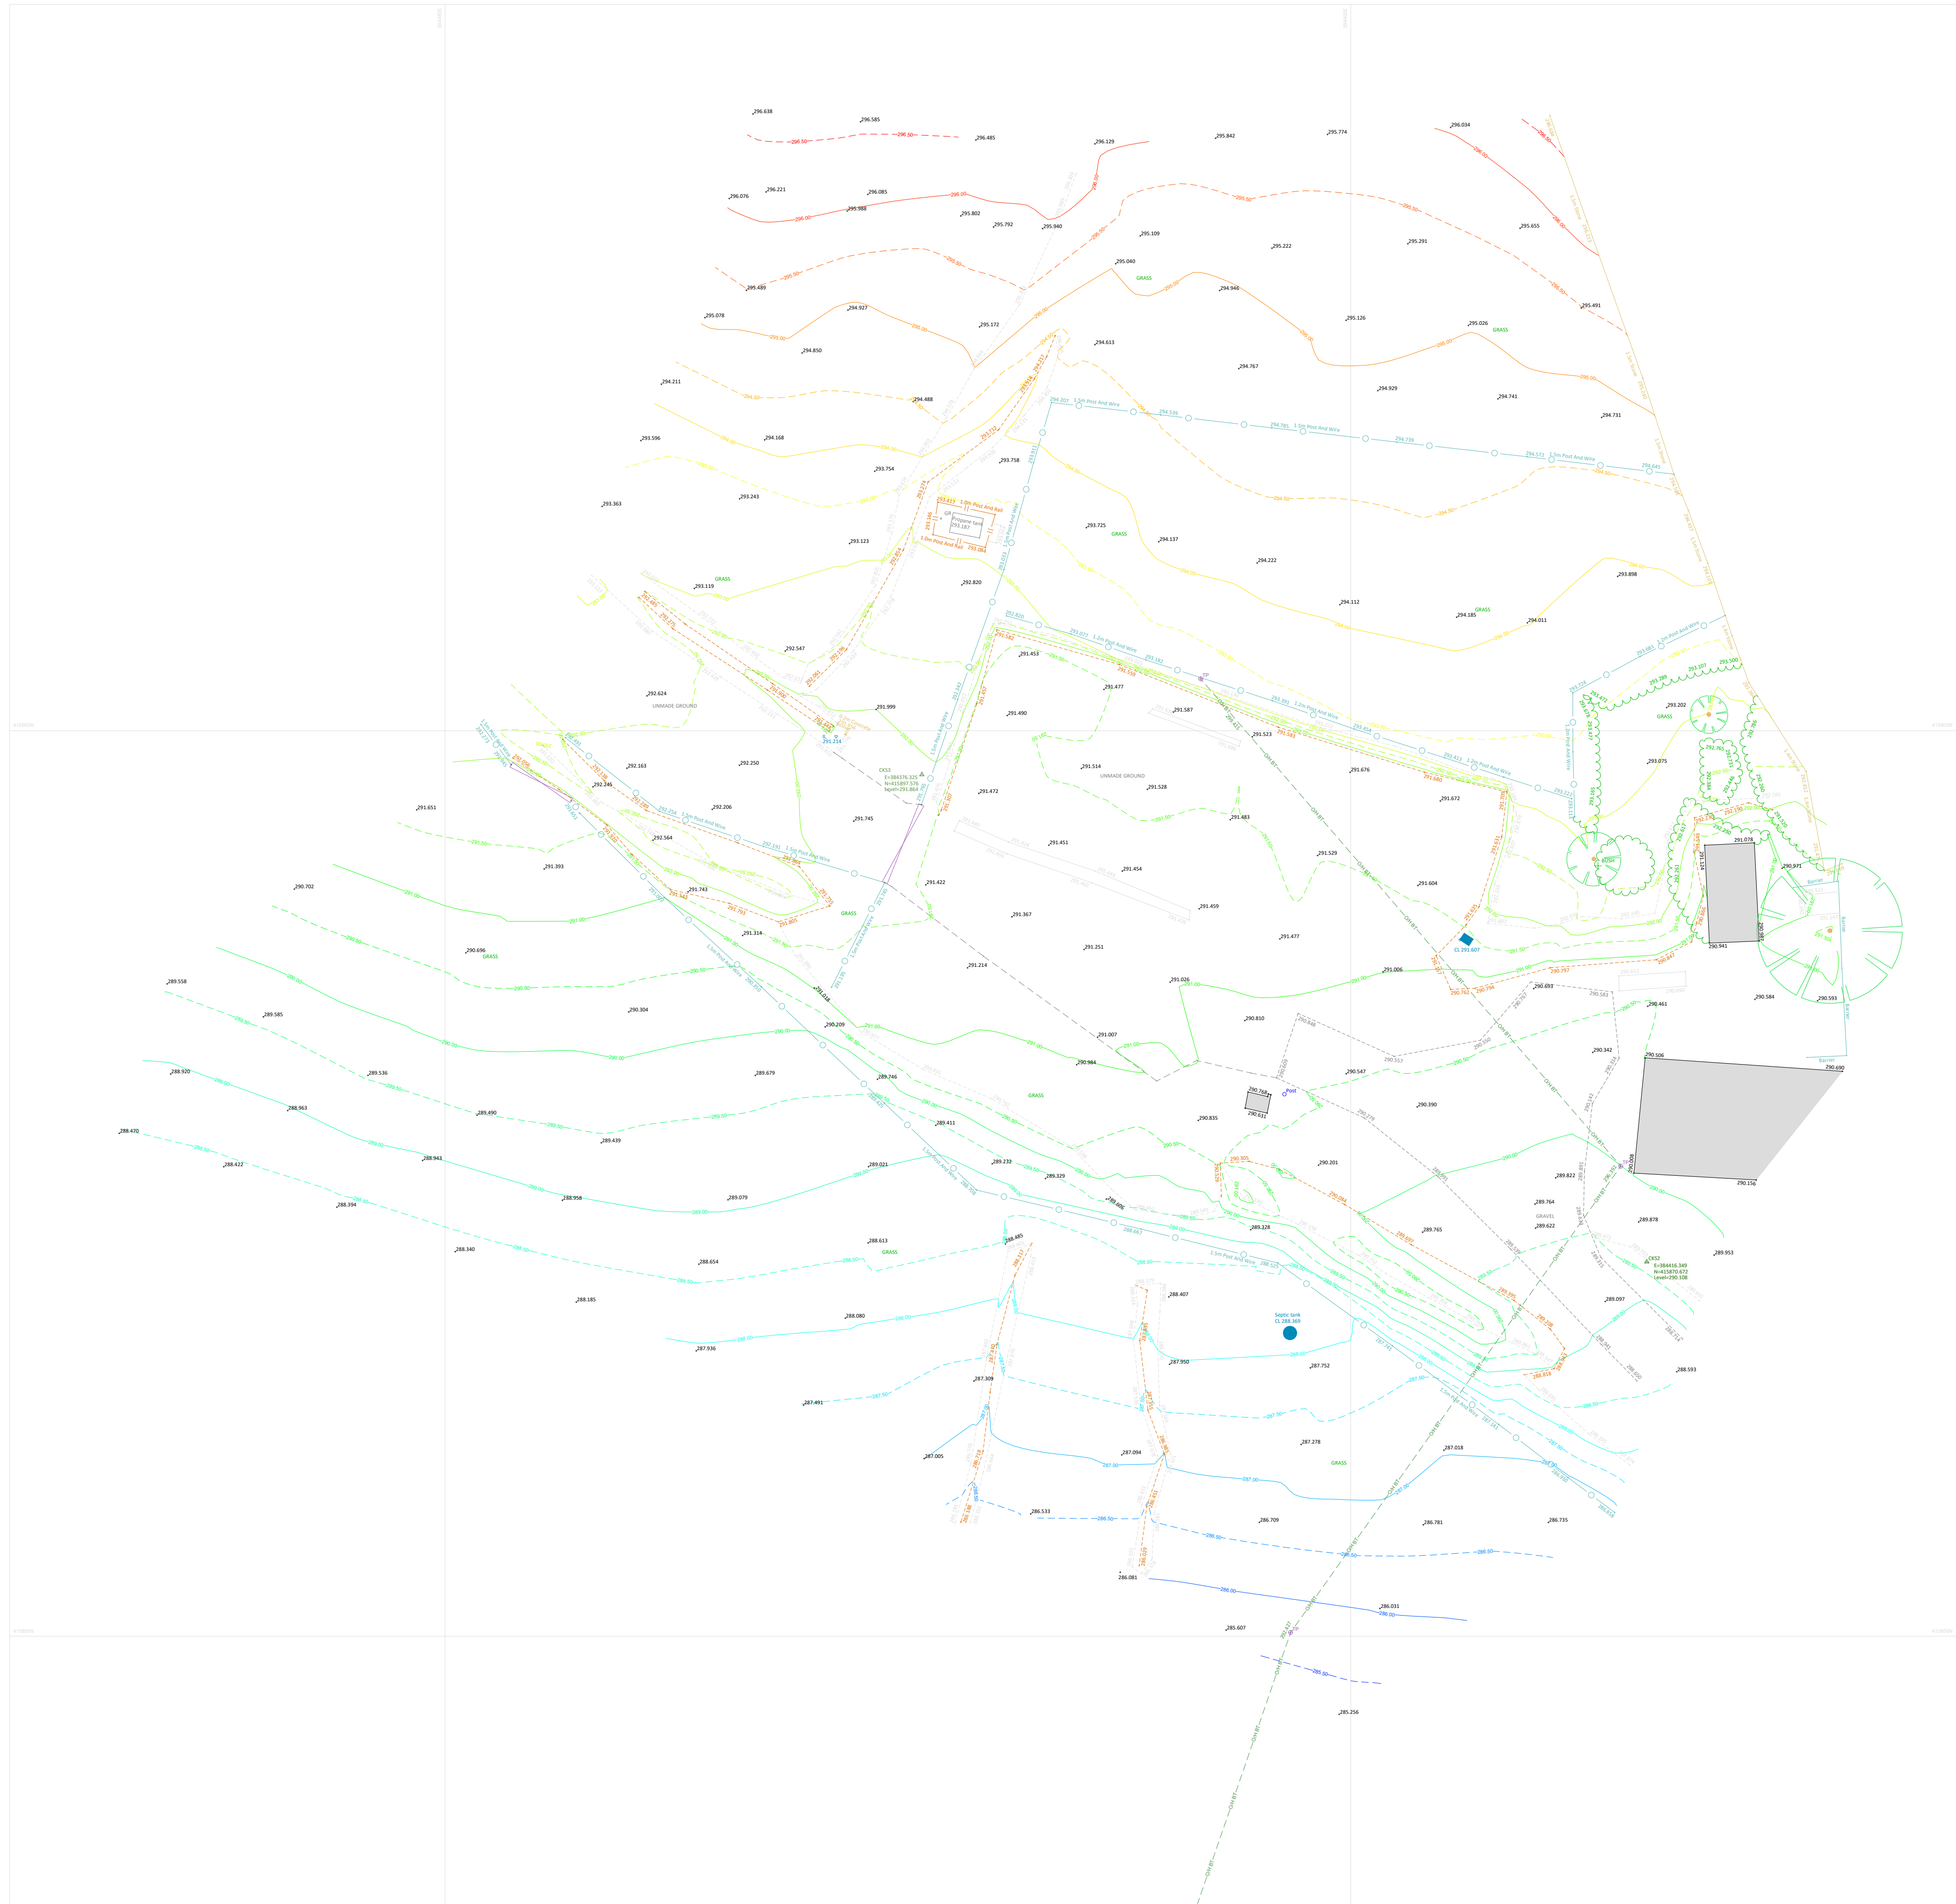
3.0 TOPOGRAPHICAL SITE PLAN

Topographical Survey

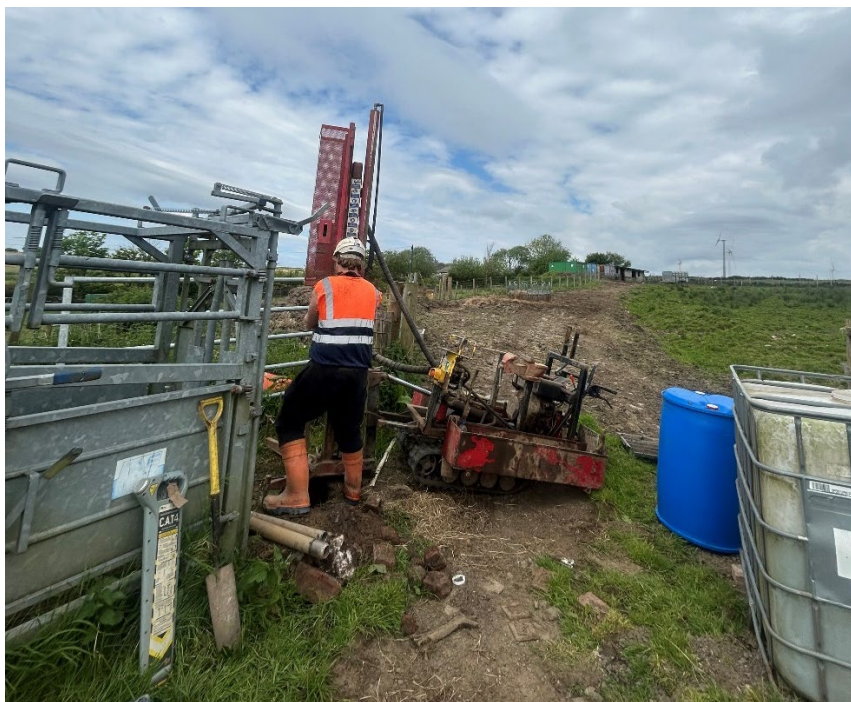
**Figure 2: General Site Photographs**

View on the day of the site works and the drilling of a borehole using the window sample rig.

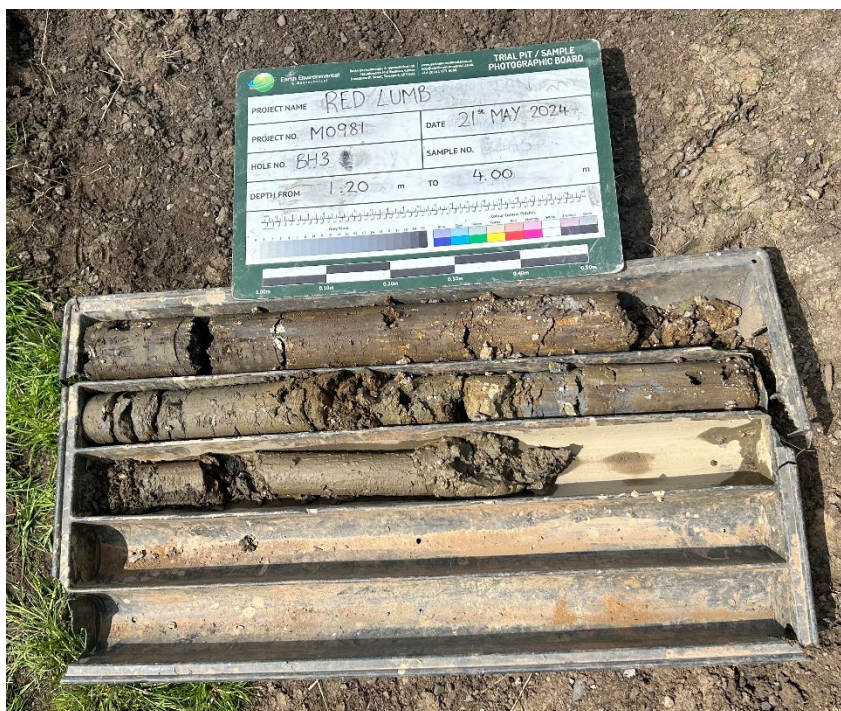
View showing spoil from BH3.

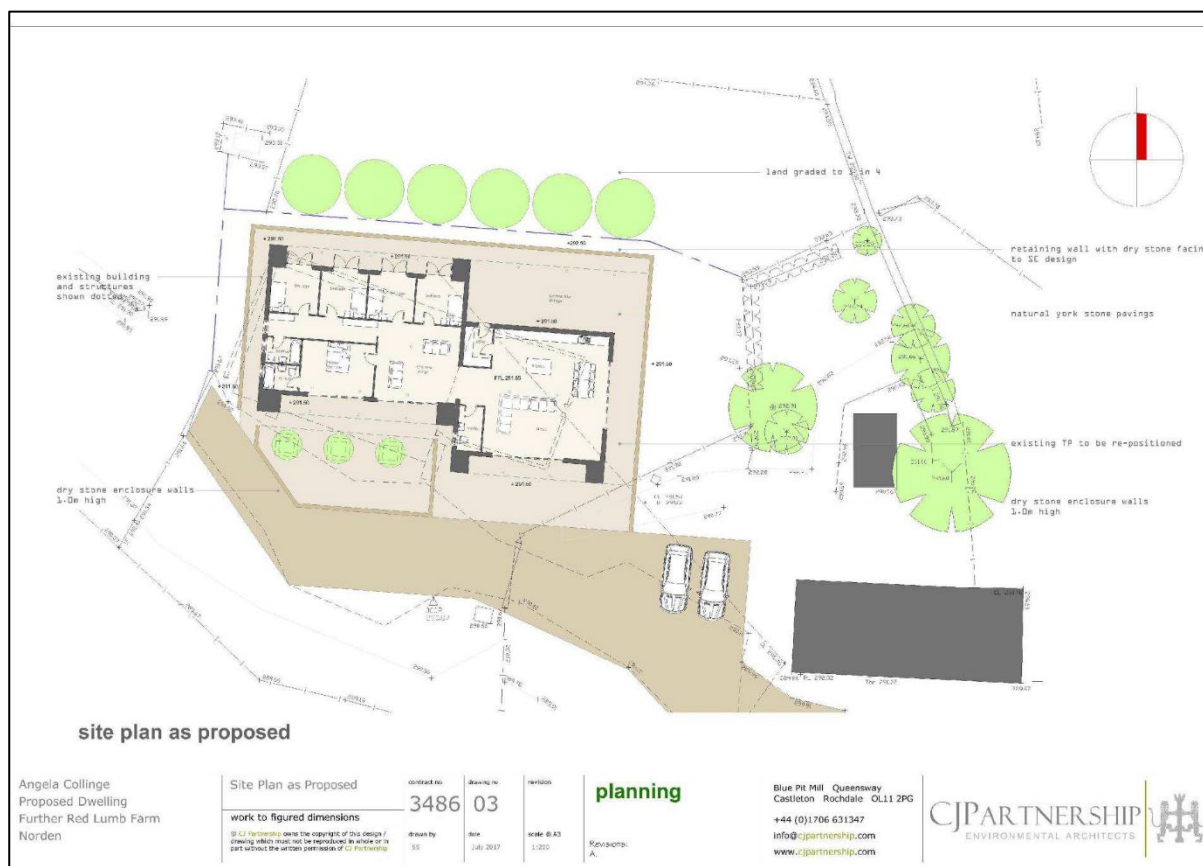
**Figure 3: Proposed Development Plan**

The client intends to demolish the existing building structure and construct a new single storey dwelling with soft landscaping built in its place.

A proposed development plan is shown in Figure 3, below.
