Wilson Bowden Developments Ltd &  
David Wilson Homes Ltd  
Plot W Kingsway Business Park  
Rochdale

Phase 1 and 2 Geo-Environmental  
Assessment

December 2019

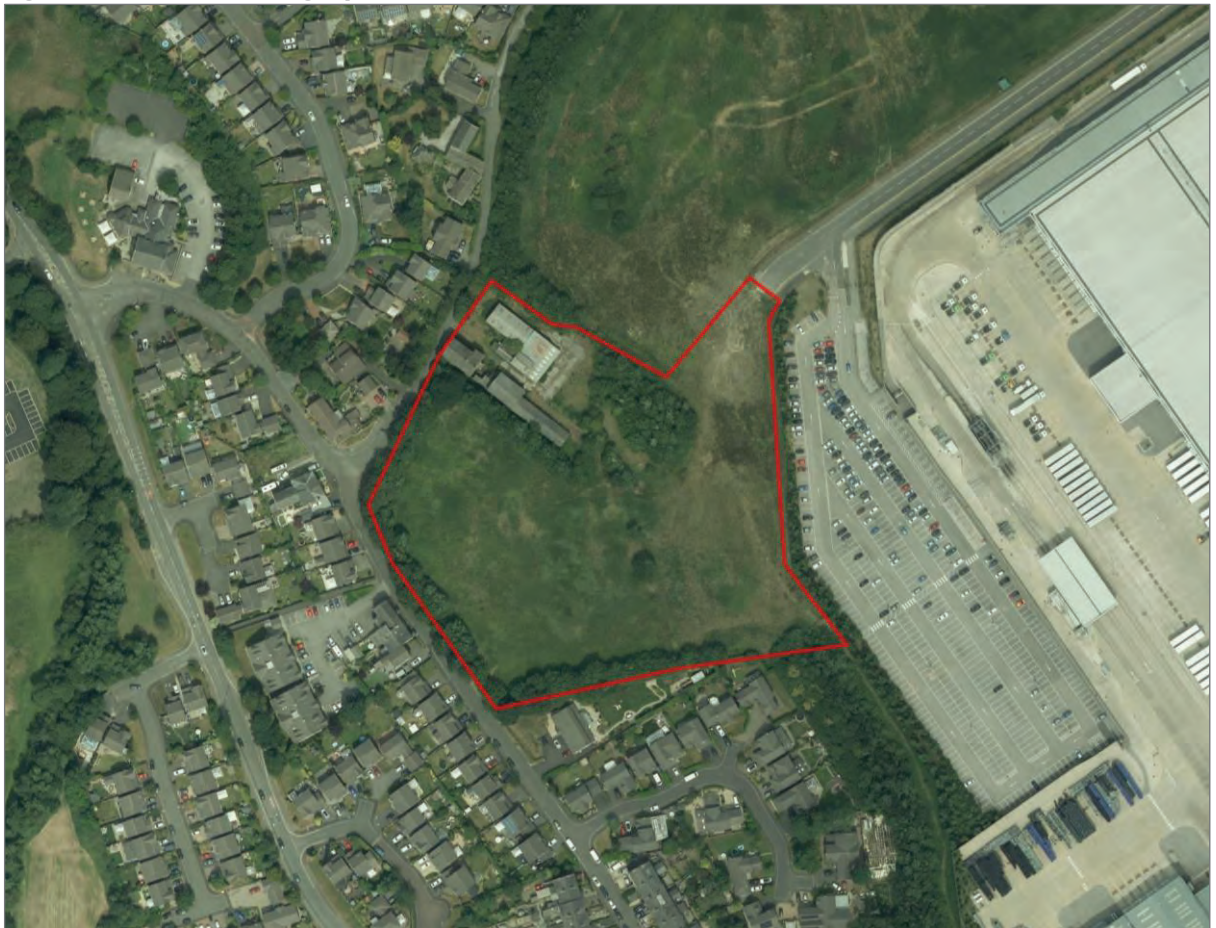
**Figure 2-2: Aerial Photograph**

- 2.6 An aerial photograph representative of the site and surroundings, dated 26<sup>th</sup> March 2012, is presented below as **Figure 2-2**.
