# GEO-ENVIRONMENTAL AUDIT

PHASE 1 Preliminary Risk Assessment

Proposed Residential Development

Tweedale Street (53-61)

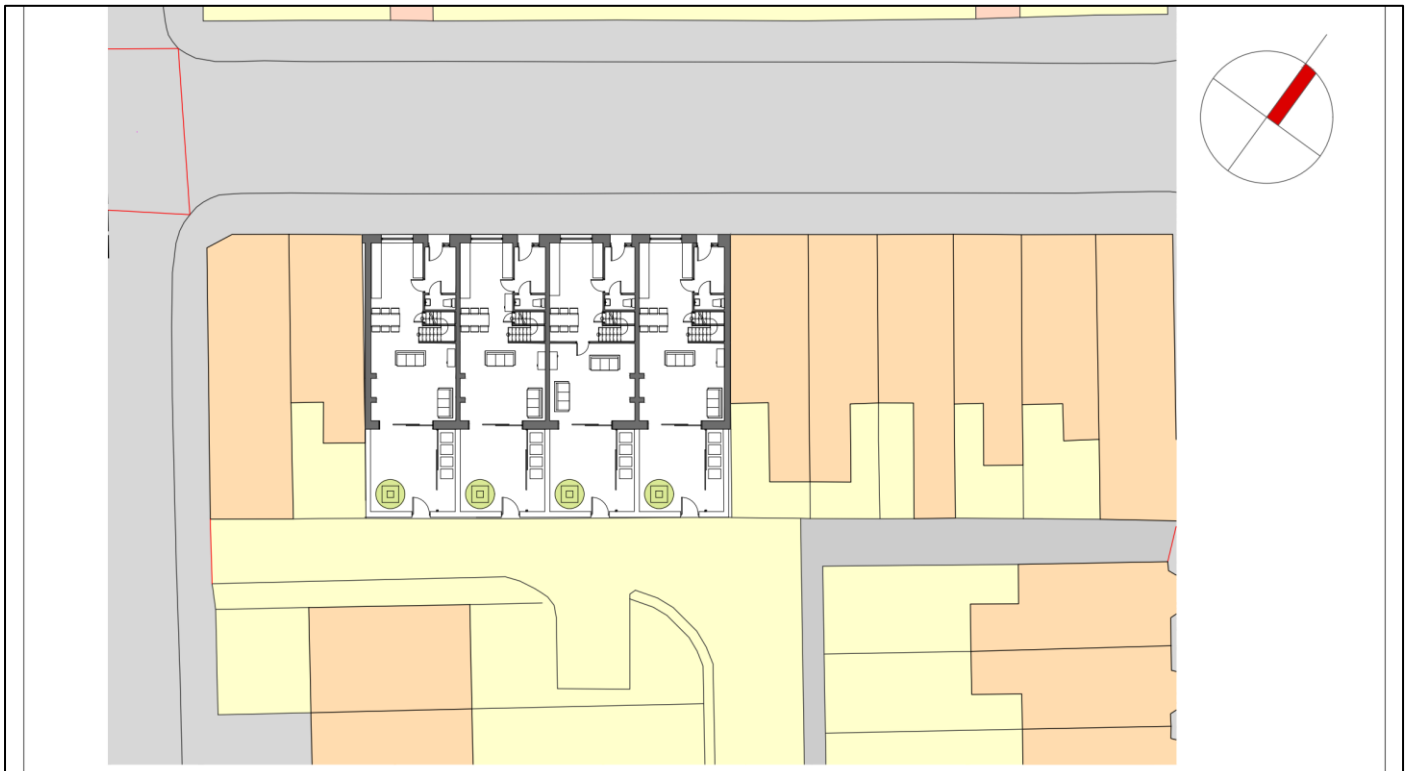
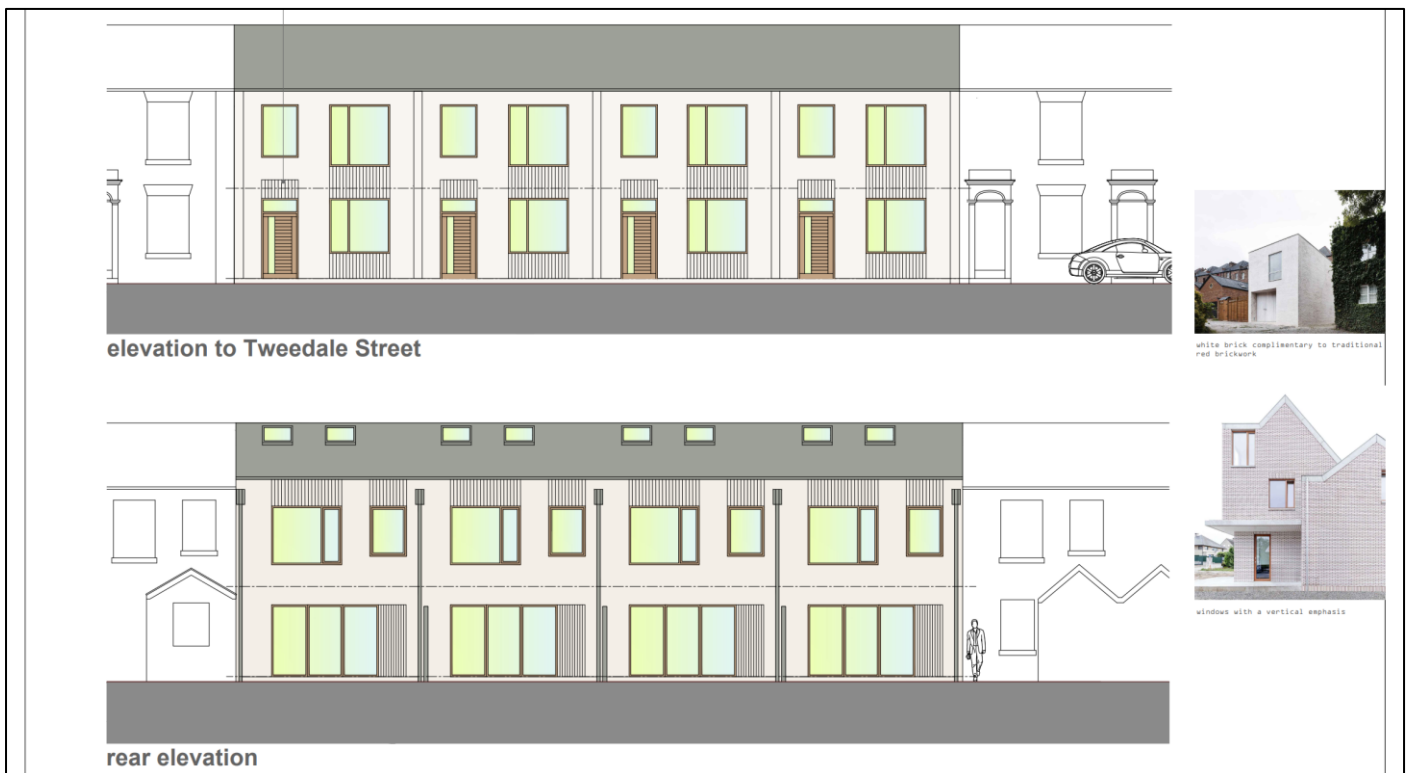
### 5.2. Proposed Development

4No. residential dwellings will be erected between the existing dwellings surrounding the Site.

The new properties will front directly onto Tweedale Street with car parking/yards to the rear.

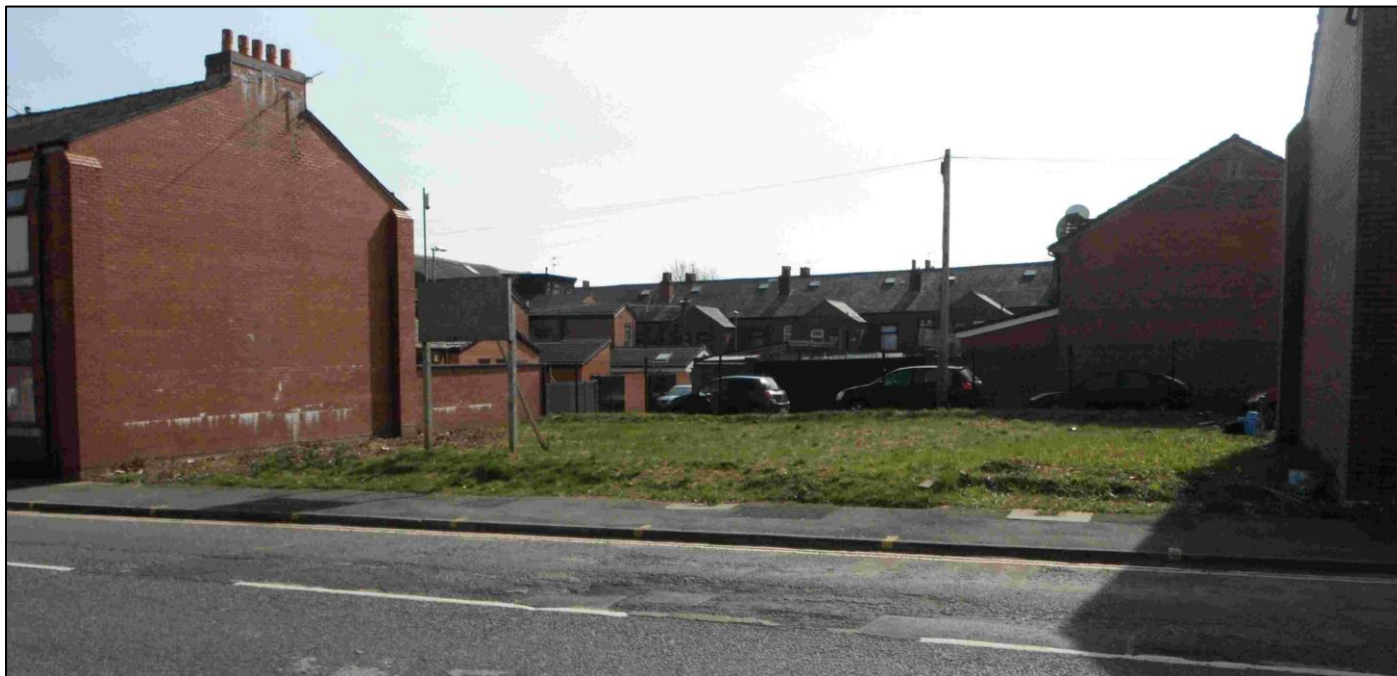
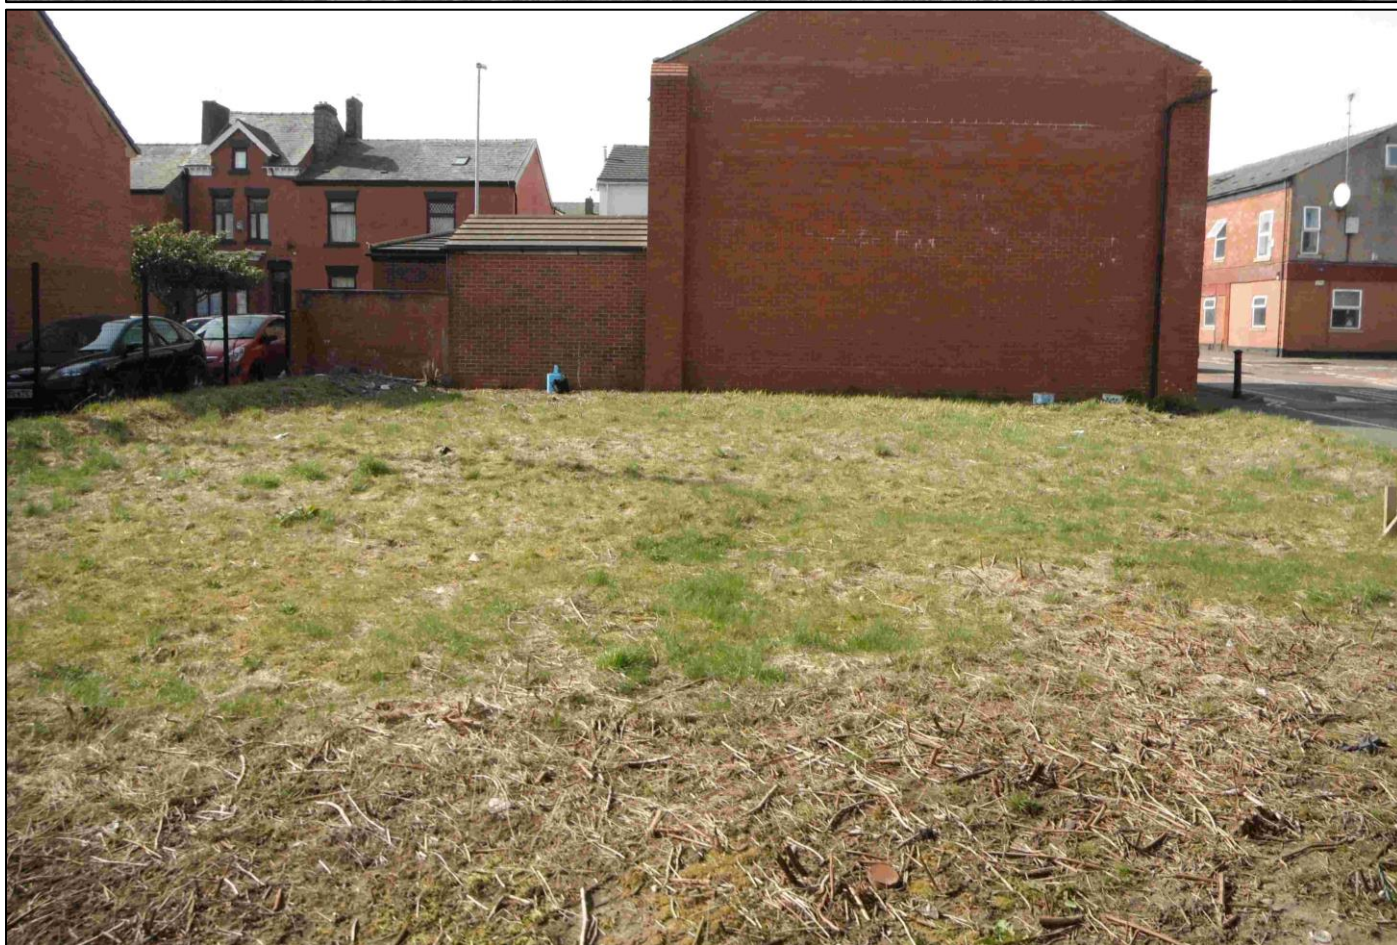
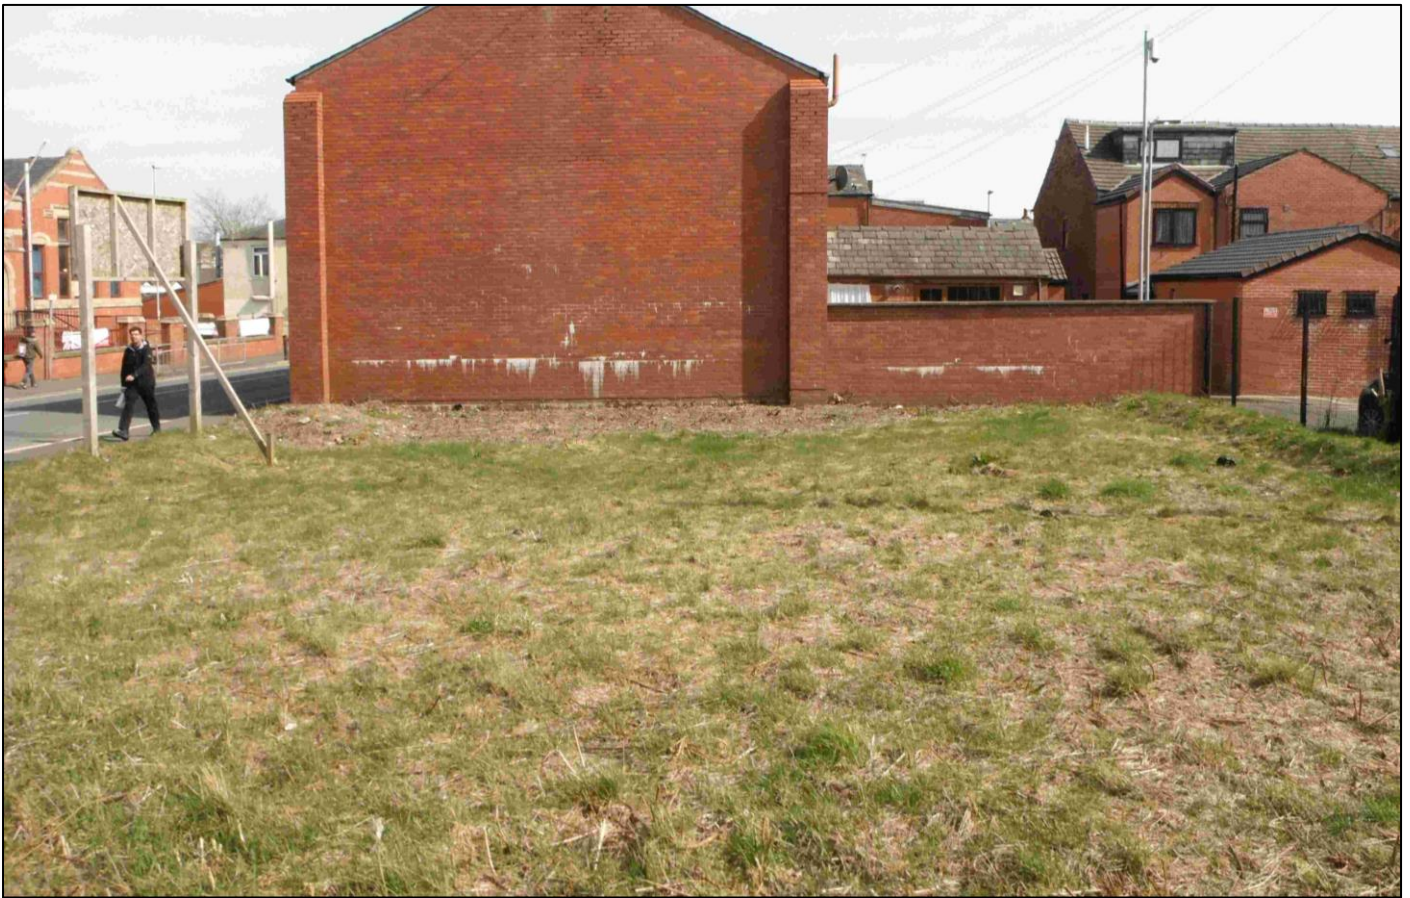
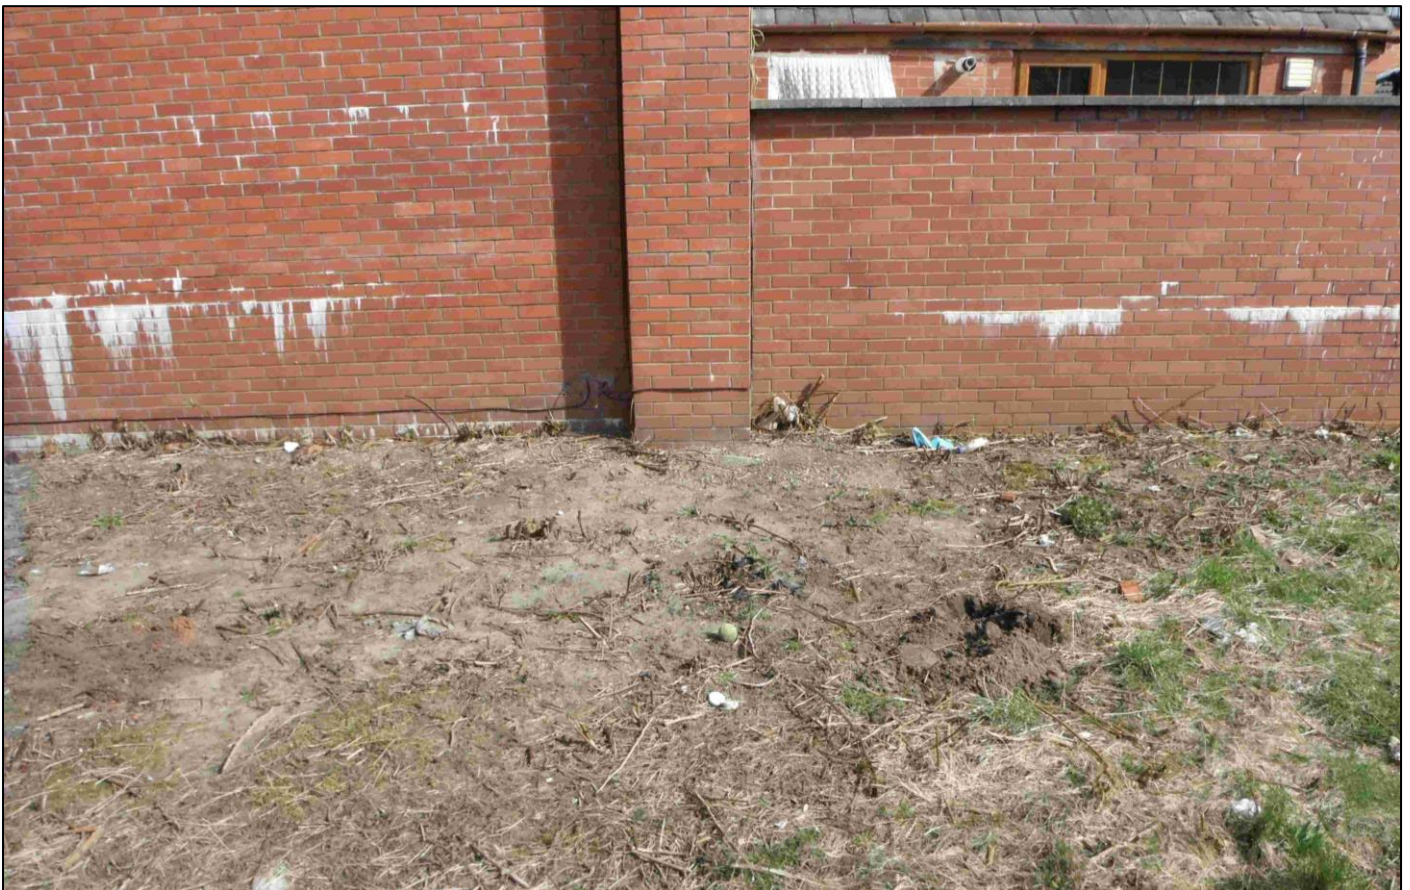
### 6.1. Reconnaissance 2020

| Details of Existing Structures: | <p>The Site was accessed via the main road. It was vacant, and comprised a made ground surface, with vegetation recently cut.</p> <p>There was a small (nominally 500-600mm high) bund to the front and rear, presumably to stop vehicular intrusion.</p> <p>No structures were noted on site except from the masonry brick walls to the adjacent properties denoting the boundaries to the west and east sides, and the paladin fencing to the rear south side.</p> |
| Areas of Discoloured Soil, Polluted Water, Vegetation, and Significant Odours: | Made ground identified which is likely contaminated with minor contaminants but no visual or olfactory evidence of major contamination. |

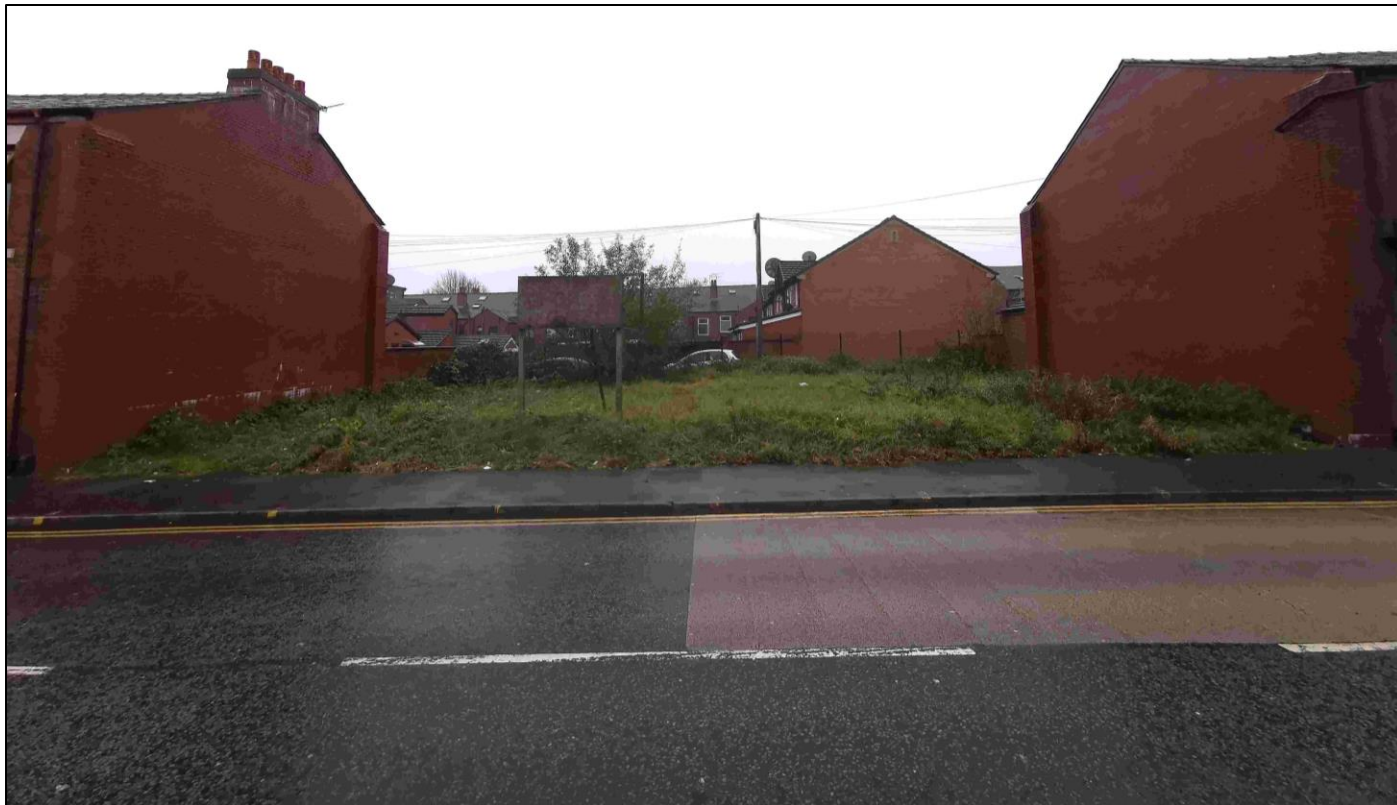
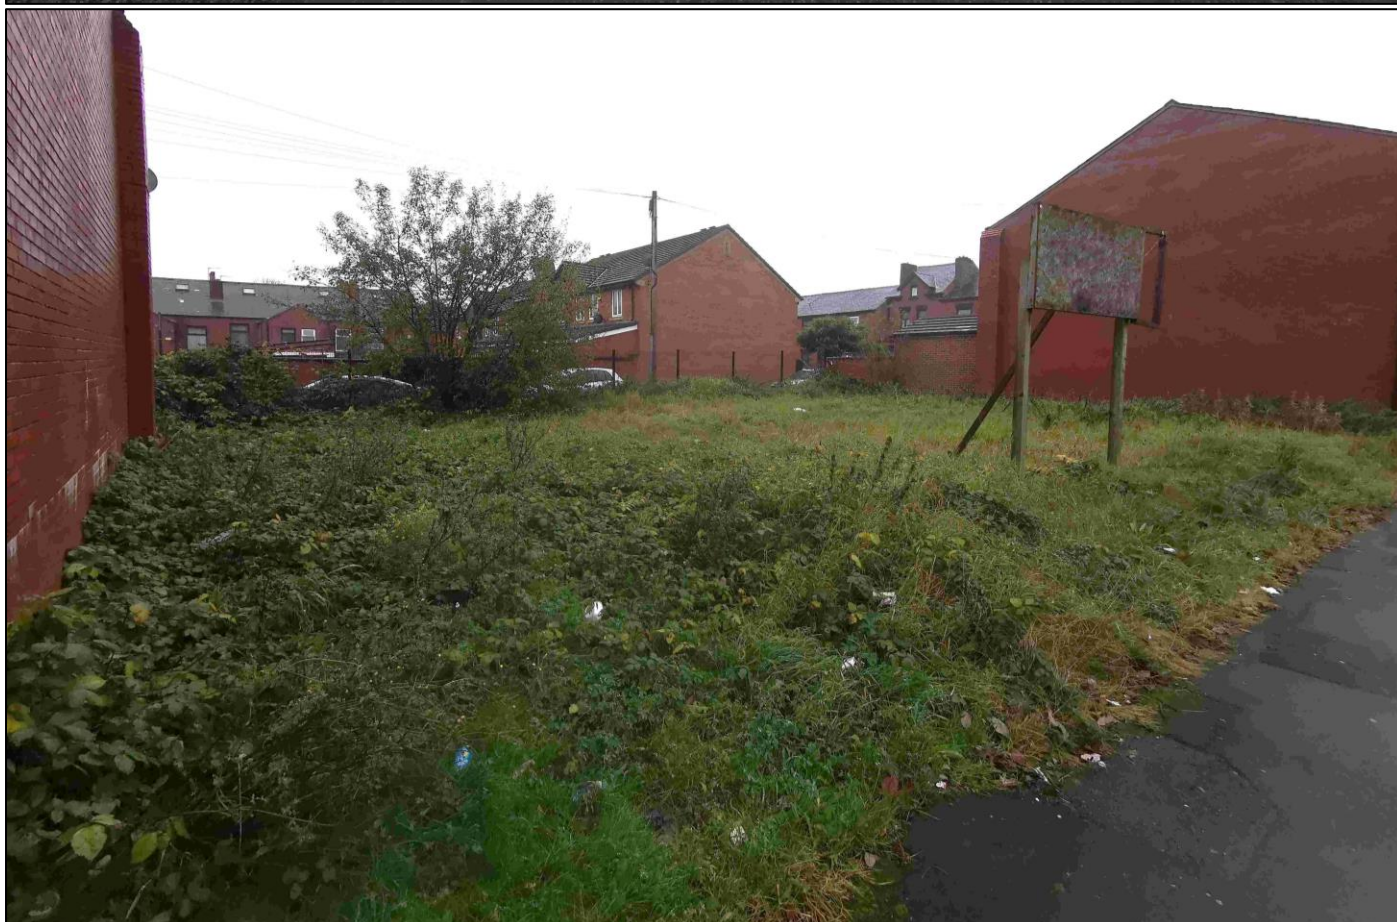
## 6.2. Reconnaissance 2023

The Site was unchanged from the earlier 2020 reconnaissance, apart from slightly higher vegetation, and minor general tipping. Refer to photos in Appendix.
