**Redrow Homes Limited**

# **Land at Stakehill, Rochdale**

**Coal Mining Risk Assessment**

**Report No. 322974-R02 (00)**

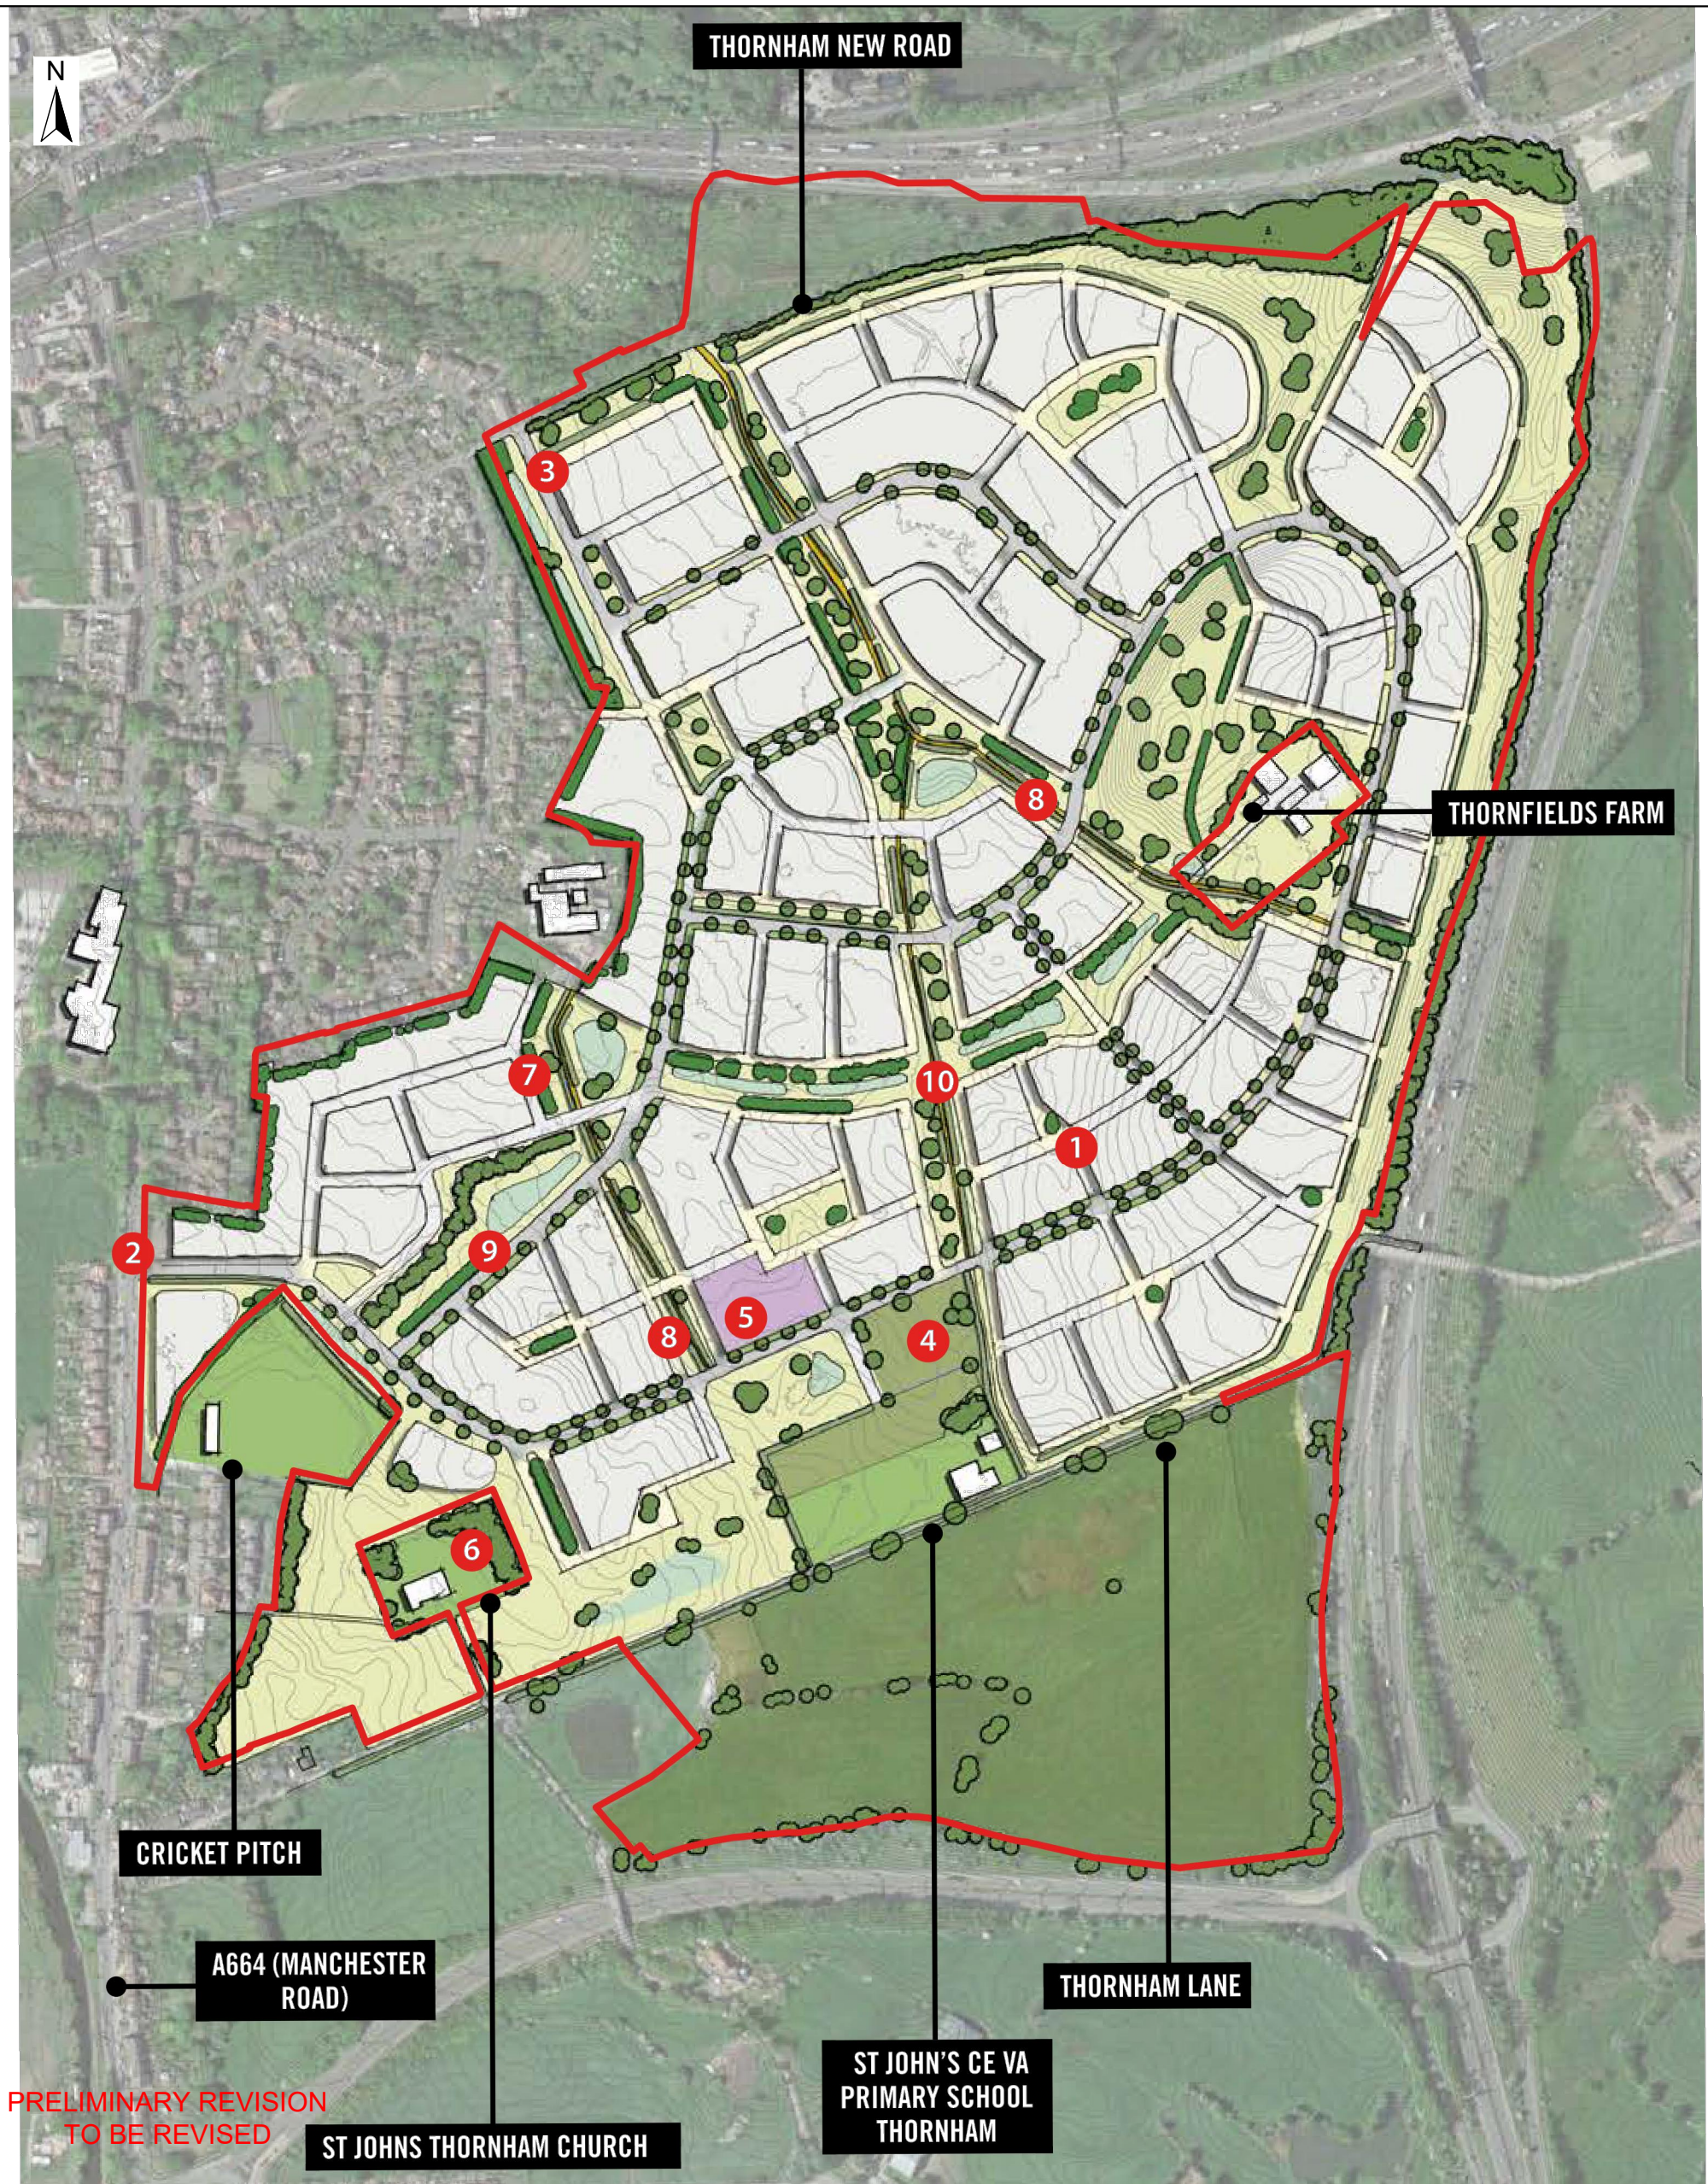
## **APPENDIX B    PROPOSED LAYOUT OF THE SITE**

The proposed layout of the site, at the time of preparing this report, is shown in Appendix B.

The site is to be developed for residential housing with associated access roads and private gardens with additional areas of soft landscaping plans planned.
