# GEO-ENVIRONMENTAL AUDIT

PHASE 1 Preliminary Risk Assessment

Proposed Residential Development

Land off Belfield Lane

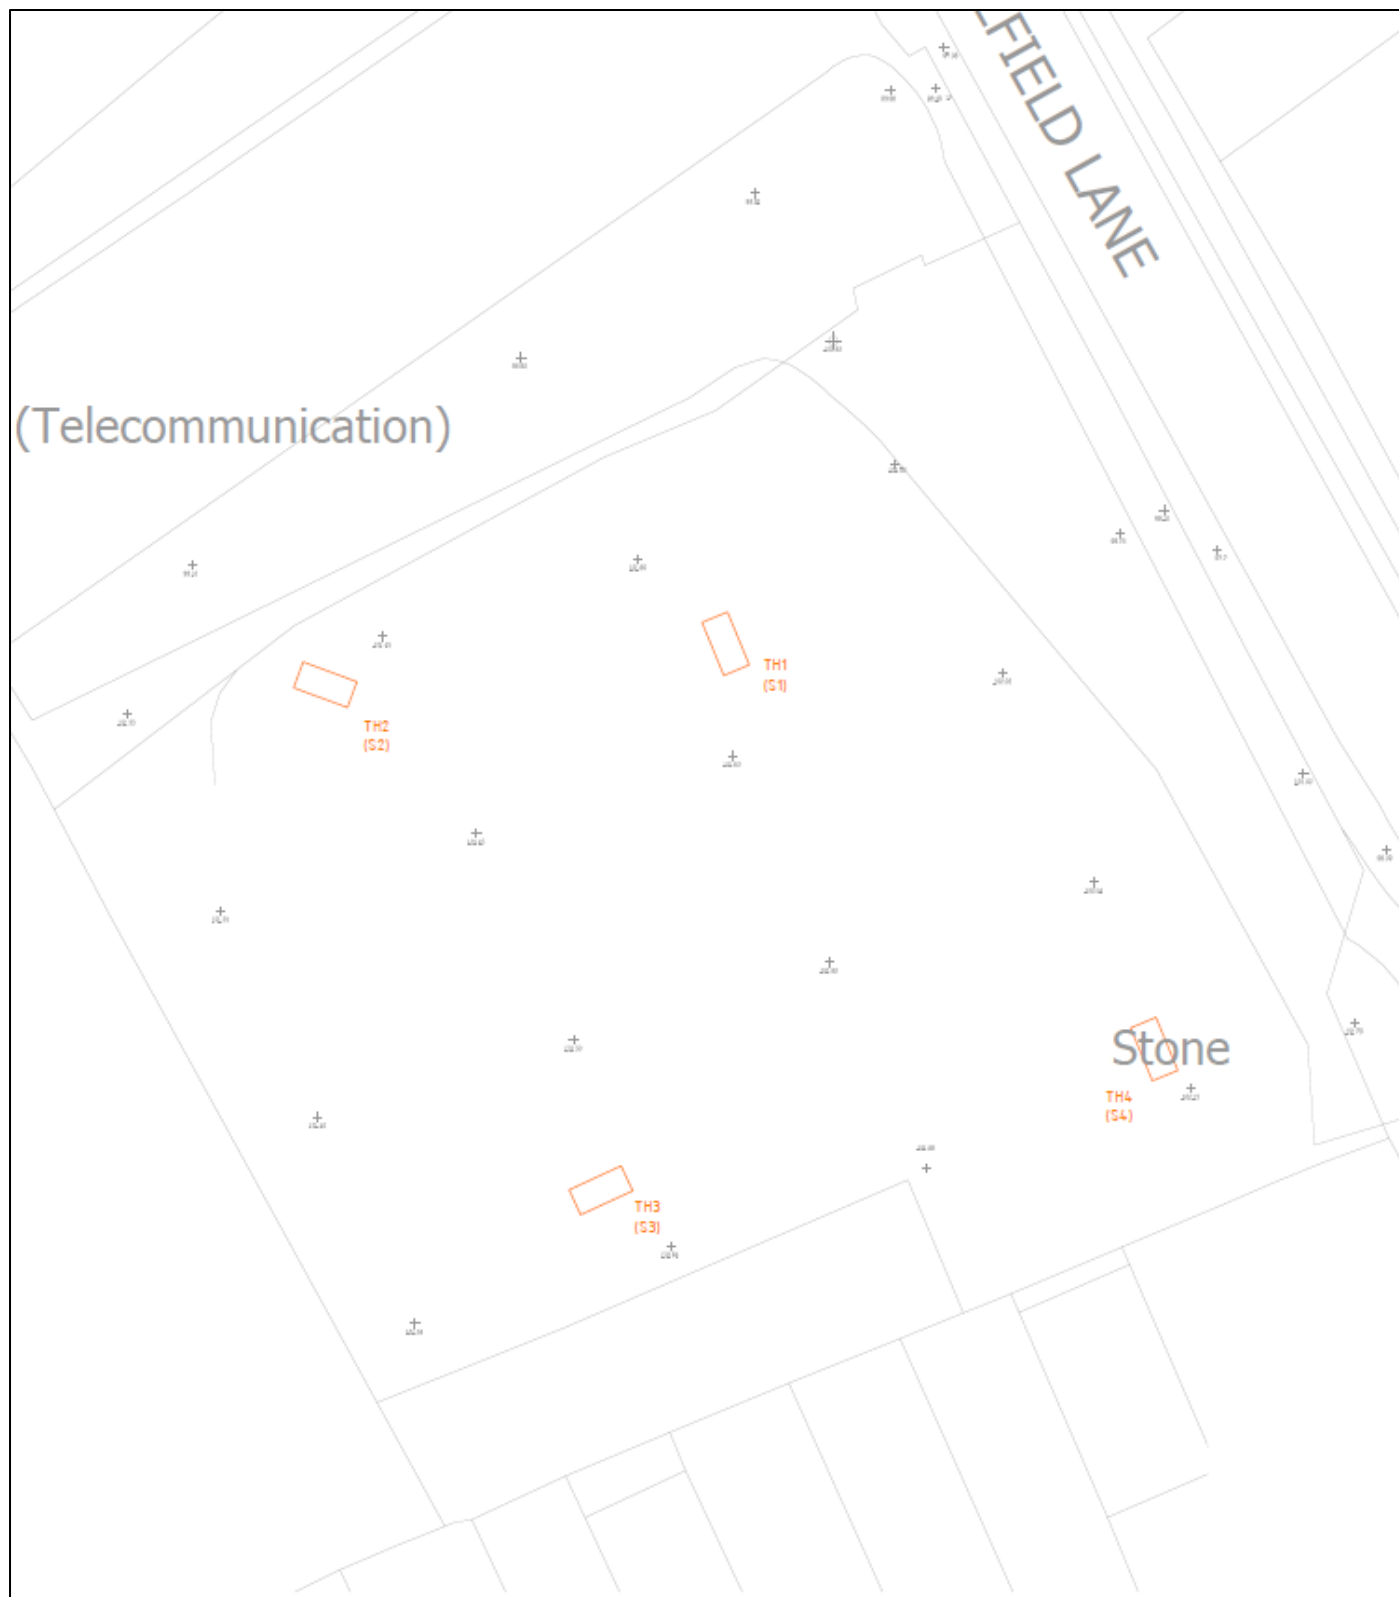
#### 4.4. Site Investigation Plan

Site Investigations were undertaken by T J Booth Associates and comprised 4No. machine excavated trial holes (THs 1-4), undertaken with a 3.5t back acting excavator.

Trial holes were located in a grid format around the Site to gain an understanding of the geology for future geotechnical design, and particularly to assess for potential shallow soil contamination due to the lack of specific contaminant sources noted in the data search.

4No. soil samples (S1-4) were taken from the upper made ground horizon in each trial hole.

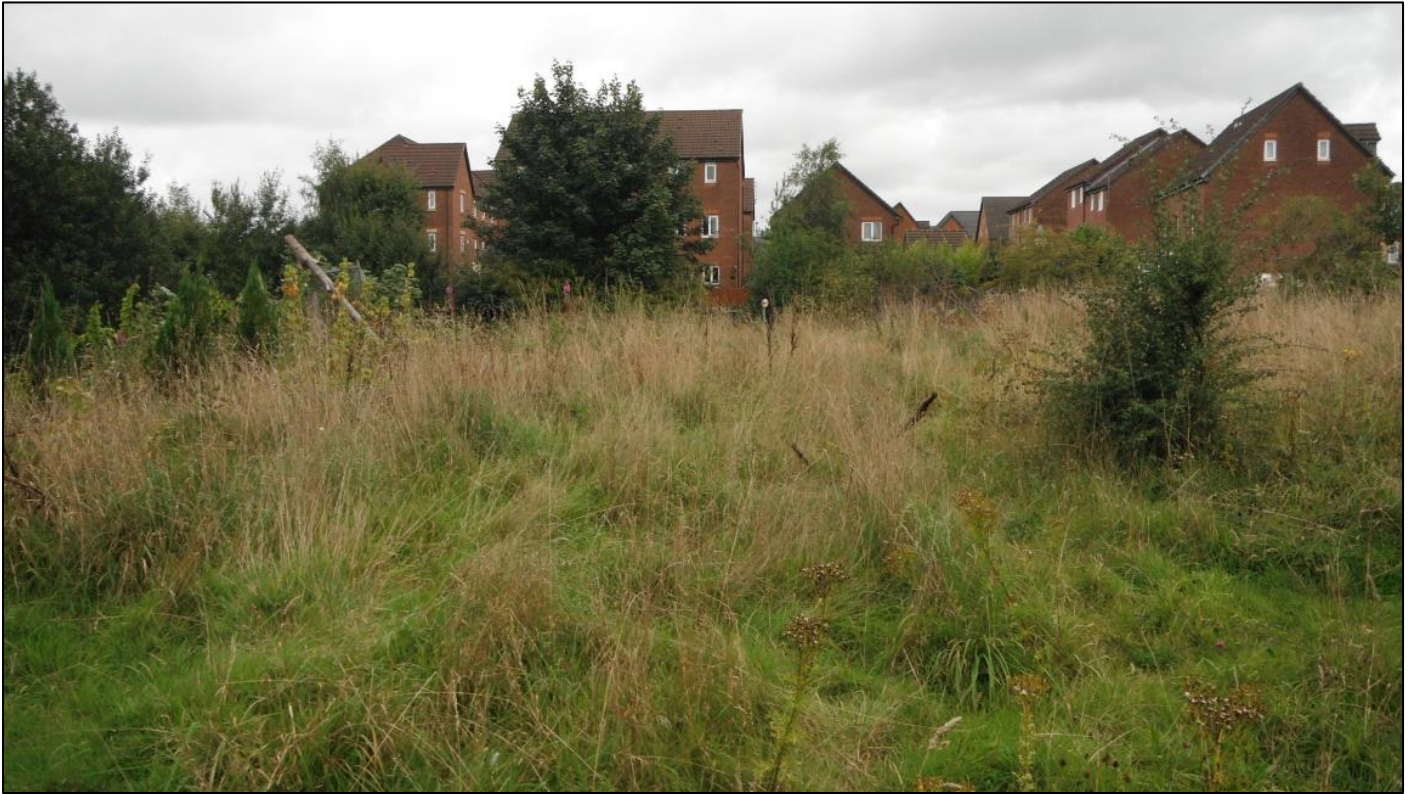
View towards northwest – 06.09.2017.

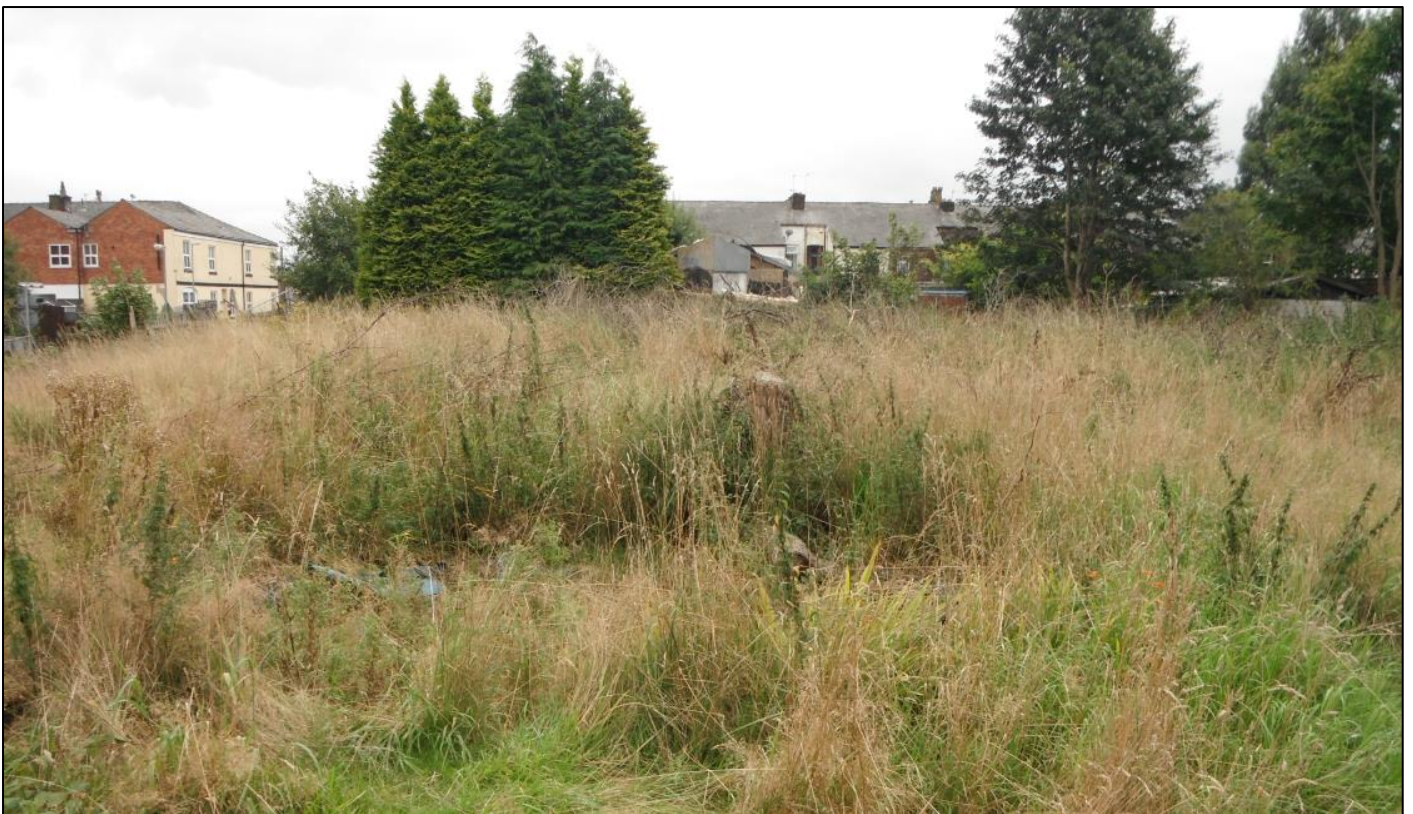
View towards southeast – 06.09.2017.

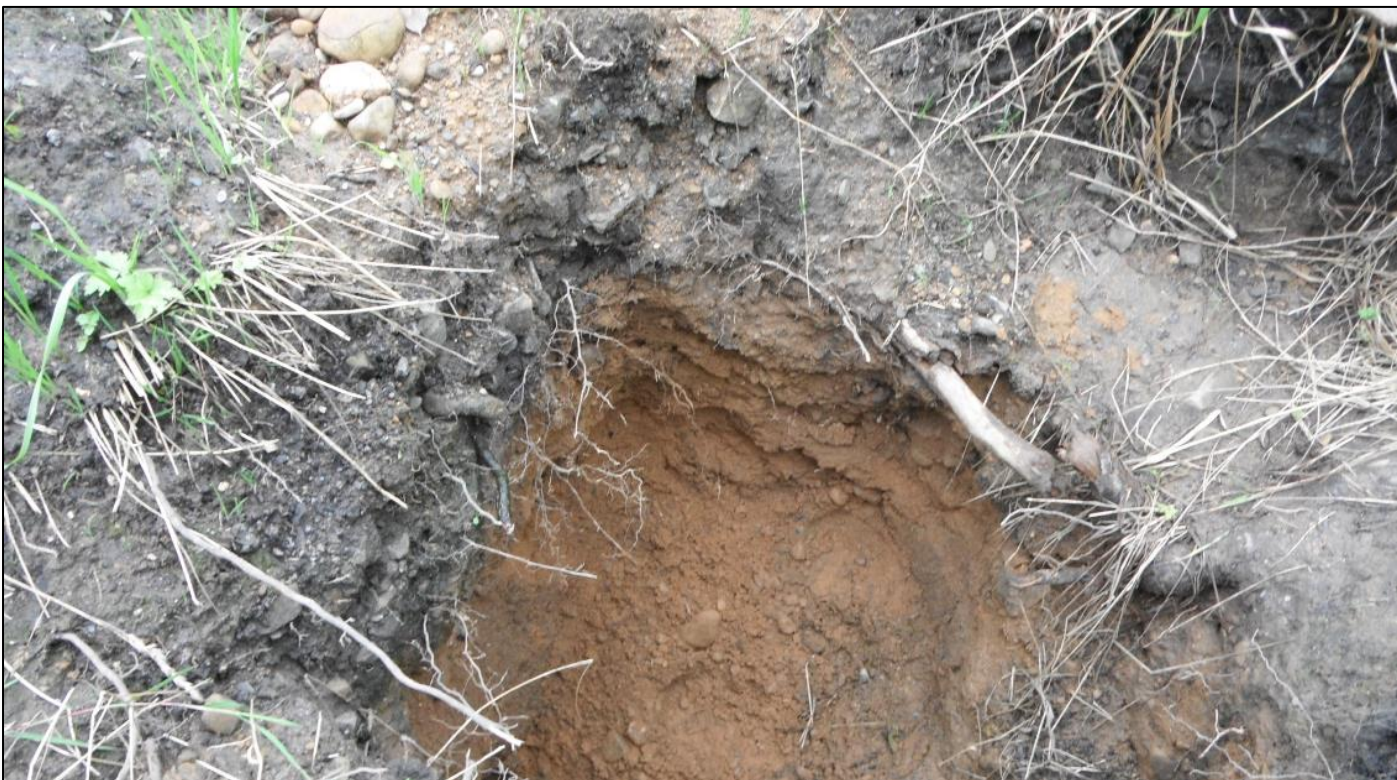
| Areas of discoloured soil, polluted water, vegetation, and significant odours: | A small excavation was noted approx 1.2m deep. The soil profile comprised approx 400mm dark brown/black ashy silty sandy stony topsoil/MADE GROUND above orange/brown SAND & GRAVEL. |

On reconnaissance, a small excavation was noted to the south side, and which enabled the profile of the shallow ground profile to be logged. The geology comprised approximately 400mm of MADE GROUND above SAND & GRAVEL.

Small excavation/fox hole showing sand & gravel – 06.09.2017.

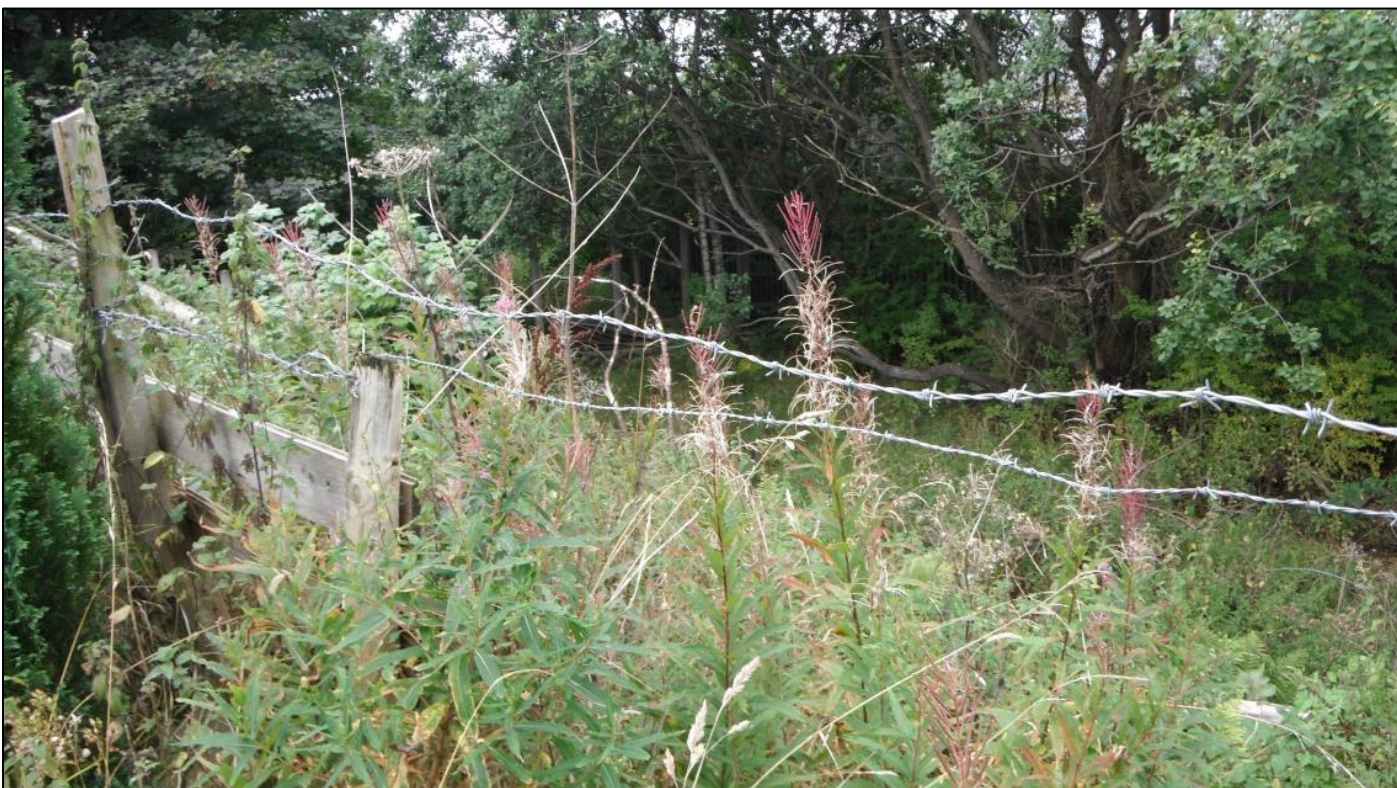
| Relevant ground levels, ground water levels, positions of wells and springs: | Site is relatively level, however at its greatest there is a fall to neighbouring land in the order of approx 4-5m to the N side/NE corner. |

View of the north boundary down the bank and towards the railway cutting.
