## GeoEnvironmental Site Investigation Report

Dobfield Road

Rochdale

**Report Ref: A5182/22/SI/V3**

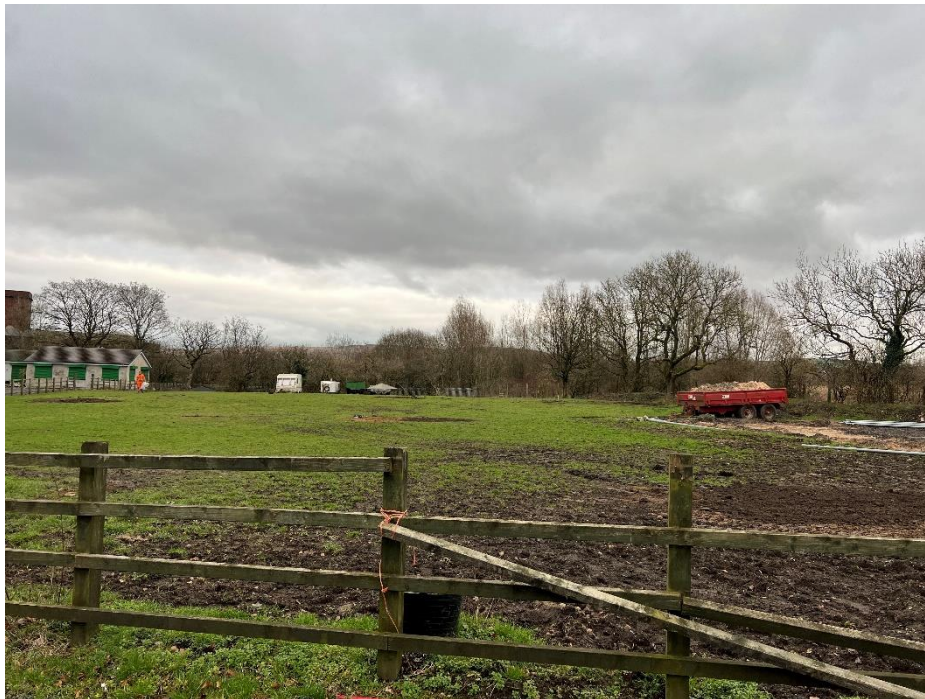
View across the site, looking southwest

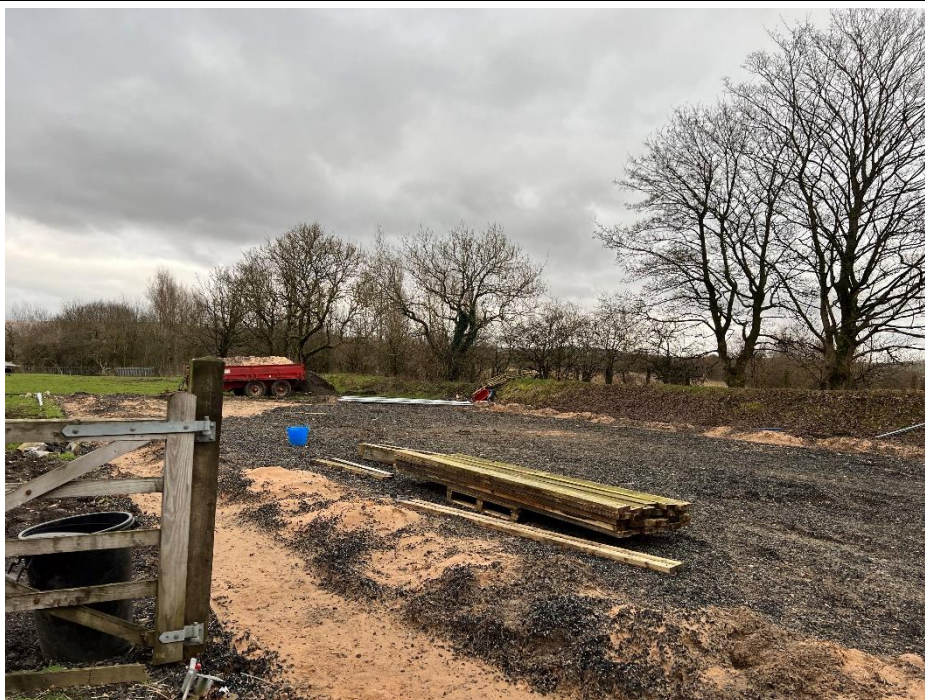
View across the training paddock, looking east

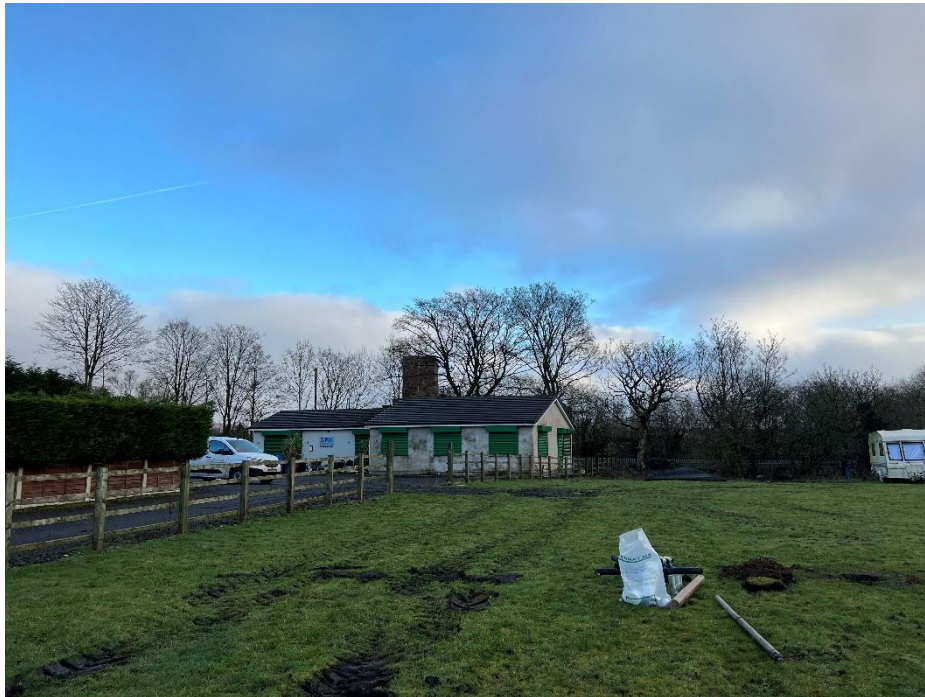
View of the on-site building, owned by PDTL, looking southwest

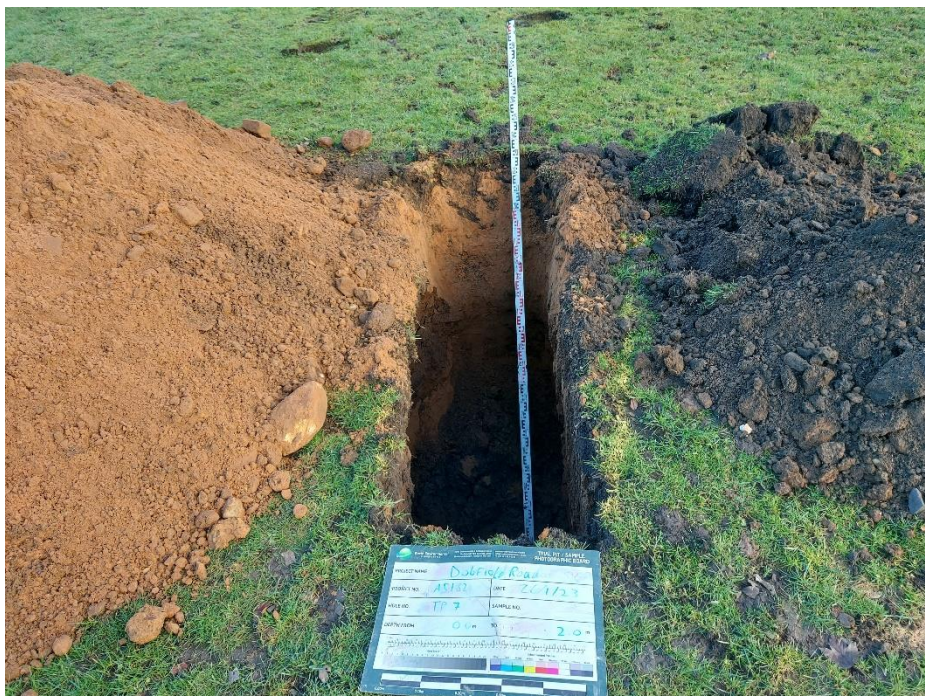
Photograph of representative soils (TP7)

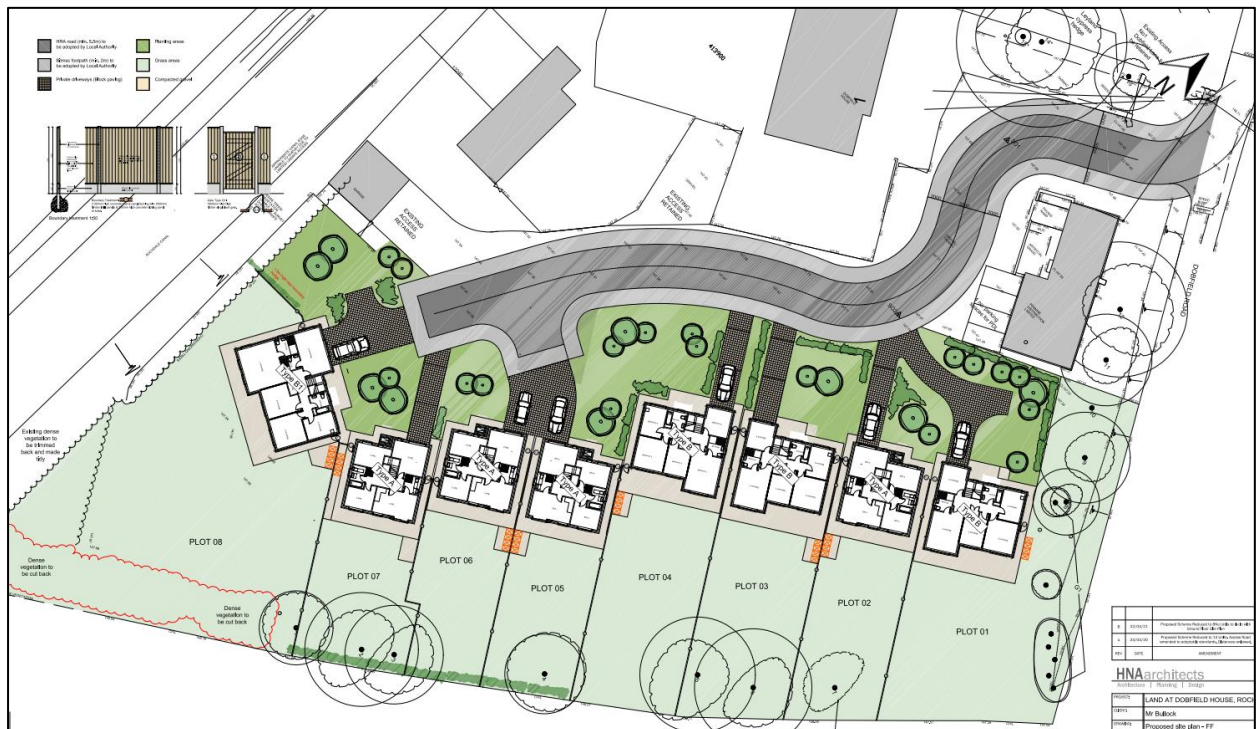
**Figure 3: Proposed Development Plan**

It is understood that the client intends to demolish all existing structures on-site and construct eight new, detached residential properties. The development will include private gardens and parking for each property, along with slight alterations to the existing access.
