# Arboricultural Impact Assessment

Hollingworth Lake High Nets

220104 1340 AIA V1

Rochdale Borough Council  
Number One Riverside  
Smith Street  
Rochdale  
Lancashire  
OL16 1XU

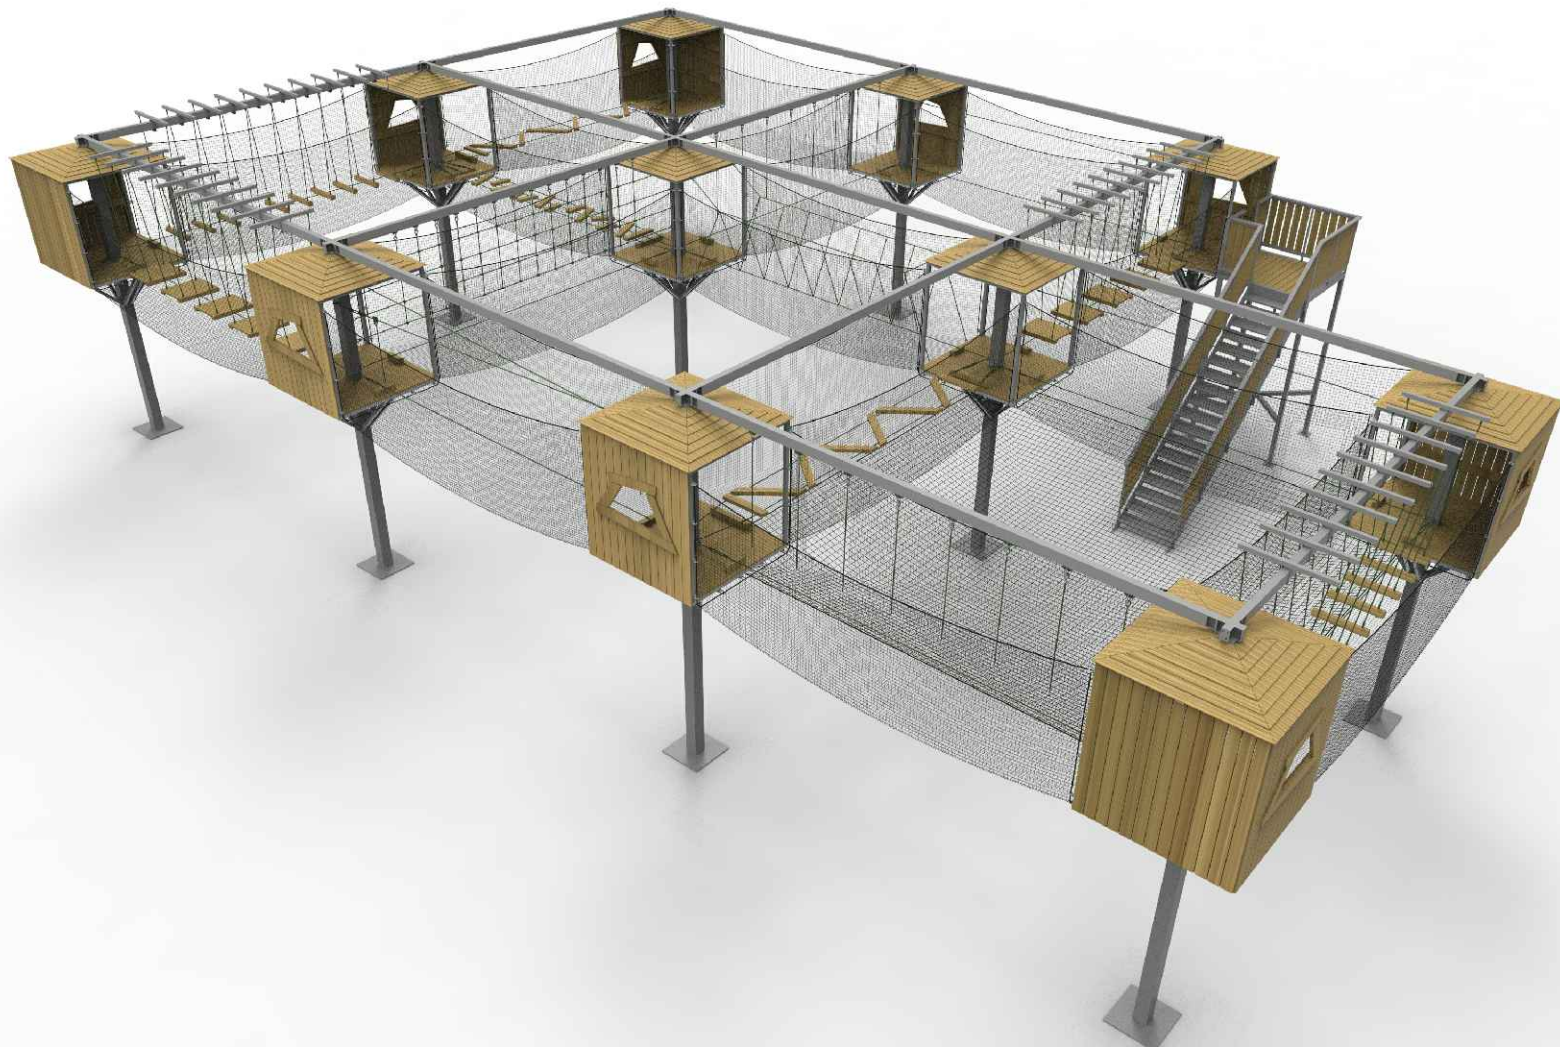
Image displaying the proposed High Nets Course
