# Bat

# Presence-Absence Survey

Unicorn House

Signature Estates (NW) Ltd

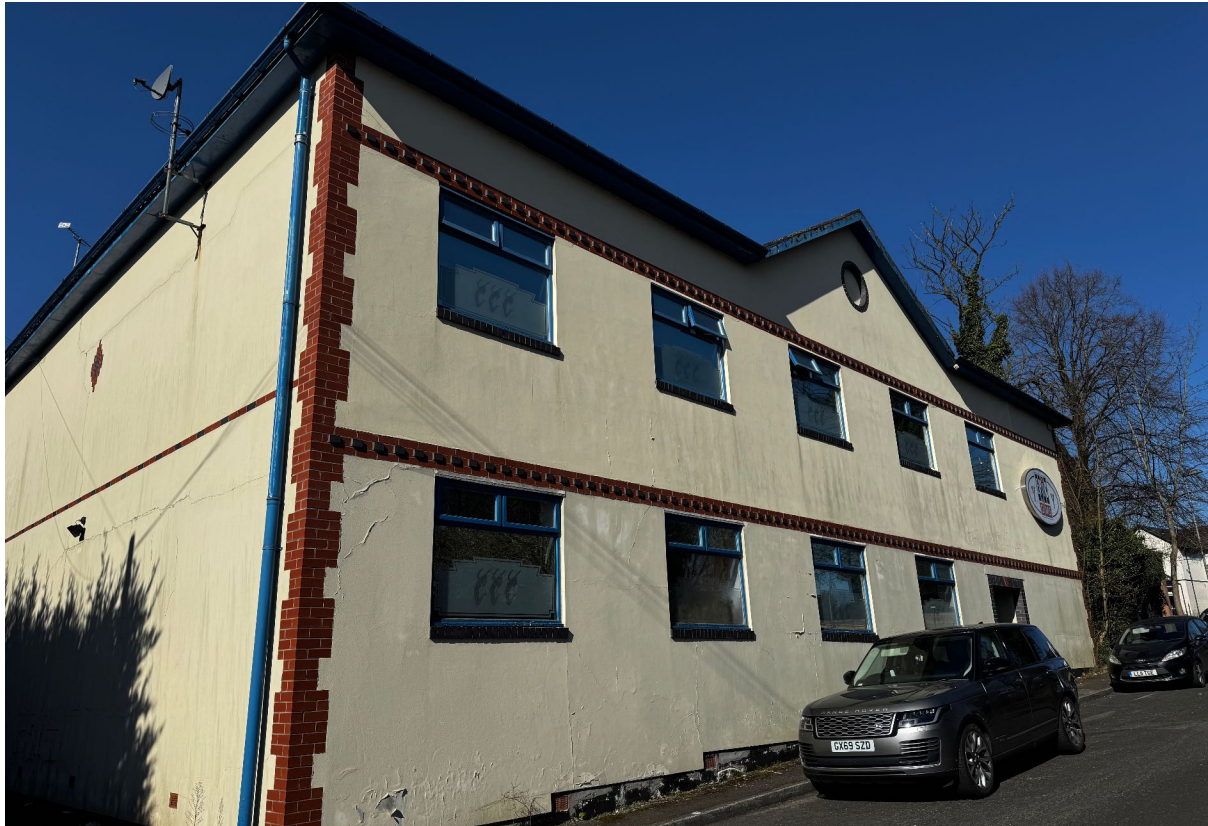
3.1a - The front of the building, from Cheetham Street.

Unicorn House is a former fitness club, which is currently empty and un-used. The building has two distinct sections as described below. The eastern section of the building adjacent Cheetham Street is two storey height, with a pitched hipped roof, covered with bitumen tile-effect roofing sheets. Internally there is a single roof void. The roof has a timber trussed structure, lined with bitumen felt. The pitched roof has been constructed on top of a flat concrete roof.

The rear, western section of the building has a pitched roof covered with bitumen tile-effect roofing panels, with Velux skylight windows. Internally there is no enclosed roof void and ceilings are fully vaulted. The roof has a timber rafter and purlin structure lined with bitumen felt.

Roof pitches face north, south, east, and west. Lead flashing was fitted at the base of flues, in roof valleys, and where roofing materials abut brickwork. However, much of the leadwork has been stolen. Painted timber fascia boards and boxed soffits are fitted at the eaves. Walls are brick with an insulating cavity, with a white painted cement render. Concrete lintels are fitted, sills are brick; window and door frames are timber, all glass is intact.

The building is in reasonable condition, although there are some features present which could be used by roosting bats. In particular where lead flashing has been removed, and where timber fascia boards have perished.
