**Indigo** Ltd  
S u r v e y s

Ken Mills, Rochdale

Preliminary Roost Assessment (PRA)

28<sup>th</sup> June 2024

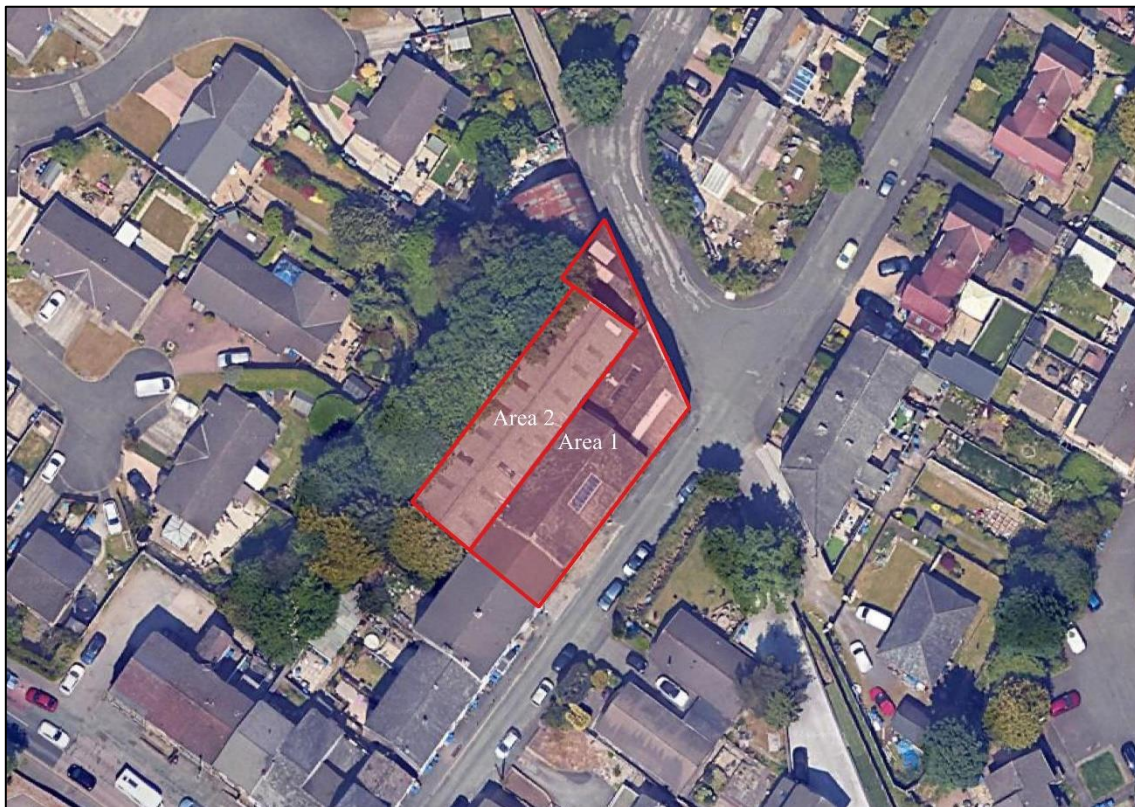
Figure 1: Showing the extent of the surveyed area.

2.2.2. The building comprises two areas, an existing single and two storey factory building (Area 1), and a large metal framed building to the rear (Area 2). For the purpose of this survey the two sections of the building have been dealt with separately.

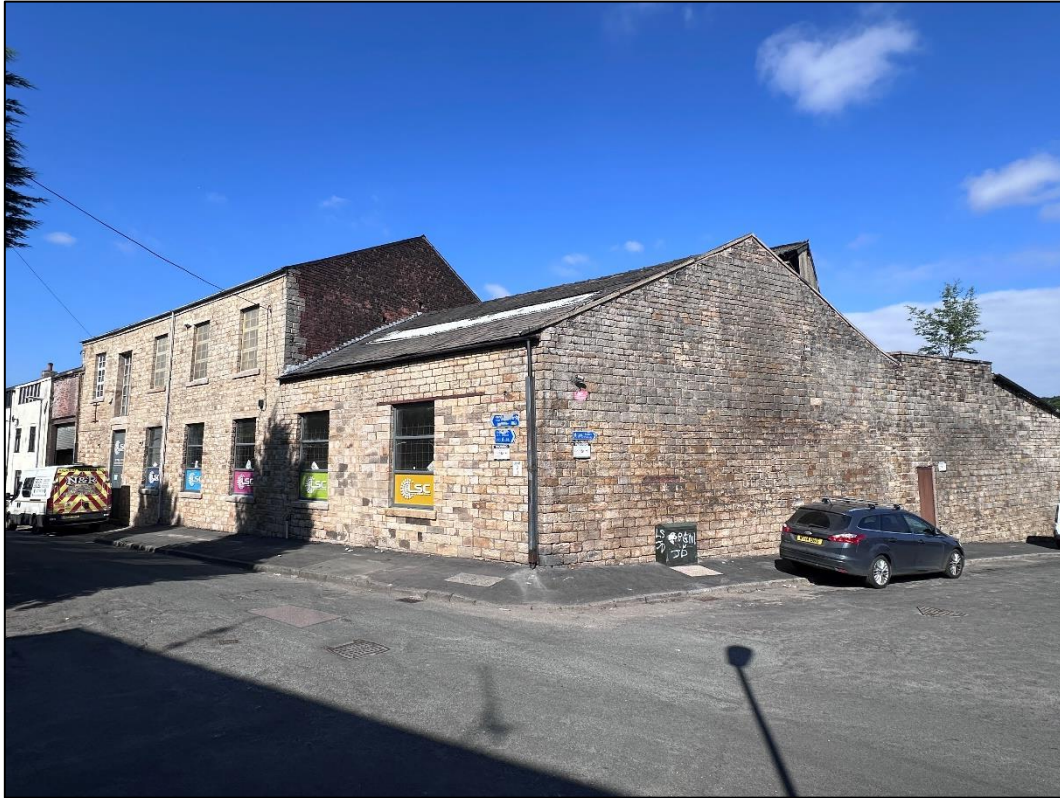
2.2.3.1. Area 1 comprises a single and two storey brick and stone factory that makes up the frontage of the site, along New Street and Sweet Briar Close. The windows to the front of the building are wood framed with the windows to the rear predominantly infilled with concrete blocks. A large roller door is present in the southern section of the frontage, providing vehicle access into the building.

Figure 2: Area 1 of the building, viewed from the northeast.

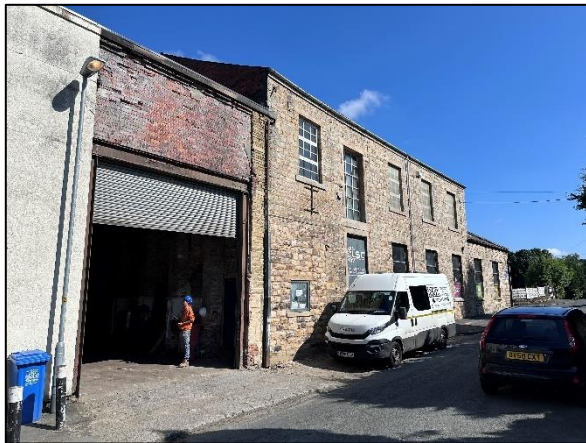
Figure 3: Area 1 of the building, viewed from the south.

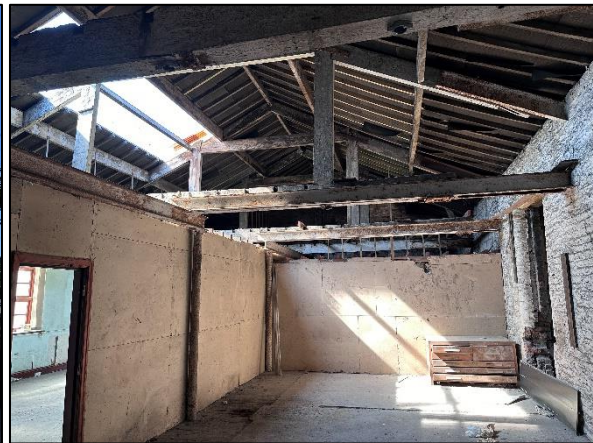
Figure 4: The interior of the two-storey section of the building.

2.2.3.4. Internally the building comprises a series of separated rooms within the two-storey section of the building, with the 1<sup>st</sup> floor rooms predominantly open into the roof void, due to the ceilings having been removed, apart from a small area to the south of the building. The single storey areas of the building are open into the roof void.

4.2.2.6. Internally the building was found to display queen post timbers with a bituminous lining felt inside of the two-storey sections of the building with a boarded ceiling present into the roof void of the single storey areas.

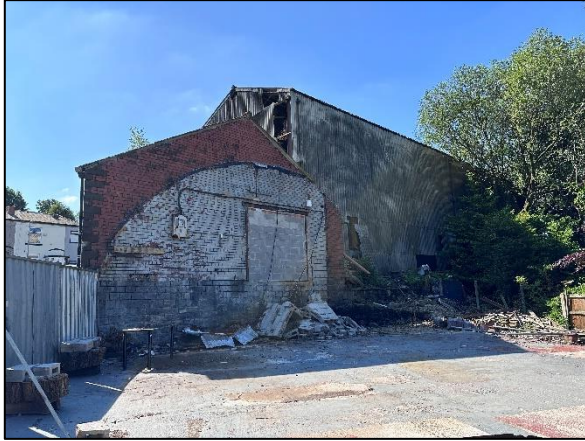
2.2.4.1. Area 2 comprises a large metal framed building located to the rear of Area 1. The building is clad with concrete sheets with a pitched concrete sheet roof.

Figure 5: Area 2, the large metal framed structure.

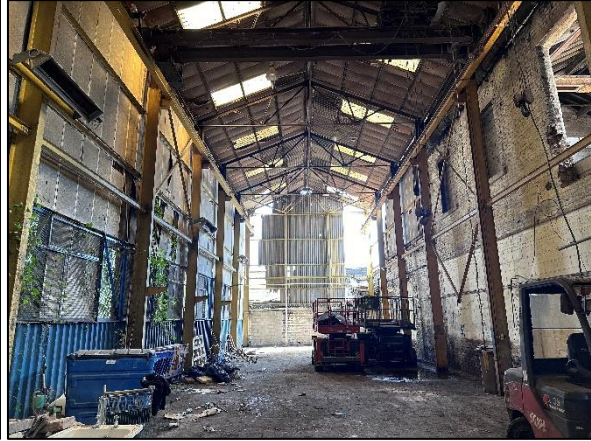
Figure 6: The interior of Area 2.

2.2.4.2. Internally the area comprises a single room that is open to the inside of the cement sheets. The building is directly connected to the internal spaces within Area 1 through a window opening towards the centre of the building and the vehicle access to the south.

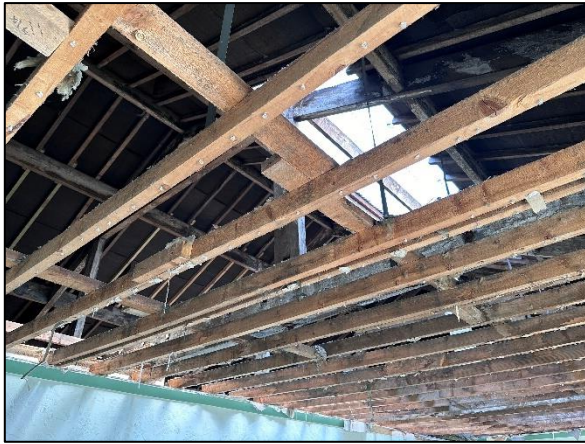
*Figure 8: Removed ceilings within Area 1.*

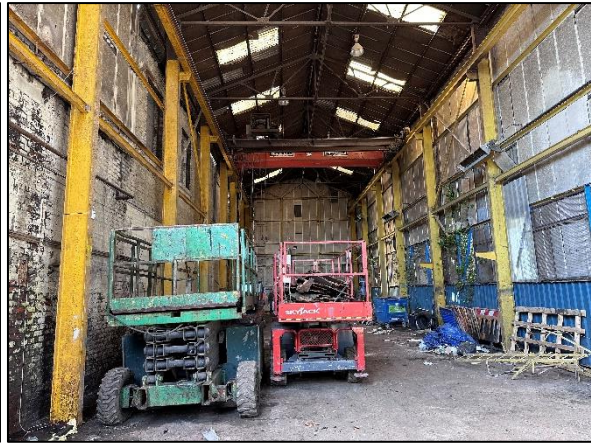
*Figure 9: Machinery due to ongoing works in Area 2.*

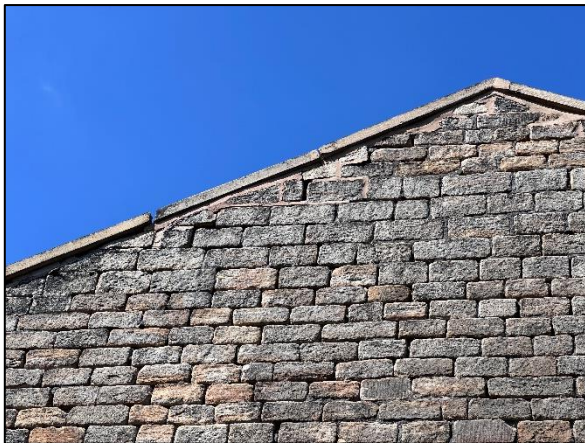
4.2.2.1. The walls of Area 1 were found to be in a generally good condition but displayed an abundance of voids due to missing pointing and dislodged or missing stones and bricks.

Figure 10: Voids in the stonework of the building.

5.1. It is recommended that no further works commence on the building prior to further bat activity surveys being carried out, in line with the Bat Conservation Trust (BCT) Good Practice Guidelines (2023).

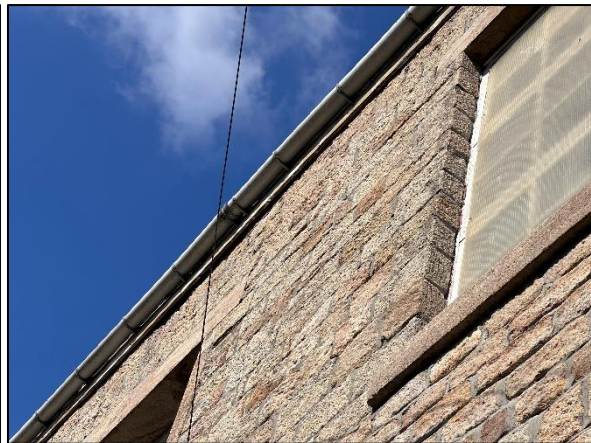
4.2.2.2. The fascia boards to the front of the building were not tight to the stonework providing access behind the fascia boards and potentially to the wall tops.

Figure 11: Voids behind the fascia boards.

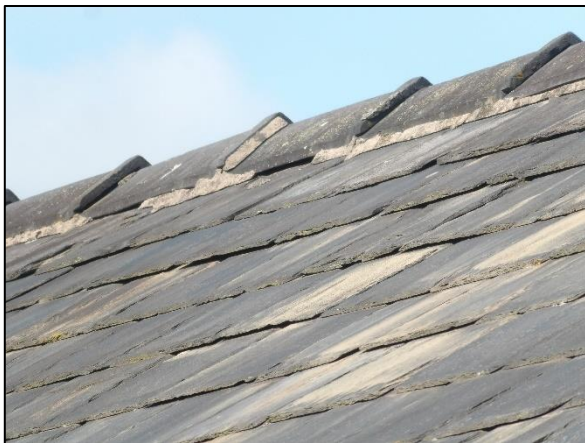
4.2.2.3. The slate roofs of the building were found to be in a generally good condition although several voids were identified leading under slightly lifted or dislodge ridge tiles and areas of leadwork on the southern section of the building.

Figure 12: Voids under the ridge tiles.

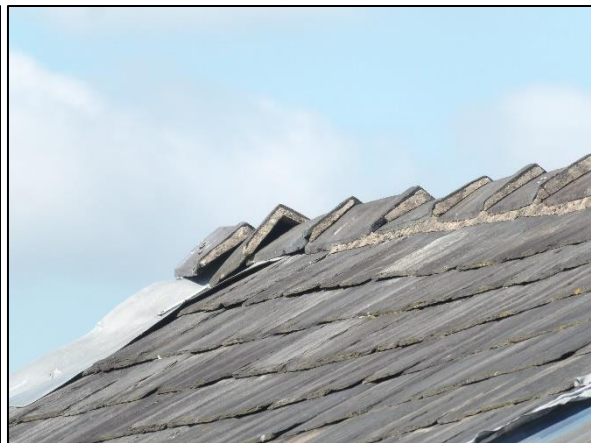
Figure 13: Dislodged ridge tiles and gaps under leadwork.

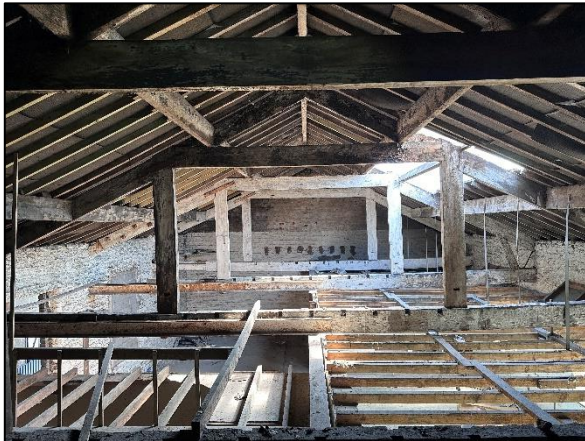
Figure 14: The roof structure in Area 1.

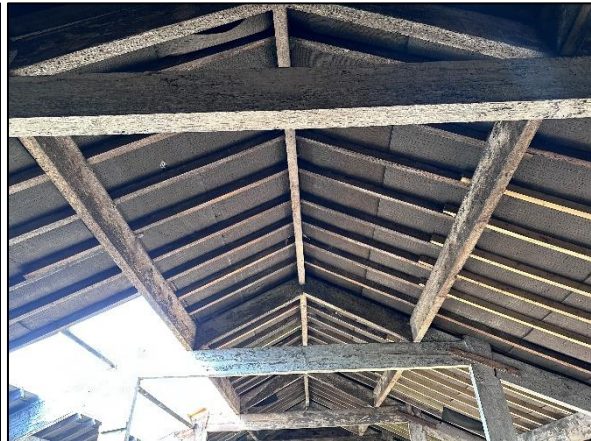
Figure 15: The bituminous lining felt present in Area 1.

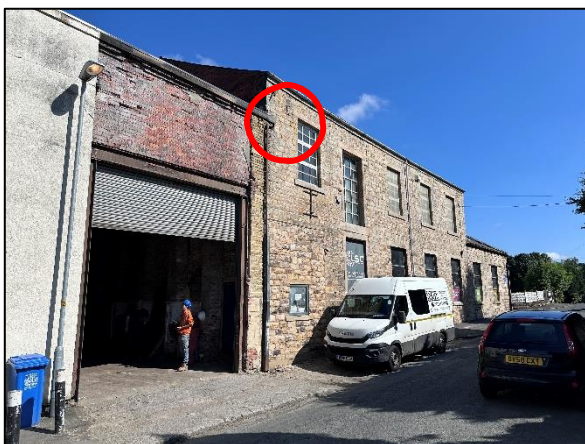
4.2.2.9. During the survey a house sparrow (*Passer domesticus*), a species on the UK Birds of Conservation Concern (BoCC) red list, was identified entering a void in the stonework on the front of the building, as shown in Figure 16, implying the presence of a nest in that location.

Figure 16: The location of the sparrow nest (circled).

5.6. It is recommended that no works are carried out in the vicinity of the sparrow nest, identified in the front of the building, until the young have fledged from the nest.

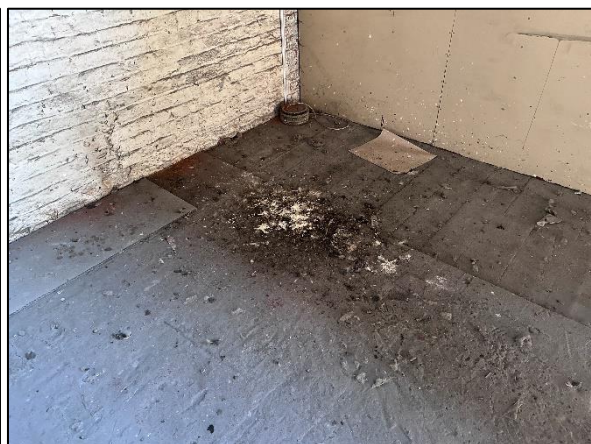
Figure 17: Tawny owl field signs.

4.2.2.10. Abundant feathers, droppings and pellets were identified throughout the two-storey areas of the building with the signs implying that tawny owls (*Strix aluco*), a species on the UK BoCC amber list, use the building as a feeding perch or nest site. No active nest was identified in the building at the time of the survey.

5.7. It is recommended that any works on the building avoid the nesting season, which is March to September, where possible. Any works that are carried out during the nesting season should be immediately preceded by a thorough nesting bird survey, carried out by a suitably experienced surveyor. Any nests identified must remain undisturbed until the young have fledged from the nest.

5.8. As an enhancement to the site, it is recommended that consideration is given to including bat and bird boxes in the buildings during the development. It is also recommended that consideration is given to including a tawny owl nest box in a suitable location on site during the development.

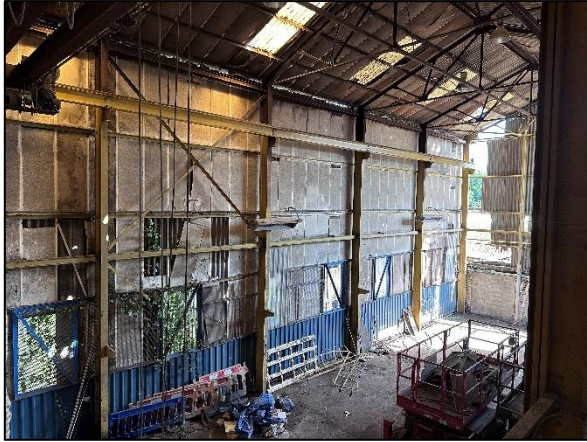
*Figure 18: The interior of Area 2, viewed from Area 1.*

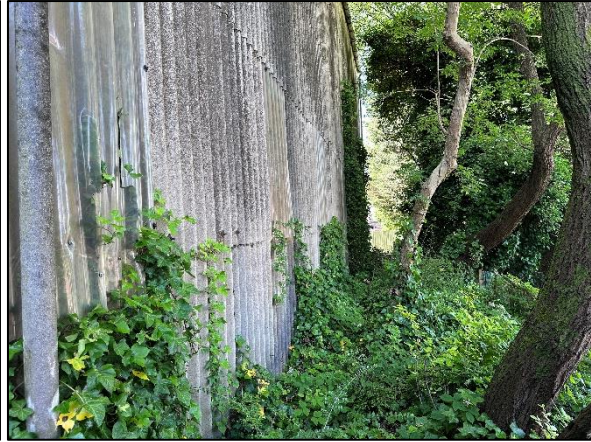
4.2.4. The trees to the rear of the building were inspected from the site side and no Potential Roost Features (PRF) were identified. However, the trees could not be thoroughly inspected from all sides and were therefore assessed to provide Further Assessment Required (FAR) suitability for roosting bats. Any works that impact the trees, either directly through removal of the trees, or indirectly, through increased levels of disturbance and changes in lighting or noise, may impact on roosting bats if they are present in the trees.

*Figure 19: The tree line to the rear of the building.*

5.4. It is recommended that the trees to the rear of the building are retained during the proposed development. If there is a need to remove any of the trees it is recommended that the works are preceded by further surveys of the trees, commencing with a ground assessment including full access around the trees, and a re-assessment of the likely impact on foraging and commuting bats.
