SMITHY BRIDGE ROAD,  
LITTLEBOROUGH

PHASE 2 GEO-ENVIRONMENTAL  
INVESTIGATION, RISK ASSESSMENT  
AND REMEDIATION STRATEGY

**Job Number:** LKC 22 1183

**Client:** Taylor Wimpey Strategic Land (North)

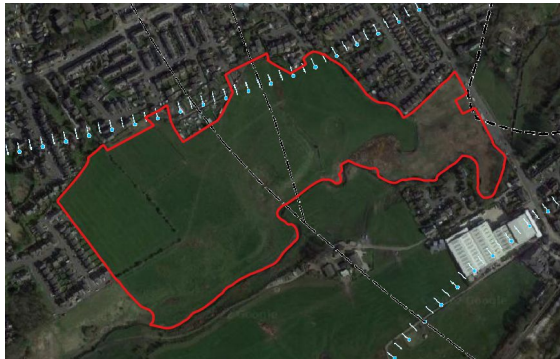
Plate 2-1: Extract of superficial geology mapping.

Although not discussed in the Betts Geo Environmental Ltd (PRA Ref: 17TAY040/DS, dated August 2017), according to the BGS online 1:50,000 linear features and Sheet 76 1:50,000 BGS digital mapping dated 2008, the site is located within a glacial channel. This is shown in Plate 2-1 below.

| Categories | | | Details |
|---|---|---|---|
| | Superficial | | -Till/Devensian (gravelly sandy CLAY) across the majority of the site.<br>-Alluvium (Clay, Silt, Sand and Gravel) across the south of the site.<br>-Landslip deposits against the southern boundary in the centre of the site.<br>-Site located in glacial channel, see Plate 2-1. |

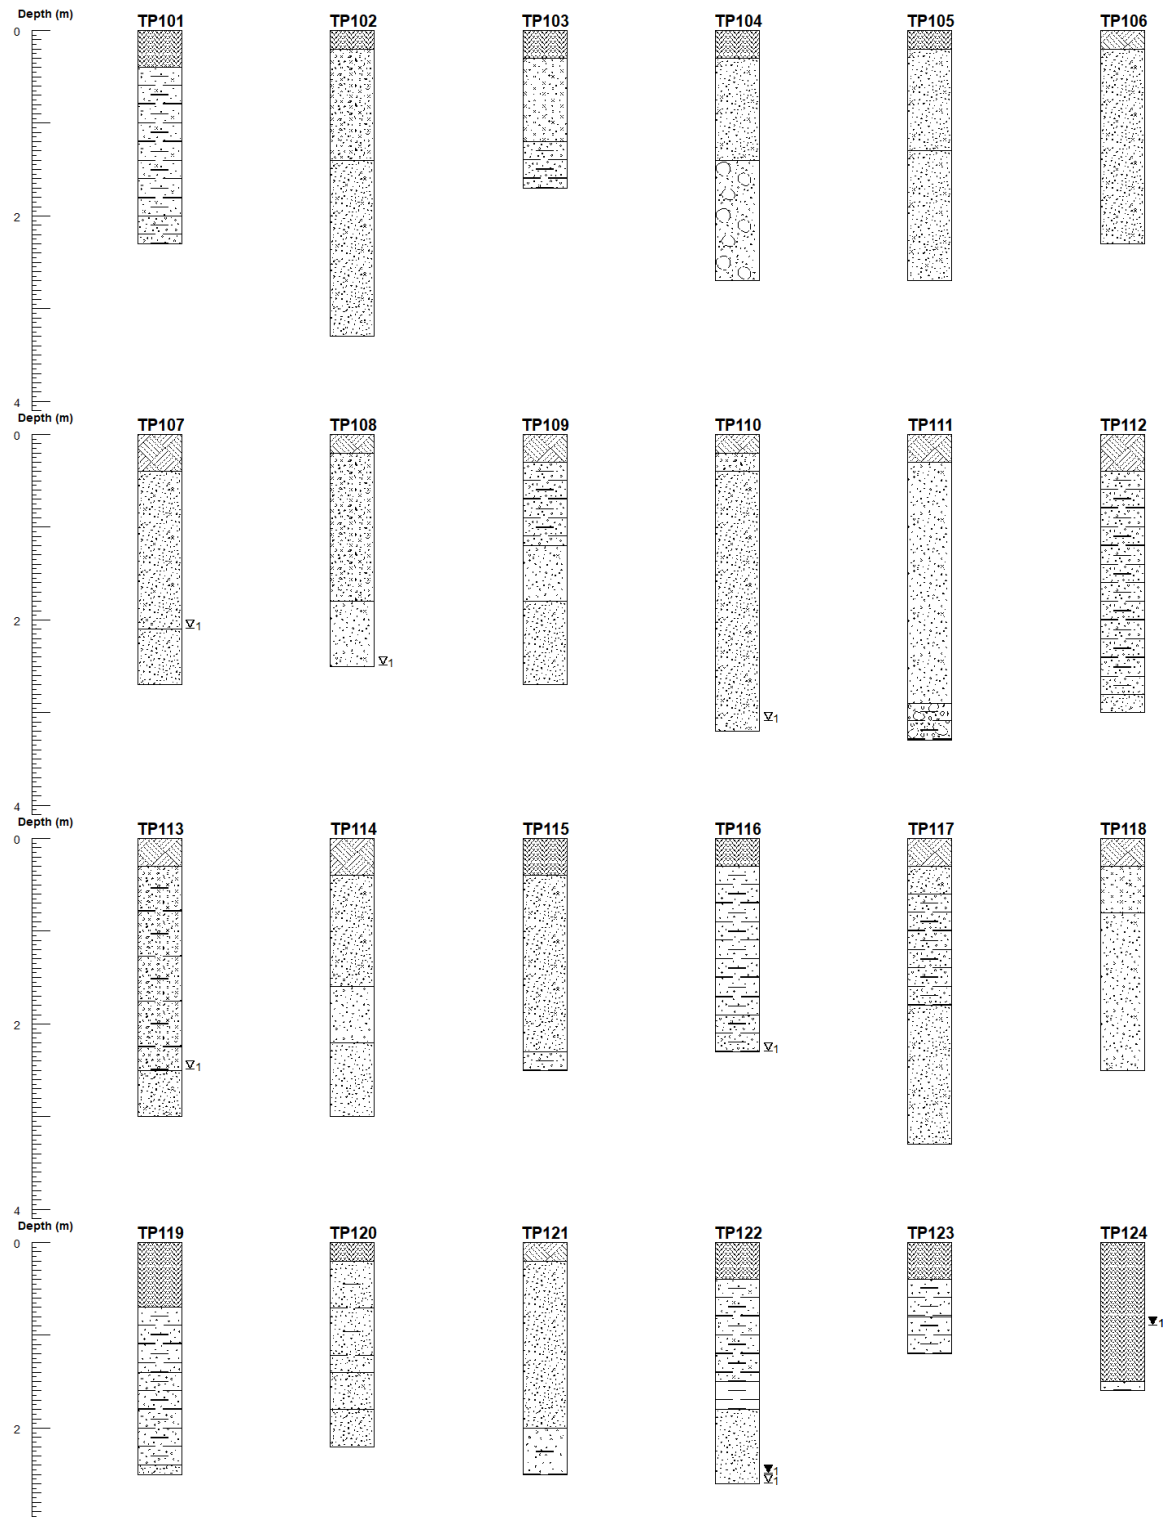
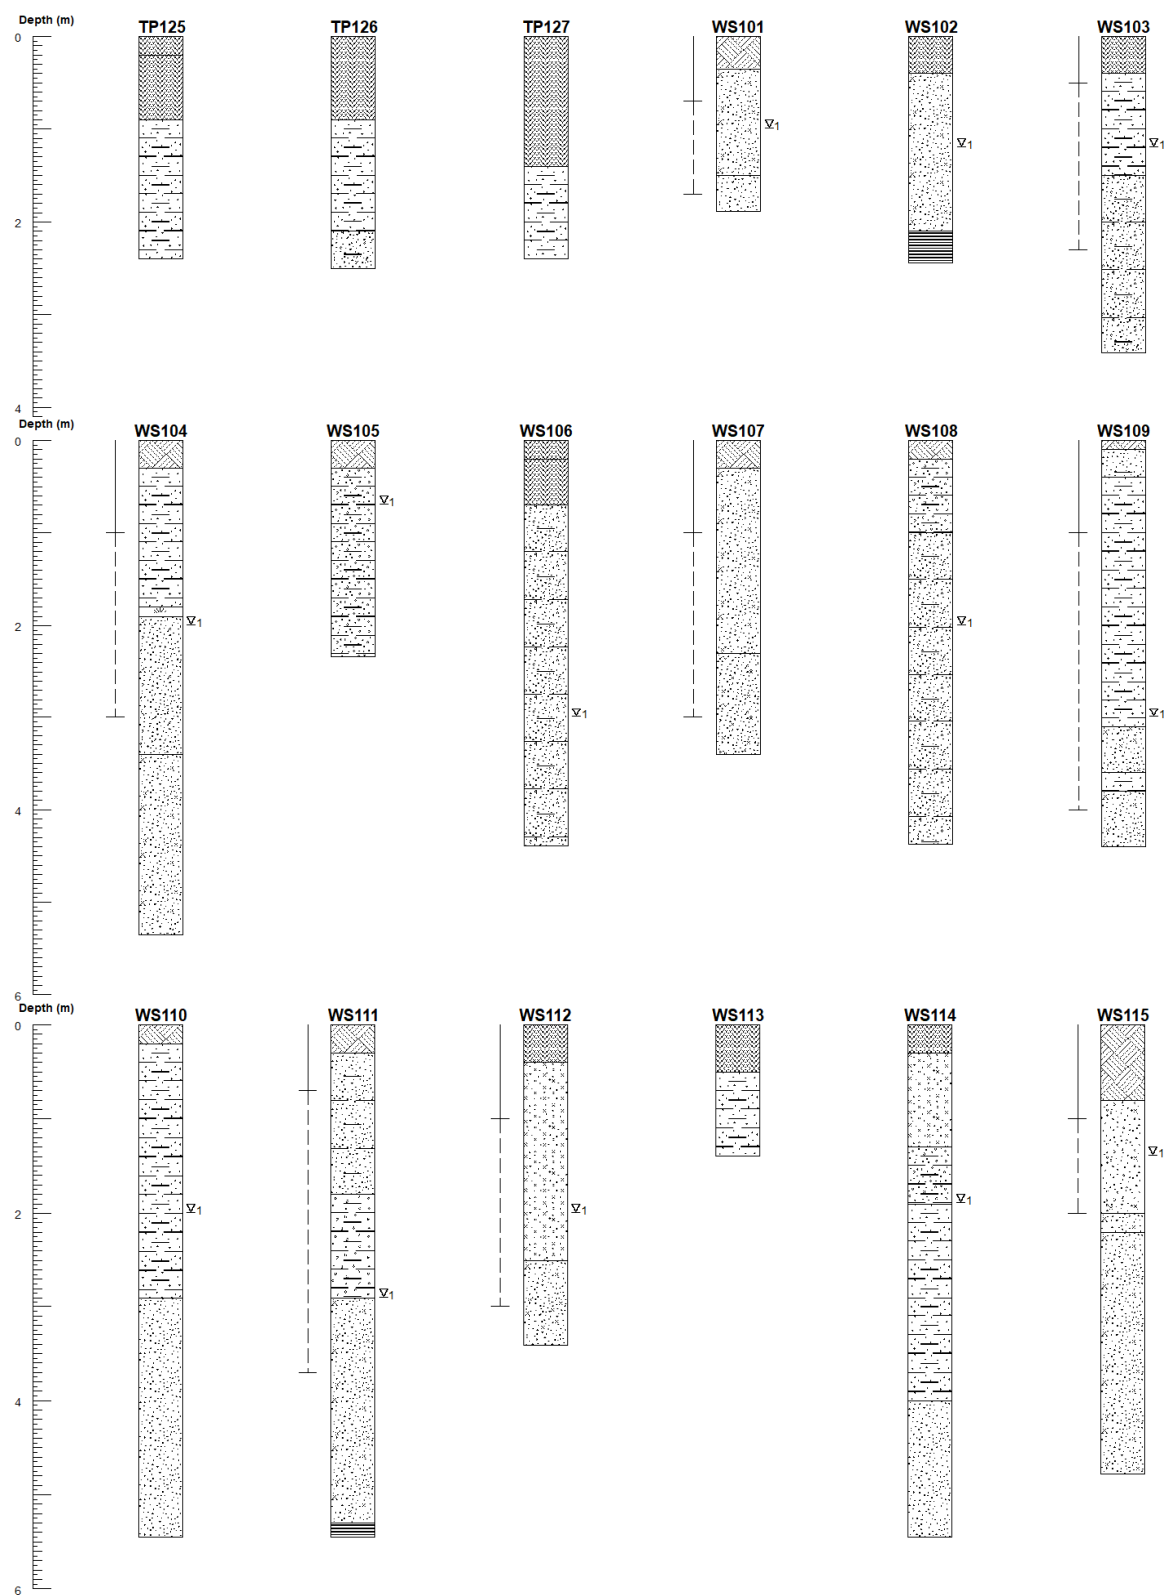
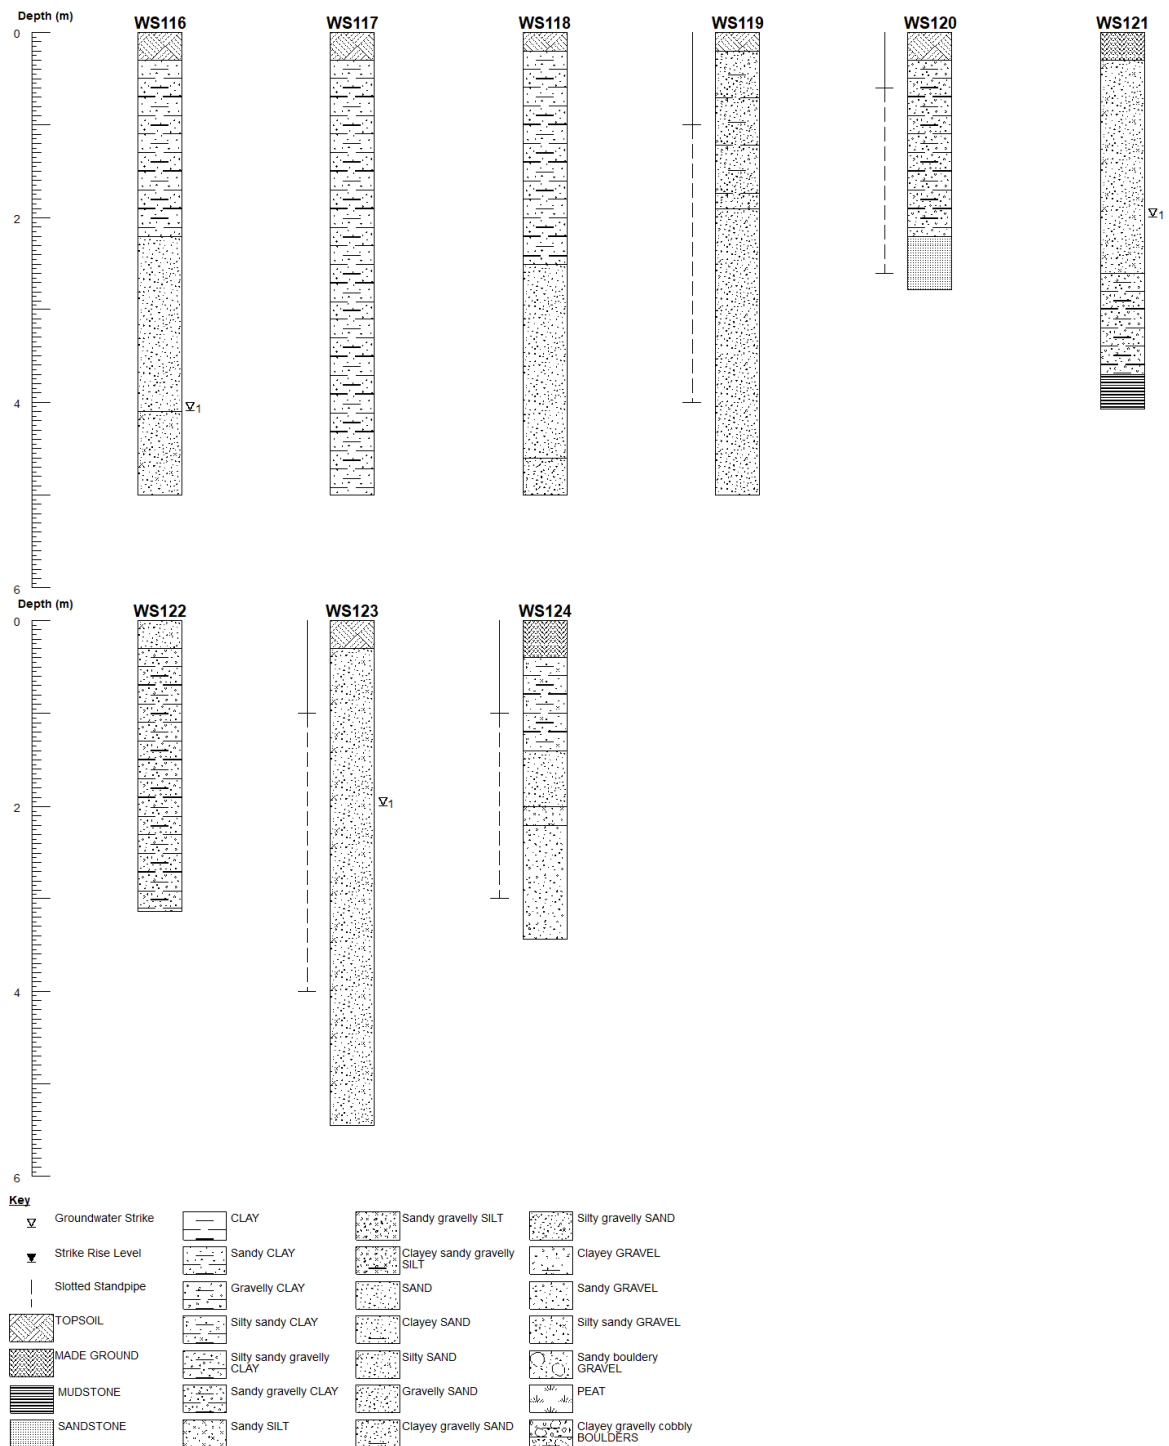
Plate 4-1: Summary of ground conditions.

The ground conditions beneath the site comprised thin reworked sandy topsoil underlain by natural sands and clays. A summary section of the logs is provided in Plate 4-1, with additional comments below.

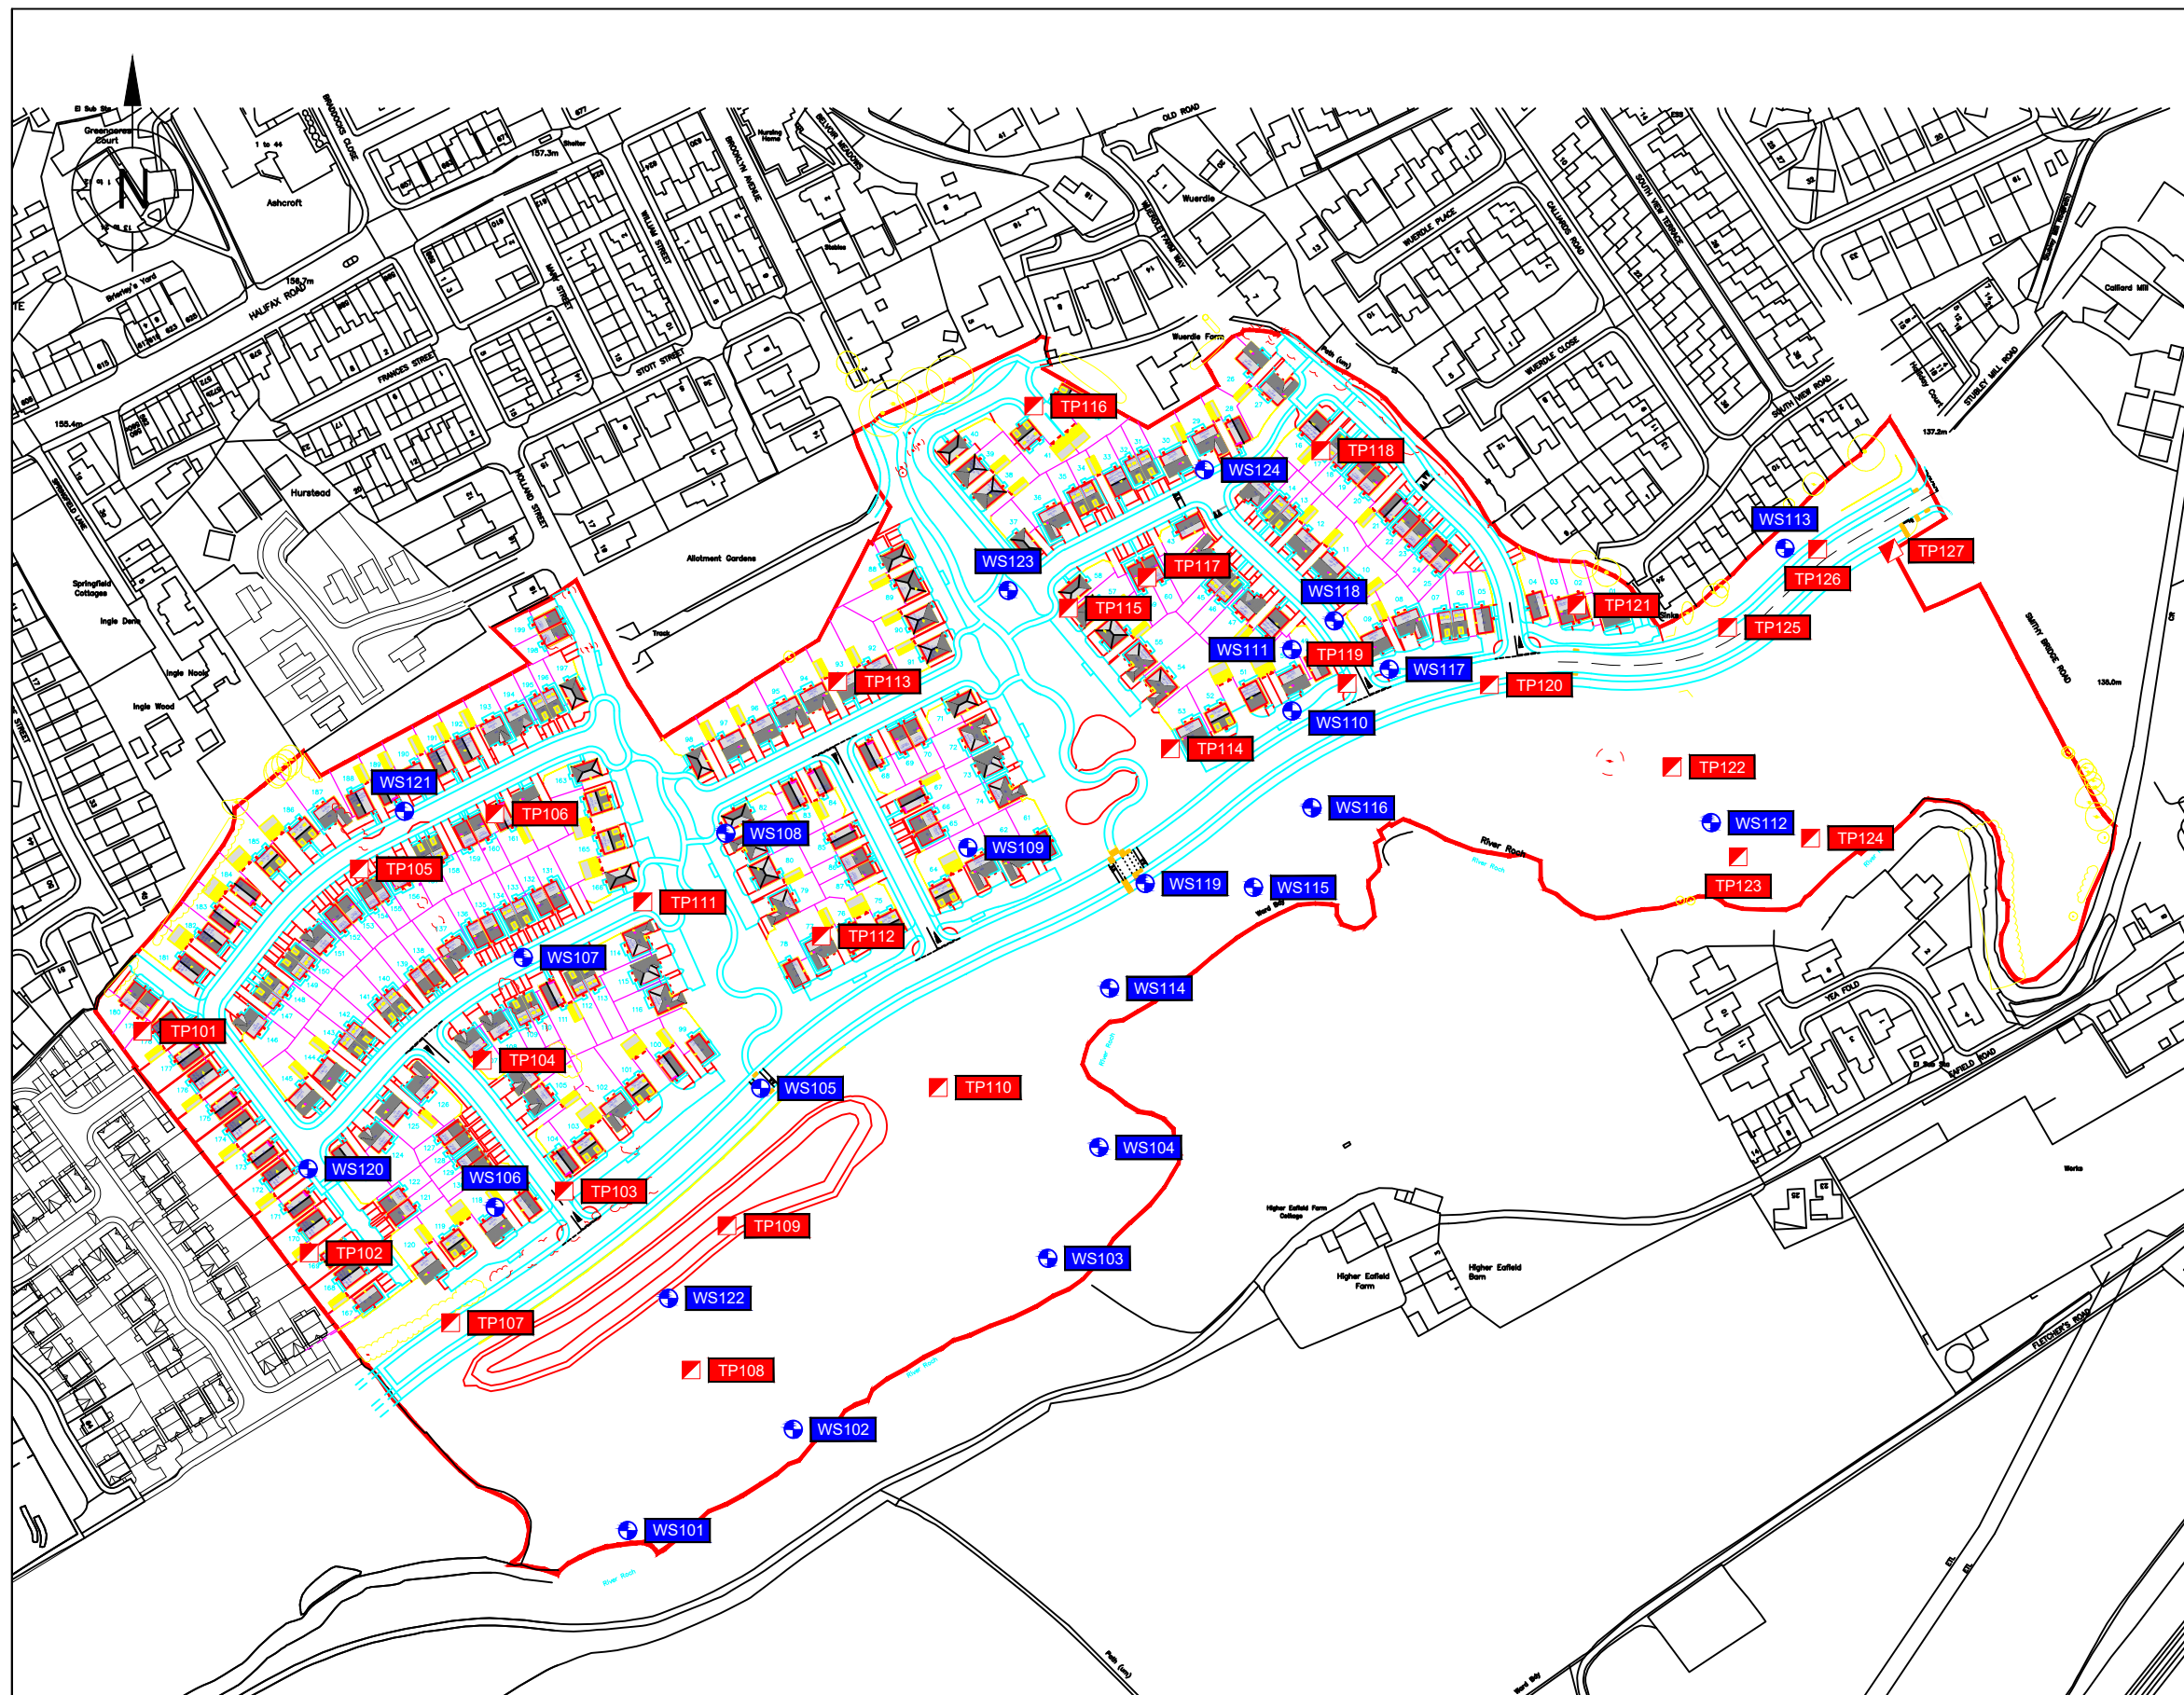
- Site Boundary
- Window Sample Borehole (WS)
- Trial Pit (TP)

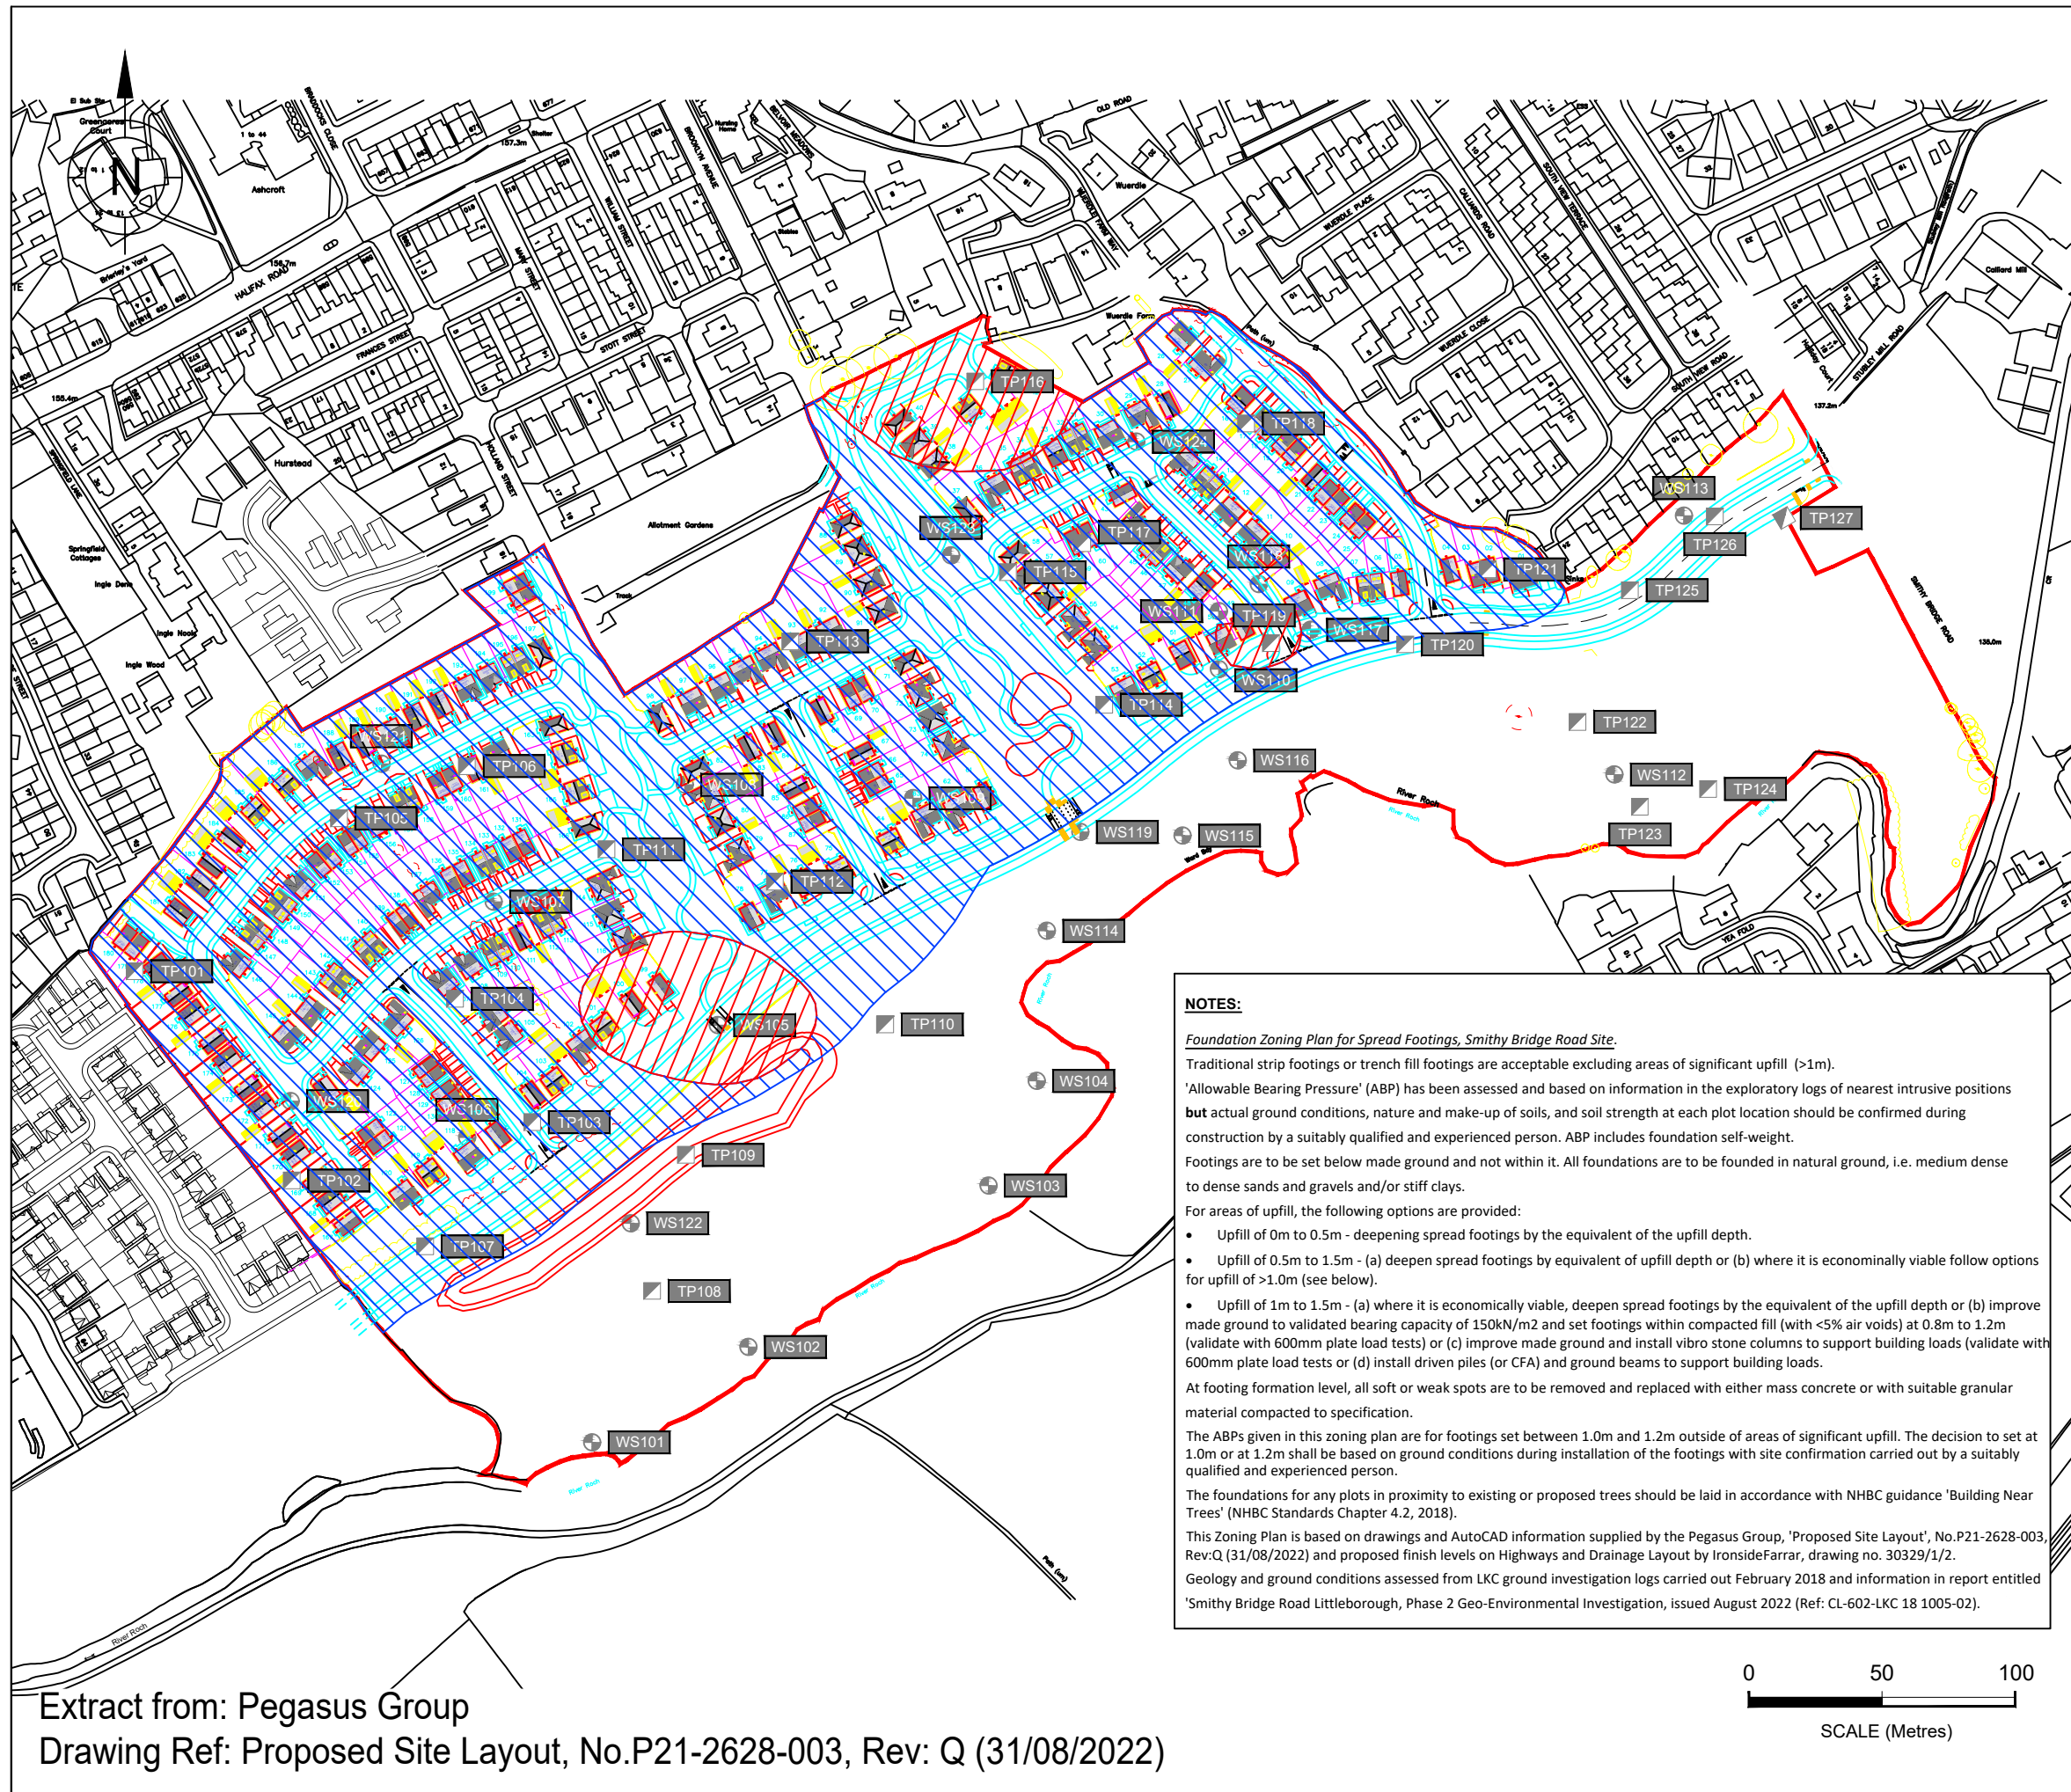
Figure 5: Foundation Zoning Plan

- Site Boundary
- Window Sample Borehole (WS)
- Trial Pit (TP)
- Allowable Bearing Pressure:  $\leq 100\text{kN/m}^2$   
Footings Set At or Below 1.0m to 1.2m (See Notes)
- Allowable Bearing Pressure:  $100\text{kN/m}^2 - 120\text{kN/m}^2$   
Footings Set At or Below 1.0m to 1.2m (See Notes)

Geology and ground conditions assessed from LKC ground investigation logs carried out February 2018 and information in report entitled 'Smithy Bridge Road Littleborough, Phase 2 Geo-Environmental Investigation, issued August 2022 (Ref: CL-602-LKC 18 1005-02).

| <b>Anticipated Foundation Type</b> | <p>Traditional strip or trench fill footings are considered acceptable based on ground conditions encountered during the site investigation. An outline foundation zoning plan is presented in Figure 5.</p> <p>Made ground on site is unsuitable as a founding stratum and all foundations should be founded in natural ground.</p> <p>Further assessment of the ground conditions at each plot location should be undertaken by a suitably qualified and competent person.</p> <p>If the soil at foundation level is found to be loose, soft or consisting of made ground, we recommend excavation and removal of this material and replacing with suitable granular material compacted to specification (or mass concrete).</p> <p>Consideration needs to be given for the potential for differential settlement due to the presence of both granular and cohesive deposits at foundation level. While a granular material may settle 'immediately' the cohesive material will settle over time leading to differential settlement. Additional reinforcement may be required where these ground conditions are encountered.</p> |

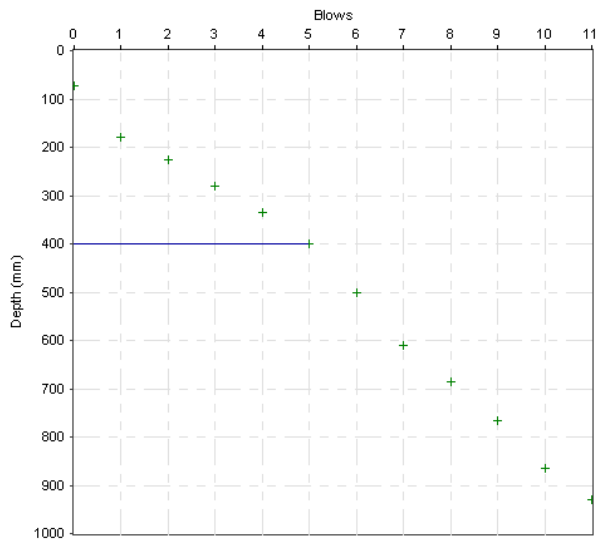
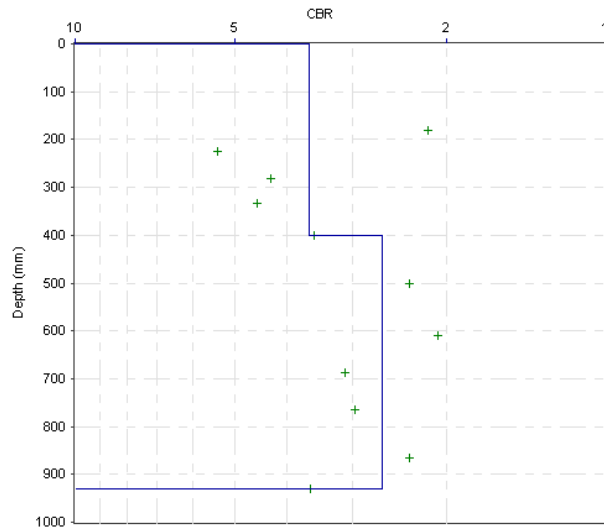
Layer Boundaries: Chainage 1.000

Layer Boundaries Chart

CBR Chart
