Date: 13th March 2023  
Ref:14-768-L4-2

## **SUPPLEMENTARY GROUND INVESTIGATION HEYWOOD ROAD, CASTLETON (MAIN DEVELOPMENT SITE)**

##### **1.2.1. E3P – PHASE I & II GEOENVIRONMENTAL SITE ASSESSMENT, CASTLETON SIDINGS, ROCHDALE REF: 14-768-R1-3, DATED MARCH 2023, ON BEHALF OF KELLEN HOMES.**

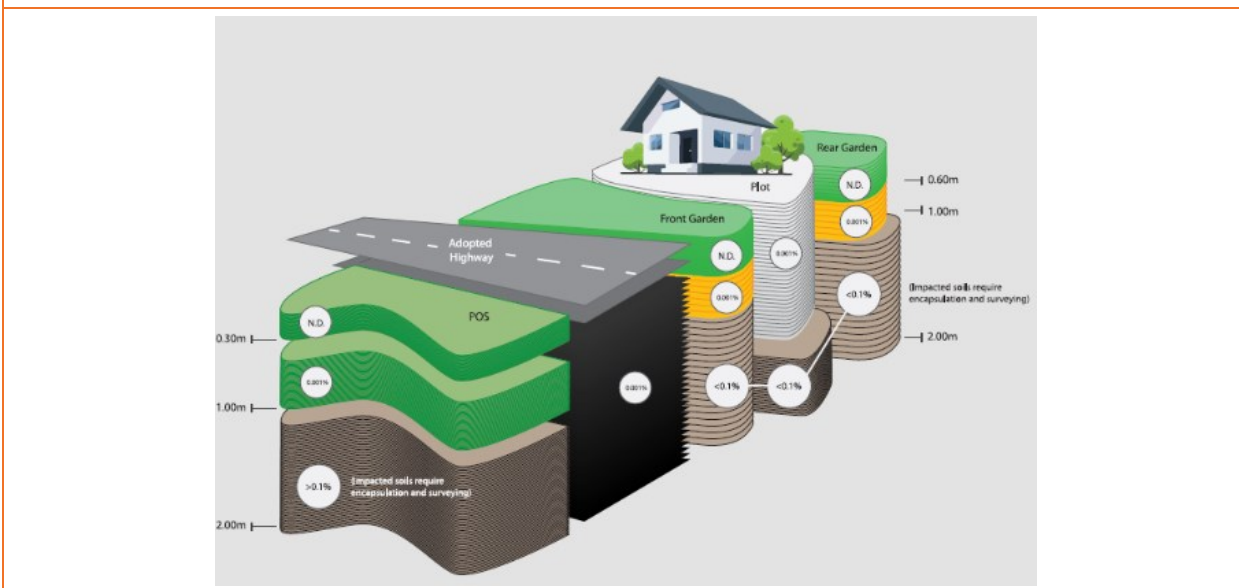
FIGURE 3.1 ASBESTOS RISK MITIGATION CONCEPTUAL SITE MODEL

Asbestos impacted Made Ground soils should be managed in accordance with the E3P asbestos risk mitigation conceptual site model shown in Figure 3.1. In this instance, the risks can be mitigated by placing the impacted soil from TP112 beneath a 600 mm clean cover system in garden/landscaped areas or placed at 1.0 m beneath plots.

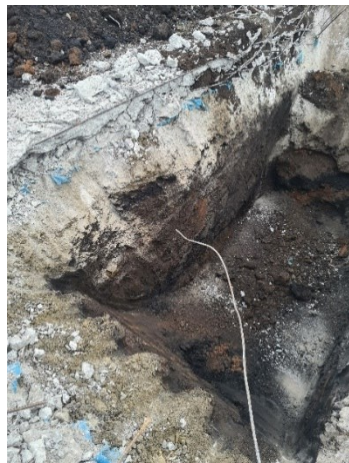
| TRIAL PIT | NOTES | PHOTO |
|---|---|---|
| TP301 | Reinforced concrete:<br>GL-0.25 m bgl<br><br>Sub-base:<br>0.25 m-0.80 m bgl<br><br>(Bearing on Made Ground) | |
| TP302 | Concrete slab:<br>GL-0.70 m bgl<br><br>Sub-base:<br>0.70 m-1.20 m bgl<br><br>(Bearing on Made Ground) | |

It is noted that in all cases, foundations and slabs appear to be bearing on Made Ground. In some instances, in particular TP309 (exposing the foundation of the railway platform), a 1.00 m thick granular layer was encountered beneath the base of the structure, directly overlying Made Ground with no obvious signs of a subsurface footing. It is considered possible that piled foundations may be present beneath this structure.

Allowances should be made for encountering piled foundations and 'hard spots' beneath areas of former structures during the Made Ground turnover at enabling works stage. If encountered, piles/pile caps would need to be trimmed to a suitable level so not to interact with the new foundations and their locations would need to be accurately surveyed in order to design new piled foundation/stone column arrangements in a manner that does not result in any conflict with the relict piles.

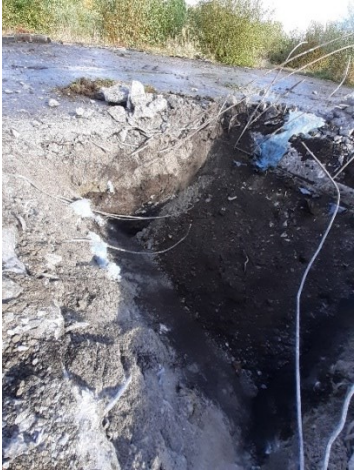
| TRIAL PIT | NOTES | PHOTO |
|---|---|---|
| <b>TP303</b> | Reinforced concrete:<br>GL-0.30 m bgl<br><br>Sub-base:<br>0.30 m-0.50 m bgl<br><br>(Bearing on Made Ground) | |
| <b>TP304</b> | Concrete slab:<br>GL-0.40 m bgl<br><br>Brick Fill:<br>0.40 m-1.00 m bgl<br><br>(Bearing on Made Ground) | |
| <b>TP305</b> | Concrete slab:<br>GL-0.60 m bgl<br><br>Concrete step:<br>0.60 m-1.00 m bgl<br><br>(Bearing on Made Ground) | |

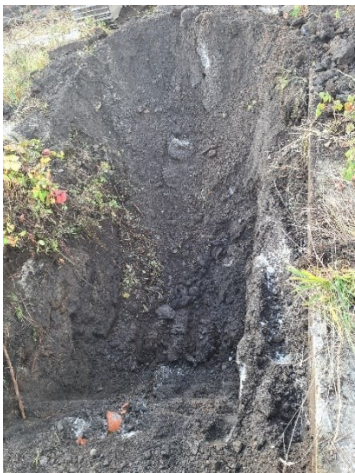
| TRIAL PIT | NOTES | PHOTO |
|---|---|---|
| TP306 | Concrete slab:<br>GL-0.60 m bgl<br><br>Concrete Step:<br>0.60 m-1.00 m bgl<br><br>(Bearing on Made Ground) | |
| TP307 | Concrete slab:<br>GL-0.70 m bgl<br><br>Concrete step:<br>0.70 m-1.20 m bgl<br><br>(Bearing on Natural Strata) | |
| TP308 | Concrete slab:<br>GL-0.60 m bgl<br><br>Concrete step:<br>0.60 m-1.00 m bgl<br><br>(Bearing on Made Ground) | |

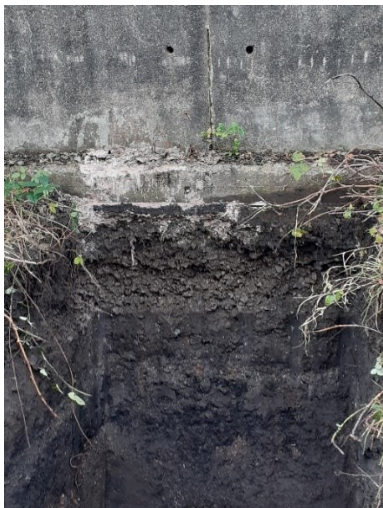
| TRIAL PIT | NOTES | PHOTO |
|---|---|---|
| <b>TP309</b> | Platform thickness above ground level: 1.80 m<br><br>Sub-base:<br>0.50–1.00 m bgl<br><br>(Bearing on Made Ground) | |

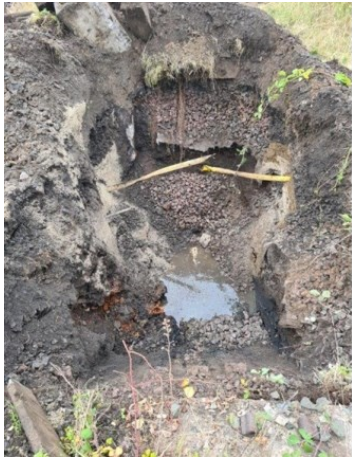
| EXPLORATORY HOLE | THICKNESS (M) | PHOTO |
|---|---|---|
| TP211N | 1.00 | |

However, it should be noted that chemical analysis has not been undertaken on the material. Given the nature of the site, there is a high likelihood of it being contaminated with semi/volatile contaminants (e.g. from fuel leaks from stationary rail carriages). Therefore, if used in the temporary works platform, chemical analysis of the material should be undertaken in accordance with an approved remediation strategy, and/or mitigation measures should be incorporated to prevent cross contamination of underlying soils and downward leaching to underlying soils (e.g. suitable geotextile) and to minimise surface water runoff of contaminants to surrounding soils and watercourses/drainage ditches (e.g. silt barriers and surface water management plan). Complete removal of the temporary works platform would be required on completion of the temporary works and either disposal or placement in an area of no future sensitivity (subject to suitable validation testing). If VOC resistant membranes are incorporated into new dwellings, it may be suitable for retention beneath plots.

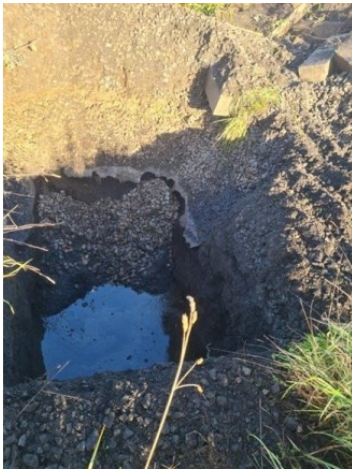
| EXPLORATORY HOLE | THICKNESS (M) | PHOTO |
|---|---|---|
| WS104S2 | 1.70 | |

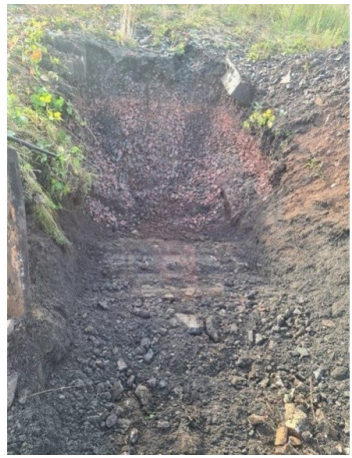
| EXPLORATORY HOLE | THICKNESS (M) | PHOTO |
|---|---|---|
| WS106BS | 1.00 | |

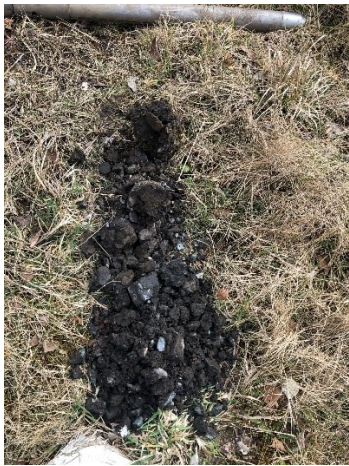
| EXPLORATORY HOLE | THICKNESS (M) | PHOTO |
|---|---|---|
| WS114A | >0.70 | |

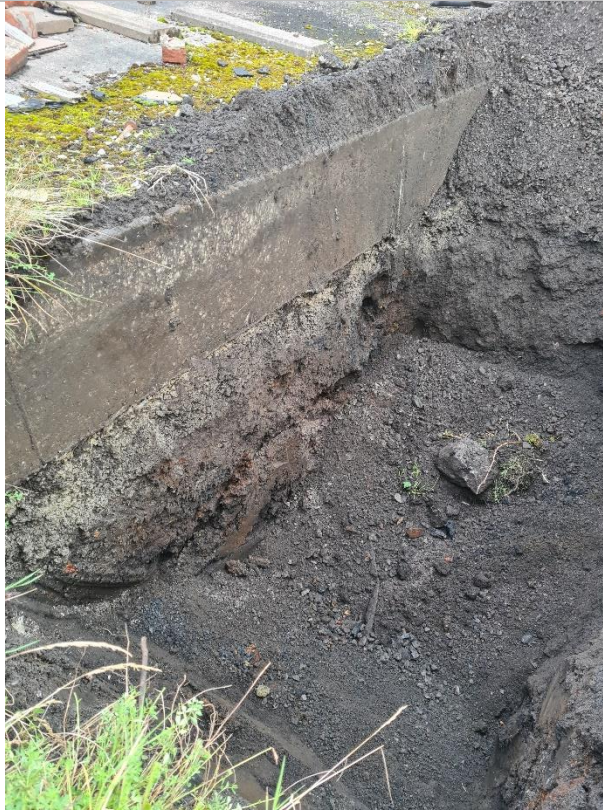
PLATE 1

SLAB – TP302

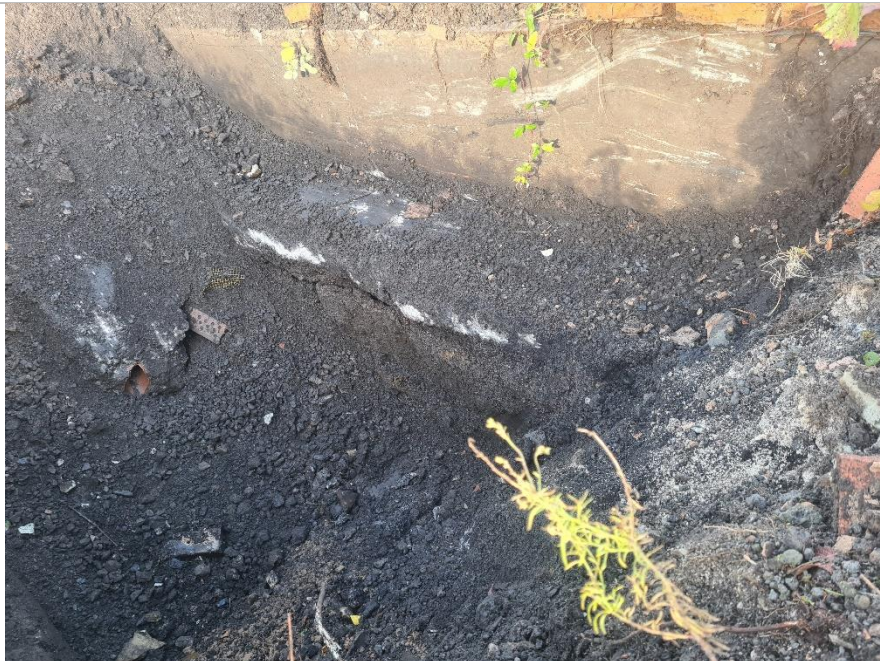
PLATE 2

EXPOSED FOUNDATION – TP307

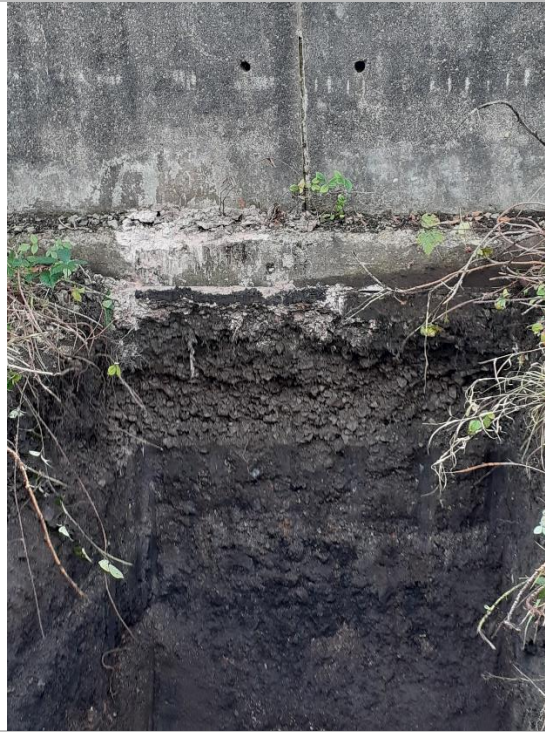
PLATE 3

BASE OF RAIL PLATFORM – TP309

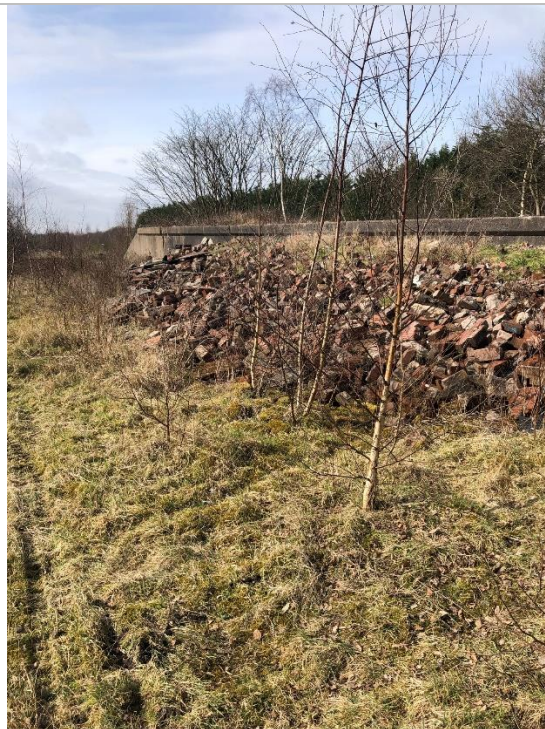
PLATE 4

WS202 ARISINGS

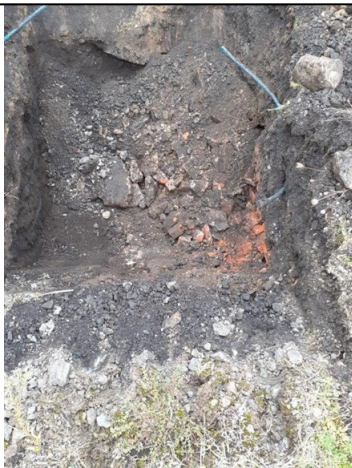
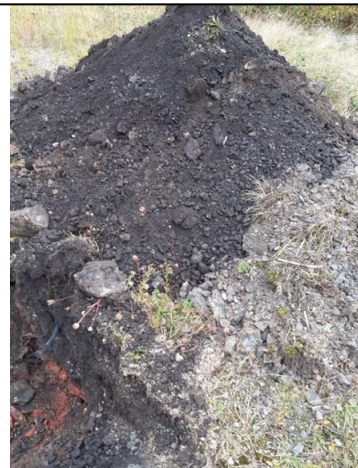
TP116 East spoil

Remarks: 1. Complete 2. Brick fill encountered in north eastern corner of trial pit from 0.50m to 1.40m bgl. 3. Disused plastic pipe encountered at 0.60m bgl.

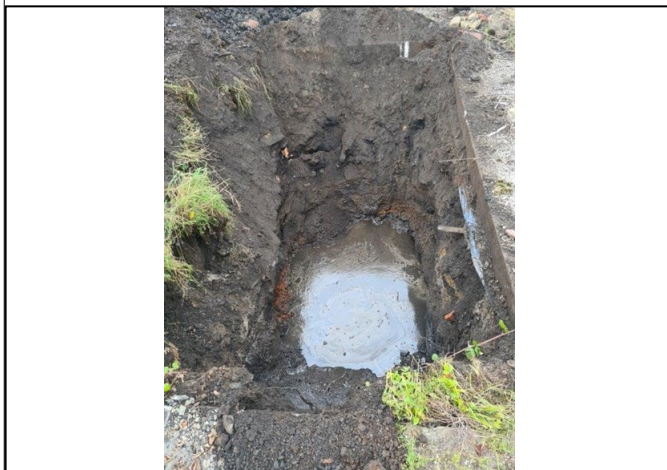
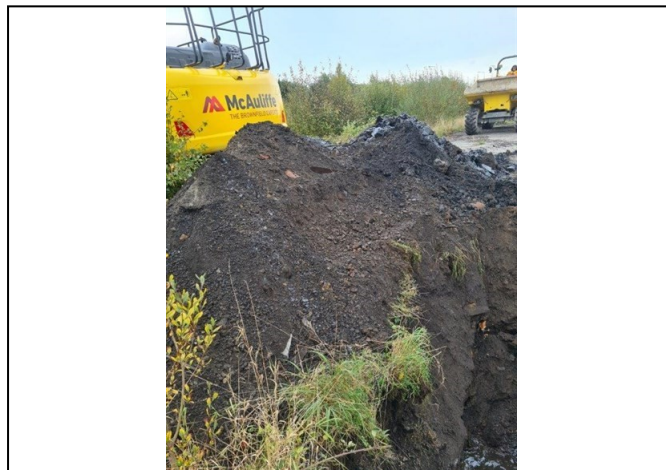
TP211 East

Remarks: 1. Complete 2. Strong hydrocarbon odour and oily sheen encountered between 1.60m and 2.00m bgl. 3. Water strike encountered at 2.30m bgl- moderate seepage.

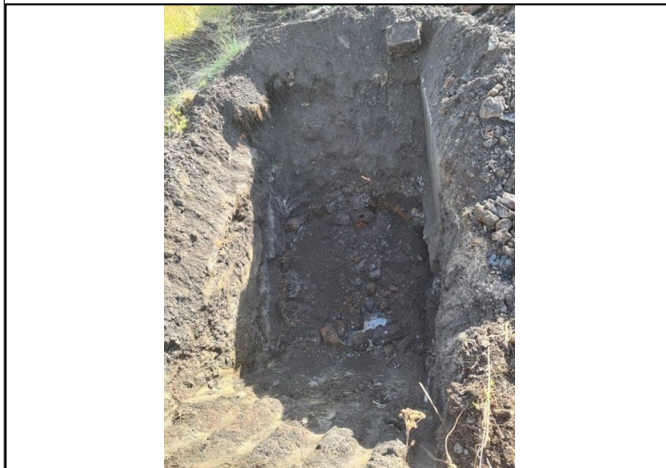
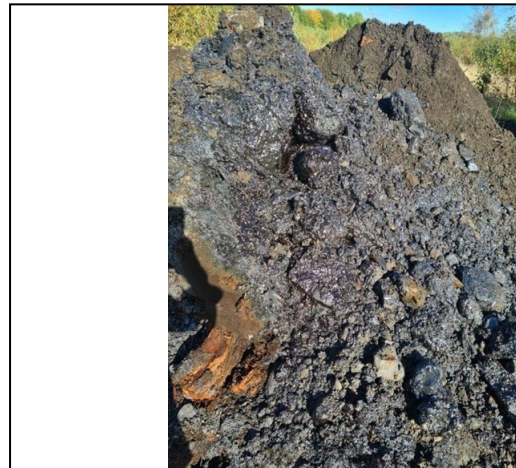
TP211 east (2)

Remarks: 1. Complete 2. Strong hydrocarbon odour and oily sheen encountered between 1.00m and 2.00m bgl.

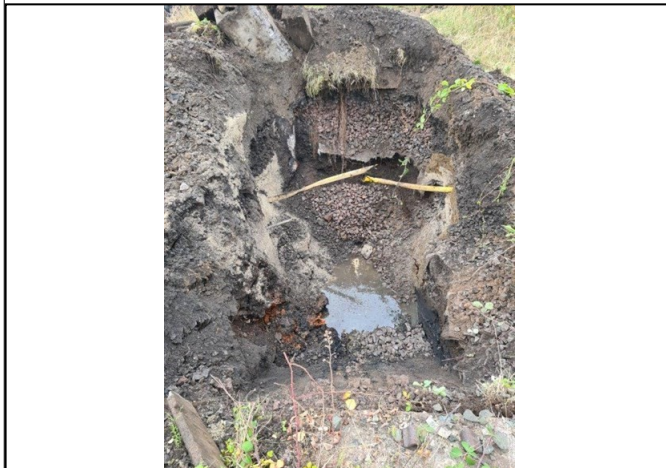
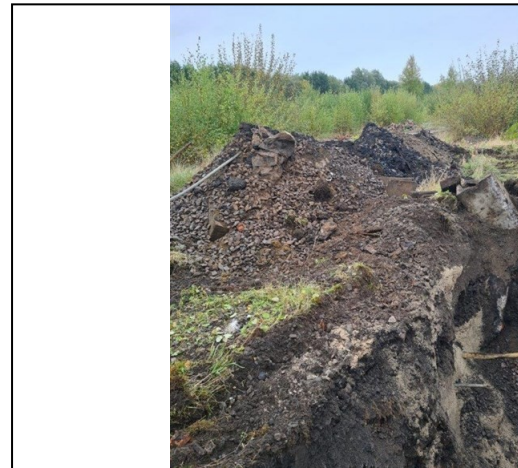
TP211 North

Remarks: 1. Complete 2. Black sheen encountered between 1.80m and 2.10m bgl. 3. Water strike encountered at 2.00m bgl- moderate seepage.

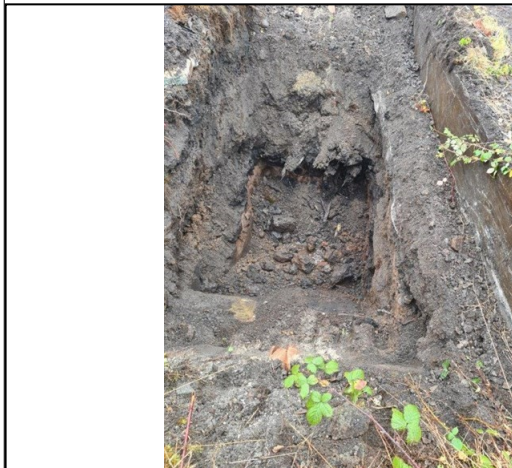
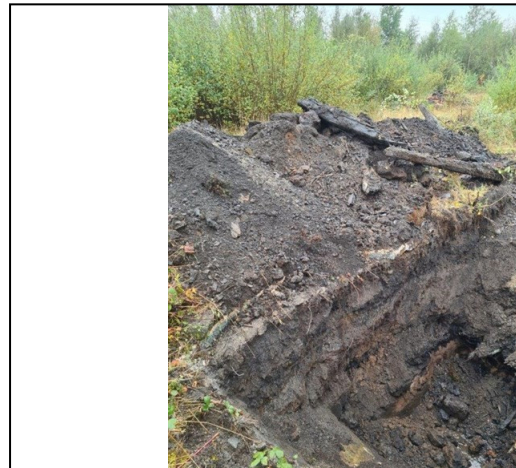
TP211 South

Remarks: 1. Complete 2. Unstable between 1.50m and 2.00m bgl due to sand collapse. 3. Slight hydrocarbon odour encountered between 1.50m and 2.00m bgl.

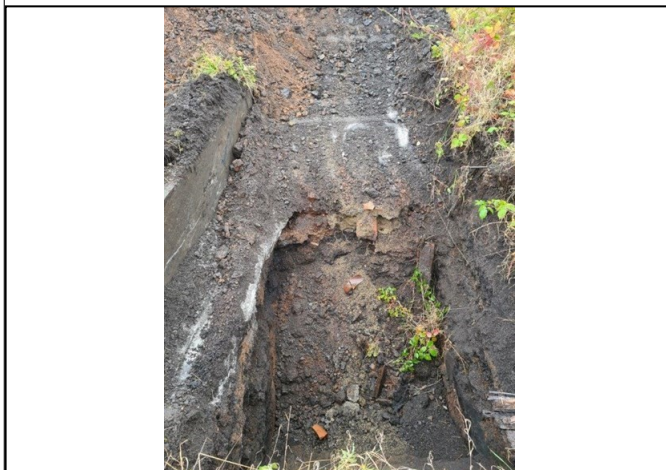
TP211 West

Remarks: 1. Complete 2. Slight hydrocarbon odour encountered between 1.00m and 2.00m bgl. 3. Concrete slab encountered to 0.60m and concrete step encountered to 0.90m bgl.

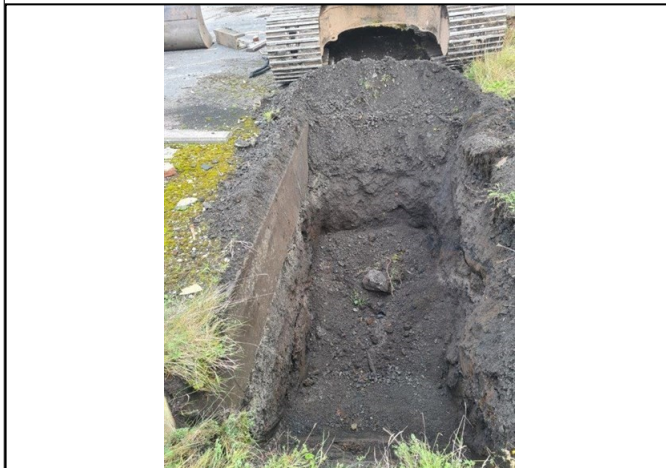
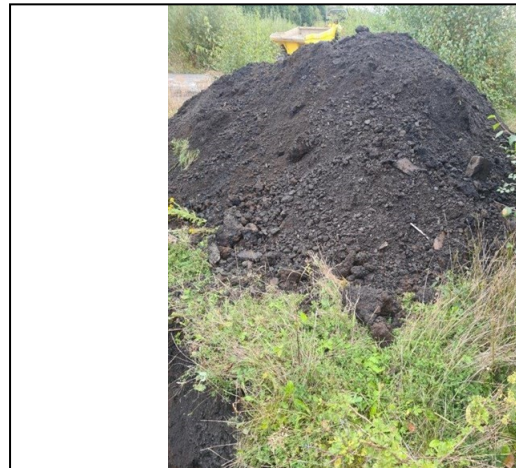
TP302

Remarks: 1. Complete. 2. Slight hydrocarbon odour encountered from 1.20m bgl in eastern wall.

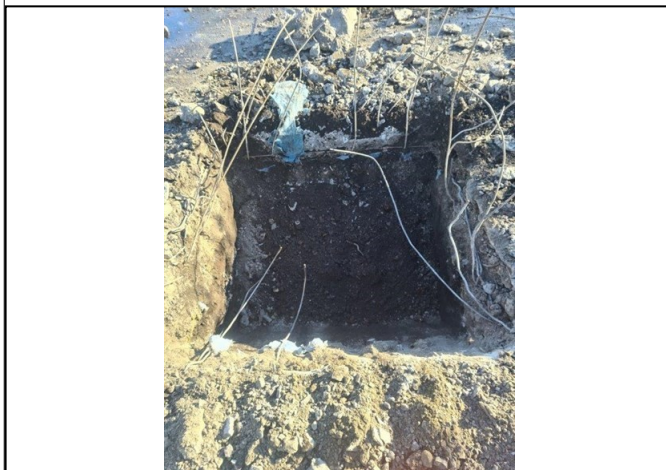
TP303

Remarks: 1. Complete 2. Deeper concrete encountered in northern wall at 0.80m bgl.

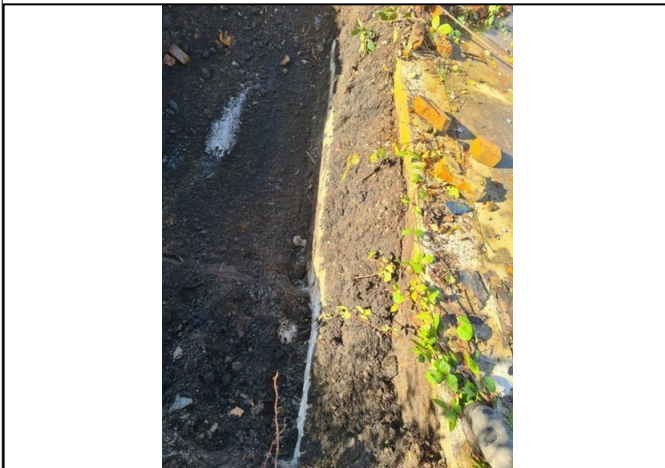
TP305

Remarks: 1. Complete 2. Plastic redundant services encountered running east to west at circa 0.80m bgl.

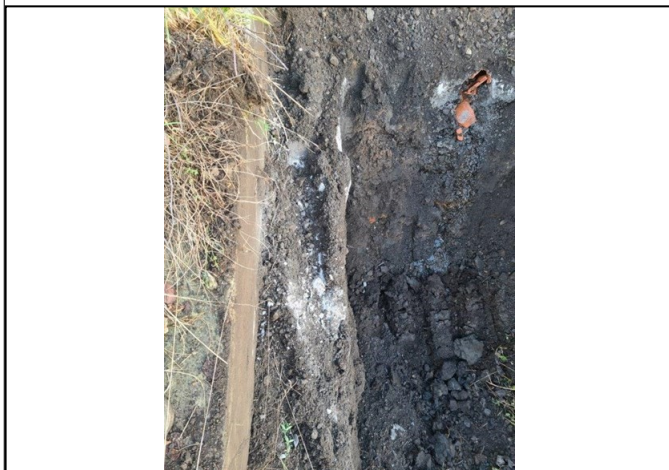
TP306

Remarks: 1. Complete. 2. Concrete slab encountered in northern wall from GL to 0.60m bgl. Concrete step in northern wall from 0.60m to 1.00m bgl.

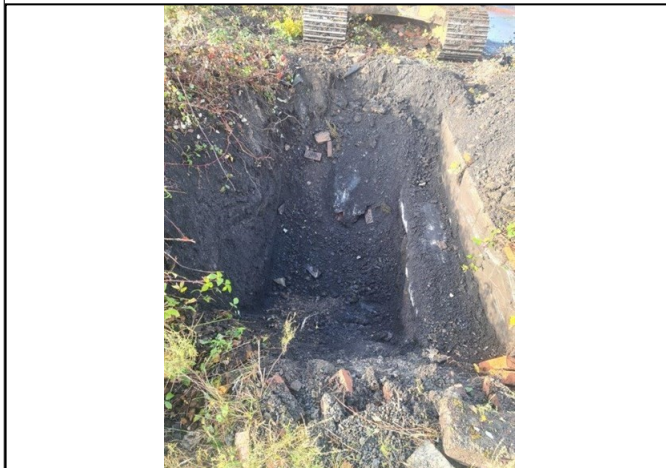
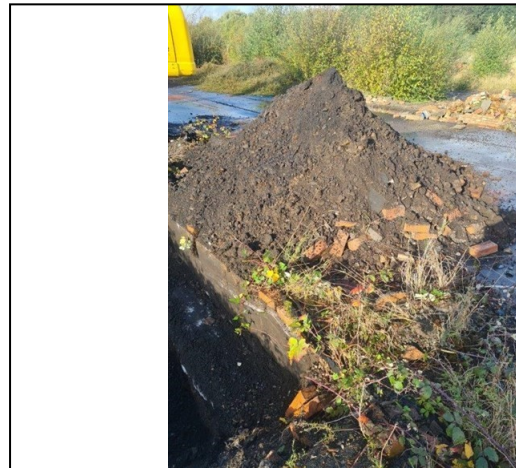
TP307

Remarks: 1. Complete 2. Concrete slab encountered to 0.70m and concrete step to 1.20m.

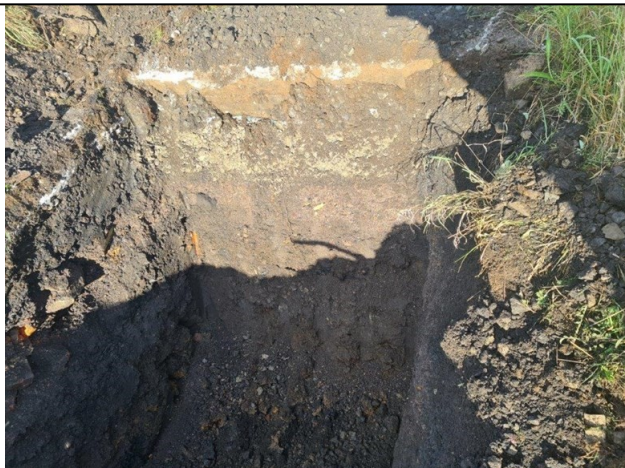
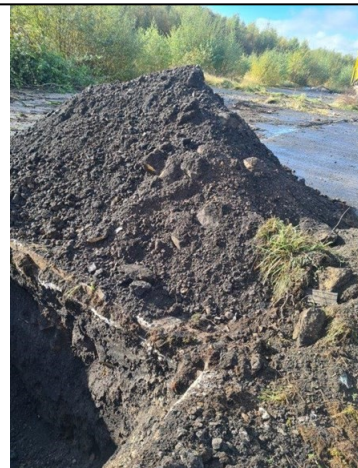
TP308

Remarks: 1. Complete. 2. Concrete slab encountered in northern wall from GL to 0.60m bgl. Concrete step in northern wall from 0.60m to 1.00m bgl.

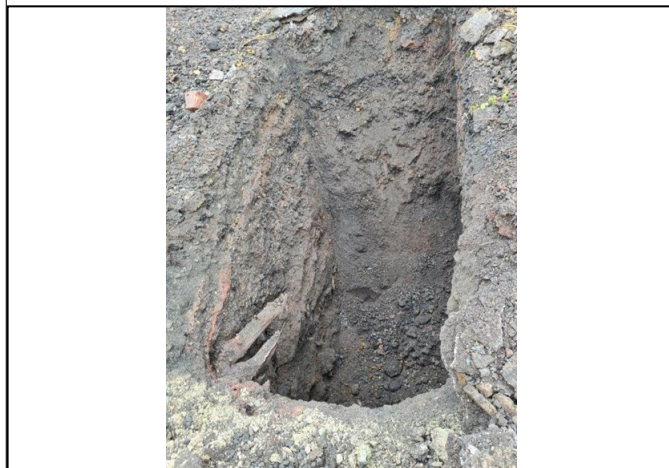
WS104 East

Remarks: 1. Complete 2. Very strong hydrocarbon odour and black sheen between 2.40m and 3.00m bgl.

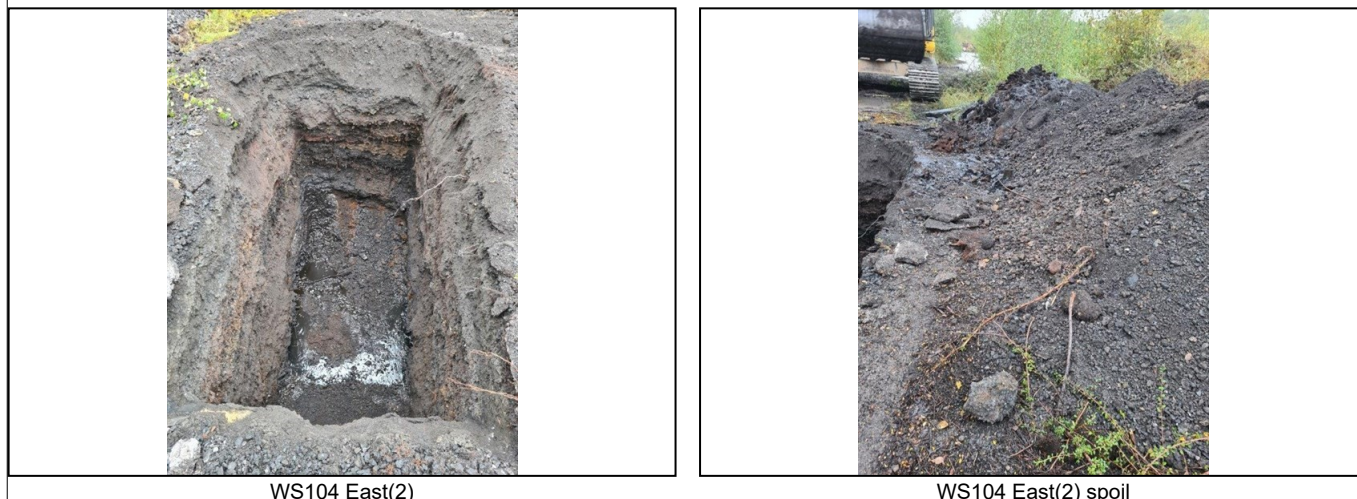
Remarks: 1. Complete. 2. Strong hydrocarbon odour and oily sheen encountered between 2.50m and 2.70m bgl. 3. Water strike encountered at 2.70m bgl - seepage.

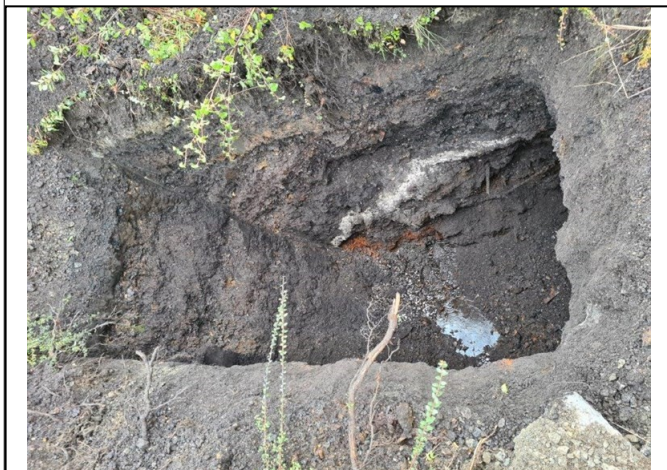
WS104 North

Remarks: 1. Complete. 2. Strong hydrocarbon odour and oily sheen encountered between 2.50m and 2.70m bgl. 3. Water strike encountered at 3.00m bgl - moderate seepage.

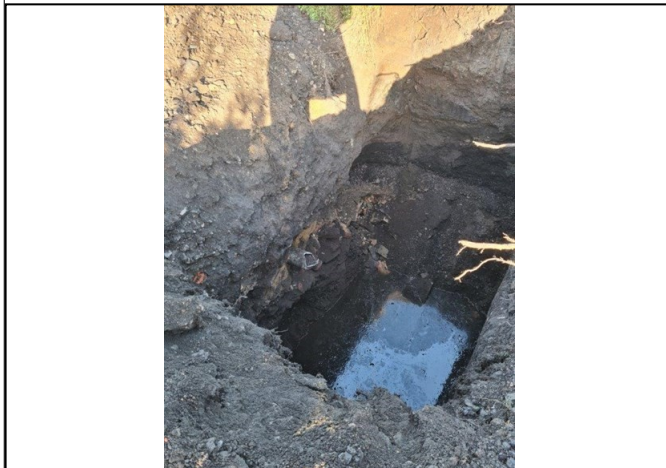
WS104 North(2)

Remarks: 1. Complete 2. Strong hydrocarbon odour encountered between 3.00m and 3.20m bgl 3. Oily sheen visible on water within trial pit. 4. Water strike encountered at 3.00m bgl - slow seepage.

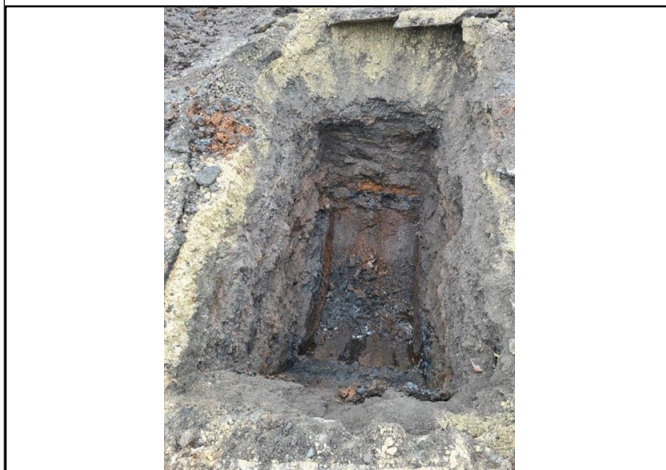
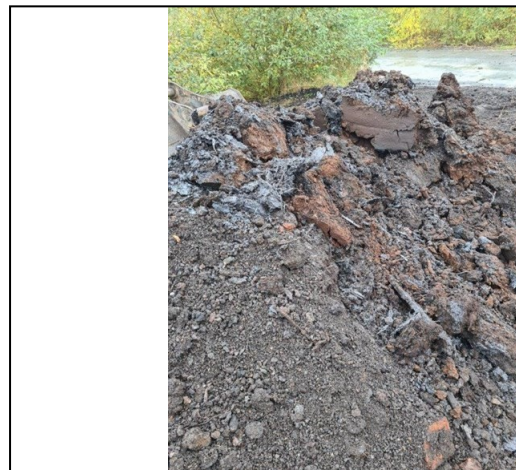
WS104 South

Remarks: 1. Complete. 2. Strong hydrocarbon odour and oily sheen encountered between 2.20m and 3.00m bgl. 3. Water strike encountered at 2.90m bgl - moderate seepage.

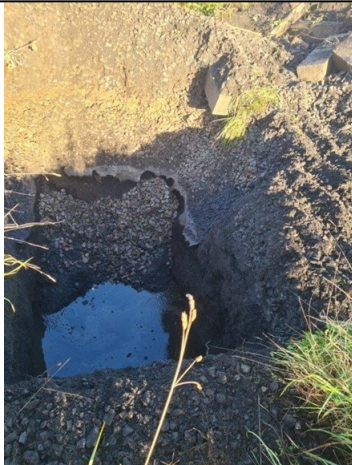
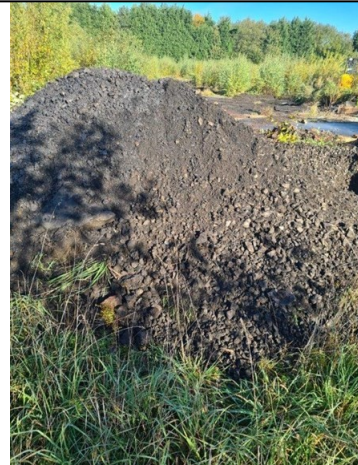
WS104 South(2) spoil

Remarks: 1. Complete 2. Slight hydrocarbon odour encountered at 0.80m to 1.70m bgl. 3. Oily sheen visible on water within trial pit. 4. Ballast encountered to 1.70m bgl in northern wall of trial pit. 5. Water strike encountered at 2.40m bgl - moderate seepage.

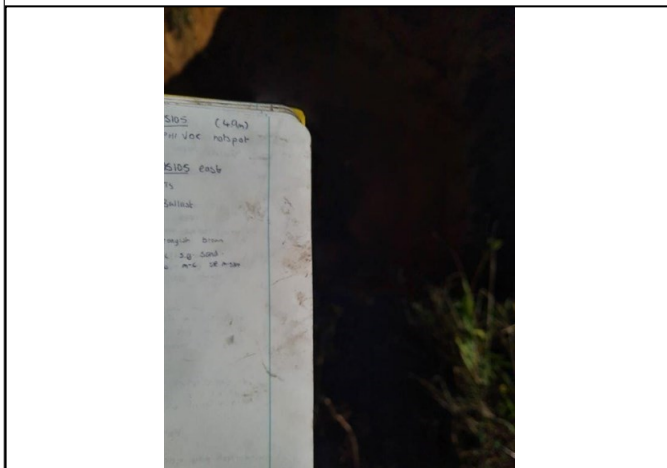
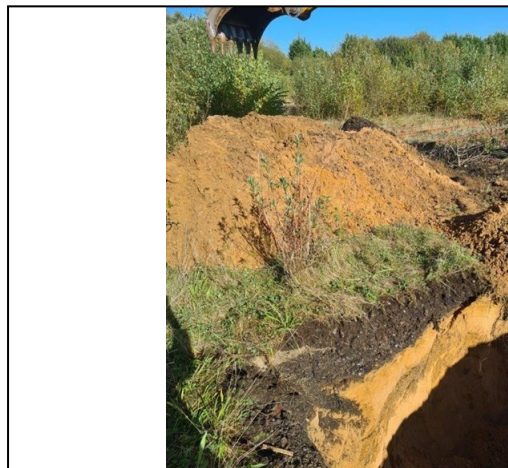
WS105 East

Remarks: 1. Terminated at 4.20m bgl due to sand collapse.

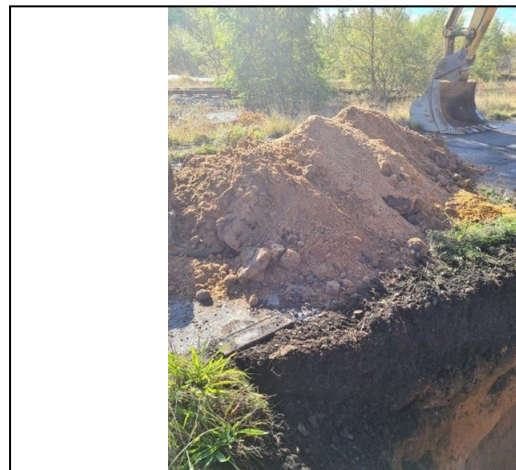
WS105 West

Remarks: 1. Terminated at 3.70m bgl due to sand collapse. 2. Water strike encountered at 2.40m bgl- Slow seepage.

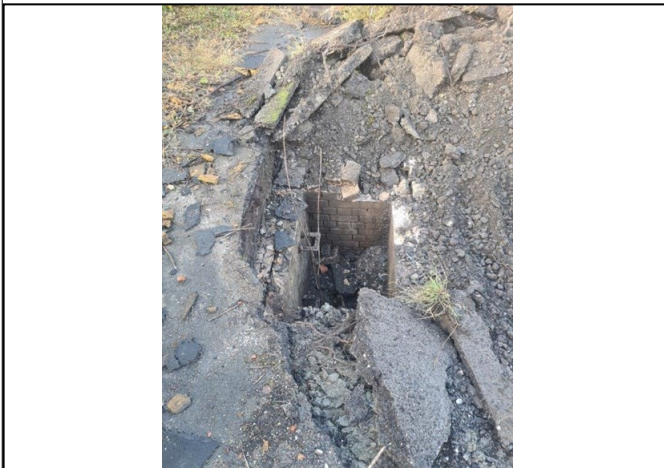
WS106b east

Remarks: 1. Terminated due to sewer manhole exposed at 0.50m bgl.

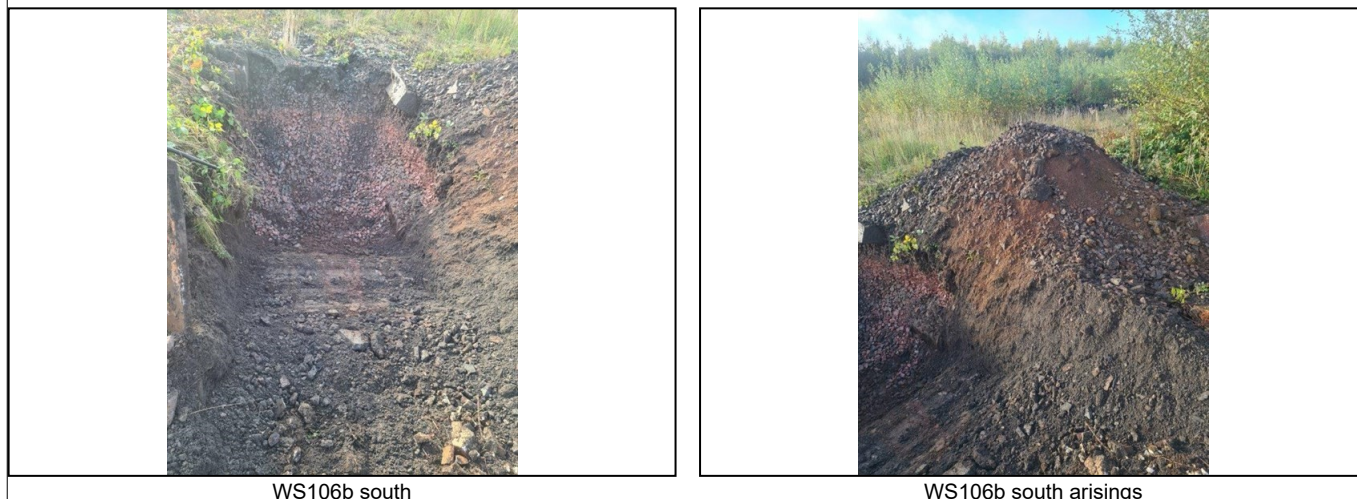
Remarks: 1. Complete. 2. Concrete slab encountered at 1.00m bgl. 3. Ballast encountered in southern wall to 1.00m bgl.
