**The Former Marina  
Ropeworks,  
Brunswick Street, Heywood  
Greater Manchester**

Archaeological Strip, Map and  
Plan

Report no. 4212  
January 2025

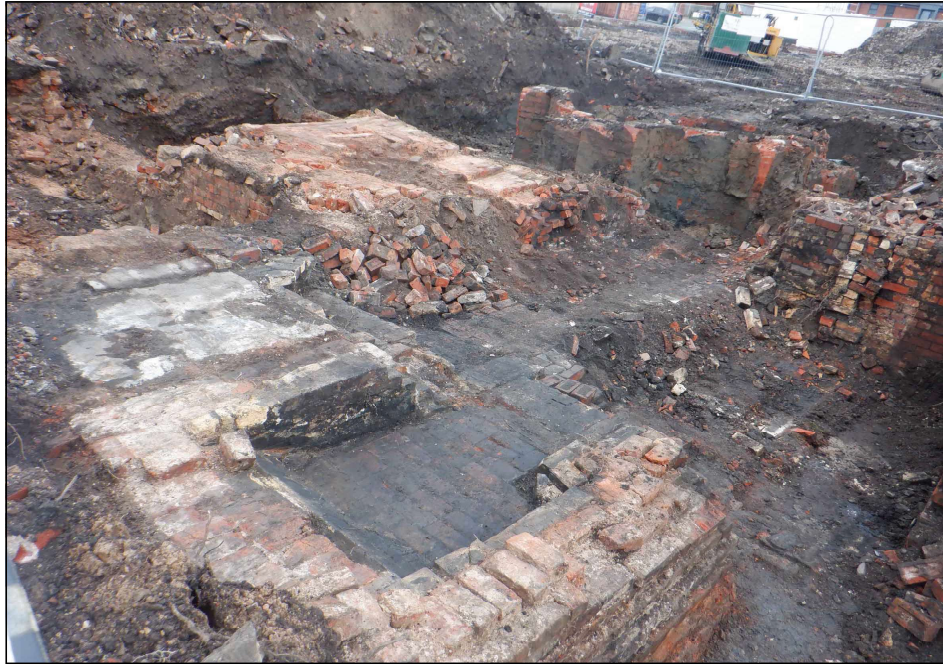
*Plate 1. Trench 1, general photo, looking north-east*

Trench 1 (Plates 1 and 2) measured 154m<sup>2</sup> in total. Overburden was machine excavated down to the uppermost archaeological horizon. The upper surfaces of the surviving structures were then hand cleaned. It rapidly became apparent that the lower deposits in the trench were contaminated with liquid elemental mercury, hydrocarbons and suspected asbestos containing materials. It was not possible to safely enter the excavation to further define the structures. It was also important not to spread any contaminants to the surrounding land and air and to avoid negative health effects for ASWYAS staff, local residents and other contractors on site by any further exposure. As such, the following represents a description the exposed structures based on the limited observations it was possible to carry out safely. Fortunately, the majority of the remains correlate with structures depicted on historic mapping which provides invaluable evidence on the date and, in some cases, the purpose of the structures.

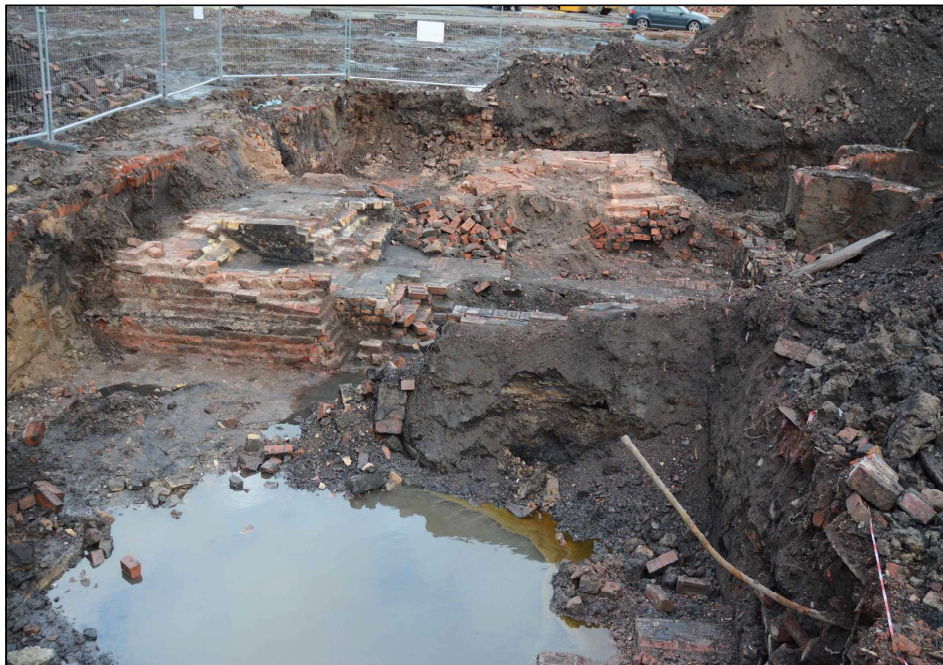
*Plate 2. Trench 1, general photo, looking north*

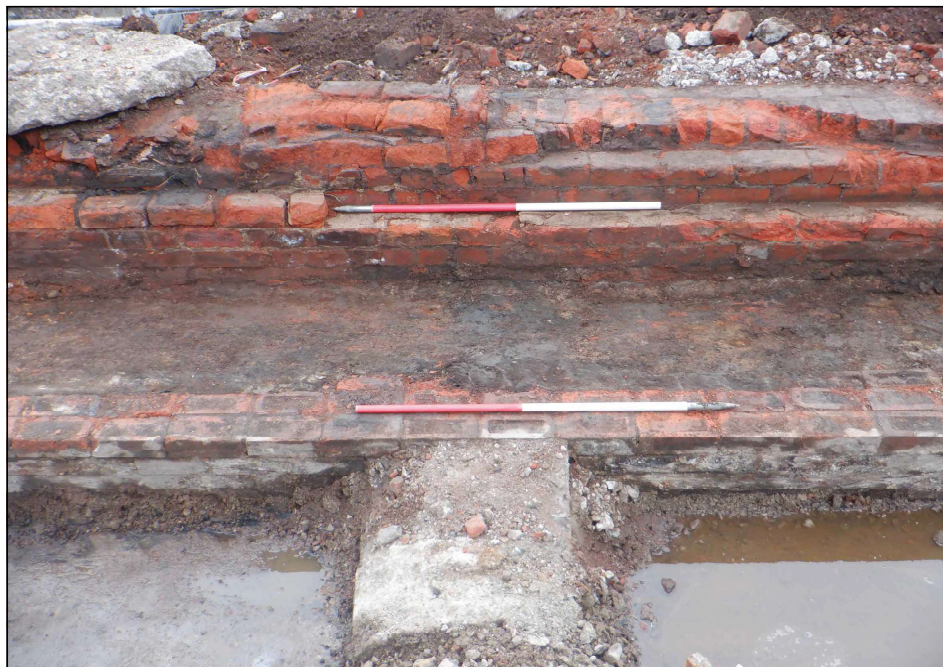
*Plate 20. Trench 2, wall 212 and 215 and wall/surface 214, looking west*

Wall 212 was an irregularly coursed brick wall, found along the western edge of the trench. It was constructed with a mix of frogged and unfrogged red bricks (L: 110.00 mm, W: 230.00 mm, H: 80.00 mm), bonded with dark grey mortar. Its relationship with Walls 213/203 and 209/208 was unclear but they are presumed to be contemporary based on them forming the original external walls of the engine house.

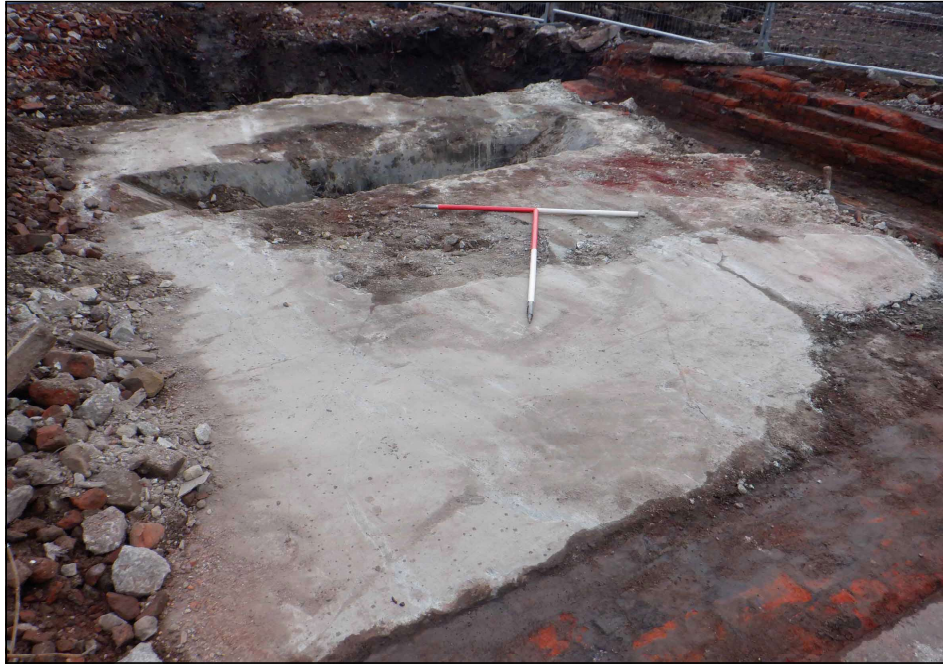
*Plate 21. Trench 2, engine bed 202, looking south*

Abutting wall 203 and surface 206 was engine bed 202 (Plate 21), constructed in a light yellowish grey concrete with angular stone aggregate (up to 0.05m). The bulk of this structure was formed by a deep rectangular foundation extending eastwards beyond the edge of the trench, measuring 3.63m long, 4.5m wide and *c.* 1.1m deep. The northern edge of the engine bed was much shallower and, visible in the west-facing elevation, was seen to be constructed above a dark greyish-brown silty-clay levelling deposit (216). It was itself constructed above the natural geology. It was not visible at the surface. It is possible that this represents a later shallow surface abutting the large concrete engine bed but the concrete of the two surfaces appears continuous, albeit with cracks. Similarly the southern extent of the deposit is much shallower and forms an apparently contemporary low surface. In the centre of the engine bed, a trapezoid-shaped pit, was aligned west-south-west to east-north-east (Plate 22). It measured 3.04m long and 0.77m wide and was 0.70m deep and is considered likely to represent a fly wheel pit. It is, however, also possible that it provided clearance for

There was some phasing of the structures in this area evidenced by stratigraphic relationships in the brick and concrete walls. The two northern and southernmost walls and presumably the western wall form the original foundations of the engine house, constructed in 1902, supported by the above ground structure recorded in the historic building recording (Salford Archaeology 2024). Two internal concrete plinths and a concrete surface may relate to an earlier engine bed, though no further evidence was found for an earlier engine. The latest structures in the trench relate to the large concrete engine bed with a possible flywheel pit.

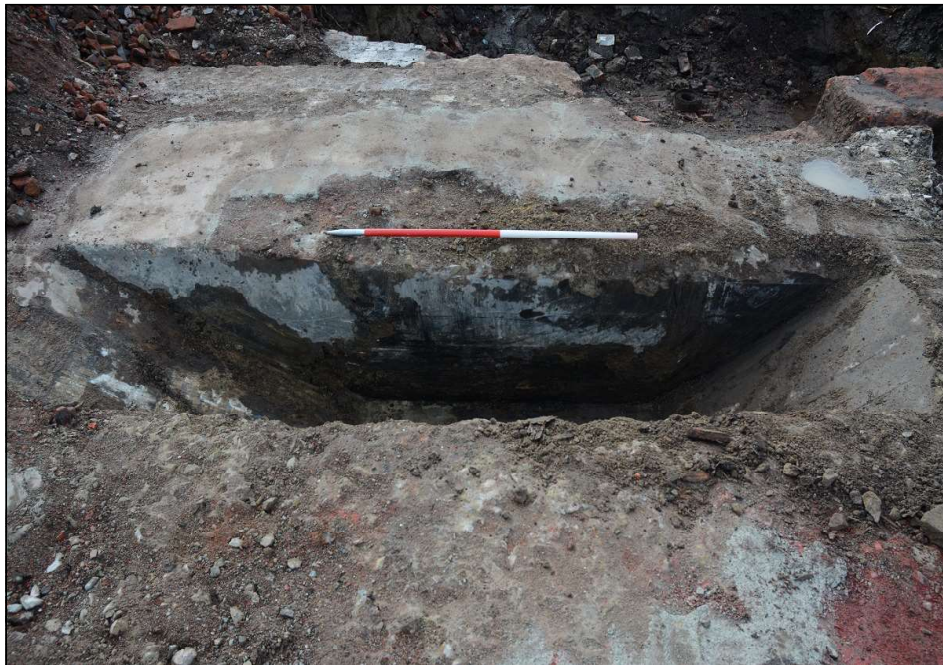
*Plate 22. Trench 2, wheel pit, looking south*

The height and small footprint of the engine house suggest it contained a vertical or upright engine. The pit's shape, orientation and location are immediately suggestive of a flywheel pit, with the flywheel close to the base of the engine. This would be required if an inverted vertical engine were housed here. Typically, vertical engines have the flywheel at the top, such as a several preserved at Bolton Steam Museum, and doubt has been raised as to whether the pit would be sufficient to accommodate the flywheel. The pit is likely too small to represent a rope drum but may have accommodated another engine component such as the extension of the crank arm (Ian Miller pers. comm.). On balance the use of an inverted engine with a flywheel pit is considered more likely. Though comparative examples in such a setting are sparse, such engines are pictured in an advertisement by J. Chadwick and Sons in Manchester (Grace's Guide 2024b).
