## Phase II Site Investigation Report

Further Red Lumb  
Rochdale

**Report Ref: M0981/A1**

**June 2024**

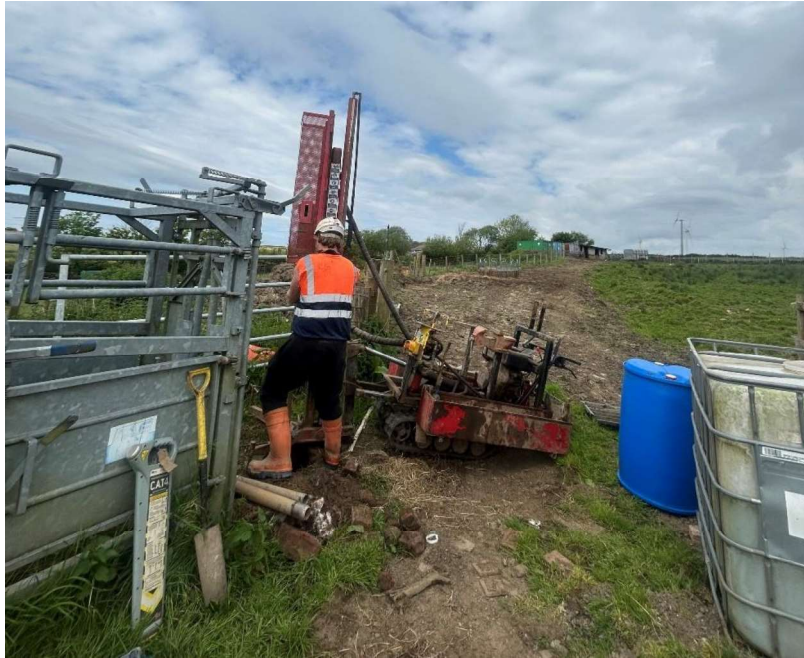
**Figure 2: General Site Photographs**

View on the day of the site works and the drilling of a borehole using the window sample rig.

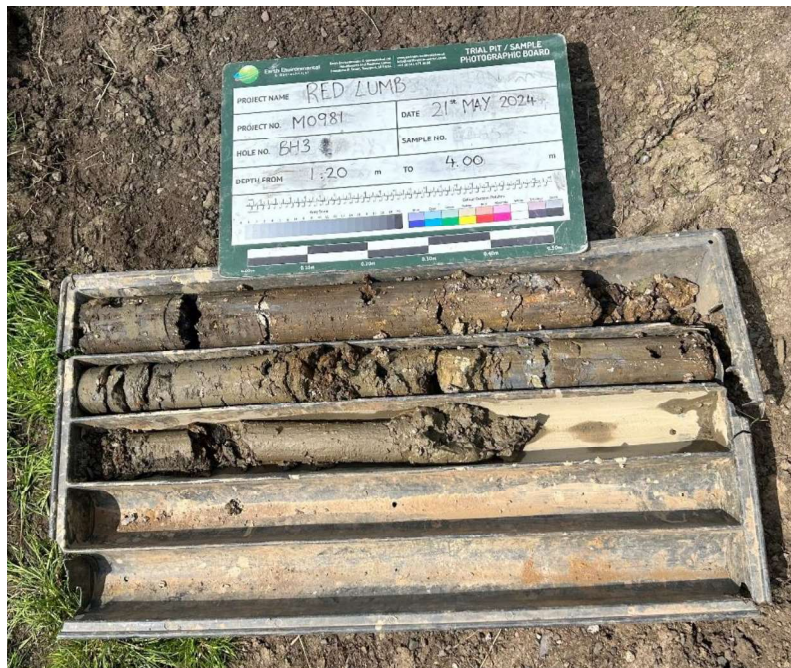
View showing spoil from BH3.

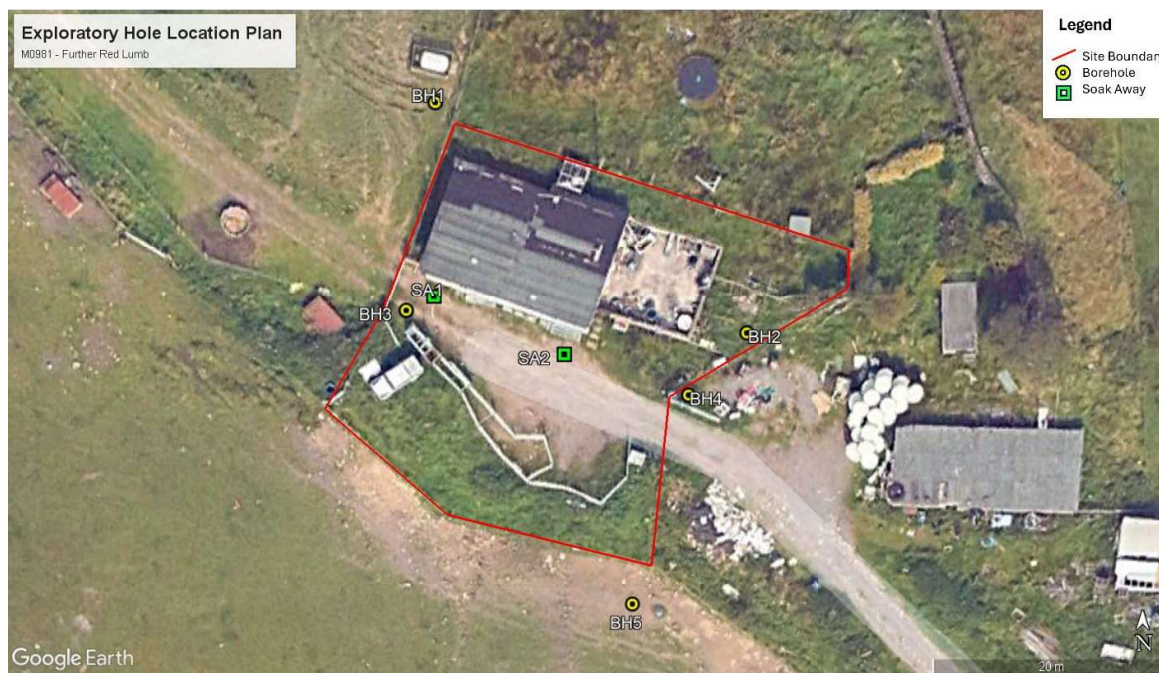
**Figure 4: Exploratory Hole Location Plan**

- Five window sample boreholes (designated BH1 to BH5) were each sunk to depths of between 1.20m to 4.00m below existing ground level. Due to restricted access, BH5 had to be excavated by hand to 1.20m. Window sampler boring is carried out with a small, track-mounted rig, which uses a chain-driven trip hammer to drive sampling tubes or penetrometers into the ground. These tools are coupled to the anvil of the hammer by solid drill rods. Sampling tubes comprise “windowless samplers”, which are plain sampler tubes in which a continuous disturbed sample is recovered within a semi-rigid plastic liner. In order to reduce friction within the borehole, sampling tubes of progressively smaller diameter are used as the borehole depth increases. Sampler diameters generally range from between approximately 90mm to 50mm. Standard Penetration Tests (SPTs) were undertaken in the boreholes in accordance with BS EN ISO 22476-3. Groundwater observations were noted where possible. These observations relate to the time of the investigation only, and do not necessarily reflect seasonal fluctuations. Exploratory hole logs are included in Appendix 1. Exploratory hole locations were selected on-site by an EEG engineer based on the proposed development layout and avoiding known services. BH1, BH2 and BH5 were backfilled using arisings/spoil, whereas BH4 and BH5 had ground gas monitoring pipes installed.

- Two trial pits (SA1 and SA2) were excavated in the centre of the site by use of a 3-tonne 360 tracked excavator to a maximum depth of 1.00m bgl. Soakaway tests were carried out in all of the trial pits in accordance with BRE Digest 365, the results of which are included in the Appendix 1.
