# GEO-ENVIRONMENTAL AUDIT

PHASE 1 Preliminary Risk Assessment

PHASE 2 Site Investigation

Proposed Residential Development

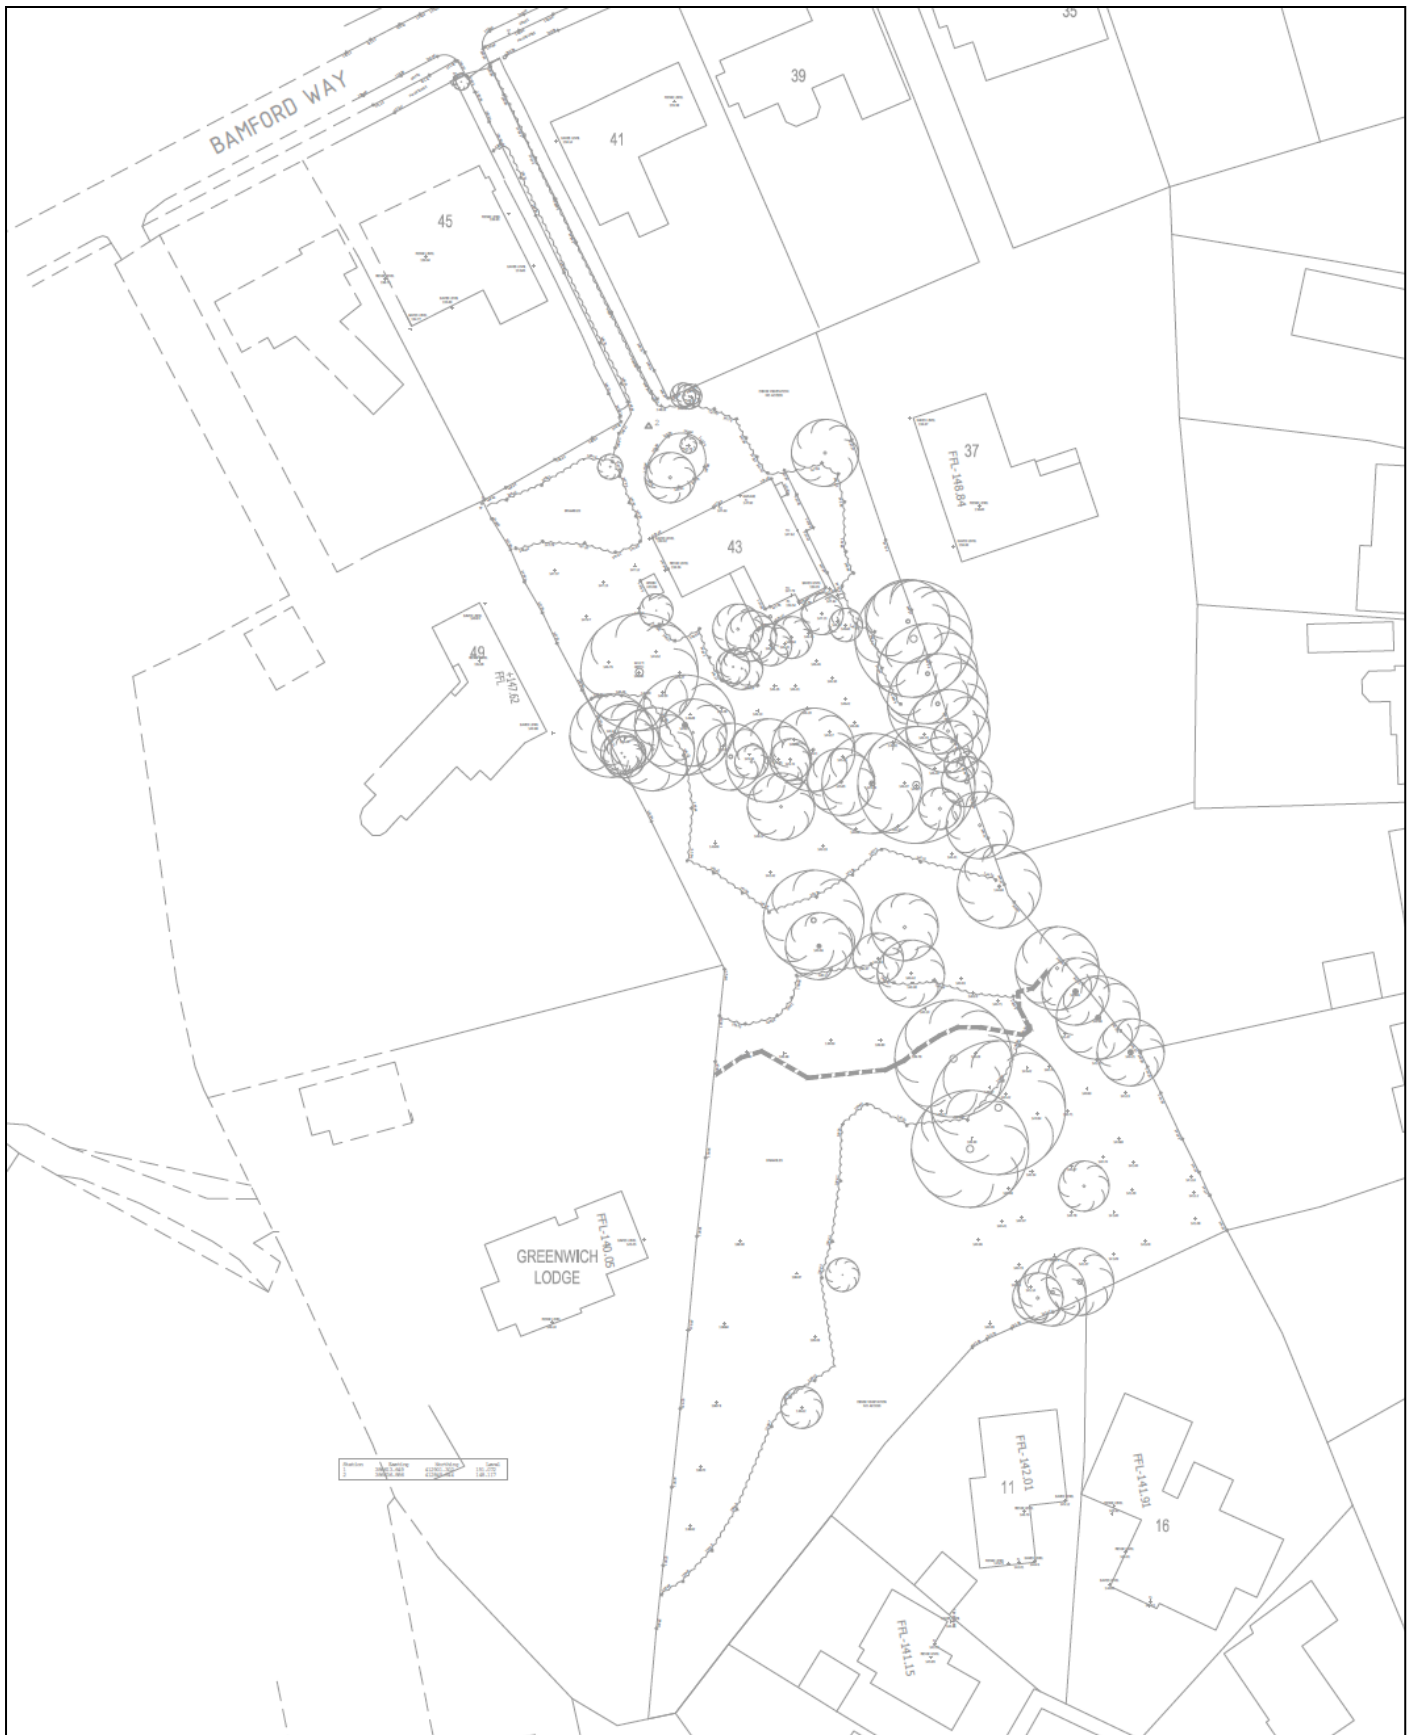
## 5.2. Existing Site Plan.

| | <p>The north part of the Site is accessed via a macadam driveway off Bamford Way. The bungalow, driveway patios and immediate landscaped garden areas are to the higher north part of the Site.</p> <p>The south part of the Site is relatively heavily vegetated with semi mature and mature trees to the perimeter east boundary, as well as other sapling around the Site.</p> <p>There is a combined manhole noted to the southeast corner of the bungalow.</p> |

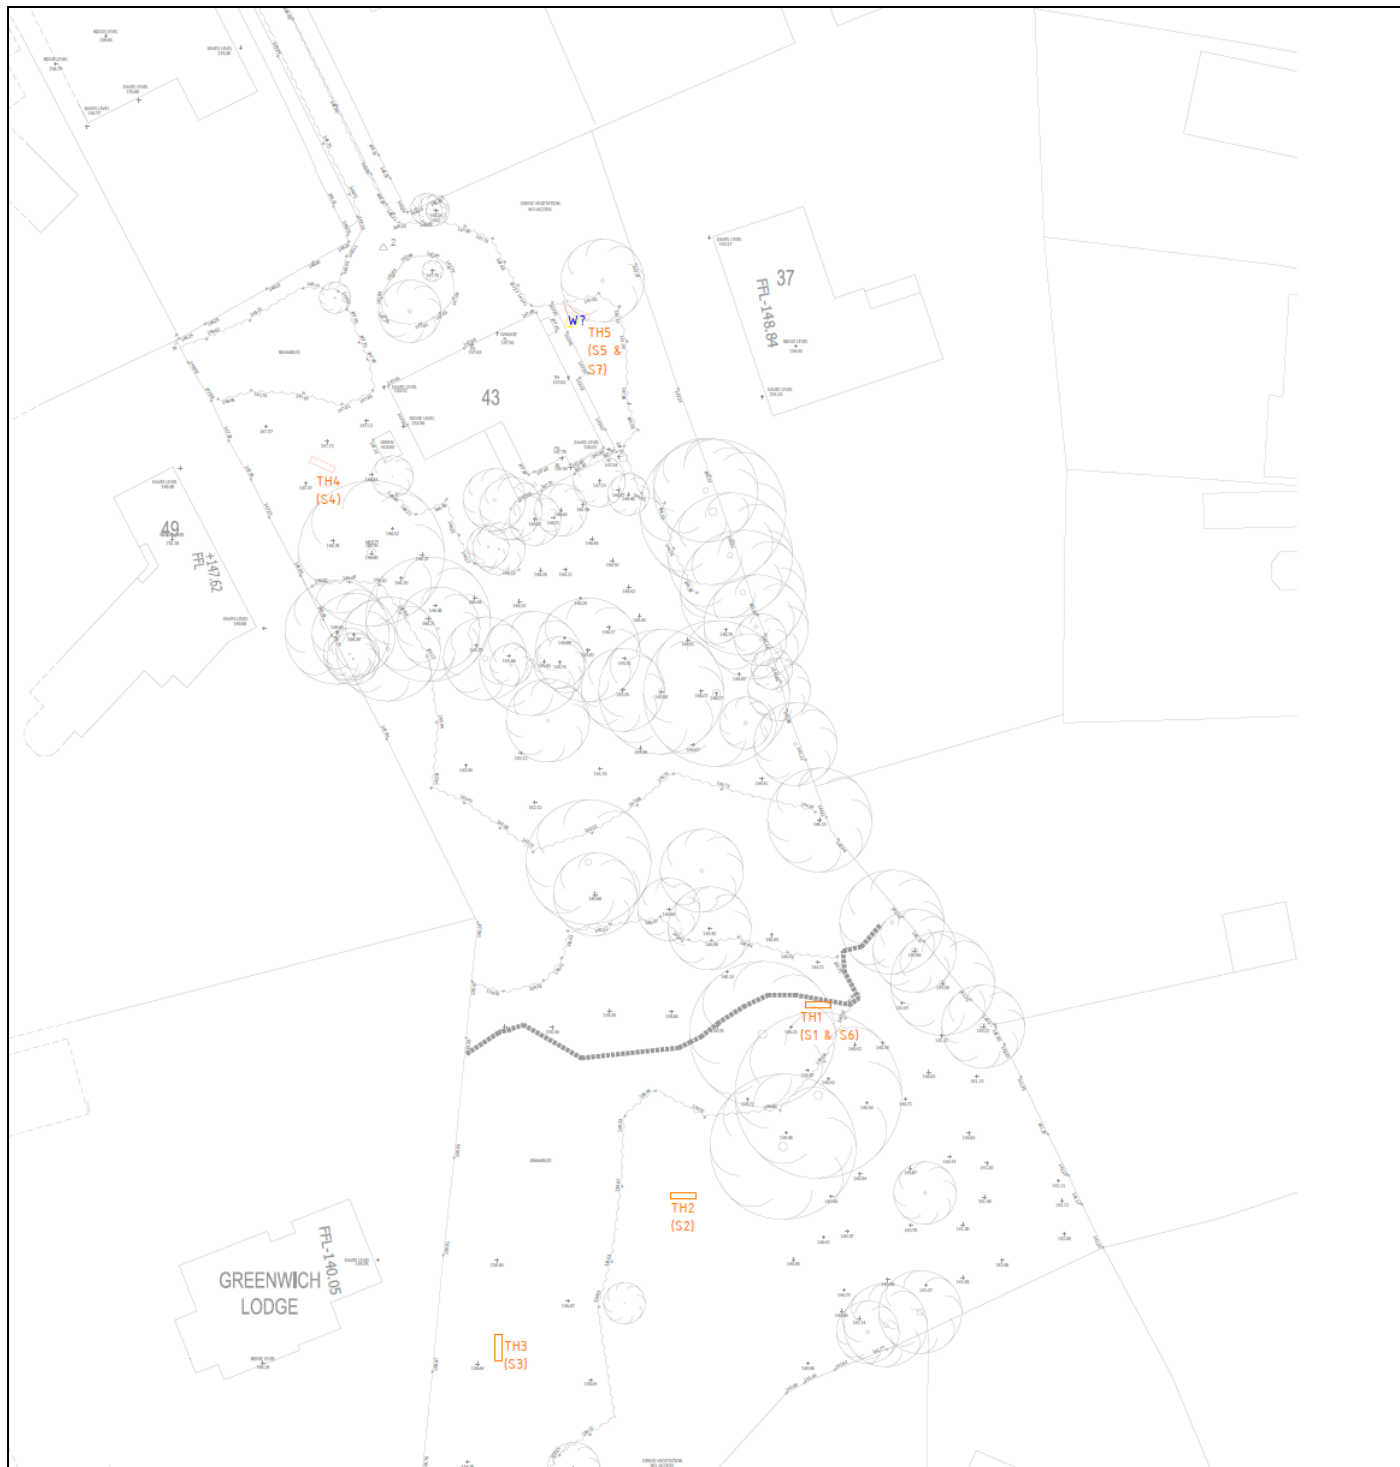
## 5.4. Site Investigation Plan.

A Site investigation was undertaken by T J Booth Associates on the 15.12.2022. The investigations comprised 5No. machine excavated trial holes (THs 1-5), undertaken with a 5t back acting excavator.

Trial holes were undertaken around the Site to gain an understanding of the geology and made ground depths for geotechnical & geo-environmental purposes. A trial hole was undertaken in the location of each proposed plot, giving a nominal grid format of investigation.

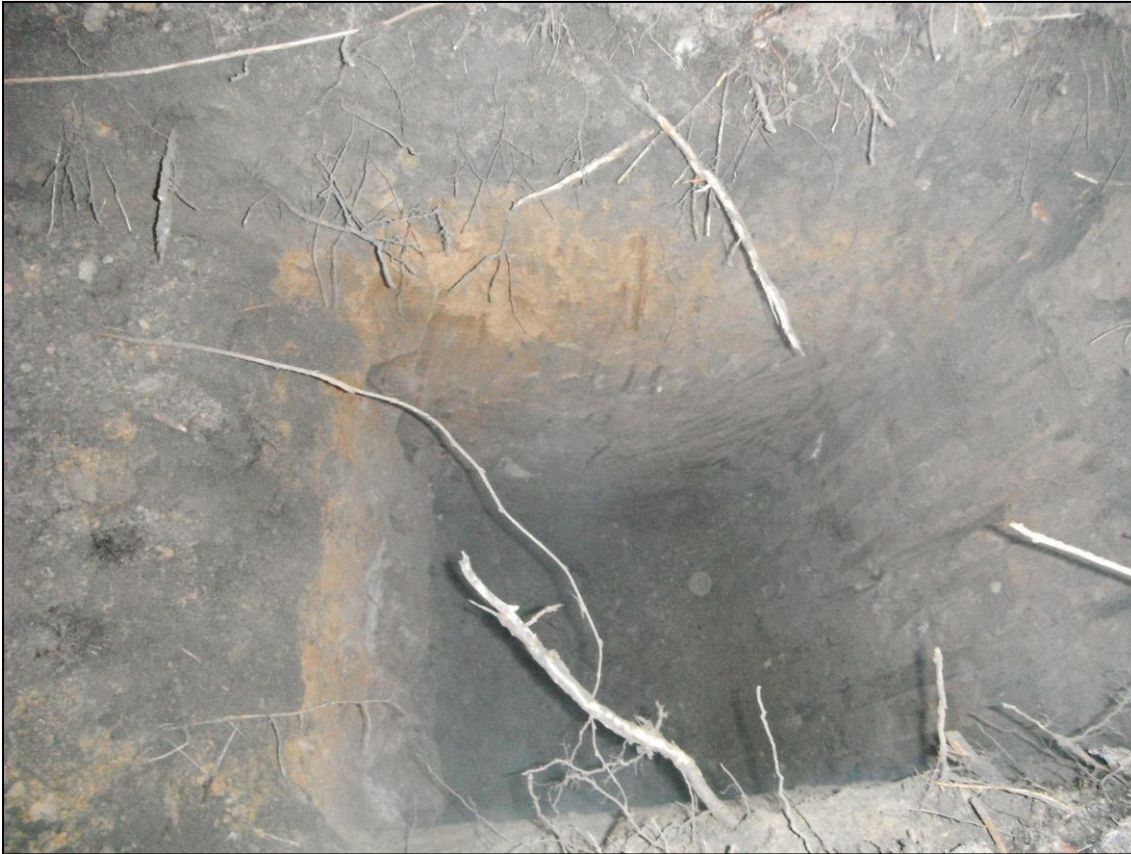
**Figure 5 – TH5.**

| Trial pit reference TH5 | | | | Sheet 1 of 1 |
|---|---|---|---|---|
| | 147.10 | X X<br>X X | (0.40)<br>0.40 | Dark brown-brown TOPSOIL with occasional gravel sized brick & broken clay pipe, (S5) |
