## **Appendix E.1: Historic Environment Desk-Based Assessment**

# Hollingworth Road, Littleborough

## Historic Environment Desk-Based Assessment

Project Ref: 332010570 | Rev: 1 | Date: November 2022

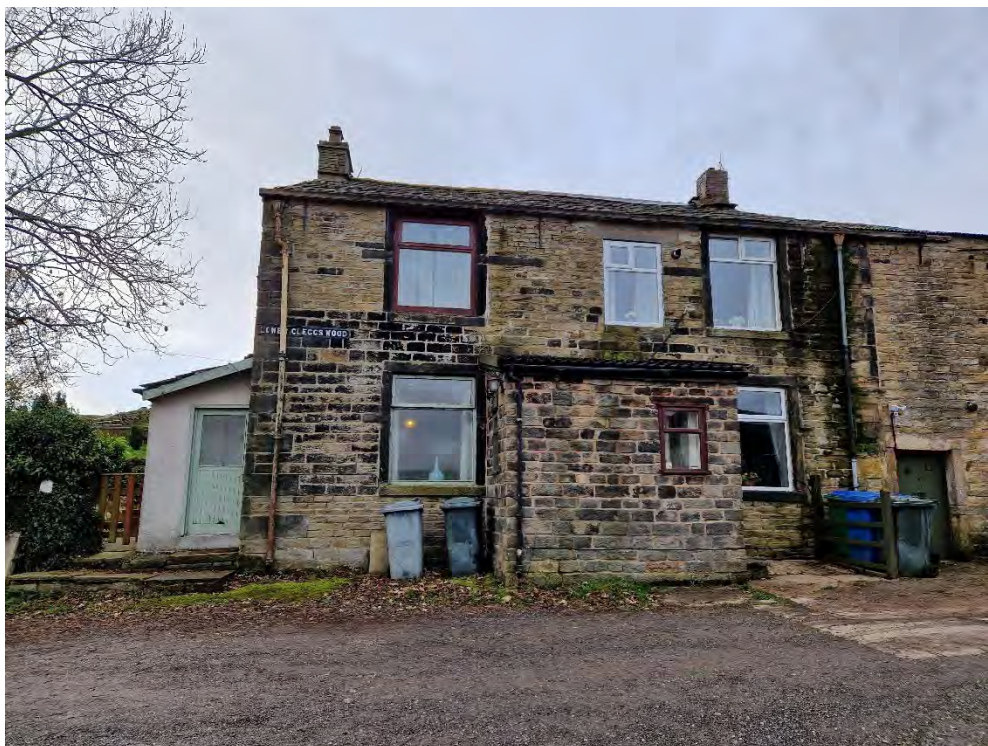
**Plate 1: Lower Cleggswood Farm cottages - building A & B (north-eastern elevation), looking south-west**

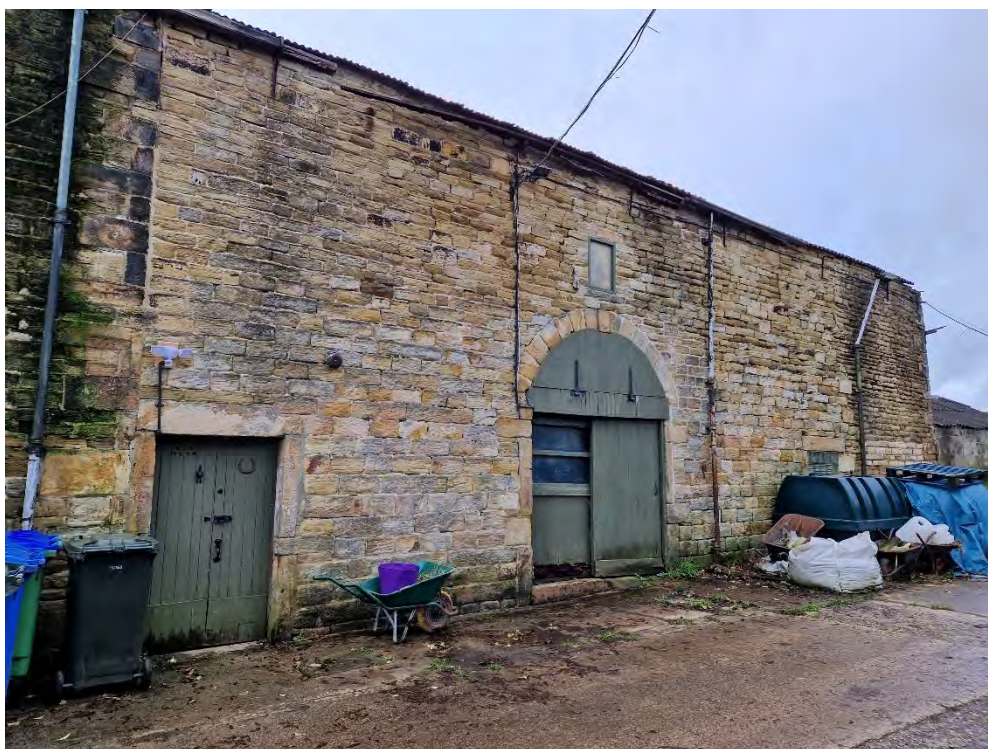
**Plate 2: Lower Cleggswood Farm barn - building C (north-eastern elevation), looking north-west**

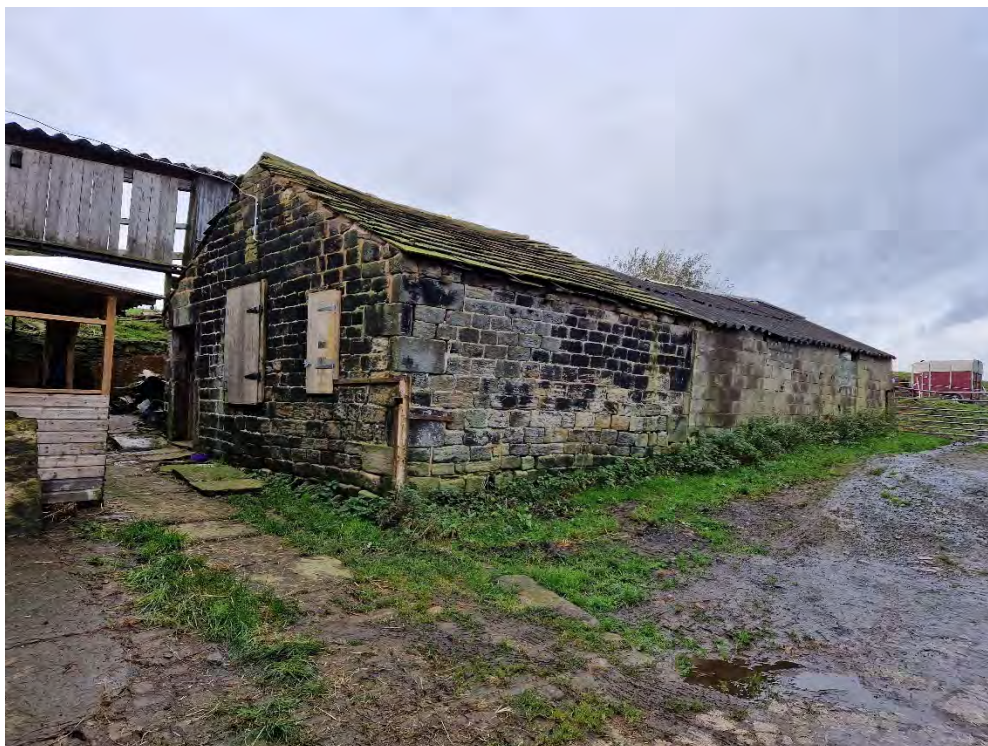
**Plate 3: Lower Cleggswood Farm outbuilding - building D (north-eastern and south-eastern elevations), looking west**

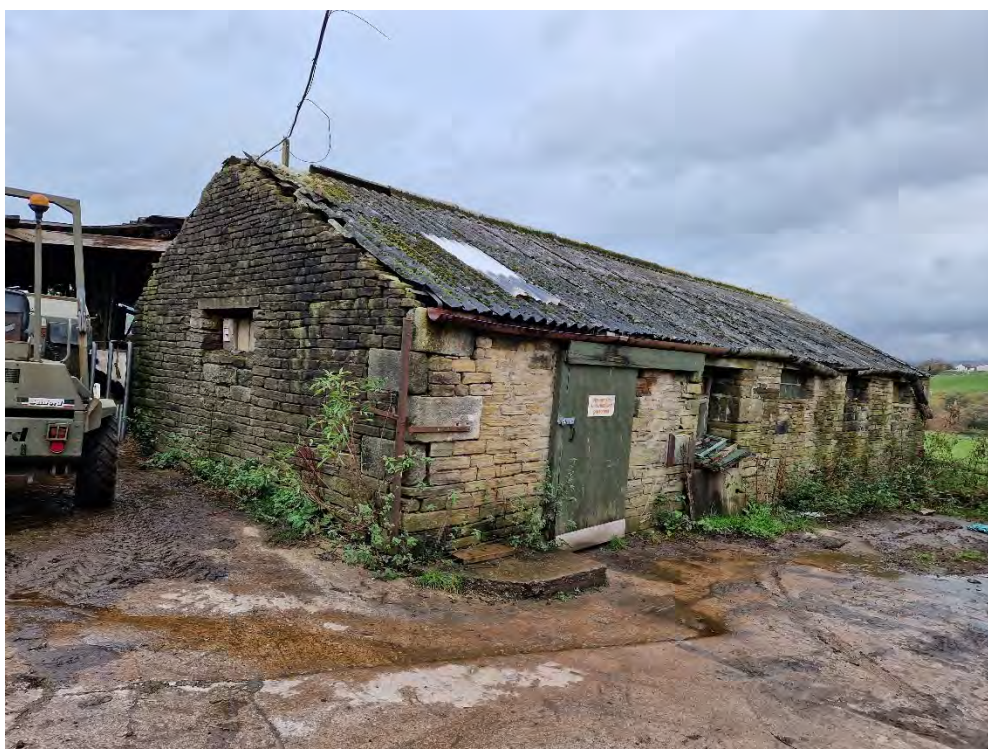
**Plate 4: Lower Cleggswood Farm outbuilding - building G (south-western and south-eastern elevations), looking north**

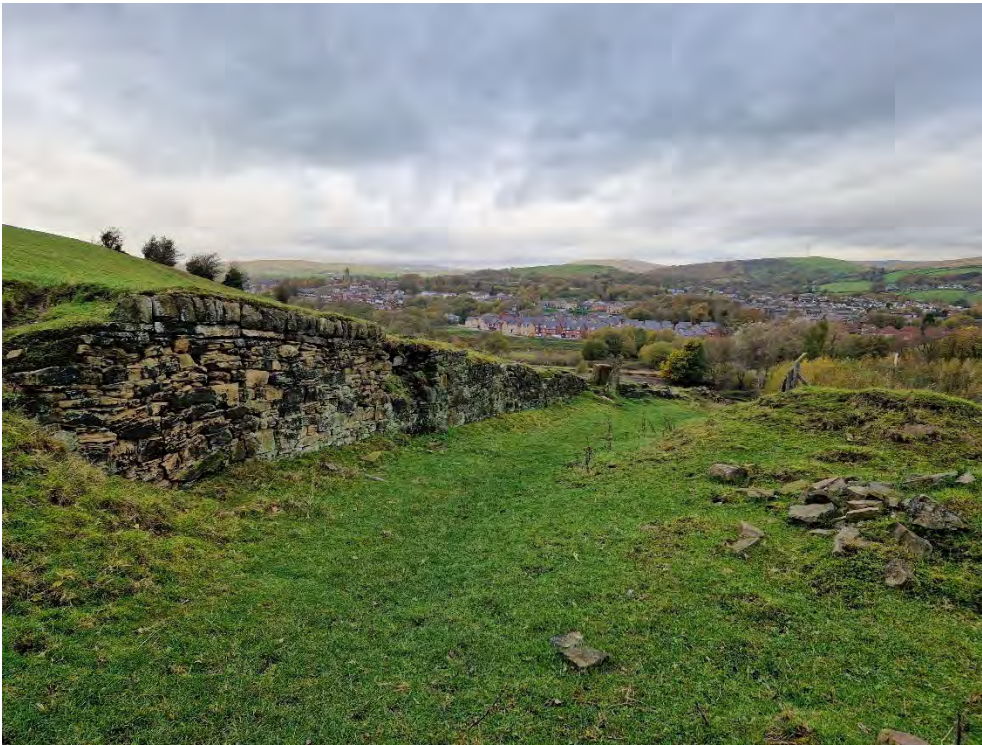
**Plate 5: Drystone wall along western edge of Heald Lane opposite former cottages at Brown Bank Top, looking north-west**

- 4.4.3 The 1851 OS map (Appendix B) shows that land within the Site was enclosed by at least this time comprising a series of regular fields with straight boundaries defined by drystone walls, the majority of which survive in varying states of condition (Plates 5-8). Several trackways are

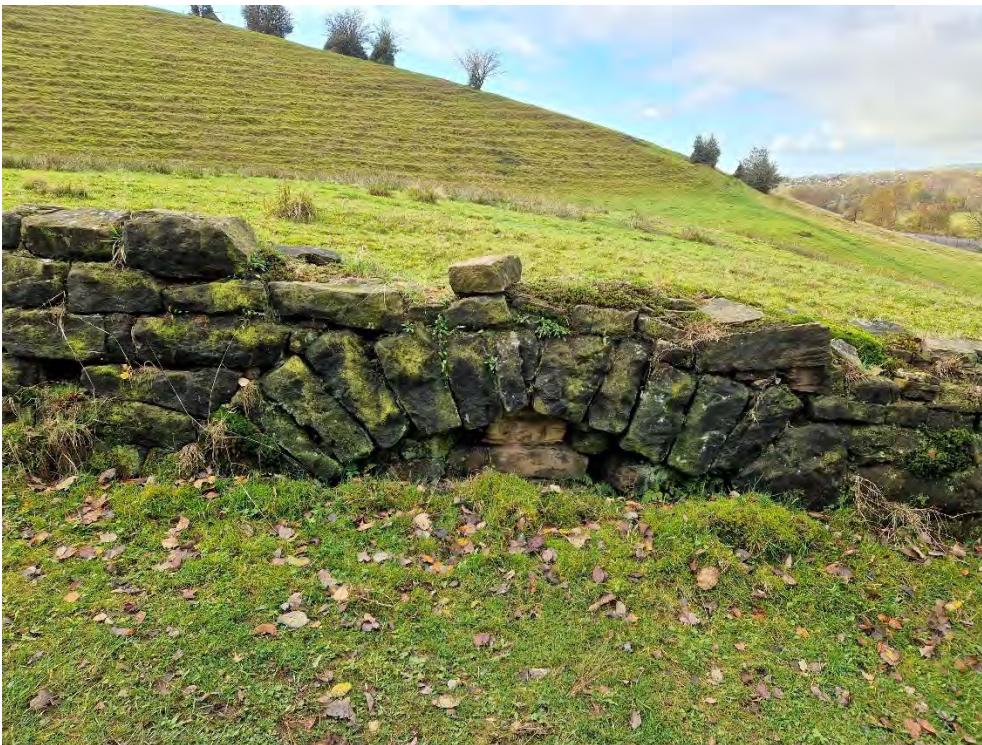
**Plate 6: Drystone wall along western edge of Heald Lane including remains of an arched opening, looking west**

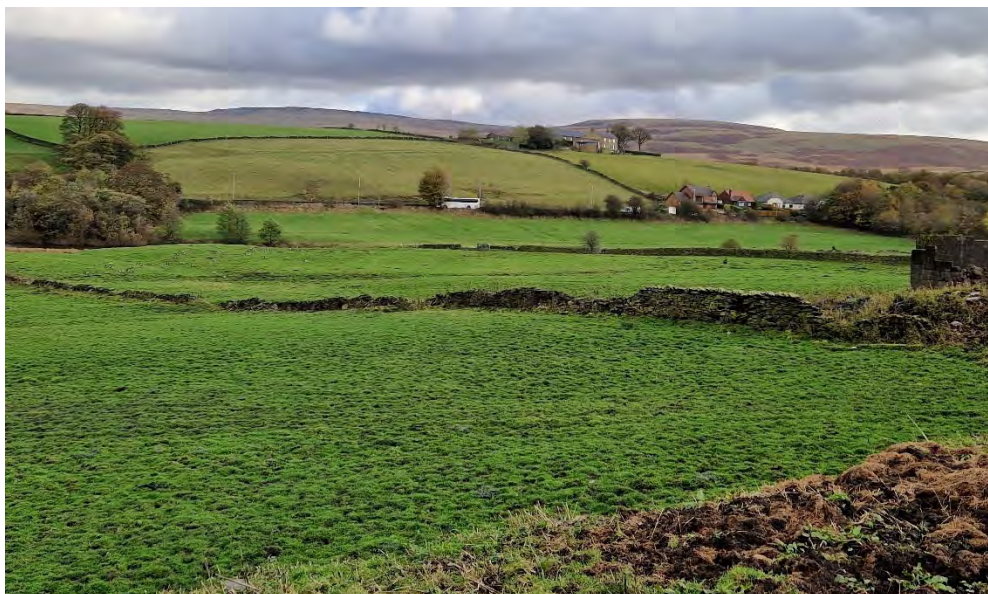
**Plate 7: Drystone walls within the eastern part of the Site, looking south-east**

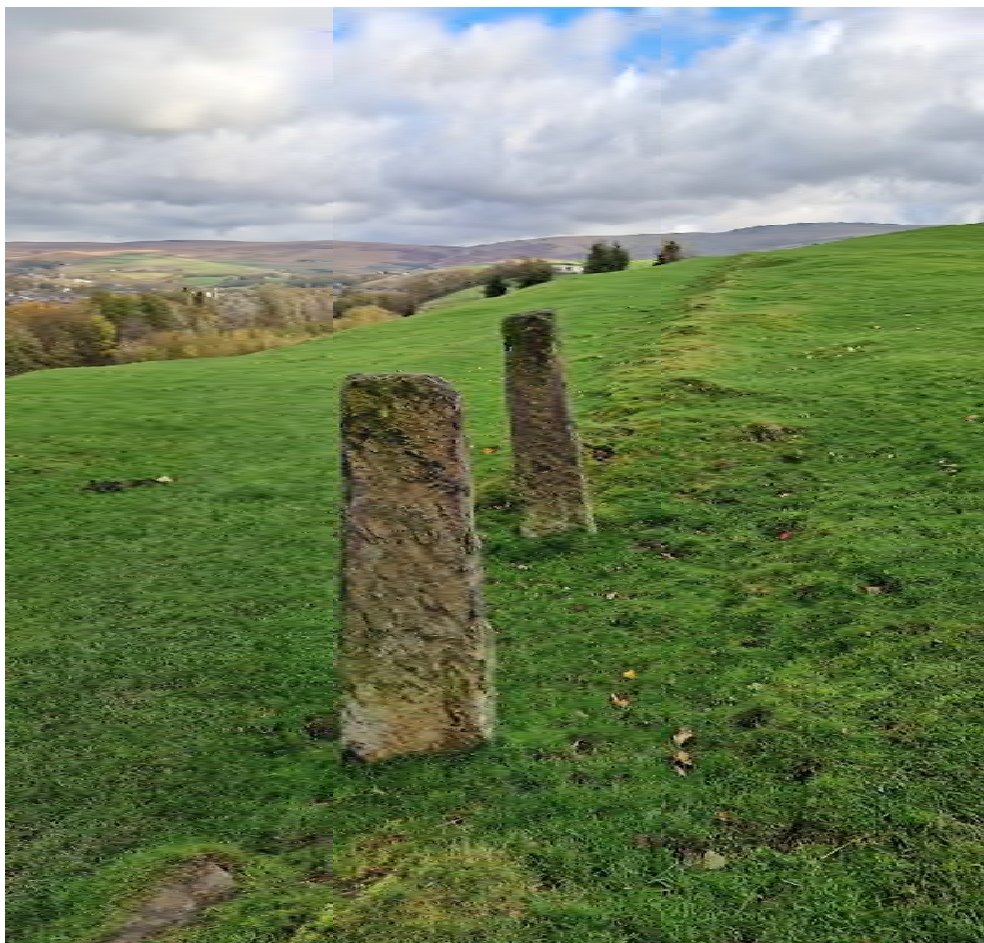
**Plate 8: Gateposts from a former drystone within the north-western part of the Site, looking east**

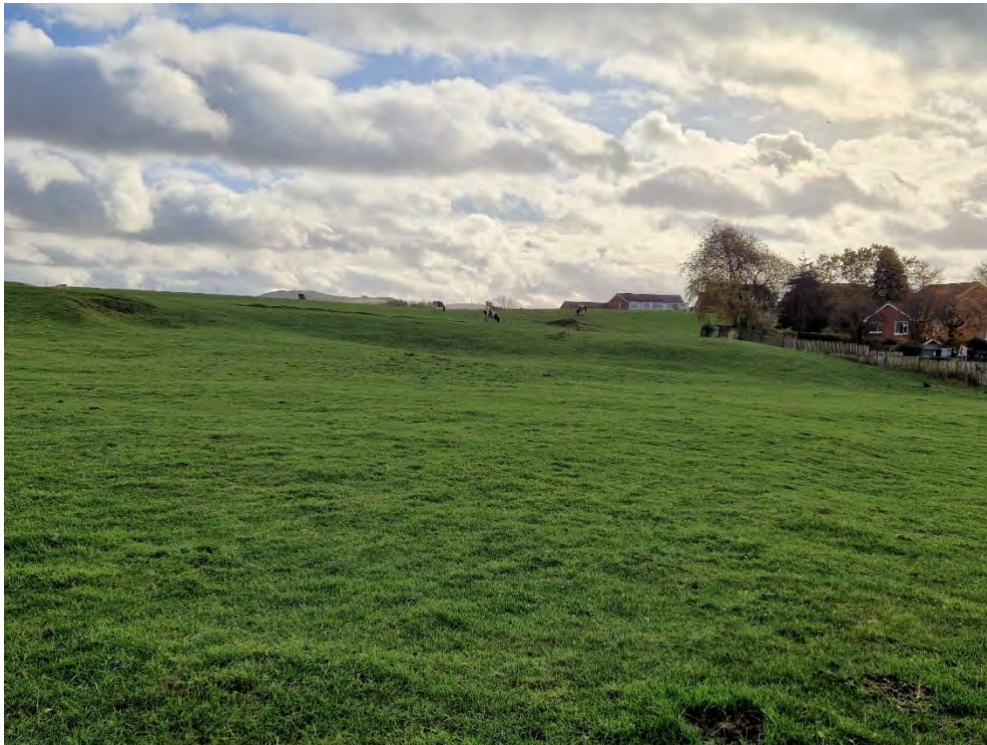
**Plate 9: 'Old quarry' pit within the north-western part of the Site, looking south**

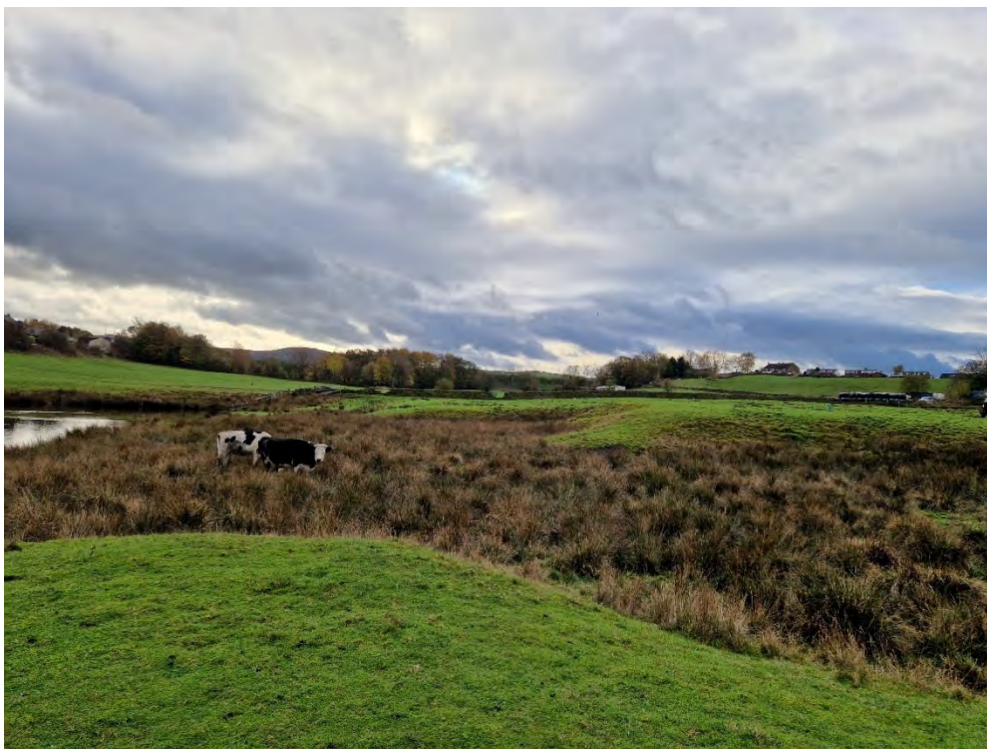
**Plate 10: Former quarry pit adjacent to the reservoir within the eastern part of the Site, looking south**

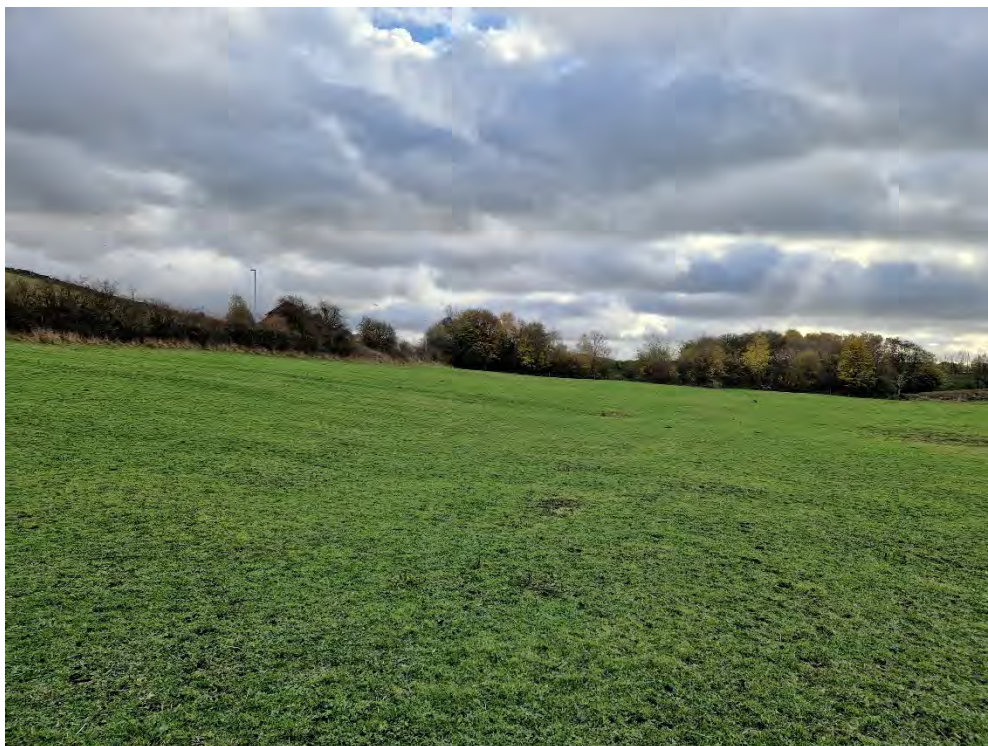
**Plate 11: Linear earthworks within the eastern part of the Site, looking south-east**

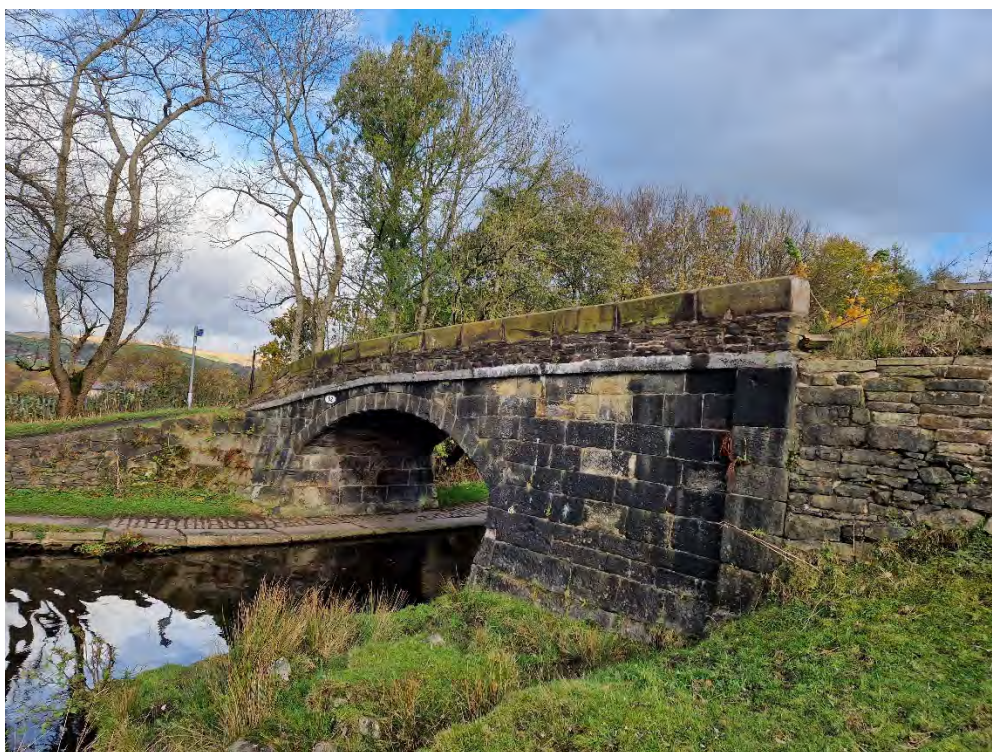
**Plate 12: Brown Bank Bridge (western elevation), looking north**

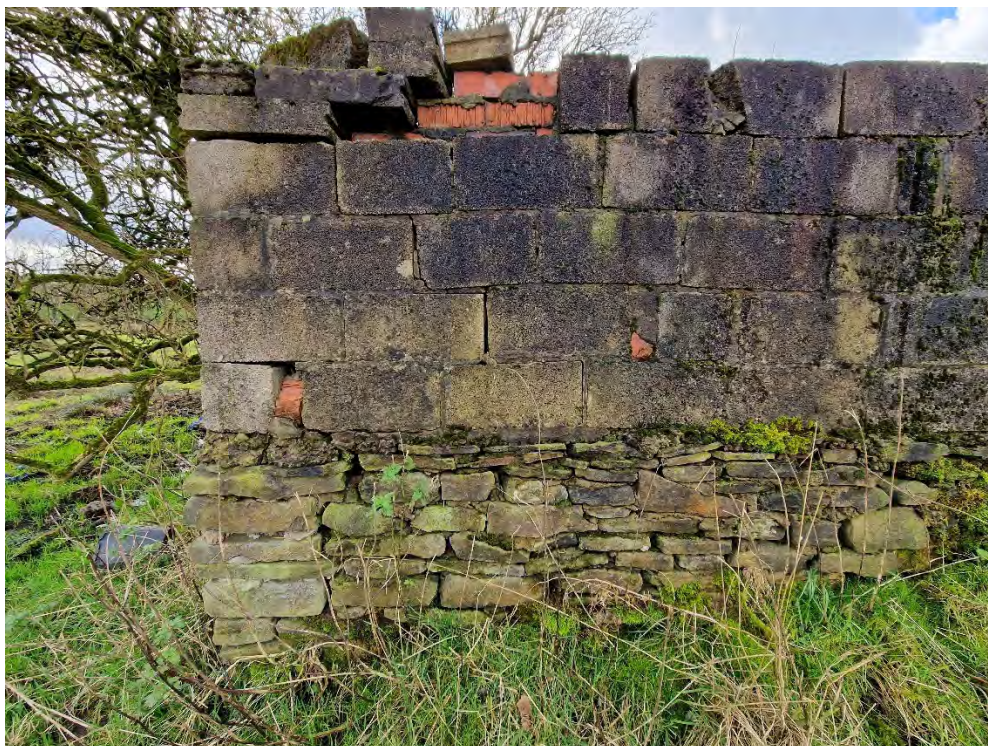
**Plate 13: Structural remains at Heald Spring, looking south**

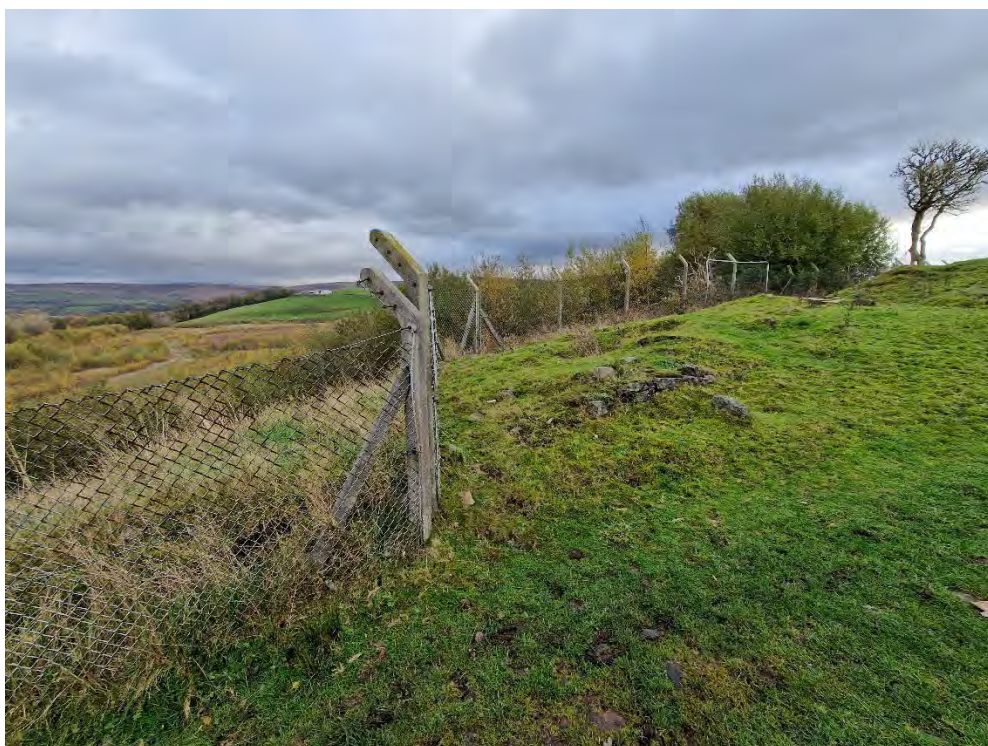
**Plate 14: Remains of Brown Bank Top cottages, looking east**
