**PHASE I ENVIRONMENTAL AUDIT.**  
**Caldershaw Centre, Ings Lane, Rochdale.**

| Client: | Iqbal Enterprises. |
| Reference: | rep-tjba-iqbal-caldershaw ctr-phs I-160813 |

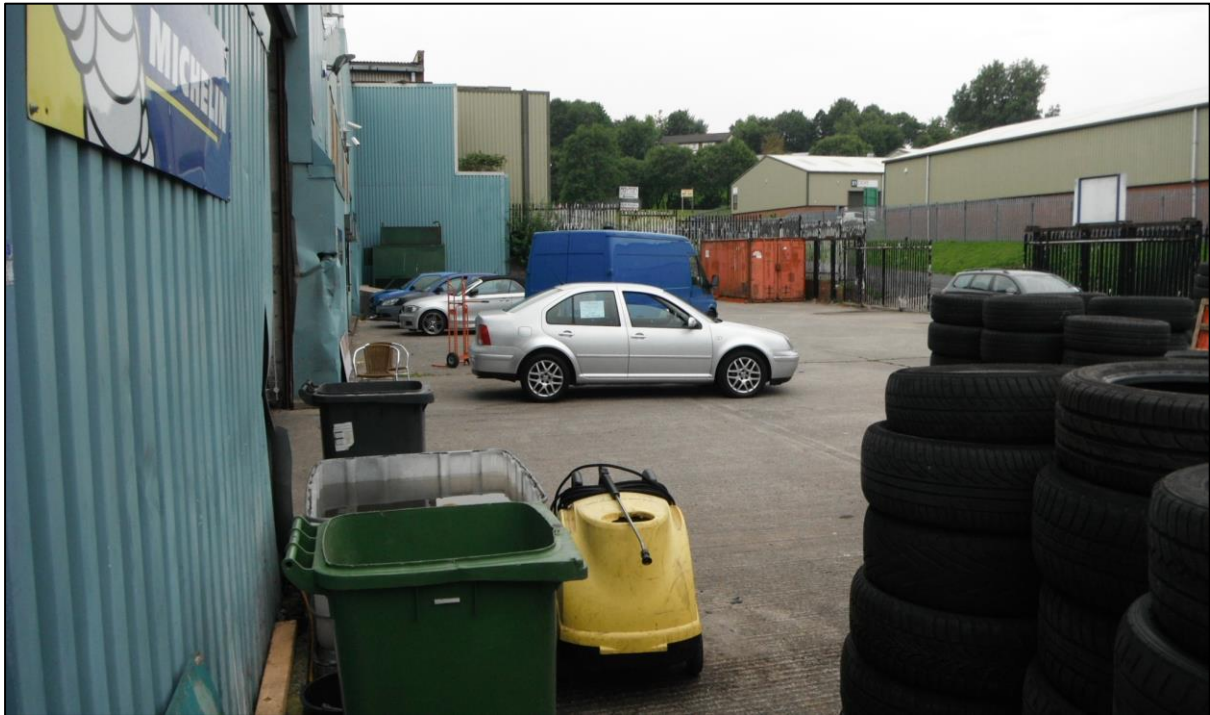
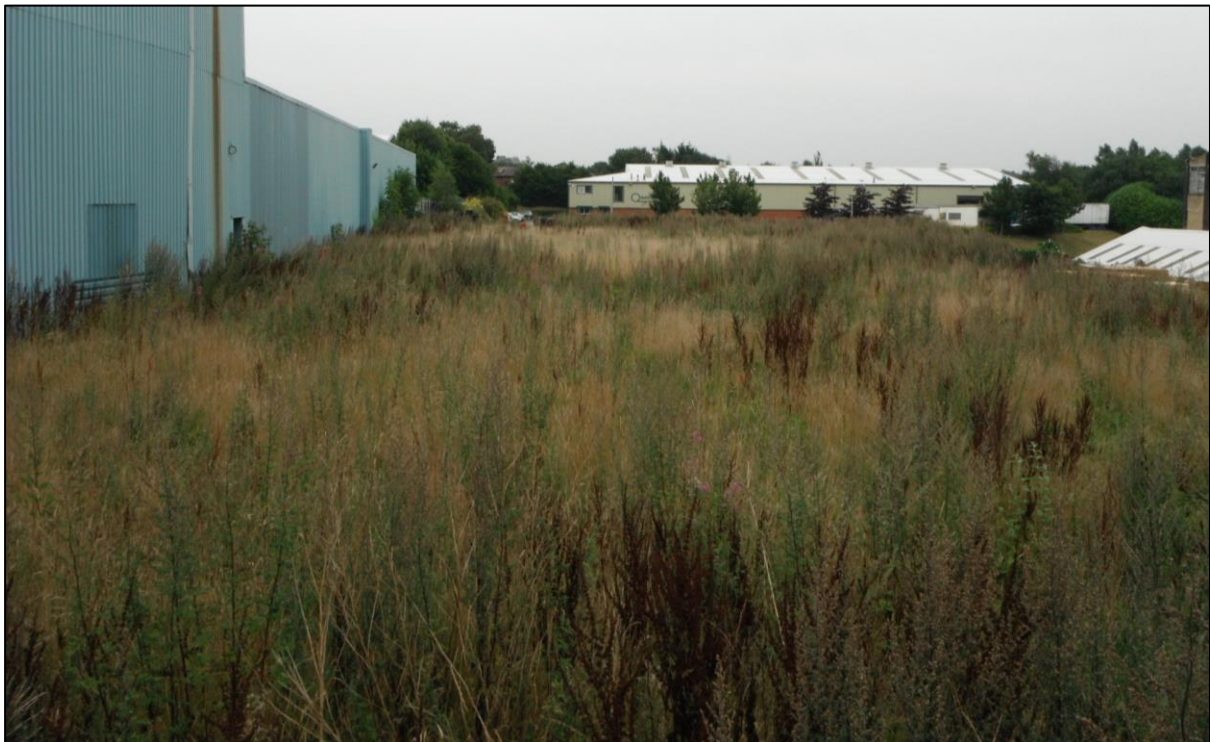
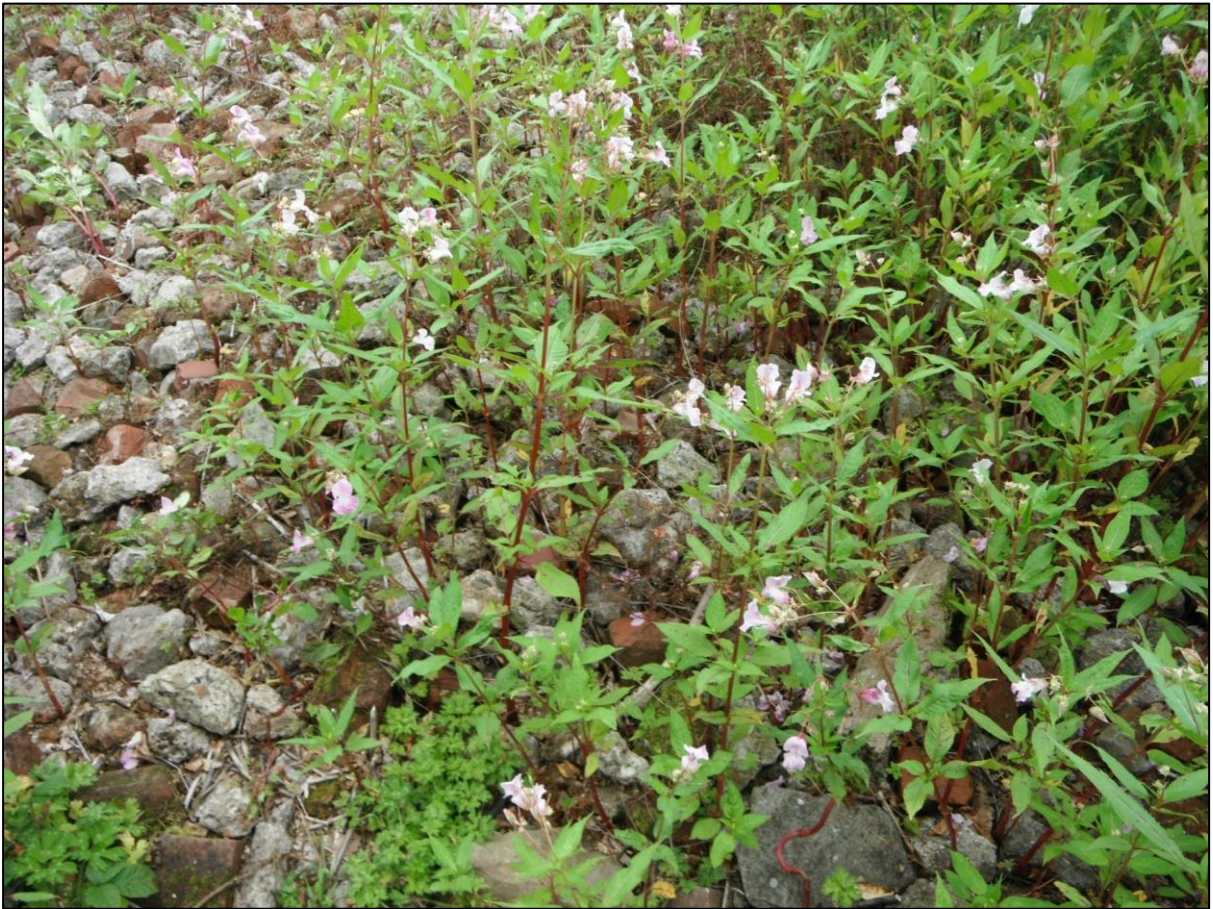
### 10.1. Photographs.

The E side of the Site comprised a concrete yard which is currently used as a car park to the Eurotyre depot. There was a tank to the NW corner of the yard situated on concrete. There was also some storage of tyres, a container and a prefabricated office block.

The S side of the Caldershaw Centre comprised a generally flat made ground (building rubble including brick, stone, conc, macadam, with occasional metal & plastics etc). The ground was vegetated with weeds/shrubs. The site sloped down to the adjacent landscaping & timber yards to the S. There were occasional areas of minor tipping on Site.

The Site was generally flat with a steep slope in the order of approx. 4m to the S boundary/perimeter. The E boundary had a retaining wall above the adjacent Site nominally 3-4m high.

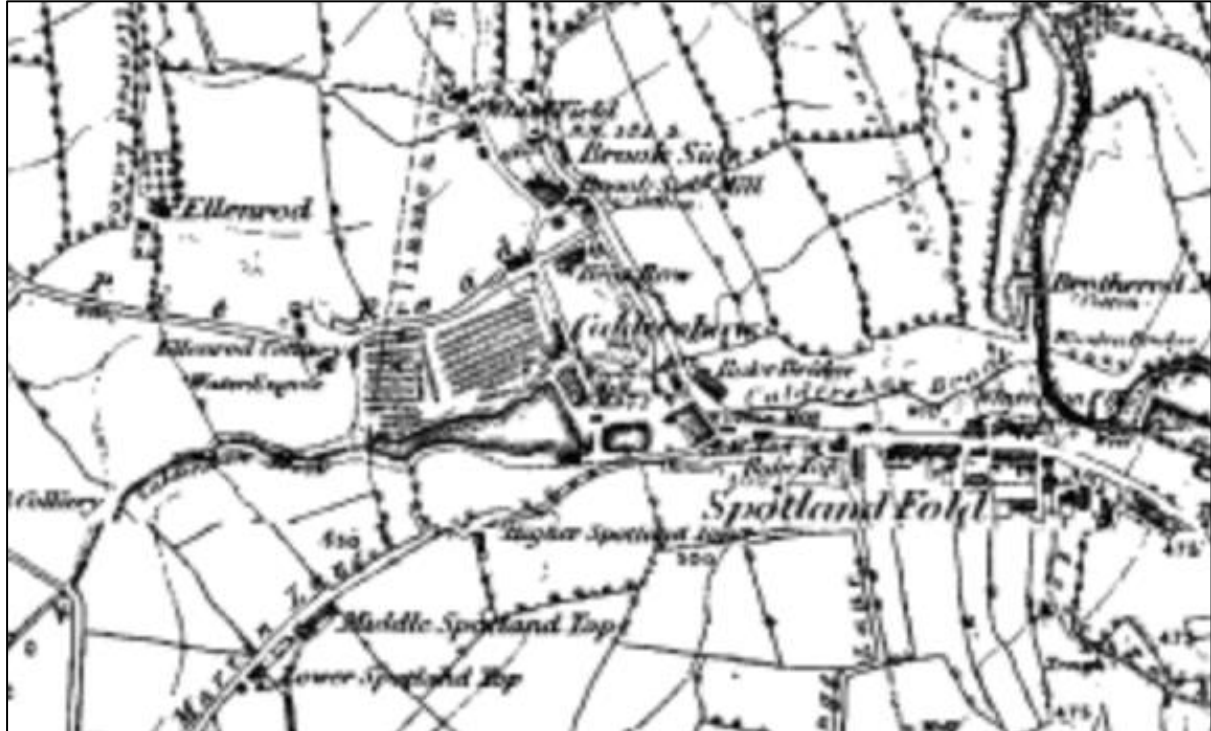
#### 11.1.1.1. Ordnance Survey c1850.

| Date | On Site | Off Site / Surrounding Area |
|---|---|---|
| c1850 | The Site generally field for the most part with structures noted to the East & west sides. | To the WNW is a tenters field, reservoirs to the SW & S. Embankment/slope noted to the S side of the Site. There are building structures to the SE. There is a colliery approx. 400m W. Caldershaw Brook is culverted to the S of the Site. Brookside Mill 150-200m N. Brotherod Cotton Mill approx. 200m E. Clod Cotton Mill 250m E. Spotland Cotton & Woolen Mills 300m E. |

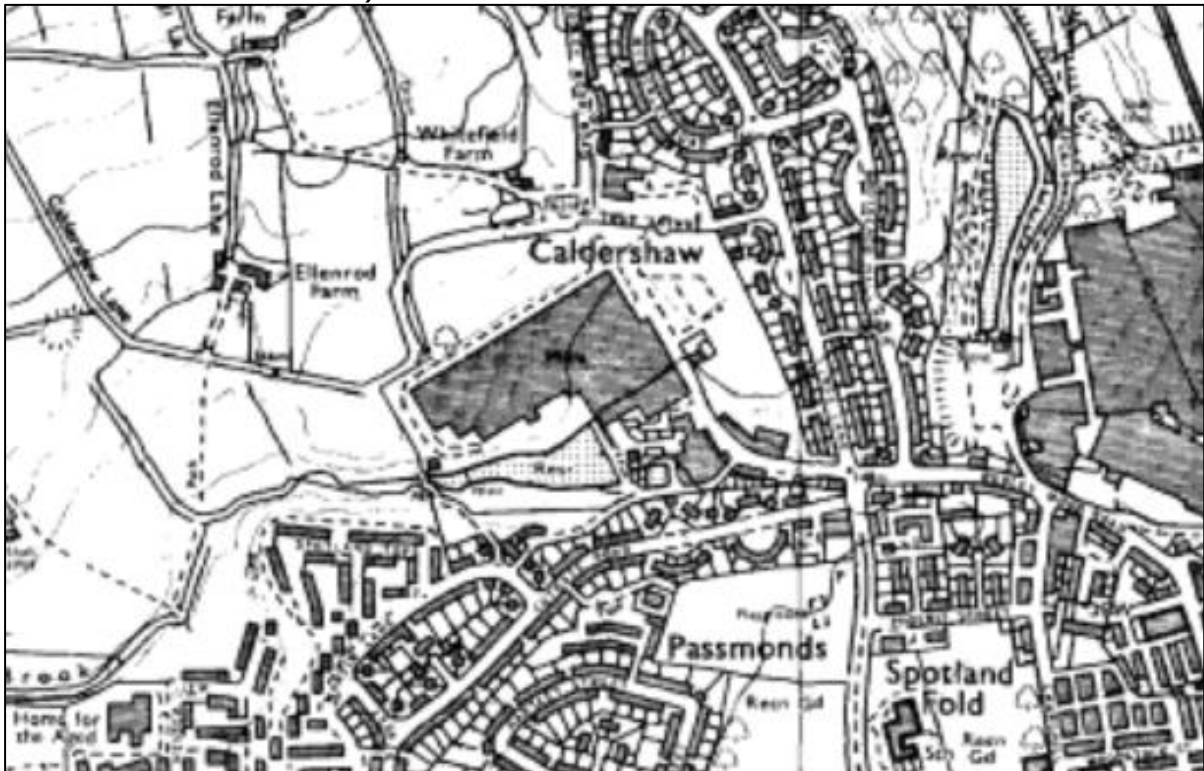
*11.1.1.6. Ordnance Survey c1980-90s.*

| c1980s-90s | Further development of Mills on Site. | Caldershaw Mill expanded to the WNW of the Site, replacing Caldershaw House. |

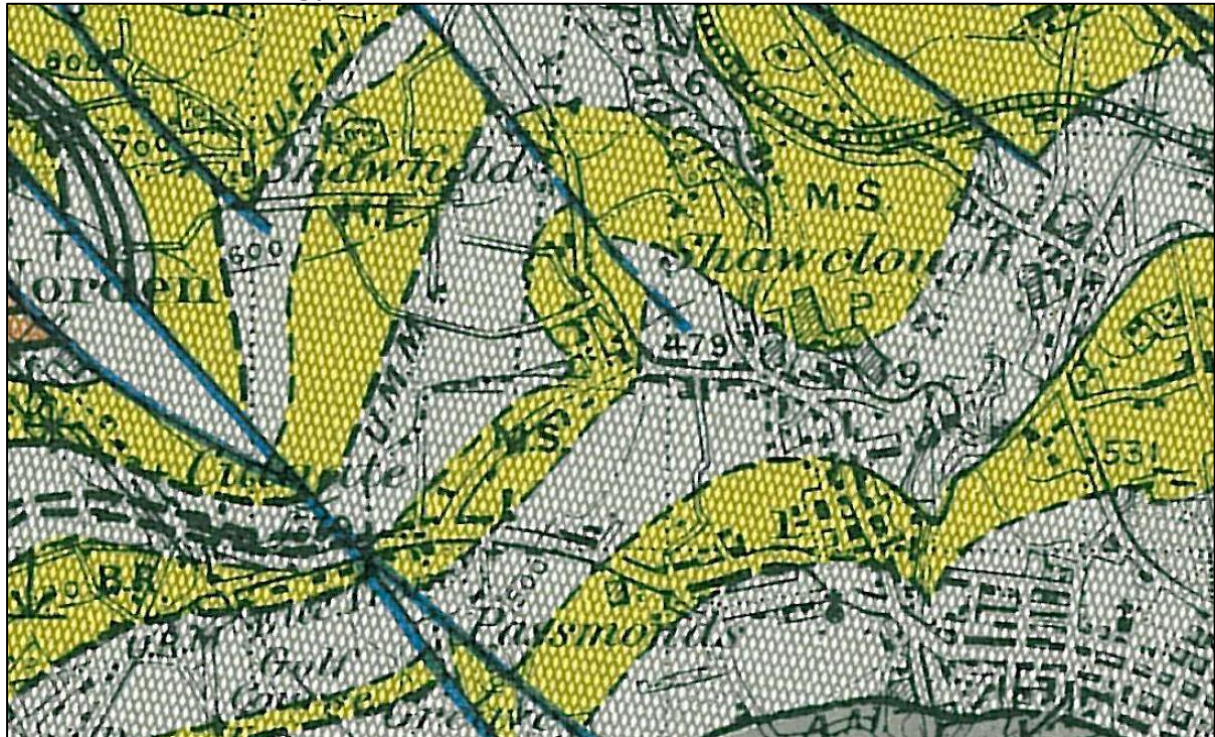
### 11.2.1.1. Solid Geology.

The mapping data indicated that the Site lay on Milnrow Sandstone of the Carboniferous Lower Coal Measures. Undifferentiated sandstones/mudstones outcrop nominally 50m W & 100m E. The Upper Mountain Mine Coal Seam outcrops nominally 450m W, and the region has a stratigraphic dip in the order of approximately 5-10° S.

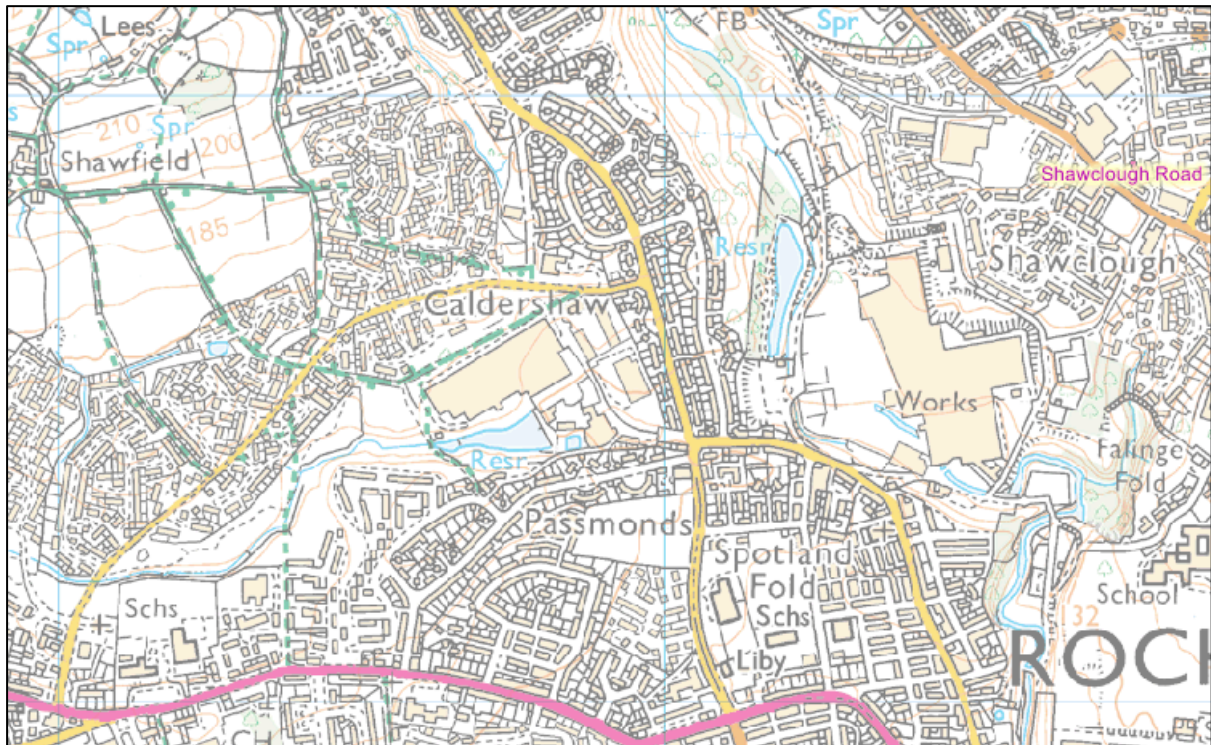
### 11.3.Environment Agency Landfill Map.

In a search on the development Site, the EA landfill mapping data indicated that the Site is not within 250m of a landfill site (refer to EA map in appendix).

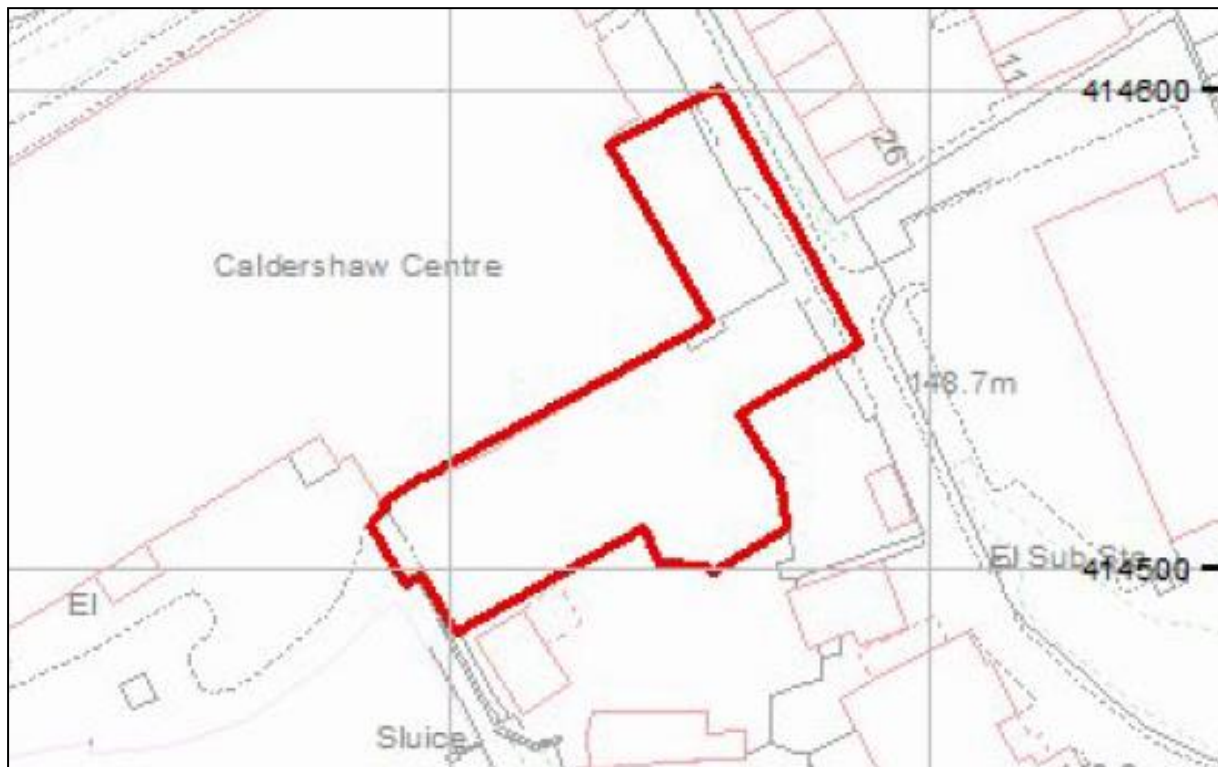
### 11.5. Coal Authority Report Map.

The Coal Authority report indicated that the site is not within the zone of likely physical influence of past or present underground workings. The site is also not within the area for which licences have, or are in the process of being granted; although reserves of coal do exist in the area. Past, present, and future open cast mining is not an issue in the area.

There are no known mine entries exist within the site, or within 20m of the site boundaries.
