Phase I Geoenvironmental Site Assessment  
Smethurst Street, Heywood

Reference: 13-224  
Date: November 2021

# PHASE I GEOENVIRONMENTAL SITE ASSESSMENT

**Report Ref: 13-224-R1-1**  
**Date Issued: 15/11/2021**

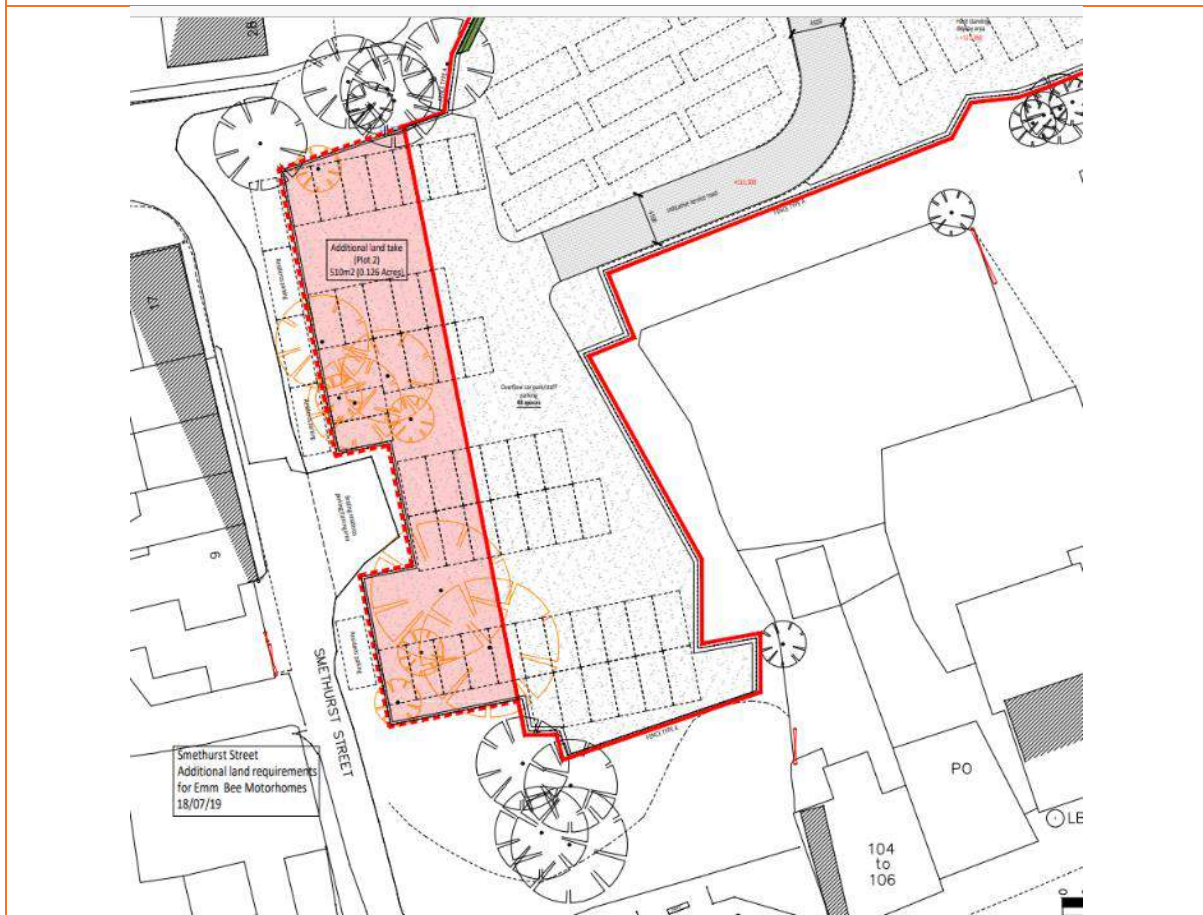
FIGURE 1.1 SNAPSHOT OF PROPOSED DEVELOPMENT

A snapshot of the proposed development area is indicated in Figure 1.1 (shaded red).

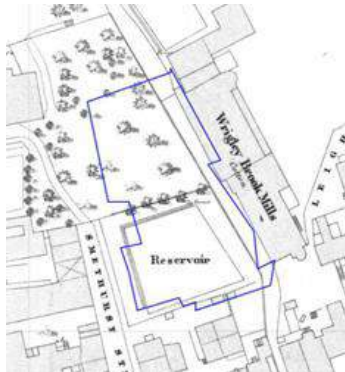
| MAP EDITION | HISTORICAL LAND USE | HISTORICAL MAP EXCERPT |
|---|---|---|
| <p><b>1851</b><br/><b>1:1,056</b></p> | <p>The site is mapped to be split into two sections. The southern section is a reservoir, while the northern section of the site is a field with trees.</p> | |

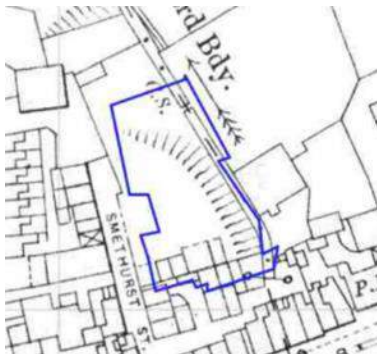
| MAP EDITION | HISTORICAL LAND USE | HISTORICAL MAP EXCERPT |
|---|---|---|
| <p><b>1910</b><br/><b>1:2,500</b></p> | <p>The site is no longer split into two sections. A cutting has been marked on site starting the southeast corner arcing round to the northwest corner. Buildings are marked present in the south of the site.</p> | |

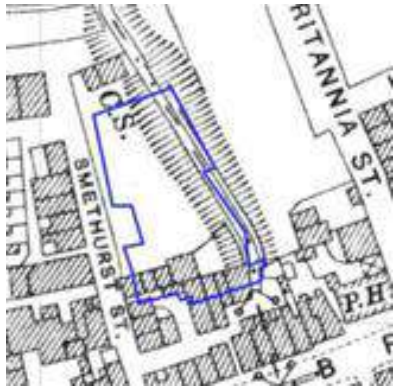
| MAP EDITION | HISTORICAL LAND USE | HISTORICAL MAP EXCERPT |
|---|---|---|
| <p><b>1929</b><br/><b>1:2,500</b></p> | <p>Groundworks have occurred onsite and the cutting has been redirected to follow the eastern boundary of the site.</p> | |

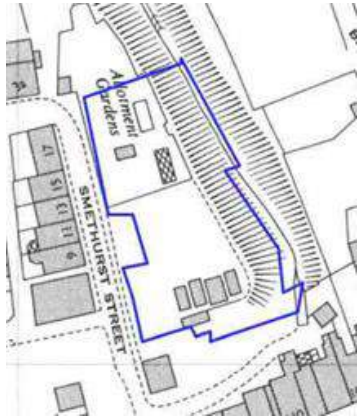
| MAP EDITION | HISTORICAL LAND USE | HISTORICAL MAP EXCERPT |
|---|---|---|
| <p><b>1956</b><br/><b>1:1,250</b></p> | <p>The site has been split up into northern and southern sections. In the northern section allotment gardens are present. In the southern section, five buildings are marked.</p> | |

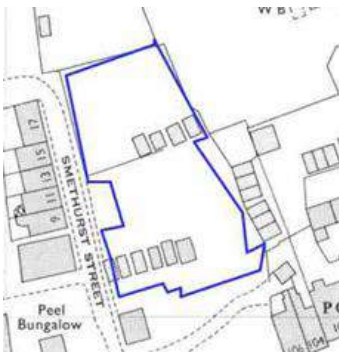
| MAP EDITION | HISTORICAL LAND USE | HISTORICAL MAP EXCERPT |
|---|---|---|
| <p><b>1970 - 1975</b><br/><b>1:1,250</b></p> | <p>The site is still split into two sections, the northern section is no longer allotments and there are four buildings marked in a row going across the site. The southern section still has five buildings however the position of these has changed, they are in a line going across the site west to east. The cutting/brook is no longer marked.</p> | |

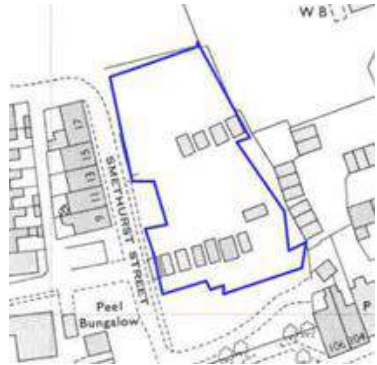
| MAP EDITION | HISTORICAL LAND USE | HISTORICAL MAP EXCERPT |
|---|---|---|
| <b>1975 – 1979</b><br><b>1:1250</b> | Two more buildings are marked in the south of the site. No other significant changes noted. | |

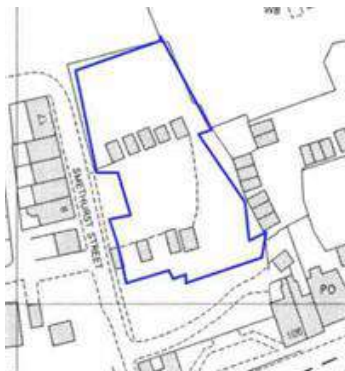
| MAP EDITION | HISTORICAL LAND USE | HISTORICAL MAP EXCERPT |
|---|---|---|
| <b>1985 – 1990</b><br><b>1:1,250</b> | A building has been added to the row in the north and the position of all the buildings has moved, they are now more spread out and cover the whole site west to east. Three buildings have been removed in the south of the site as well as the building on the eastern boundary. A path can be seen connecting the two rows. | |

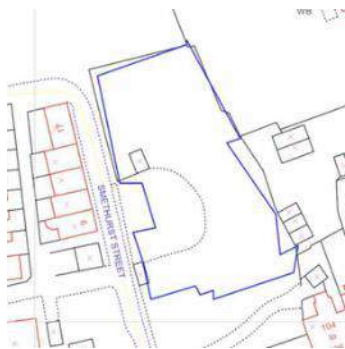
| MAP EDITION | HISTORICAL LAND USE | HISTORICAL MAP EXCERPT |
|---|---|---|
| <b>2003</b><br><b>1:1,250</b> | All the buildings have been removed from the site apart from one on the western boundary. A path is marked connecting this building to a building on the western boundary of the site. | |

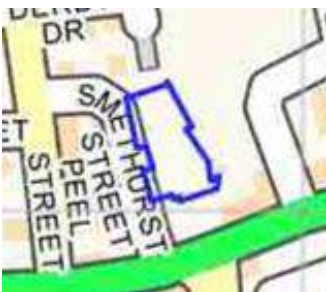
| MAP EDITION | HISTORICAL LAND USE | HISTORICAL MAP EXCERPT |
|---|---|---|
| <b>2021</b><br><b>1:10,000</b> | The site is scrubland and densely wooded. | |

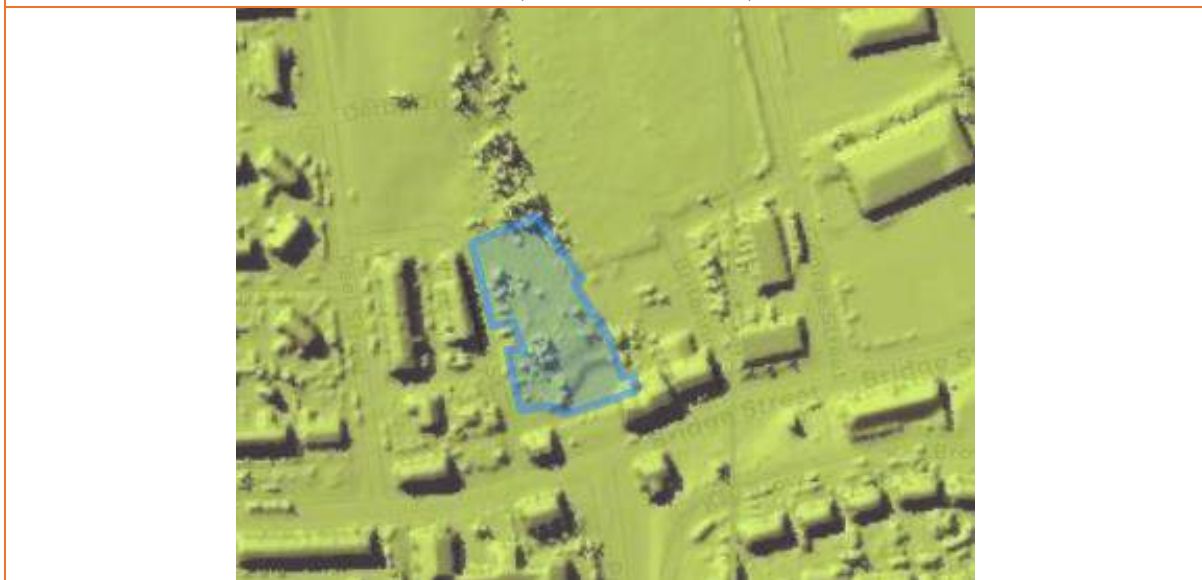
FIGURE 4.2 SURFACE LIDAR DATA (GROUNDSURE IO)

From the LIDAR imagery shown in Figure 4.2 the site has a varied topography and alteration to the natural landform has occurred. In the south-east corner, there is a ridge that is higher than the rest of the site and some smaller ridges can be seen on the western and eastern boundaries. These could be from the infilling of the cutting and reservoir.

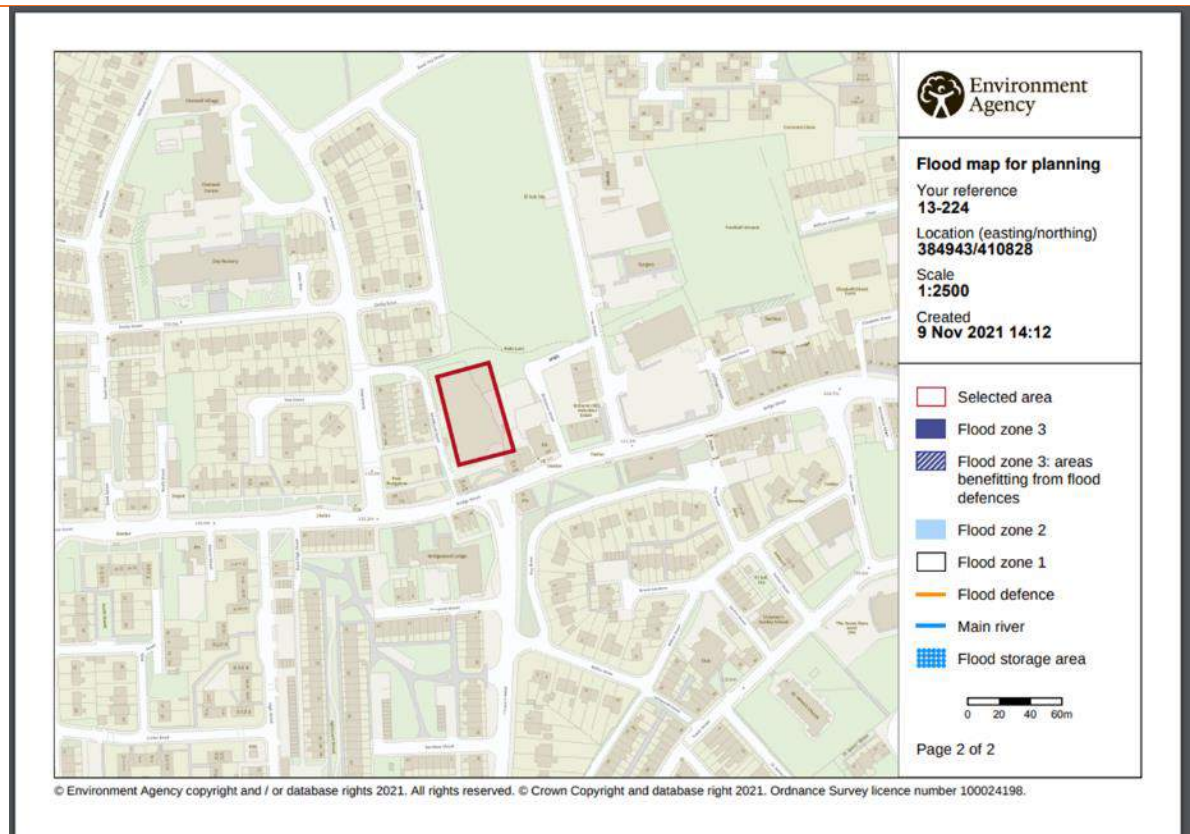
FIGURE 4.3 EA FLOOD RISK MAP

The Environment Agency (EA) Flood Risk Map for the site is presented in Figure 4.3.
