# Archaeological Record & Written Scheme of Investigation

Proposed Residential Development  
Former Sladen Mill  
Littleborough  
Rochdale

Author: Daniel Slattery  
Client: Mere group  
Reference: rep-tjba-mere grp-slade n mill-Phs 2+3 Env-250322.docx

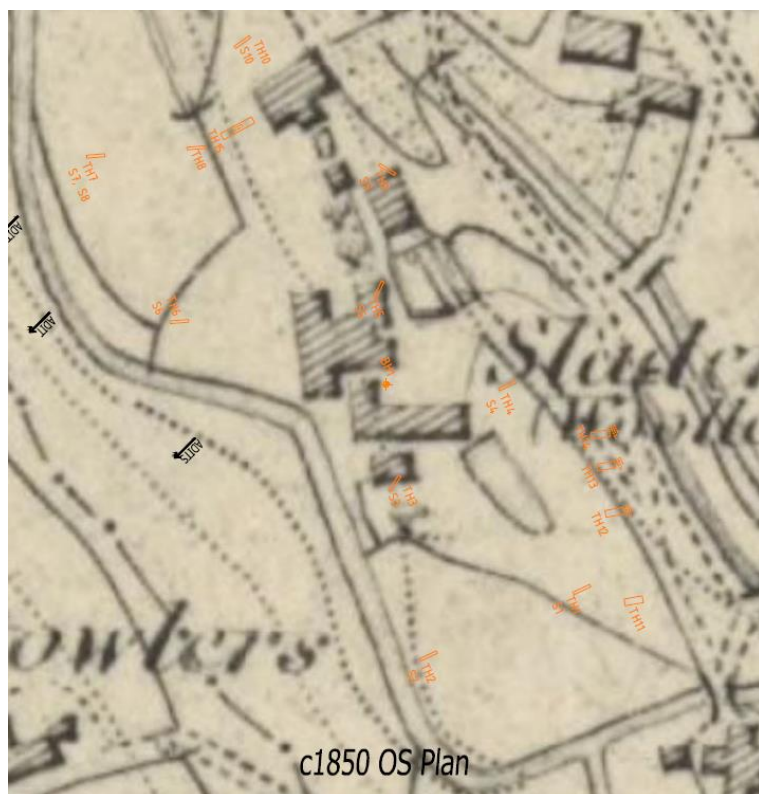
1848 plan showing THs 3 & 5 intercepting the 'original' woollen mill, and TH9 to the original cottages/outbuildings to the upper part of the Site.

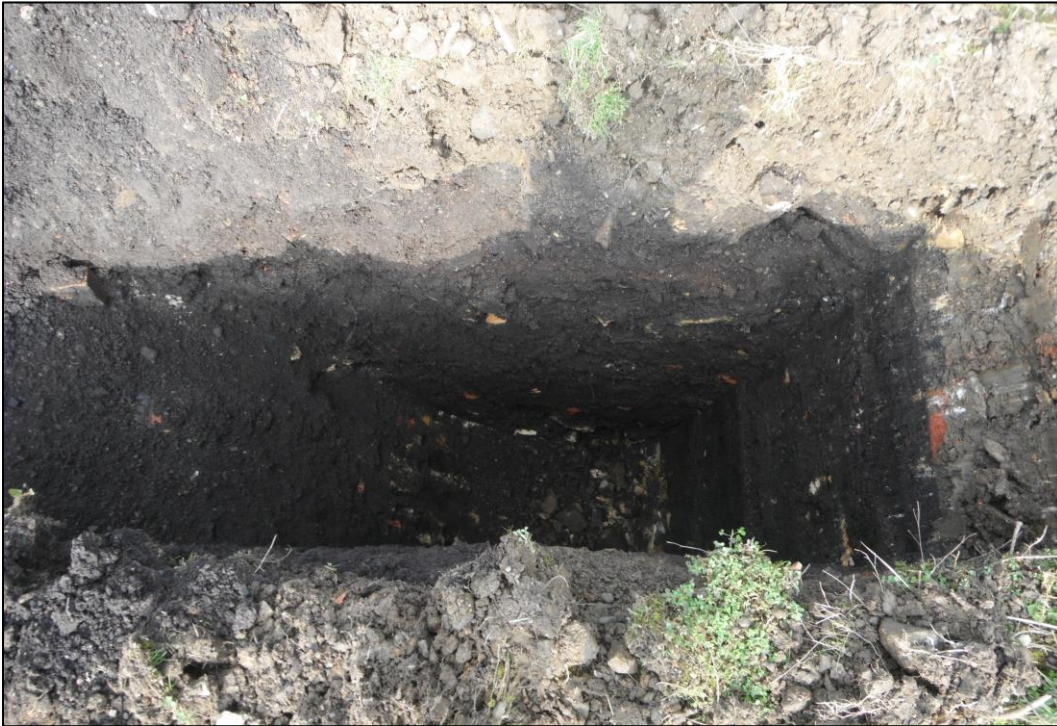
Trial Hole 1.

The investigations recorded a clayey made ground generally intermixed with building rubble, either directly over bedrock (in the case of THs 1, 2, 3, & 4), virgin ground (TH5), or clayey made ground over virgin alluvial deposits & bedrock (THs 6, 7, & 8).
