Entwistle Road, Rochdale

## Preliminary Risk Assessment, Phase 2 Risk Assessment and Remediation Strategy

**Job Number:** LKC 23 1557

**Date:** September 2023

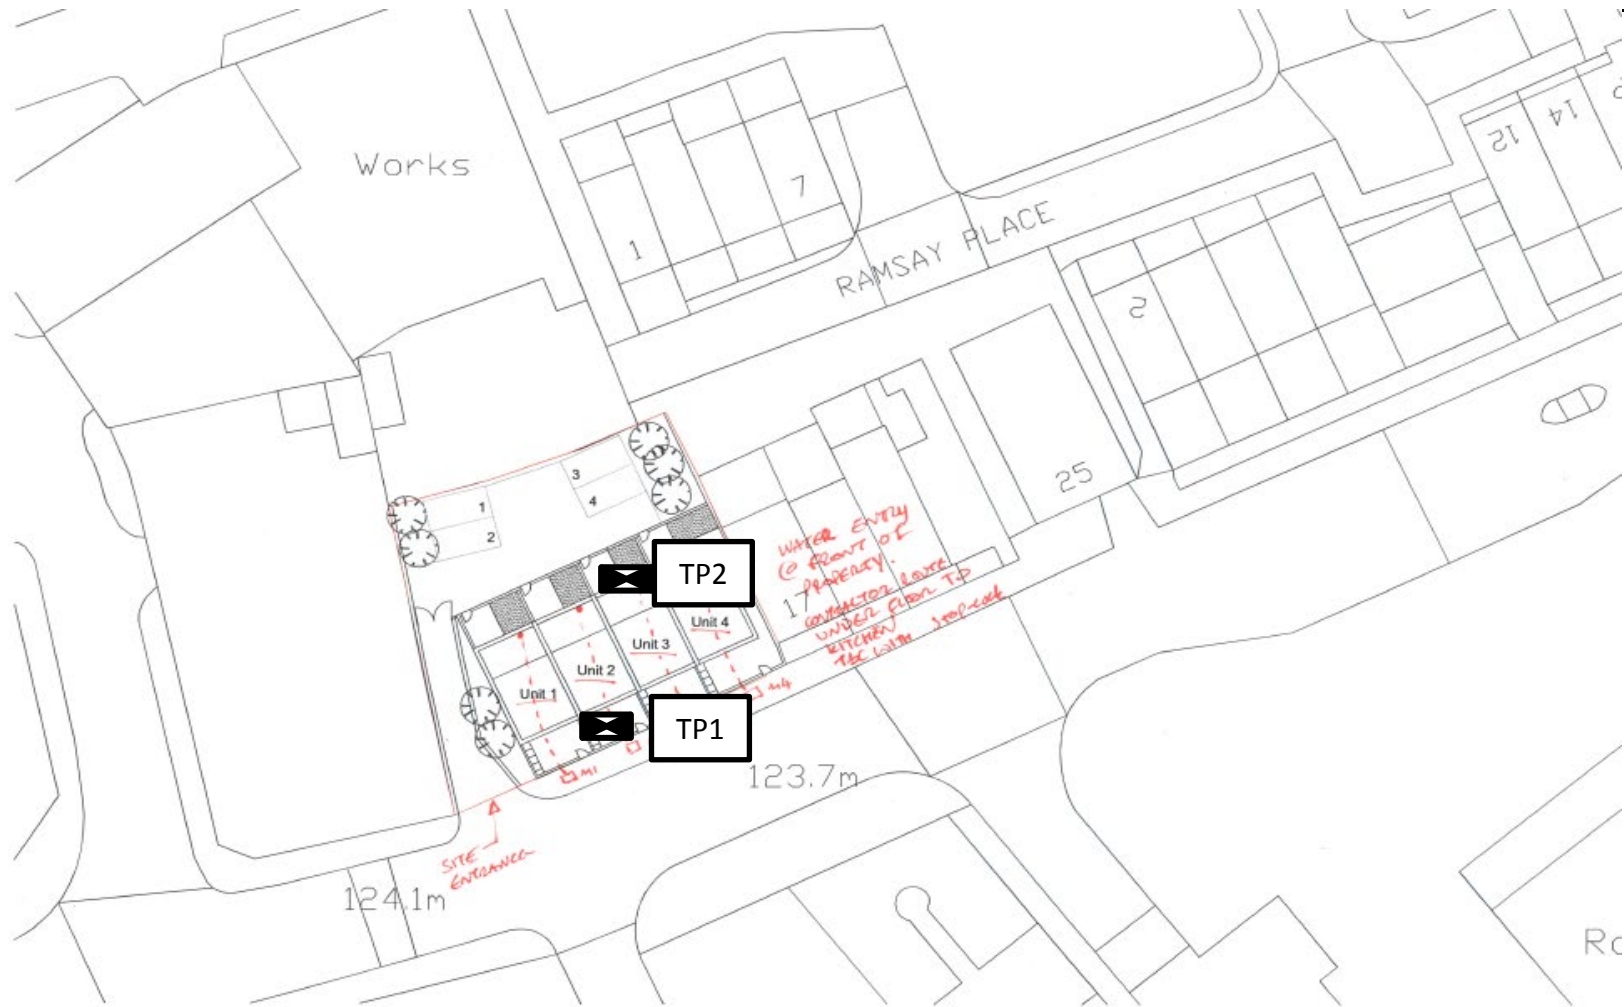
Title: **Investigation Location Plan**

Plan not to scale and investigation positions approximated from site operative's notes.
