1 Drake Street,  
Rochdale

Daytime Bat Survey  
2025

Client Paul Butler Associates  
Project Title 1 Drake Street, Rochdale  
Project Reference RHE.4468  
Project Leader Lucia Ruiz Mut  
Contact Details [lucia@rachelhackingecology.co.uk](mailto:lucia@rachelhackingecology.co.uk)

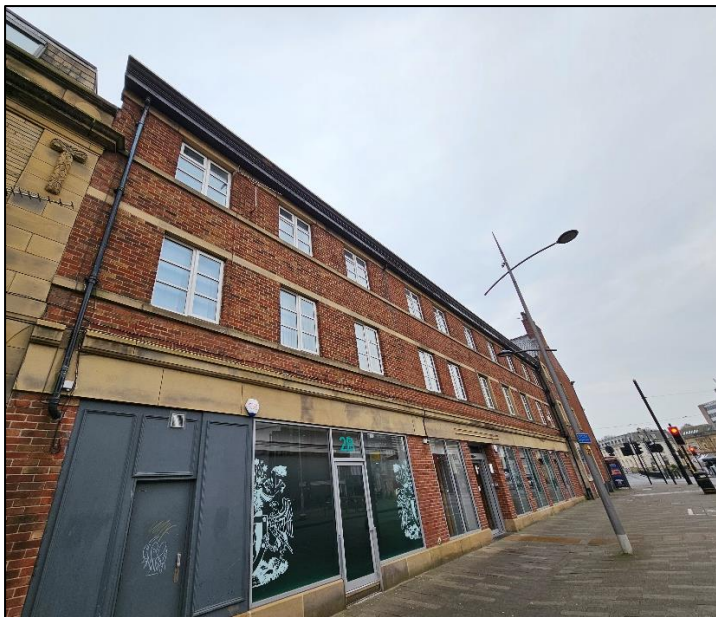
*Photograph 1 showing the newest part of the façade facing Smith Street.*

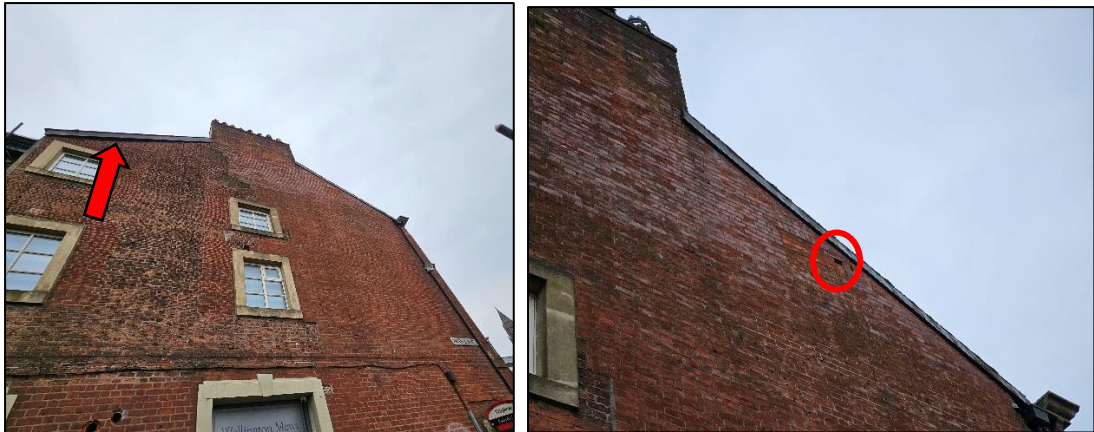
- 2.2.1 The exterior of the buildings was surveyed from the ground using binoculars, a high-powered torch and a camera drone. Features offering potential access to roosting bats were recorded. Such features may include suitable gaps in roof coverings, gaps behind external cladding/facia and gaps in masonry
- 2.2.2 Evidence indicating the presence of roosting bats was also searched for. This may include bat droppings on walls, windows or on the ground below roost entrances or staining from fur oil around roost entry points.
- 2.2.3 The interior of the building, including the roof voids, where possible, was surveyed to identify any evidence indicating use by roosting bats. Such evidence may include bat droppings, feeding remains, urine splashes, live or dead bats and staining from fur oil on timbers.

Photographs 2 (left) and 3 (right) showing gaps under barge board and hole in brickwork, respectively.

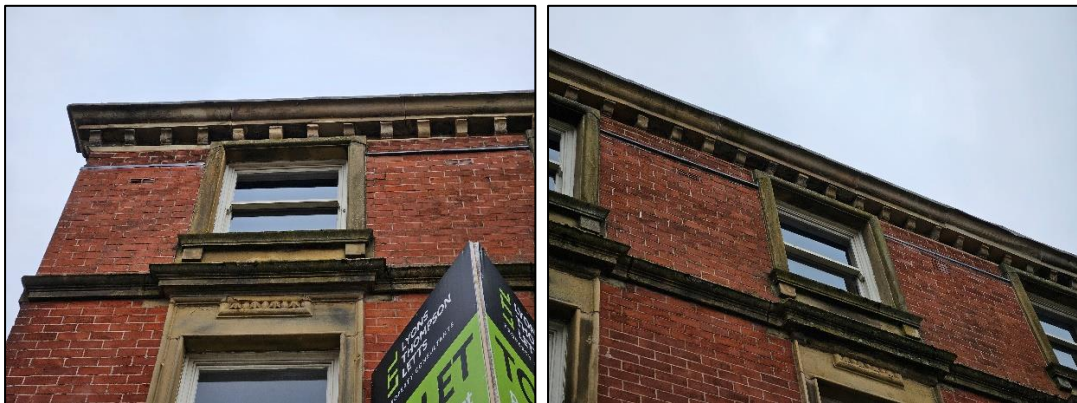
- 3.4.3 At the Drake Street elevation, external access points are not obvious. However, the modillion cornice and window frames are dated and may offer small cracks and crevices which would lead into the roof space (see Photographs 3 and 4).

Photographs 4 (left) and 5 (right) showing modillion cornice and window frames.

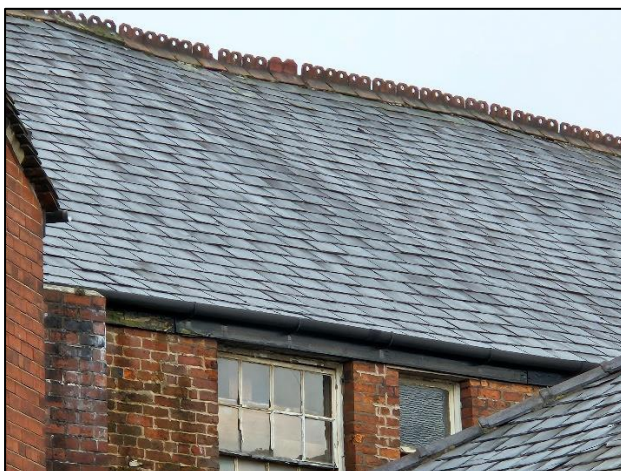
- 3.4.4 At the rear, the fascia board appeared to be in state of disrepair, potentially providing access through crevices and gaps or comprising a Potential Roosting Feature (PRFs) on itself (see Photograph 6).

Photograph 6 showing a detail of the rear elevation.

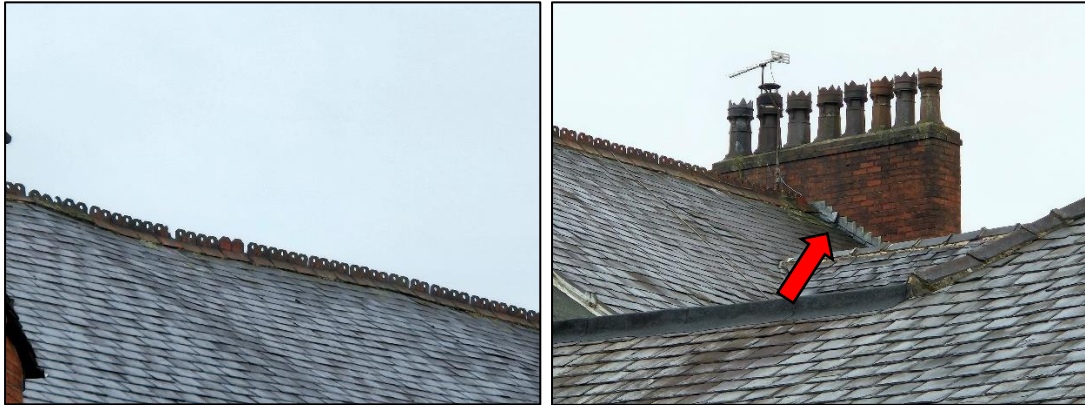
- 3.4.5 The roof offers multiple access points with lifted ridge tiles and gaps behind lead flashing (see Photographs 7 and 8). These were closely inspected from the air using a camera drone which confirmed the presence of gaps and lifted tiles. These may also comprise PRFs as bats can find shelter underneath the tiles.

Photograph 7 (left) and 8 (right) showing potential access points.

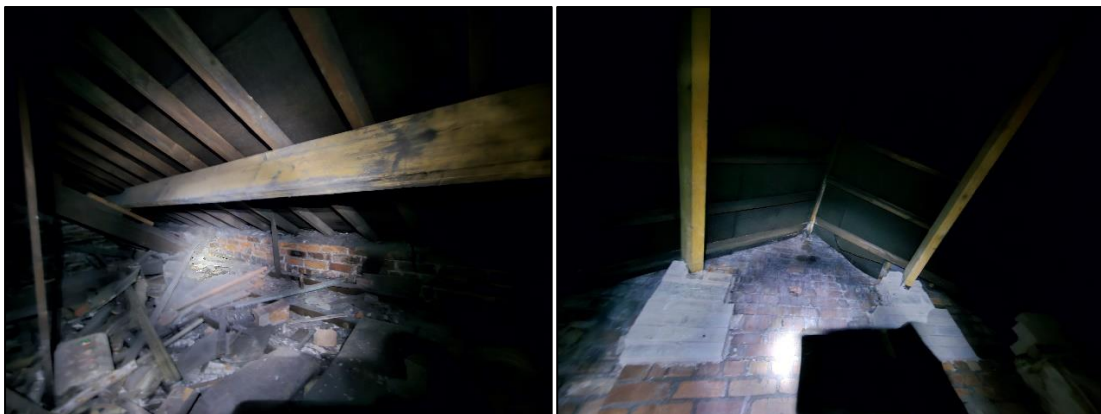
- 3.5.1 The roof void is open to ridge with wooden beams and partially covered by roof membrane and wooden cladding with no insulation (see Photographs 9 and 10). The roof space is partially sectioned with brick wall, but all parts accessed were connected, providing a large space with a height of circa 2m at the highest point.

Photographs 9 (left) and 10 (right) showing the interior of the roof space.

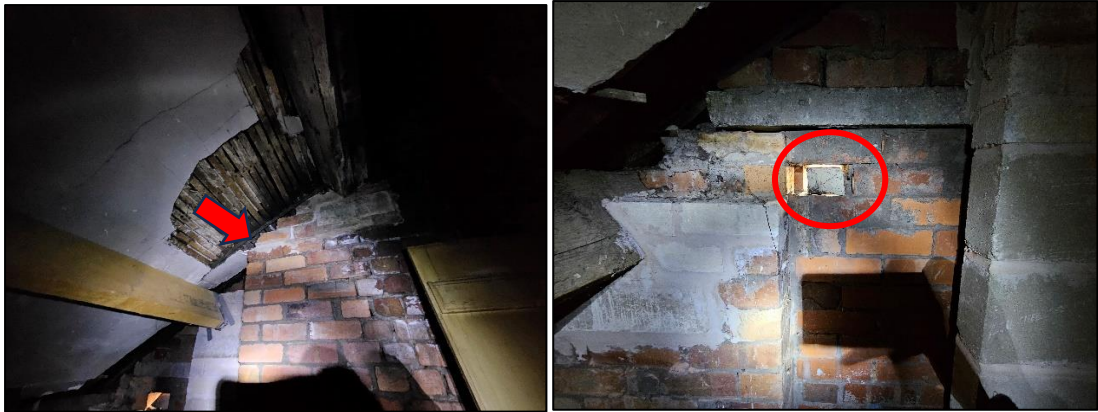
- 3.5.2 External access points were evident with daylight entering through cracks and gaps in brickwork, particularly along the gable ends (see Photographs 11 and 12).

Photographs 11 (left) and 12 (right) showing gaps along gable end and hole in brickwork, respectively.

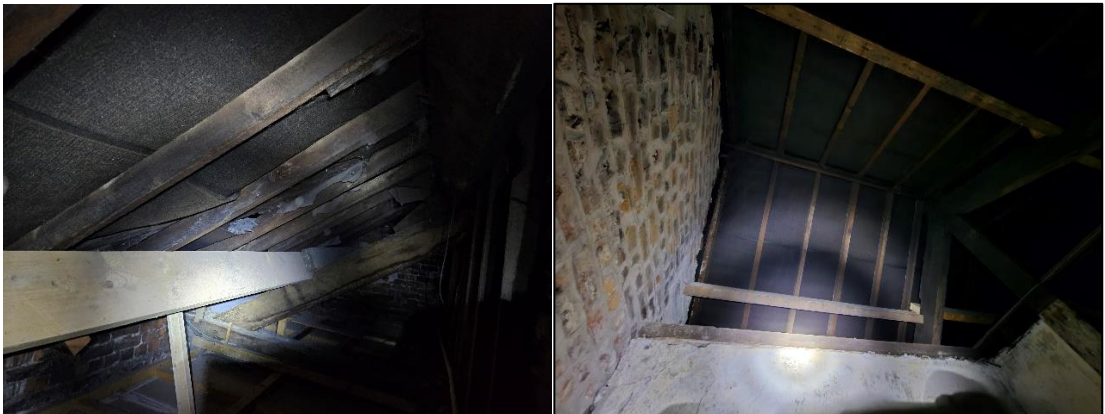
- 3.5.3 There are several PRFs within the loft space such as behind the membrane, underneath the wooden cladding, holes and gaps with the brick wall edges, or between wooden beams (see Photographs 13, 14, 15 and 16).

Photographs 13 (left) and 14 (right) showing the interior of the roof space with wooden beams and membrane, and gap at gable end, respectively.

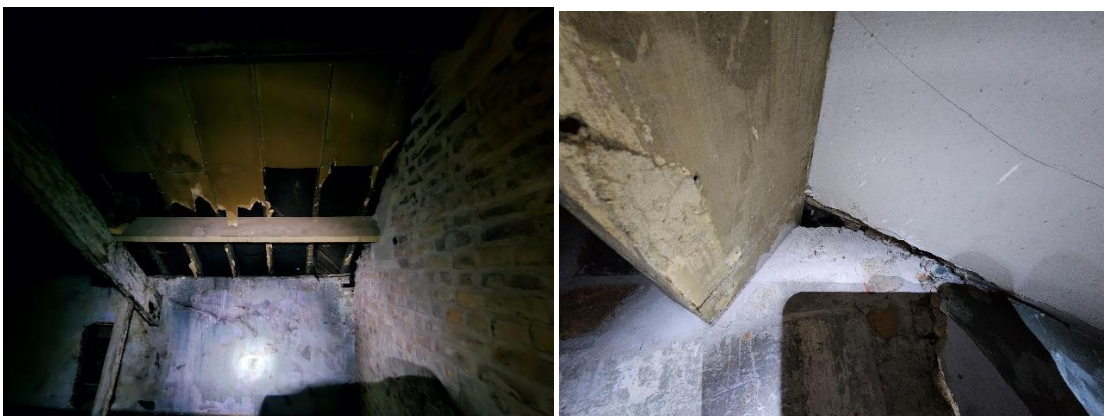
Photographs 15 and 16 showing the interior of the roof space showing wooden cladding and crack in brickwork, respectively.

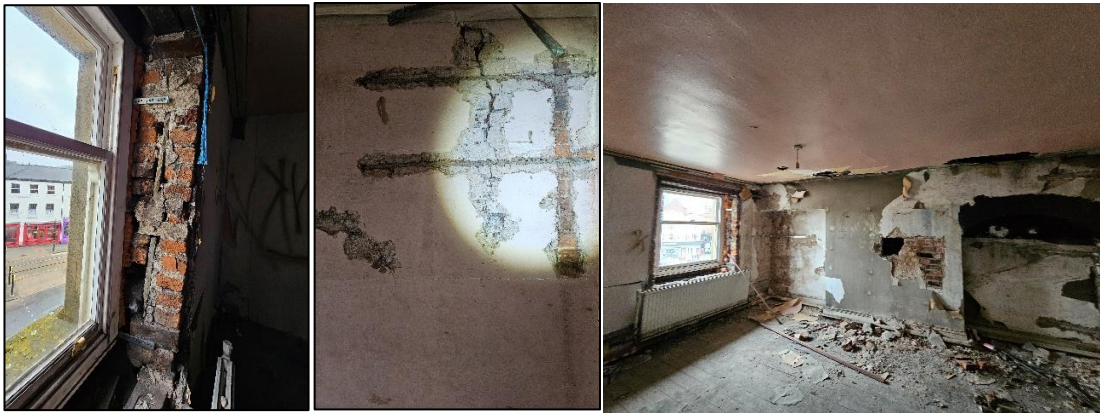
- 3.5.4 The second floor is illuminated by windows. There were several PRFs in the form of cavities between walls and cracks in brickwork surrounding the window frames (see Photographs 17, 18 and 19). The space can be accessed from the loft through holes in the ceiling (see Photograph 20).

Photographs 17, 18, and 19 (left to right) showing PRFs within the second floor.

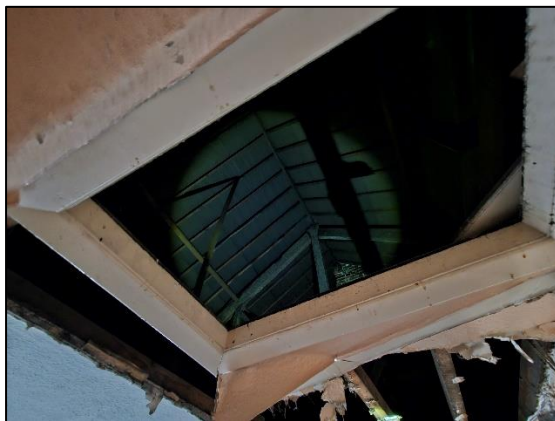
Photograph 20 showing broken ceiling giving access to the loft.

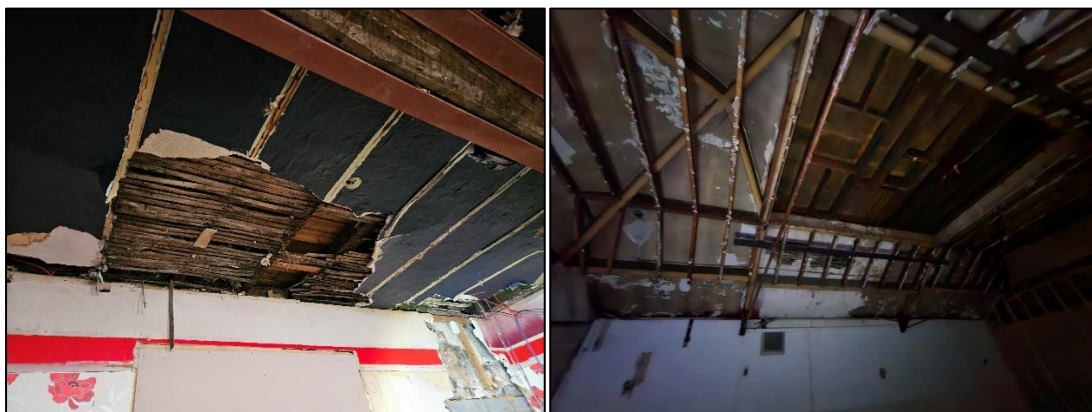
- 3.5.5 On the first floor the ceiling is in disrepair offering PRFs behind the wooden cladding (see Photograph 21 and 22), however there is no direct access from the exterior. It is also bright during the day towards Smith Street.

Photographs 21(left) and 22 (right) showing PRFs at the first floor.

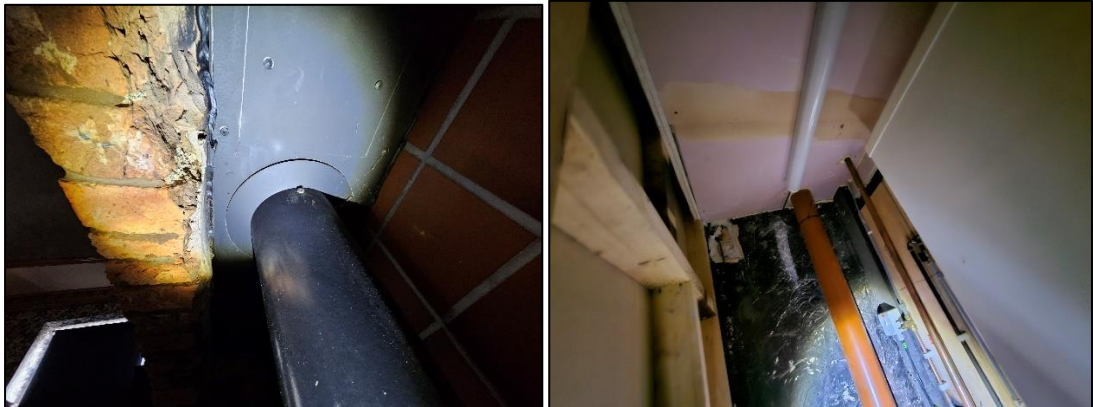
- 3.5.6 The ground floor does not offer PRFs. The chimney access and boiler room are well sealed (see Photographs 23 and 24). This floor is not accessible from the outside.

*Photographs 23 (left) and 24 (right) showing the interior of the chimney and boiler room, respectively.*

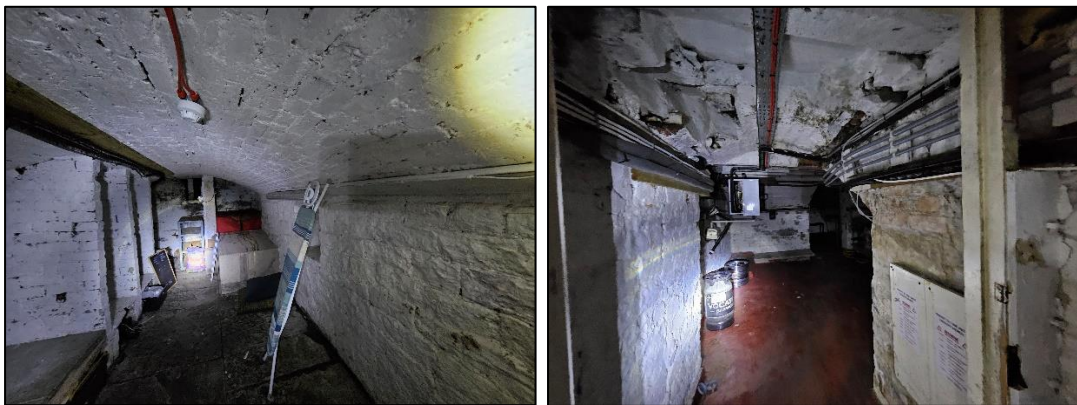
- 3.5.7 The cellar showed some small cracks in the brickwork (see Photographs 25 and 26) but these were mainly superficial and the cellar is not accessible from the outside.

*Photographs 25 (left) and 26 (right) showing the interior of the cellar.*
