Exhibition Boards Substructure - Boards Removed  
Photographs - February 2024

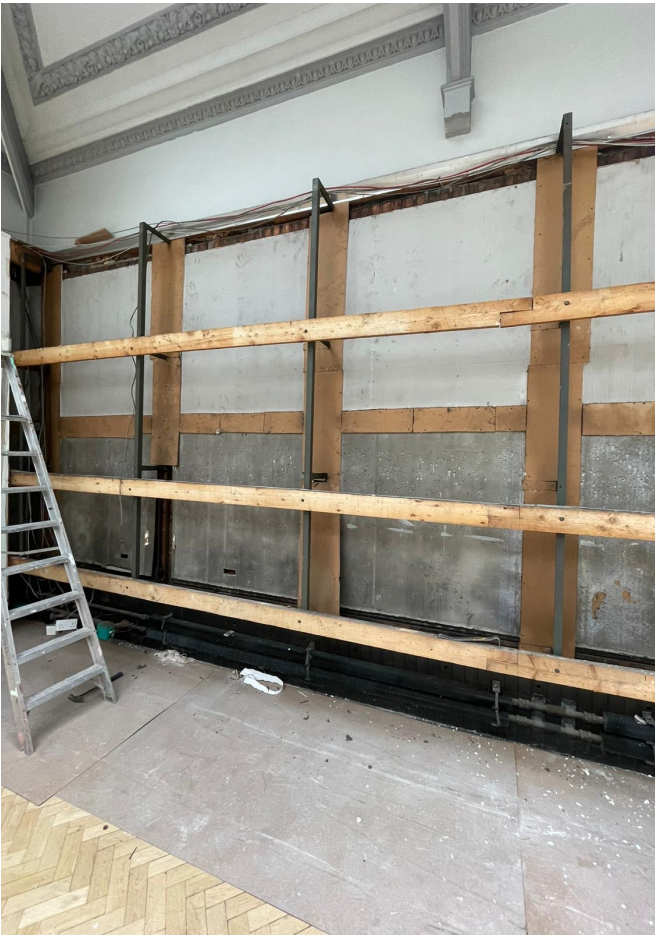
Image 01/04 -  
Section of Exhibition boarding removed to reveal location of typical vent (gallery 04). However, a further board has been installed over the original T&G to block openings.

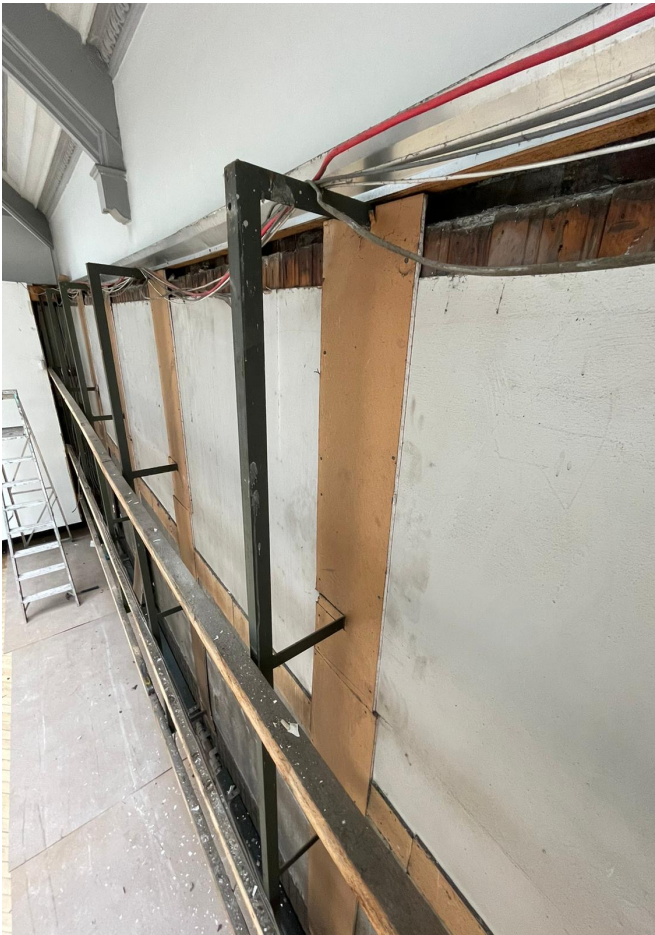
Image 02/04 -  
Closer look at existing Steel/Timber substructure, installed to hold the contemporary exhibition boards.

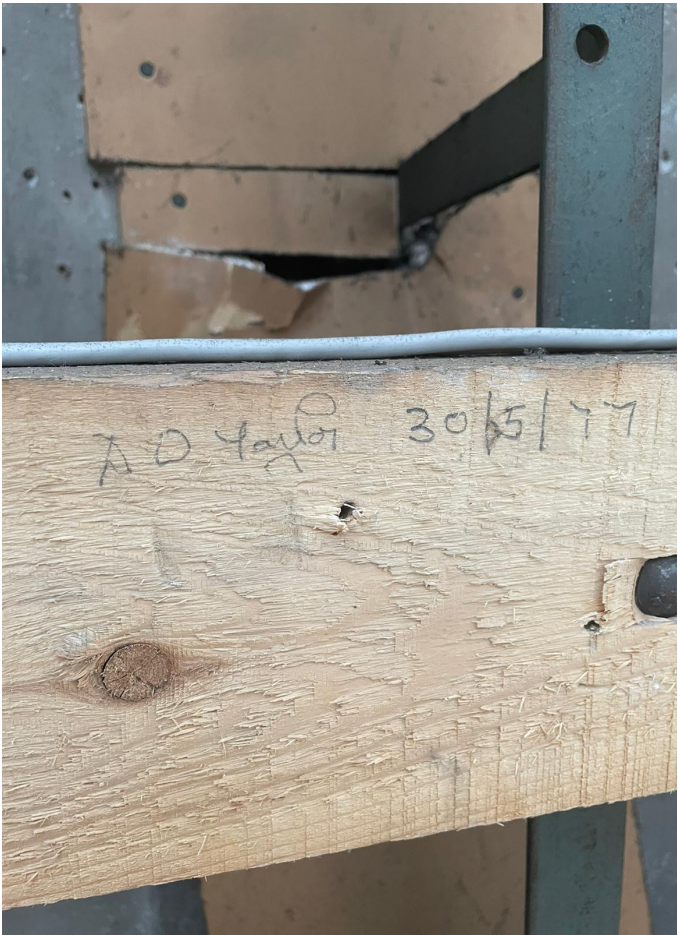
Image 03/04 -  
Exhibition boards contemporary installation date noted on concealed timber support (30/05/1977).

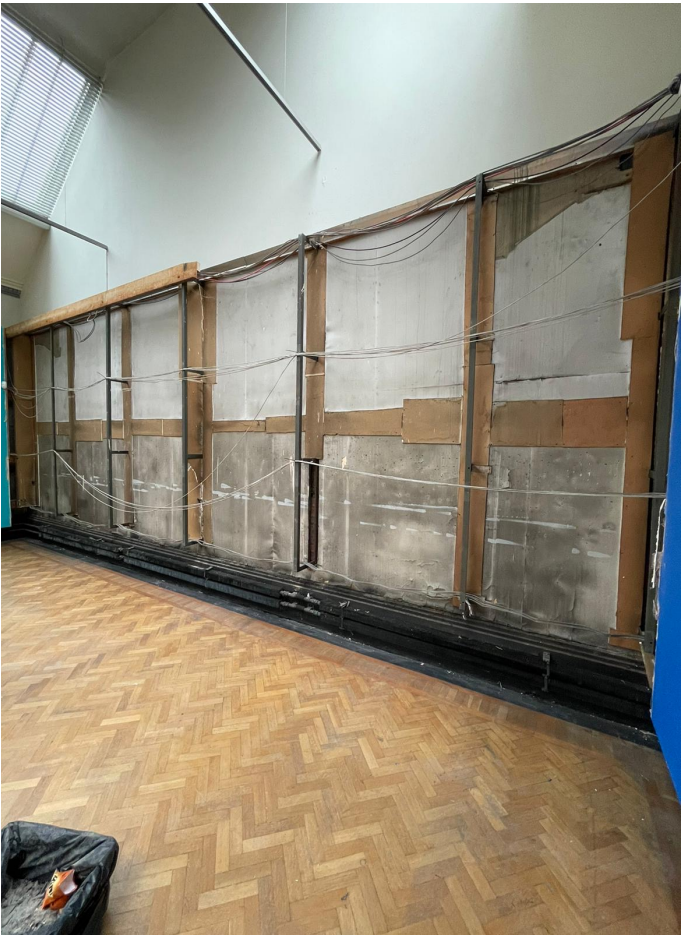
Image 04/04 -  
Timber battens elements removed leaving steel structure fixed to original brickwork walls.
