**QUEEN'S DRIVE CENTRE,  
QUEEN'S DRIVE,  
ROCHDALE**

## **PRELIMINARY ROOST ASSESSMENT**

**Prepared for  
Rochdale Borough Council**

**September 2023**

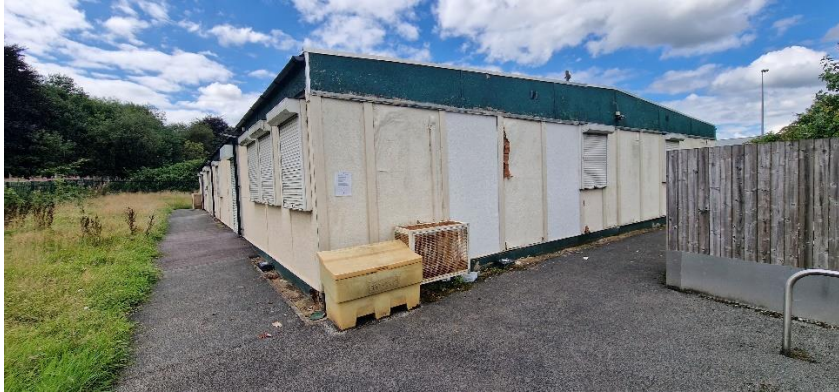
| | <p><b>North east<br/>gable end and<br/>and south east<br/>elevation</b></p> |

- 3.5 The building is modular, single storey built with a wood frame and infilled with insulated 'sandwich' panels, it is rectangular in plan view with an almost flat roof that has a very low gradient to it. The building is depicted in the Plates.

- 3.6 The building is a former medical centre that is now disused and awaiting permission for demolition. It is in a relatively poor state of repair with rockwool insulation material exposed externally in parts where the rendered wooden walls have been compromised. Many of the wood panels have begun to rot with water ingress. The roof has a very slow gradient to its pitch and is clad with bituminised felt that laps over the wall top and is fixed by a wooden batten that effectively seals the lapped edge of the felt. The lapped edge is fixed above the gutter line so further sealing any edge gaps that could be present. There many window openings along the walls are sealed with roller shutters. Occasional superficial gaps were present where wood panel joins have expanded with water ingress. Above the roller shutters there is a 'cover sheet' in place which has gaps present at each end, these are too open and exposed for use by bats but birds may use them for nesting and roosting purposes.

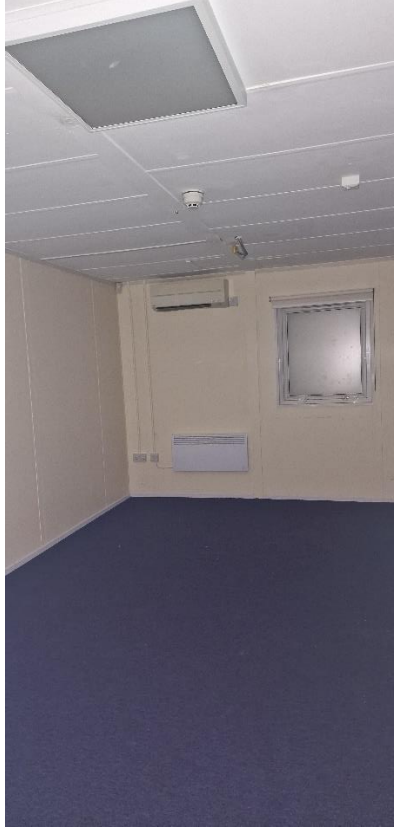
- 3.7 The interior is divided into many rooms that are well sealed and are interconnected via corridors. Occasional damp areas were noted where the panel joints had expanded and water ingress has occurred. The building had no obvious access gaps present to the inside.

| Internal room | Internal corridor |
