# Preliminary Bat Roost Assessment Survey Report

Stock Nook Barns,  
Heywood  
25<sup>th</sup> July 2022

TG Report No. 13635\_R05\_NB\_NC

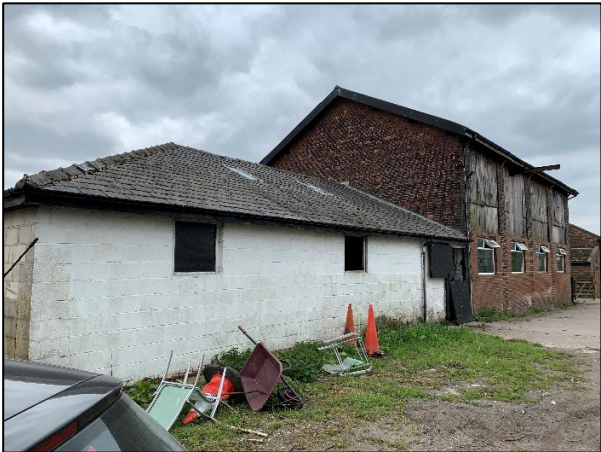
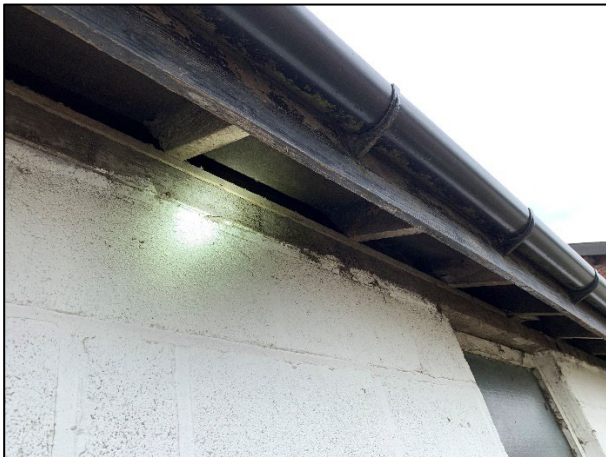
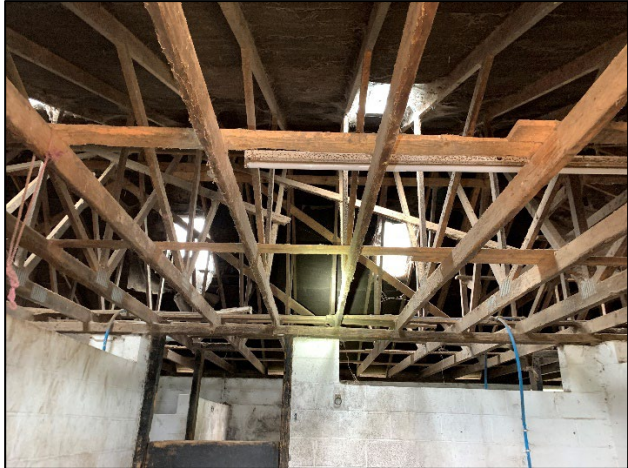
| Feature Reference | Description of Potential Roost Features | Feature Photograph |
|---|---|---|
| <b>Building 1</b> | <p>Gaps between lifted tiles, throughout roof. Cavities formed by the lifted tiles, only large enough to support individual or low numbers of bats.</p> <p>Large gap along wooden bargeboards around all aspects, leading into the stable. Interior of the stables largely unsuitable for roosting bats due to the openness, creating a poor heat profile for roosting. Although wooden frames could form suitable feeding perches.</p> <p><b>Low Potential for Roosting Bats</b></p> | |

- 4.4. Therefore, it is recommended that Buildings **B1, B3** and **B4** are subject to **at least one nocturnal** bat roost survey, with **B2** being subject to **at least two nocturnal** bat roost surveys.

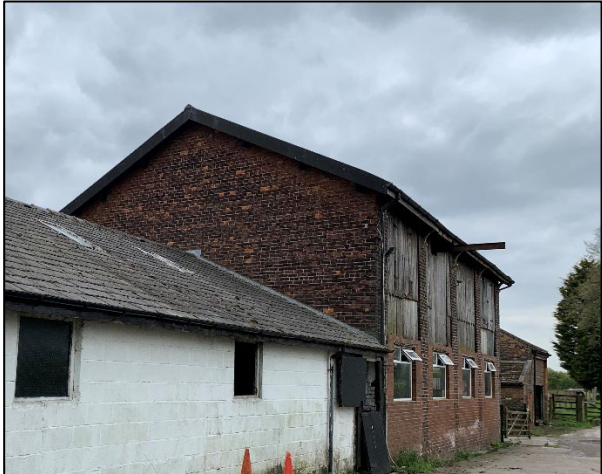
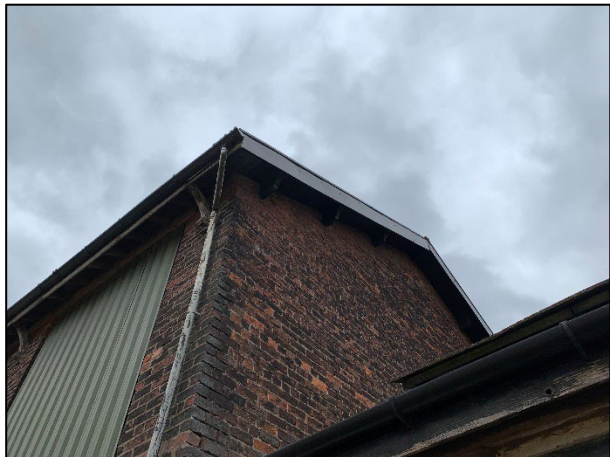
| <p><b>Building 2</b></p> | <p>Gaps in lifted tiles, the structure did not appear to be vaulted, and therefore gaps could lead to a loft void.</p> <p>Gaps in mortar between brickwork, with some large gaps on the eastern gable-end, potentially leading to an enclosed loft void.</p> <p>Gaps along wooden bargeboards and rotten wooden lintels, which could lead to an enclosed loft void.</p> <p>Overall, the features present could lead to an enclosed loft void which would provide a suitable habitat for larger numbers/ more species of bats.</p> <p><b>Moderate Potential for Roosting Bats</b></p> | |

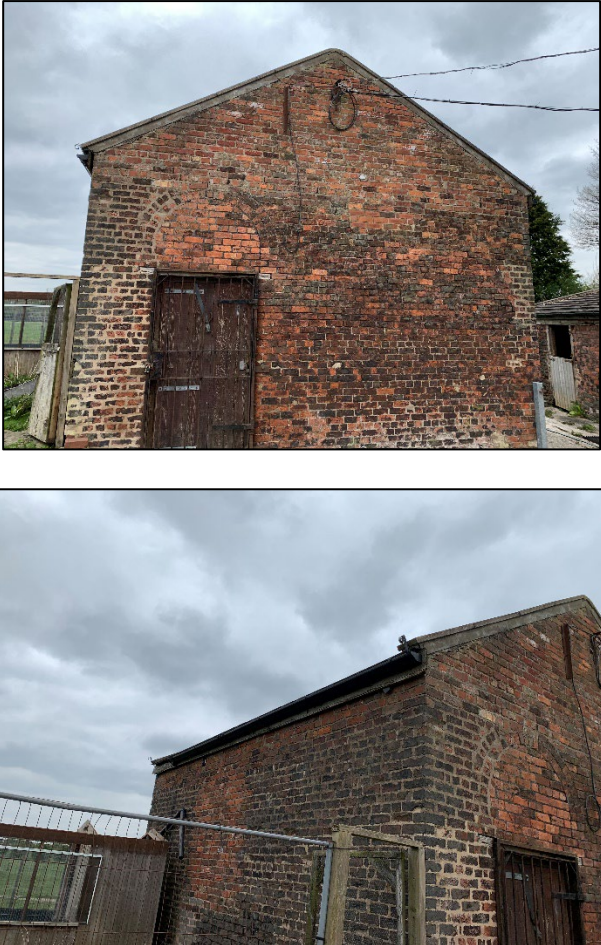
| <p><b>Building 3</b></p> | <p>Gaps between lifted tiles throughout roof. Cavities formed by the lifted tiles, only large enough to support individual or low numbers of bats. Vaulted within, with no enclosed loft void.</p> <p>Brickwork and mortar in good condition.</p> <p><b>Low Potential for Roosting Bats</b></p> | |

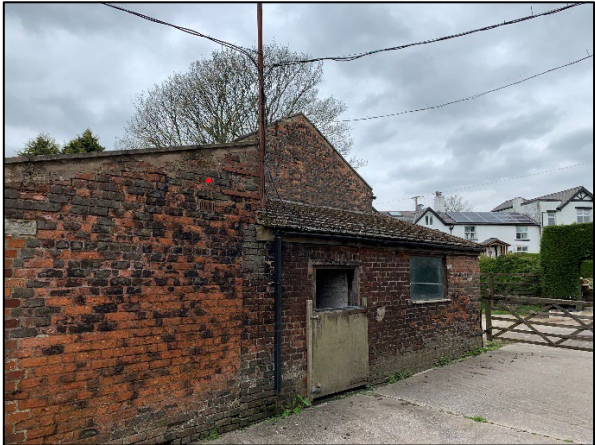
| <p><b>Building 4</b></p> | <p>Gaps between lifted tiles throughout roof. Cavities formed by the lifted tiles, only large enough to support individual or low numbers of bats. Vaulted within, with no enclosed loft void.</p> <p>Gaps and cracks in mortar between brickwork on most aspects of the building.</p> <p>Interior of the stables largely unsuitable for roosting bats due to the openness, with many open doors and windows, creating a poor heat profile for roosting. Although wooden frames could form suitable feeding perches.</p> <p><b>Low Potential for Roosting Bats</b></p> | |
