| Land at Greenbooth Road and Edenfield Road, Norden |

| Contamination Issues Plan - Leachate |

# **APPENDIX IV**

## **E3P EXPLORATORY HOLE LOGS & CROSS SECTION**

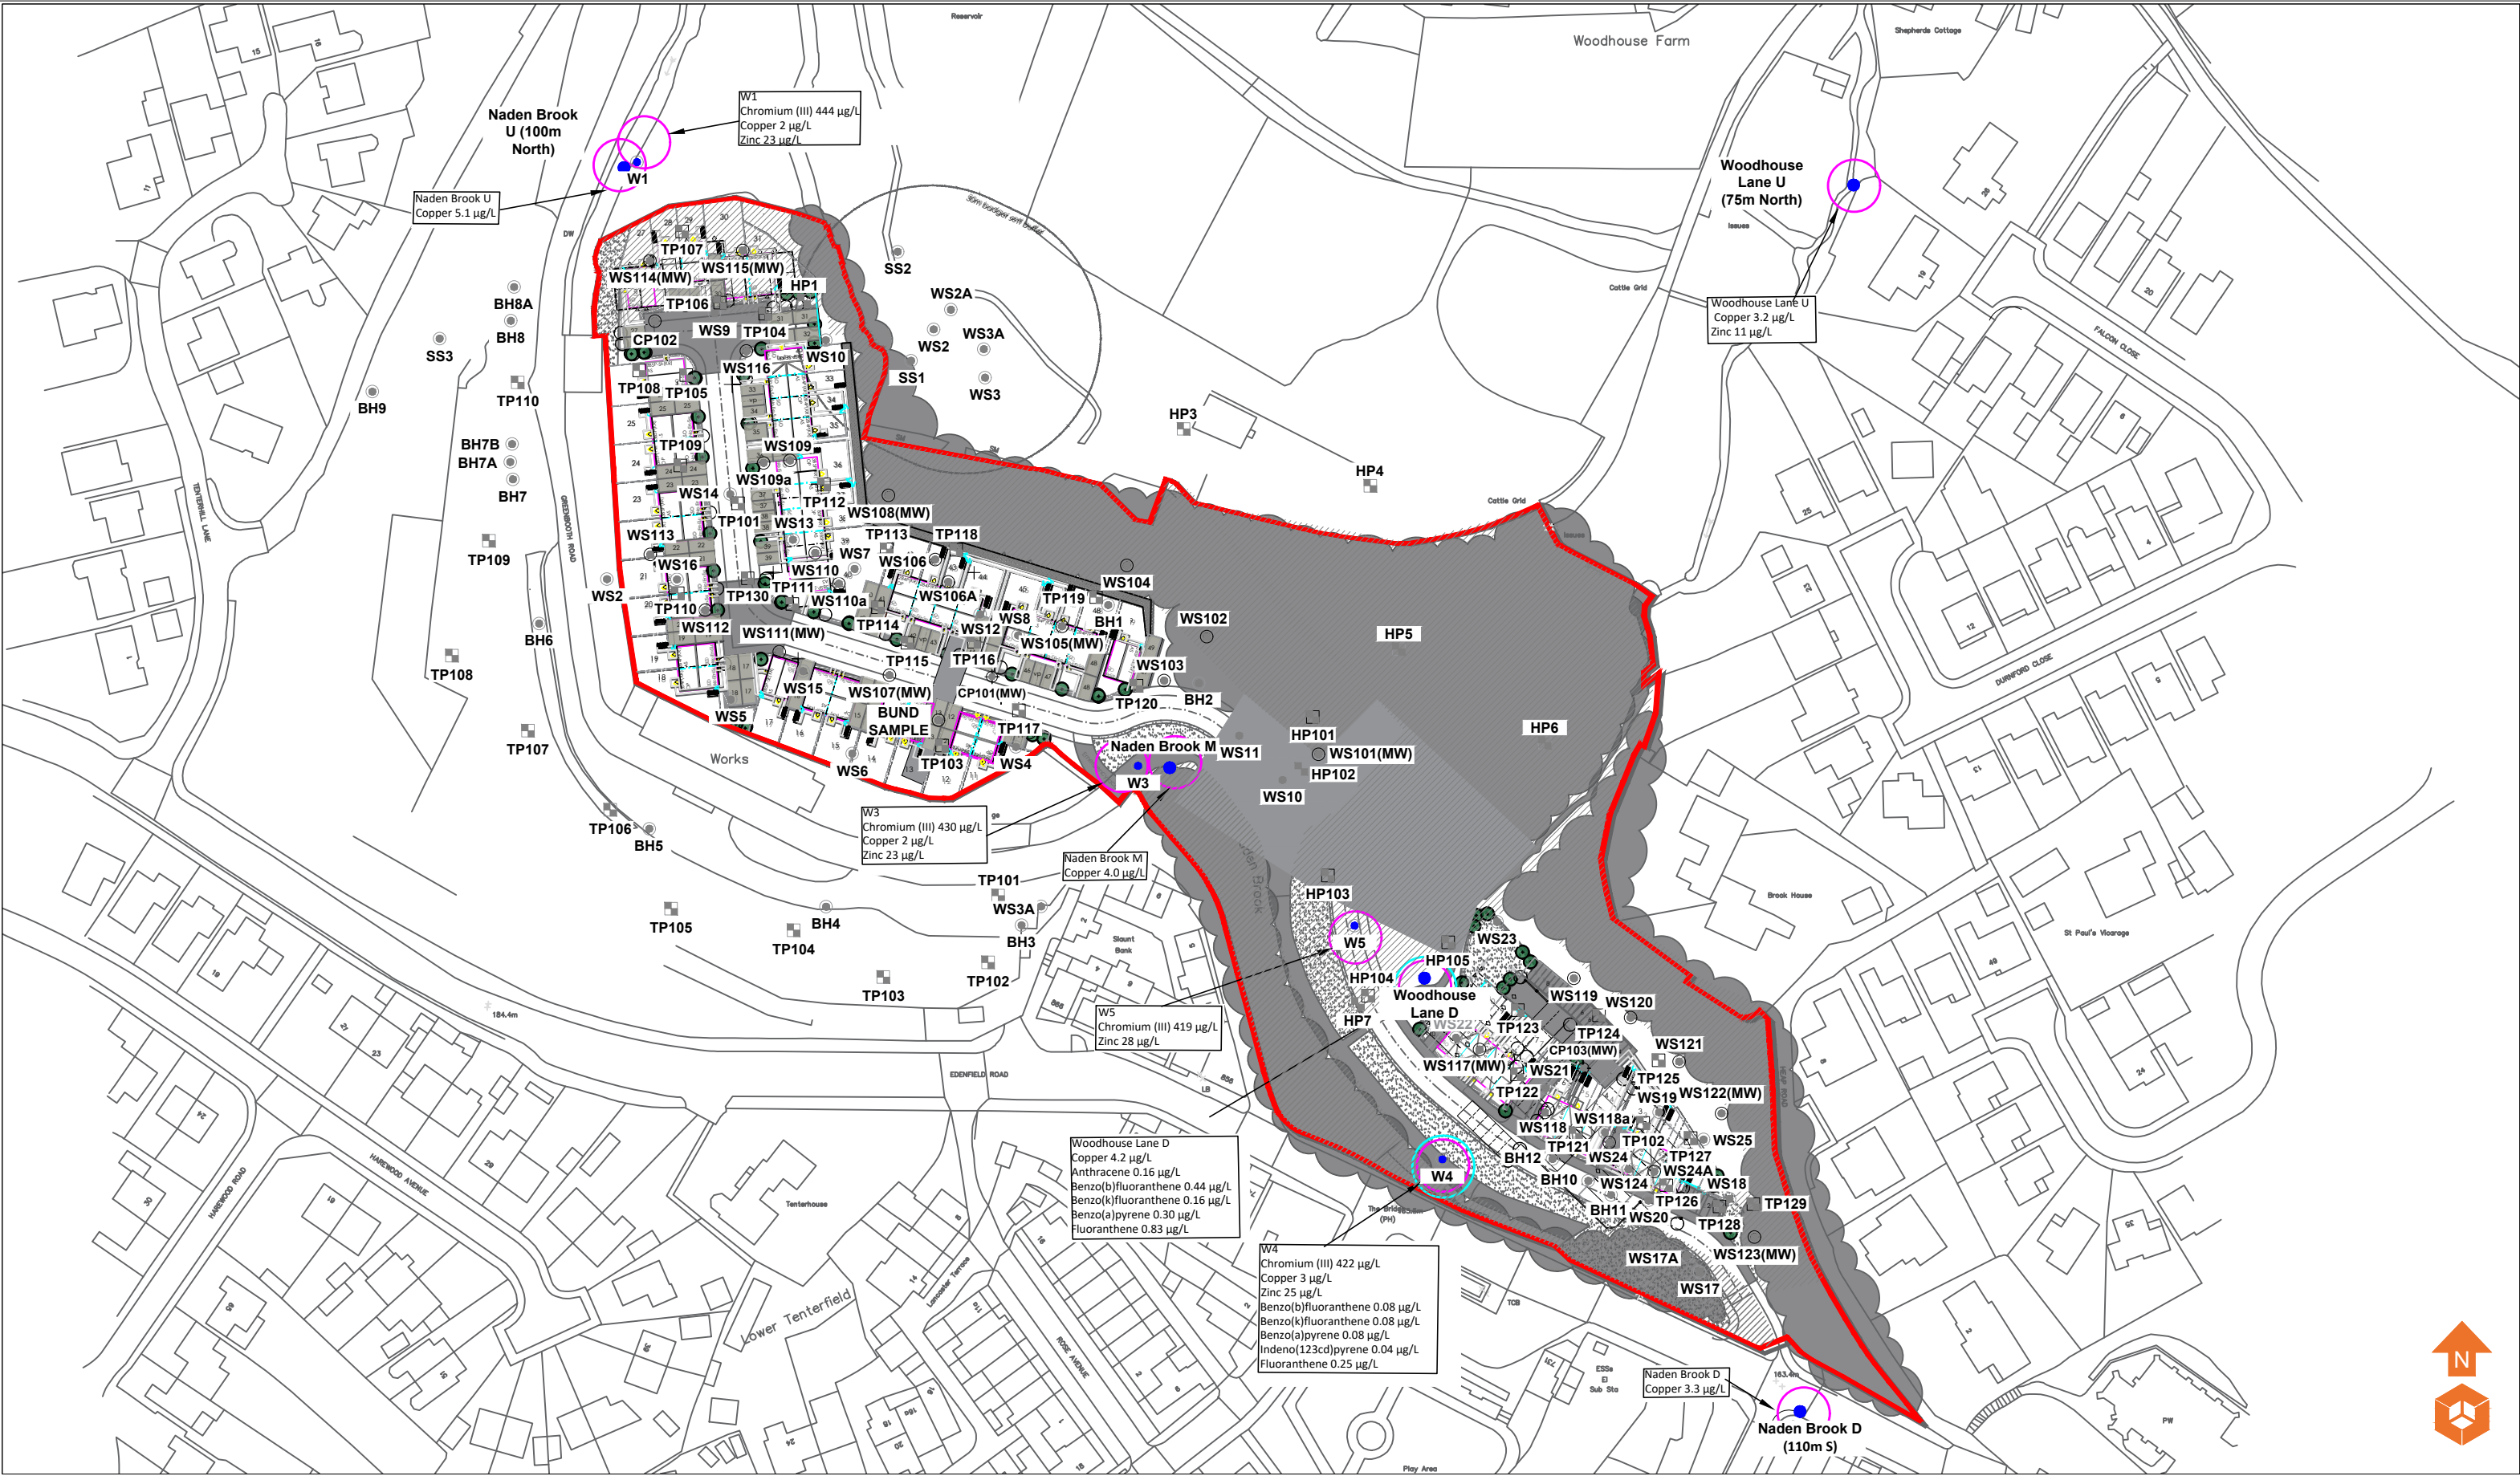
035

Surface Water Sample  
Locations

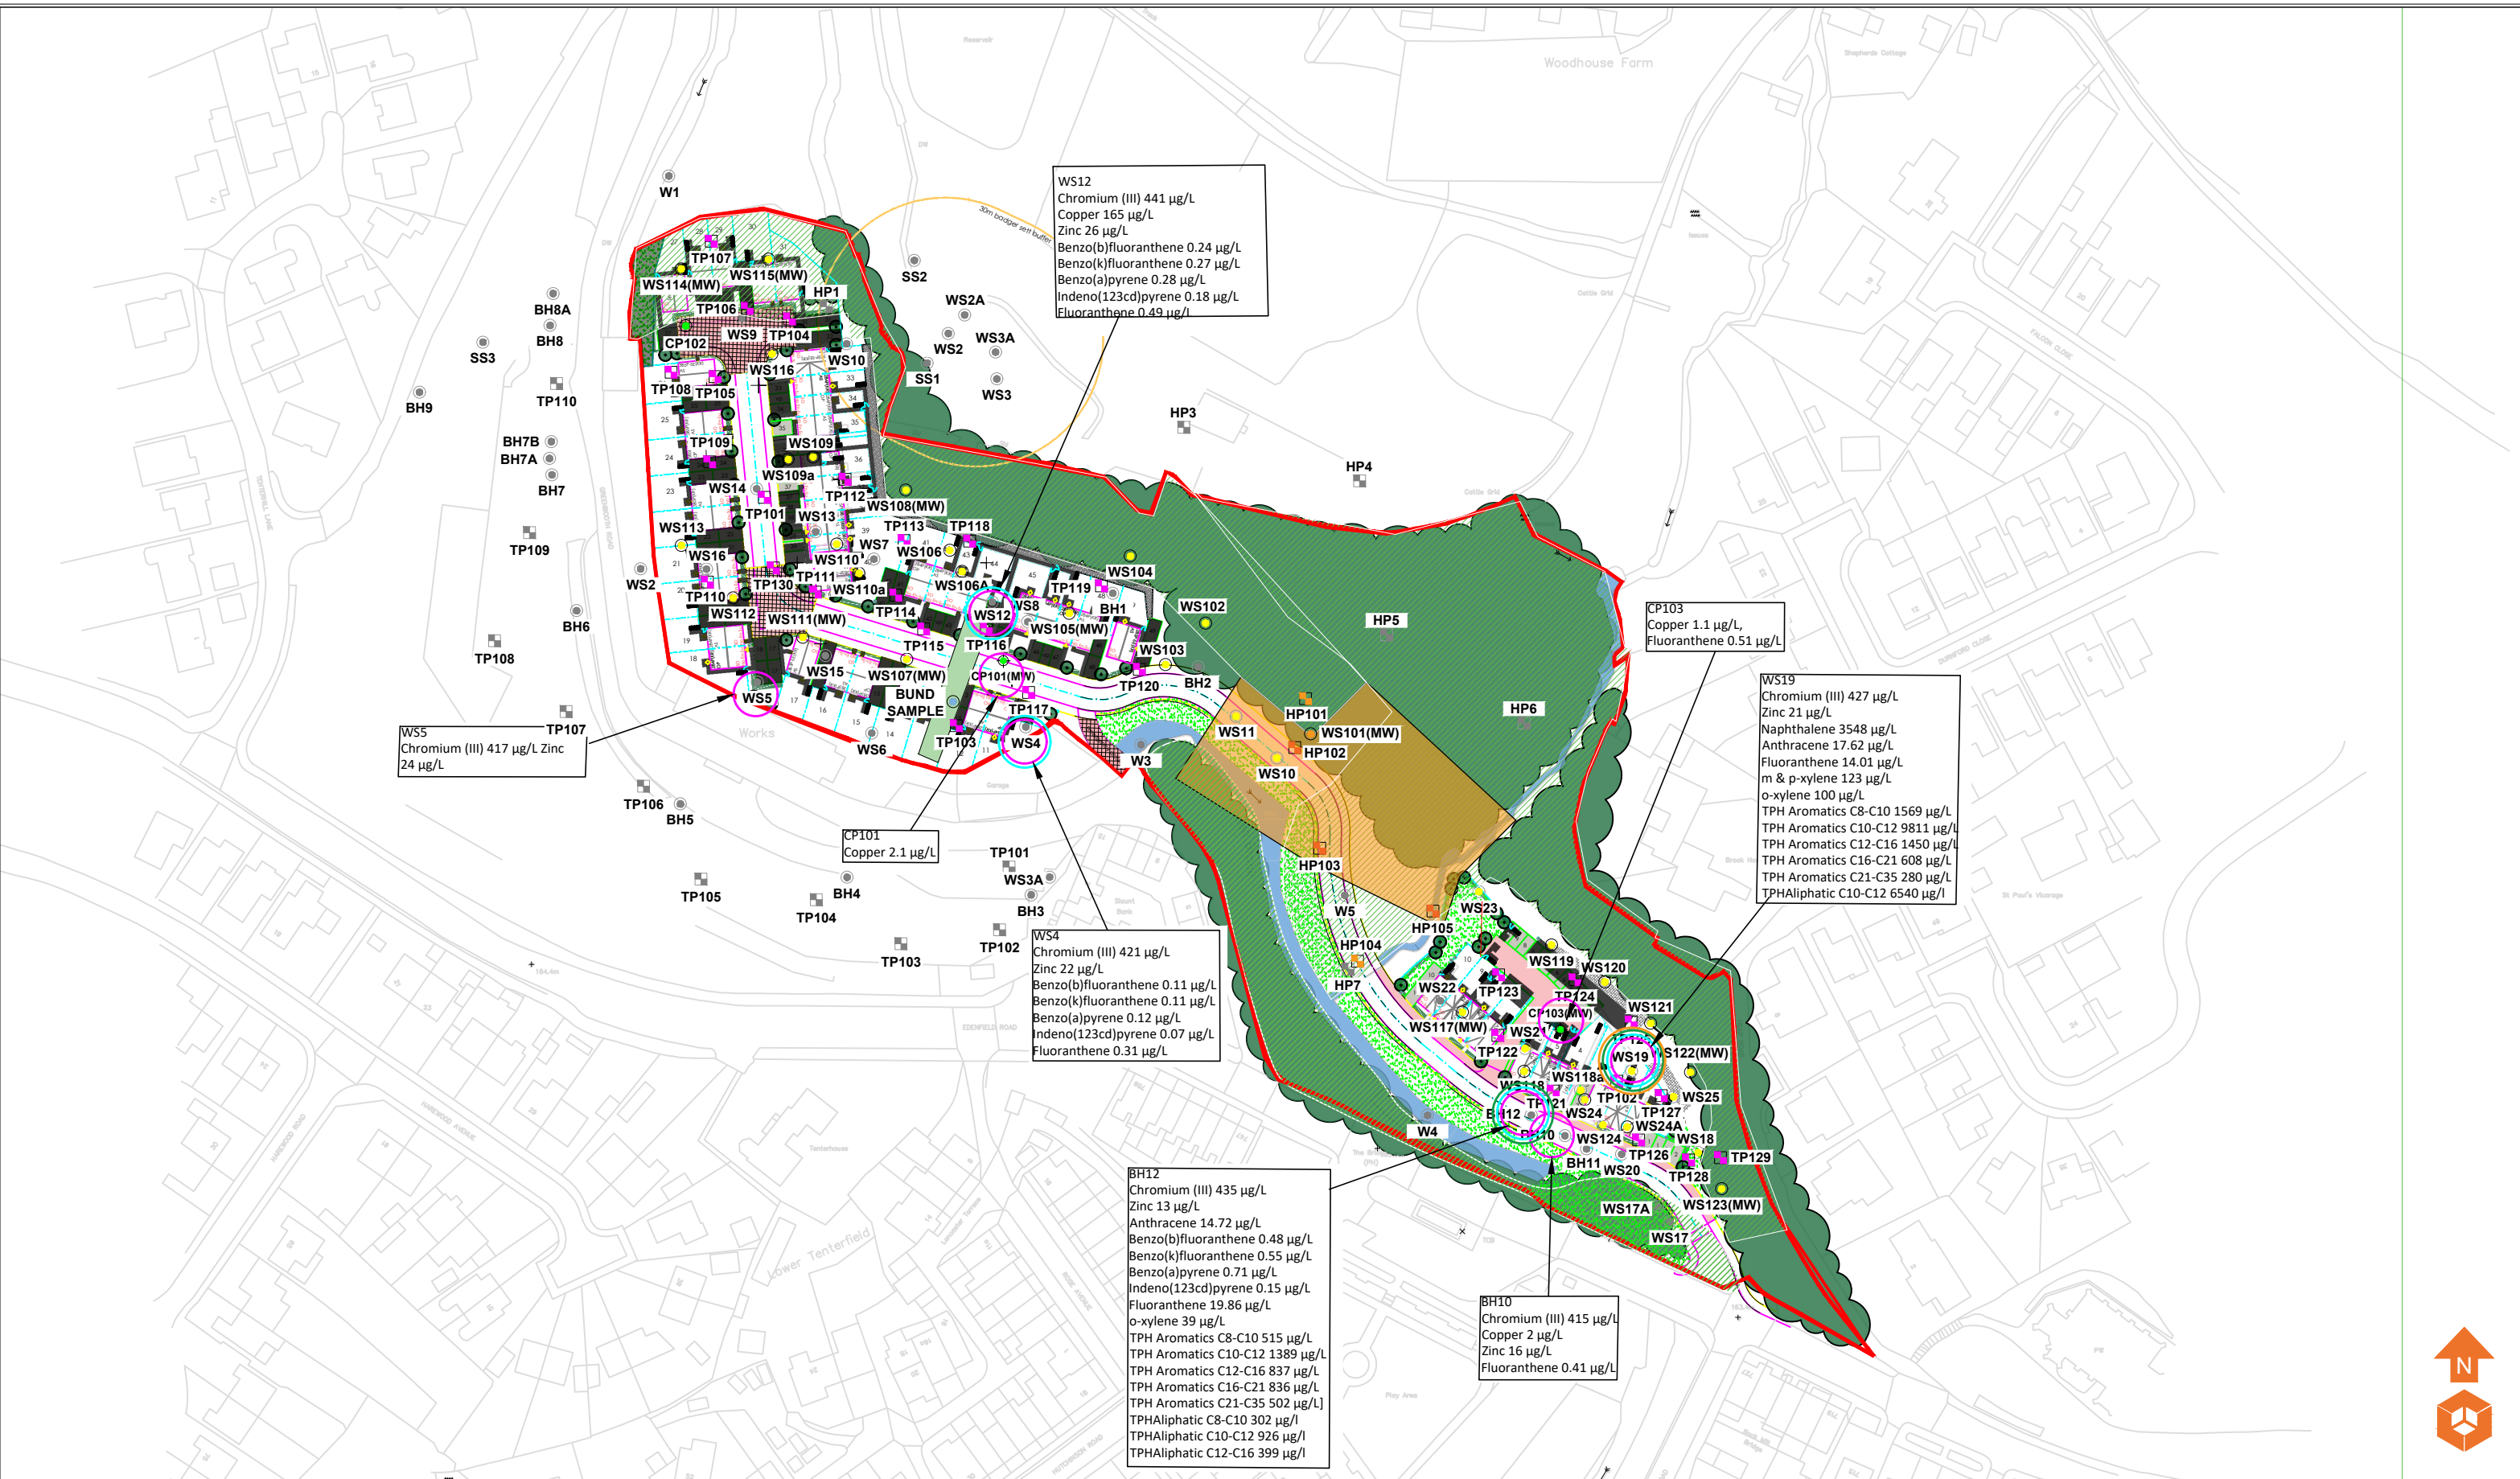
| Drawing No:<br>036 |

- Heavy Metals
- Non-Volatile PAH
- Naphthalene
- TPH

| Contamination Issues Plan<br>- Groundwater |

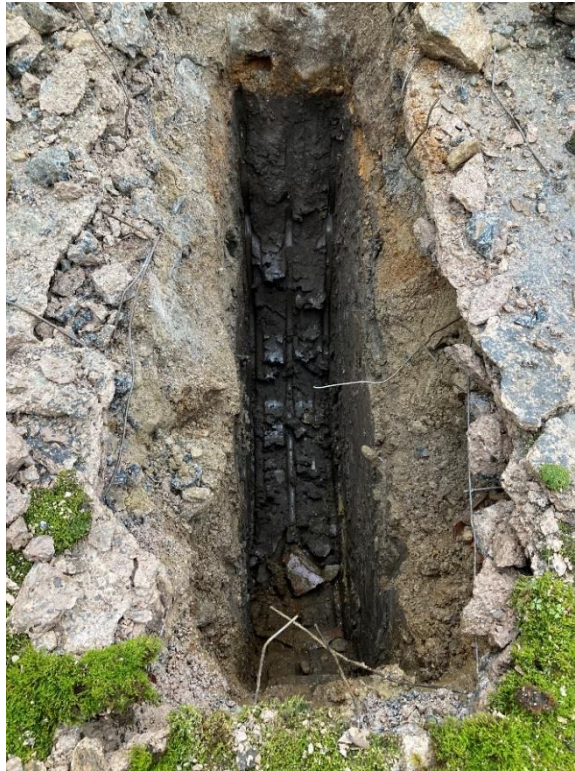
PLATE 1      TP101 EXCAVATION

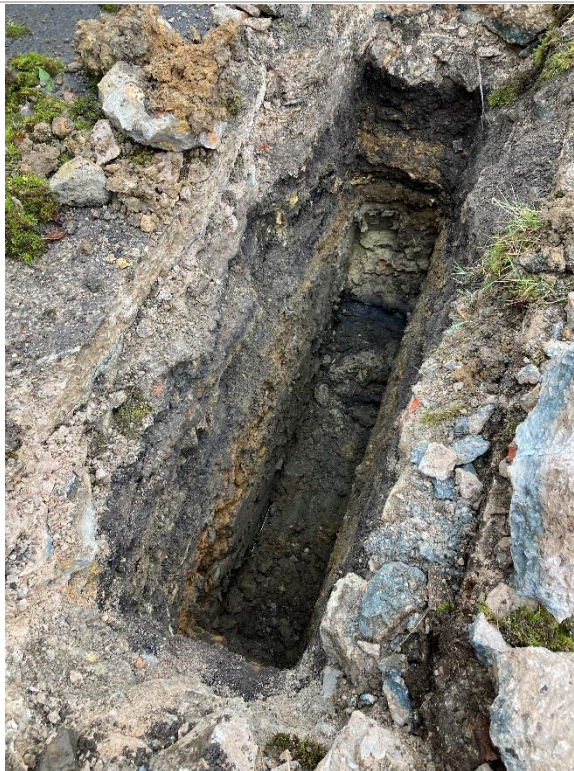
PLATE 2      TP115 EXCAVATION

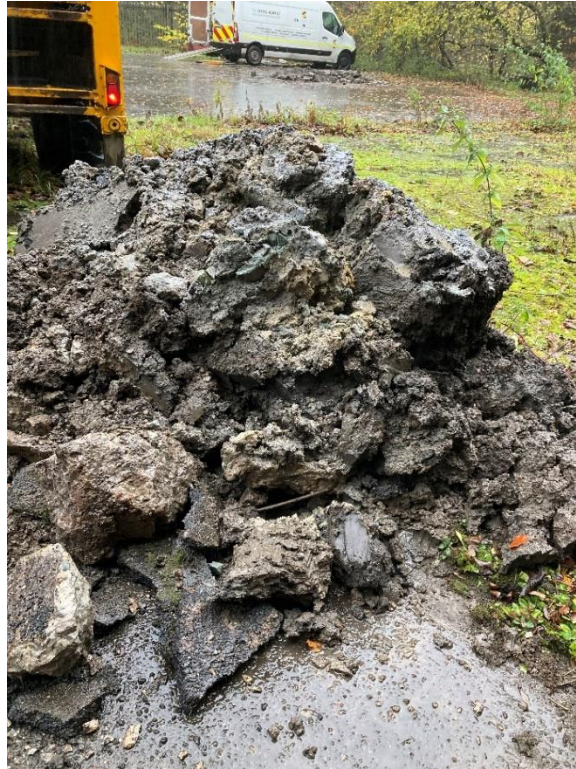
PLATE 3 TP124 ARISINGS

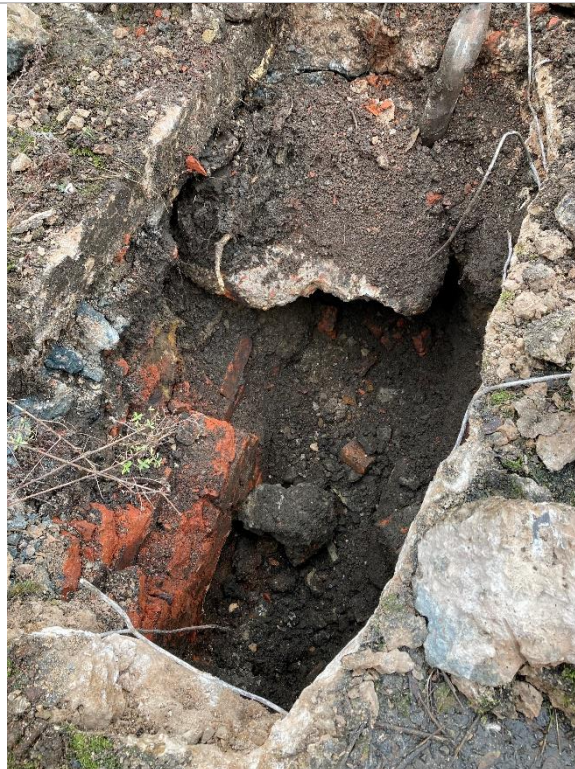
PLATE 4 TP116 EXCAVATION WITH OBSTRUCTIONS

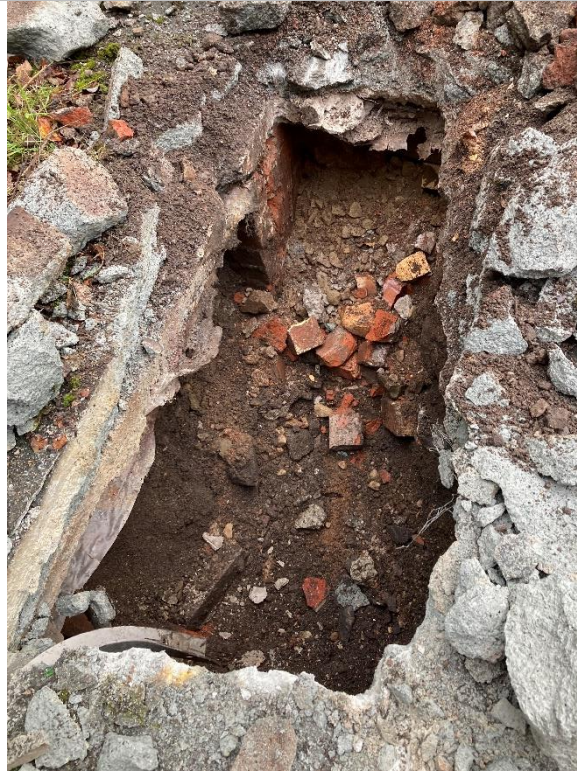
PLATE 5 TP107 EXCAVATION WITH OBSTRUCTIONS

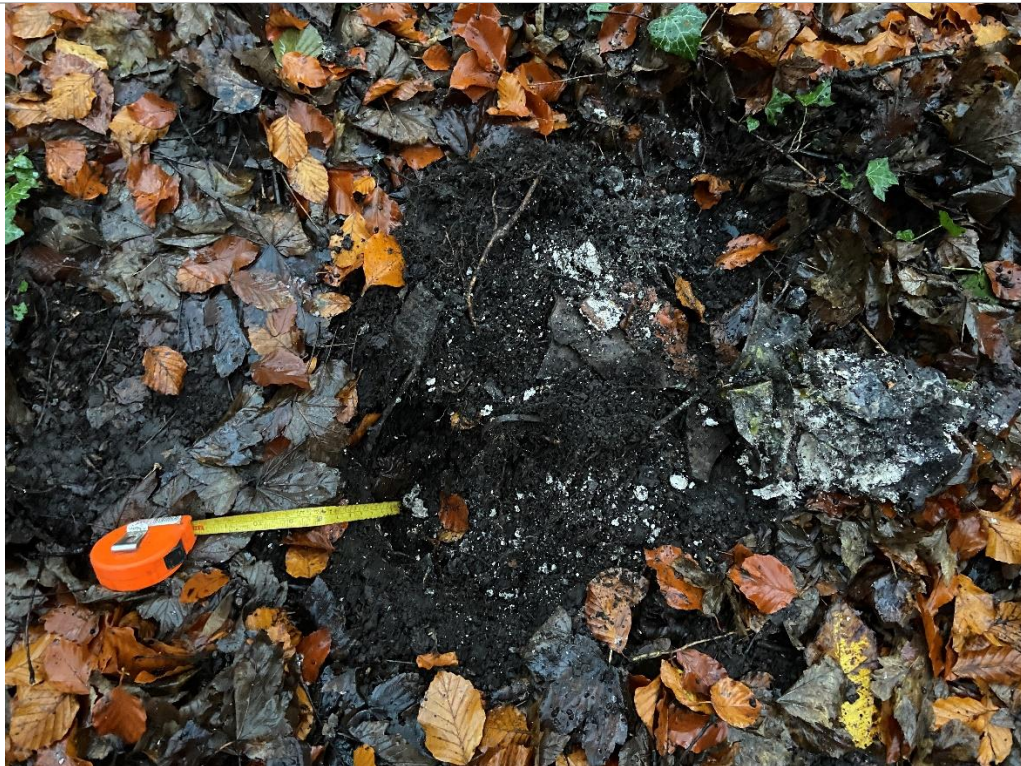
PLATE 6 HP105 EXCAVATION WITH VISIBLE ASBESTOS FRAGMENTS

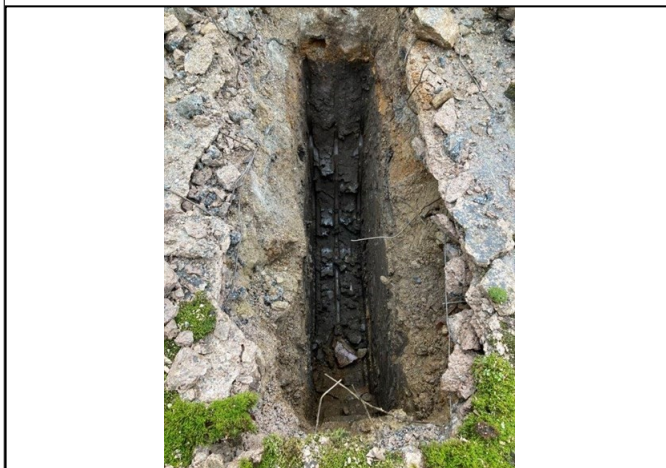
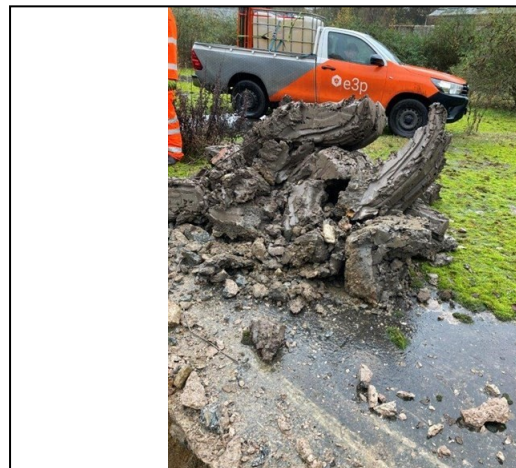
| Water Strike | Samples & In Situ Testing | | | Depth (m) | Level (m) | Legend | Stratum Description | |
|---|---|---|---|---|---|---|---|---|
| | | | | 0.80 | | | MADE GROUND: Brown sandy gravel. Gravel is fine to coarse subangular to subrounded of sandstone, mudstone, brick and concrete with occasional fragments of plastic. | |
| | 1.00 | HVP | 134 | | | | Stiff high strength brown gravelly CLAY. Gravel is fine to coarse subangular to subrounded of sandstone and mudstone. | 1 |

Trial Pit 101 Spoil

Remarks: 1. Complete. 2. Soakaway testing carried out in the trial pit. 3. No groundwater encountered.

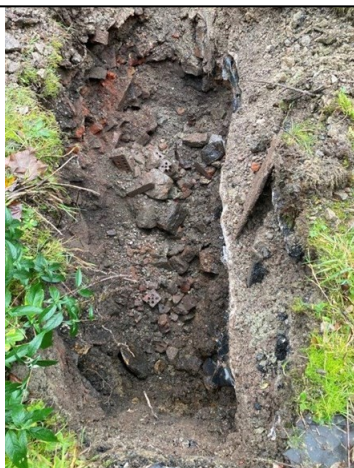
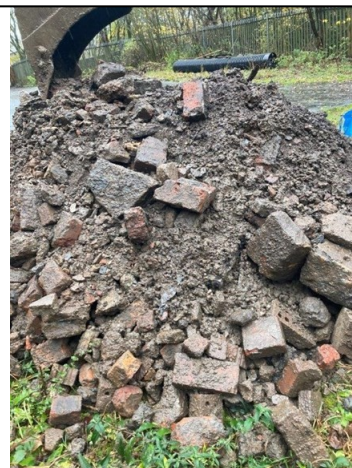
| Water Strike | Samples & In Situ Testing | | | Depth (m) | Level (m) | Legend | Stratum Description |
|---|---|---|---|---|---|---|---|
| | | | | | | | MADE GROUND: Brown slightly clayey sandy gravel. Gravel is fine to coarse subangular to subrounded of sandstone, mudstone, brick and concrete with occasional fragments of plastic and glass. |

Trial Pit 102 Spoil

Remarks: 1. Terminated due to instability. 2. No groundwater encountered.

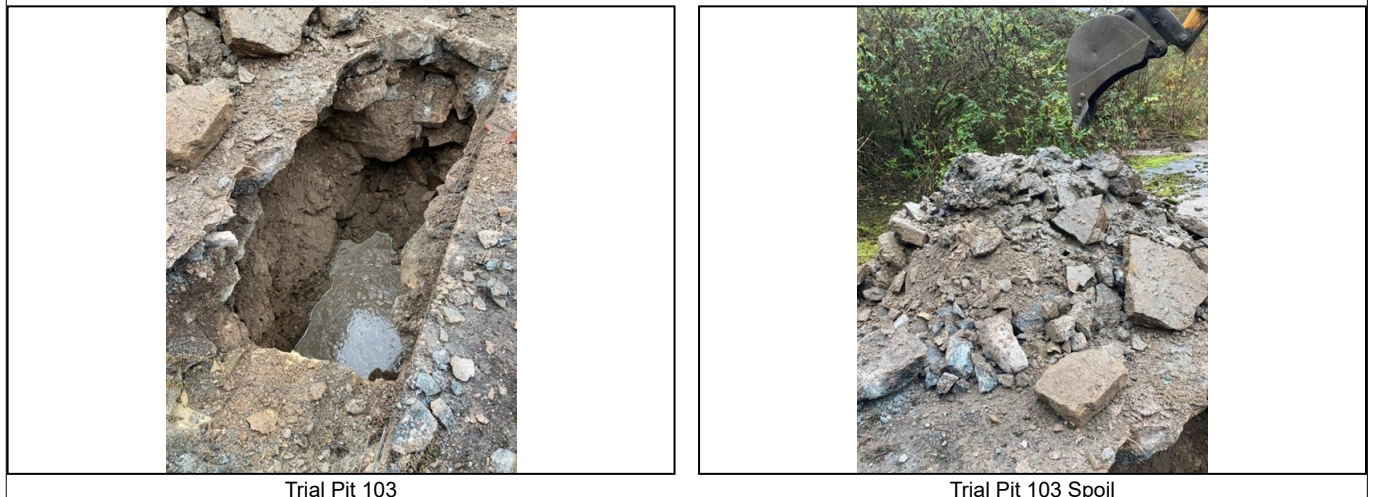
| Water<br>Strike | Samples & In Situ Testing | | | Depth<br>(m) | Level<br>(m) | Legend | Stratum Description | |
|---|---|---|---|---|---|---|---|---|
| | | | | 1.10 | | <div></div> | Brown gravelly SAND. Gravel is fine to coarse subangular to subrounded of sandstone and mudstone. | 2 |

Trial Pit 103 Spoil

Remarks: 1. Terminated due to instability. 2. Water strike encountered at 1.50 m bgl.

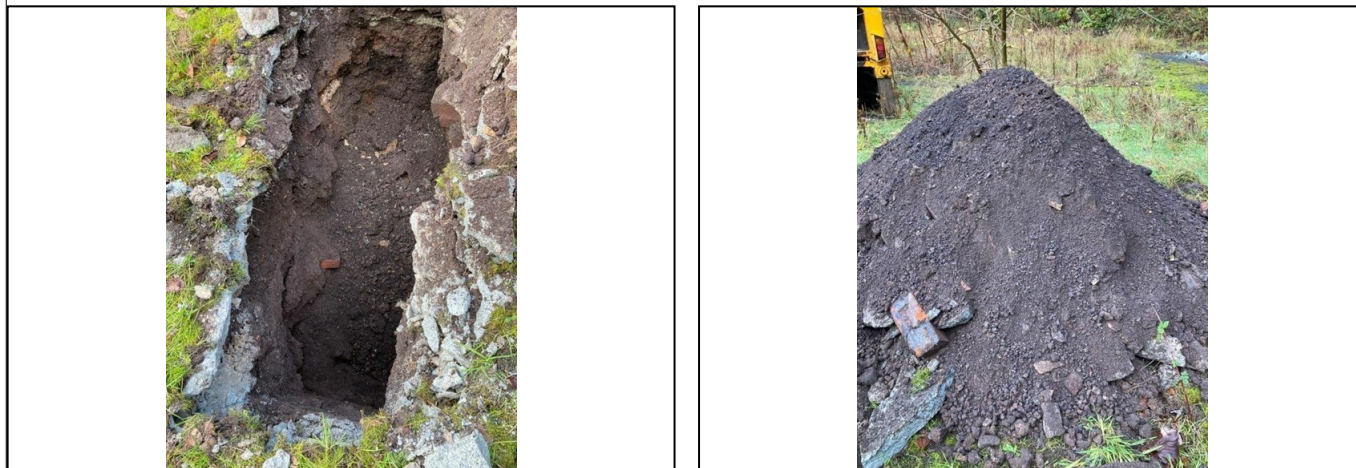
| Water Strike | Samples & In Situ Testing | | | Depth (m) | Level (m) | Legend | Stratum Description | |
|---|---|---|---|---|---|---|---|--|
| | | | | | | | MADE GROUND: Dark brown sandy gravel. Gravel is fine to coarse subangular to subrounded of sandstone, mudstone, brick and concrete with occasional fragments of wood. | |

Trial Pit 106 Spoil

Remarks: 1. Terminated due to instability. 2. No groundwater encountered

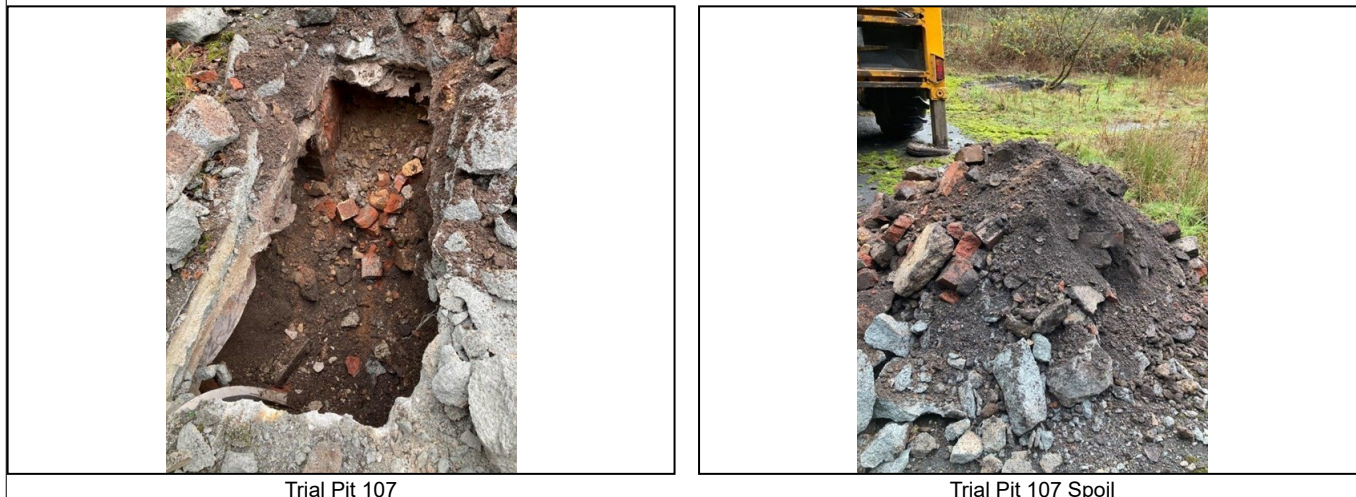
| Water Strike | Samples & In Situ Testing | | | Depth (m) | Level (m) | Legend | Stratum Description | |
|---|---|---|---|---|---|---|---|---|
| | | | | | | | MADE GROUND: Dark brown very sandy gravel. Gravel is fine to coarse subangular to subrounded of sandstone, brick, and concrete with occasional fragments of metal and ceramic. | 1 |

Trial Pit 107 Spoil

Remarks: 1. Terminated due to concrete base, scraping for 5 minutes and made no progress. 2. No groundwater encountered.

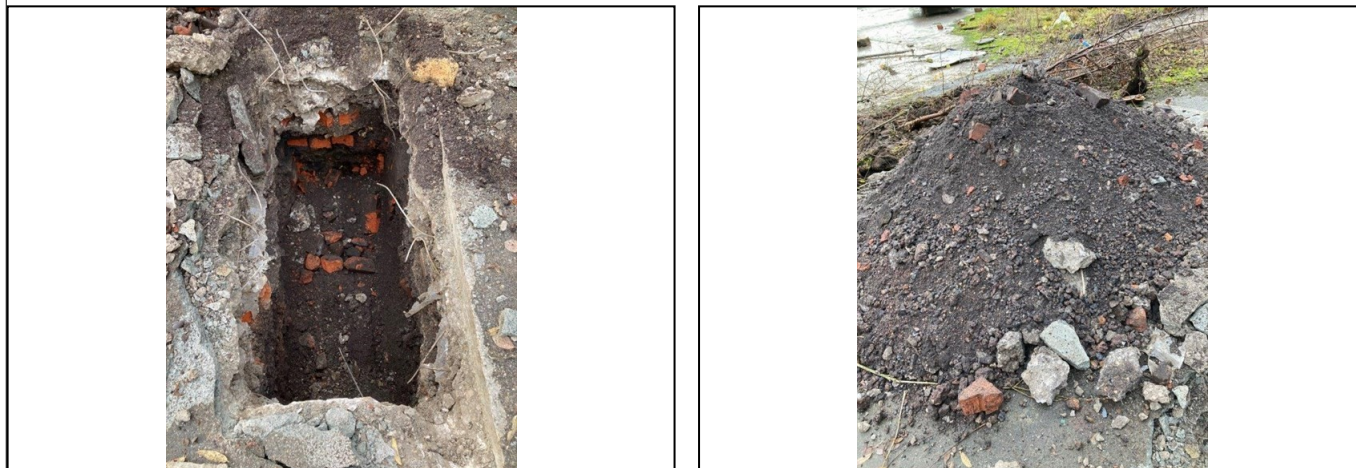
| Water Strike | Samples & In Situ Testing | | | Depth (m) | Level (m) | Legend | Stratum Description | |
|---|---|---|---|---|---|---|---|---|
| | | | | 1.20 | | | MADE GROUND: Dark brown sandy gravel. Gravel is fine to coarse subangular to subrounded of sandstone, mudstone, brick and concrete with occasional fragments of plastic. | 1 |

Trial Pit 108 Spoil

Remarks: 1. Terminated due to concrete base, scraping for 5 minutes and made no progress. 2. No groundwater encountered.

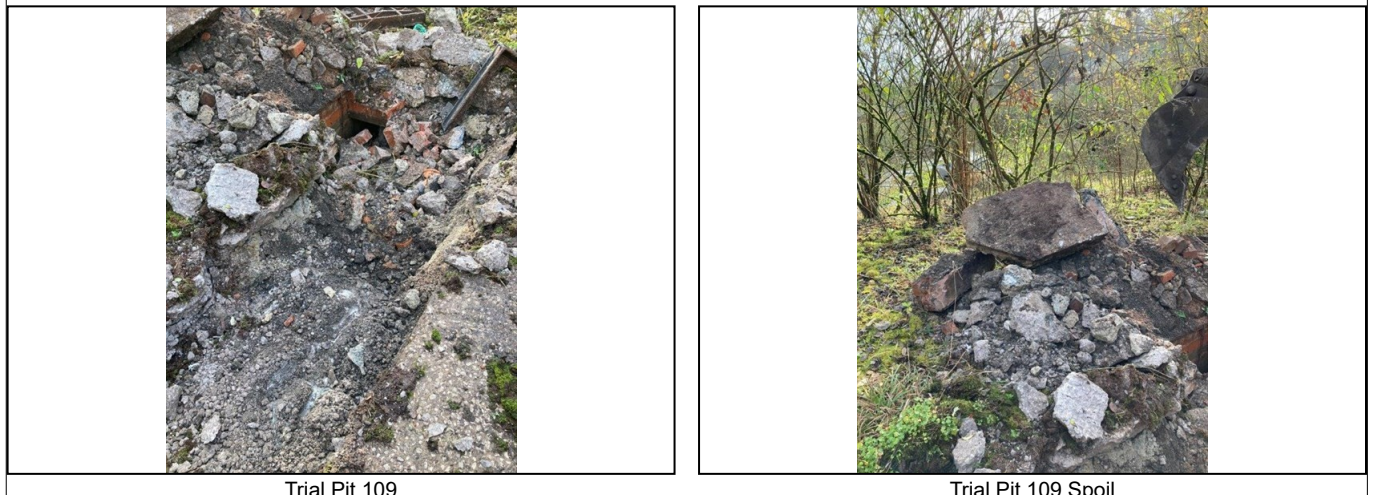
| Water Strike | Samples & In Situ Testing | | | Depth (m) | Level (m) | Legend | Stratum Description | |
|---|---|---|---|---|---|---|---|--|
| | | | | 0.70 | | | MADE GROUND: Grey slightly sandy gravel. Gravel is fine to coarse subangular to subrounded of concrete and brick. | |

Remarks: 1. Terminated due to basement feature in south of the trial pit. 2. No groundwater encountered.

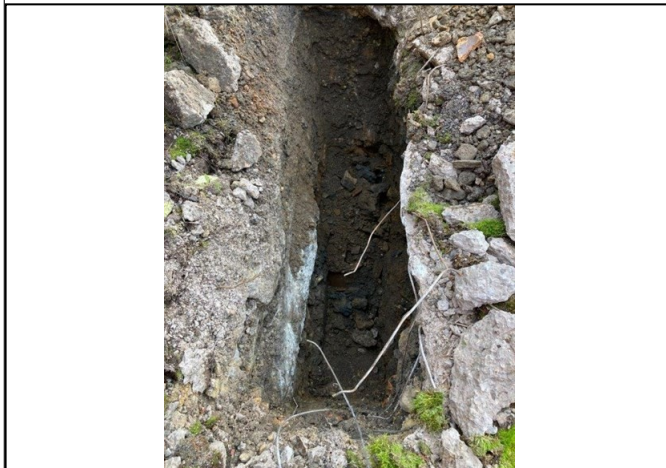
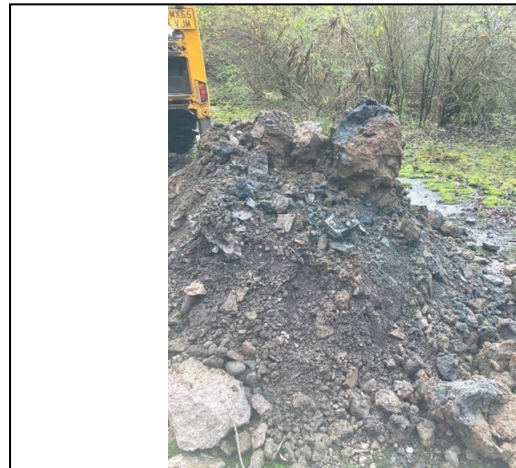
| Water Strike | Samples & In Situ Testing | | | Depth (m) | Level (m) | Legend | Stratum Description | |
|---|---|---|---|---|---|---|---|---|
| | 1.50 | HVP | 43 | 1.50 | | | Firm medium strength greyish blue sandy slightly gravelly CLAY. Gravel is fine to coarse subangular to subrounded of sandstone and mudstone. | |

Trial Pit 110 Spoil

Remarks: 1. Complete. 2. No groundwater encountered.

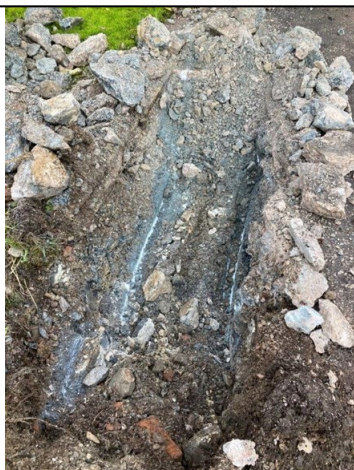
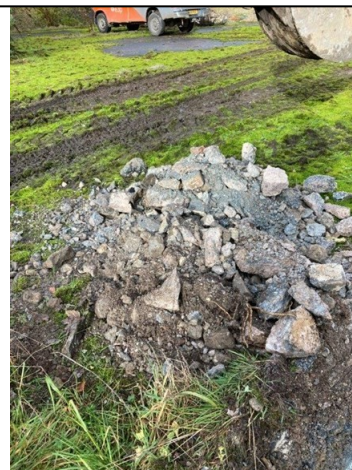
Trial Pit 111 Spoil

Remarks: 1. Terminated due to concrete base, scraping for 5 minutes and made no progress. 2. No groundwater encountered.

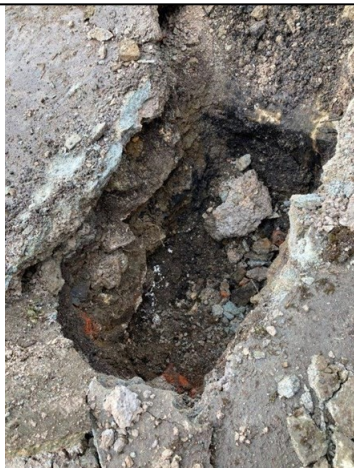
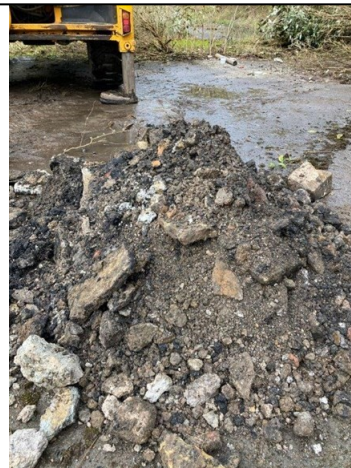
| Water<br>Strike | Samples & In Situ Testing | | | Depth<br>(m) | Level<br>(m) | Legend | Stratum Description |
|---|---|---|---|---|---|---|---|
| | 0.80 | ES | | 0.90 | | | MADE GROUND: Dark brown blackish slightly clayey slightly gravelly silt. Gravel is fine to coarse subangular to subrounded of sandstone brick, and concrete. |

Trial Pit 113 Spoil

Remarks: 1. Terminated due to pipe in base of trial pit. 2. No groundwater encountered.

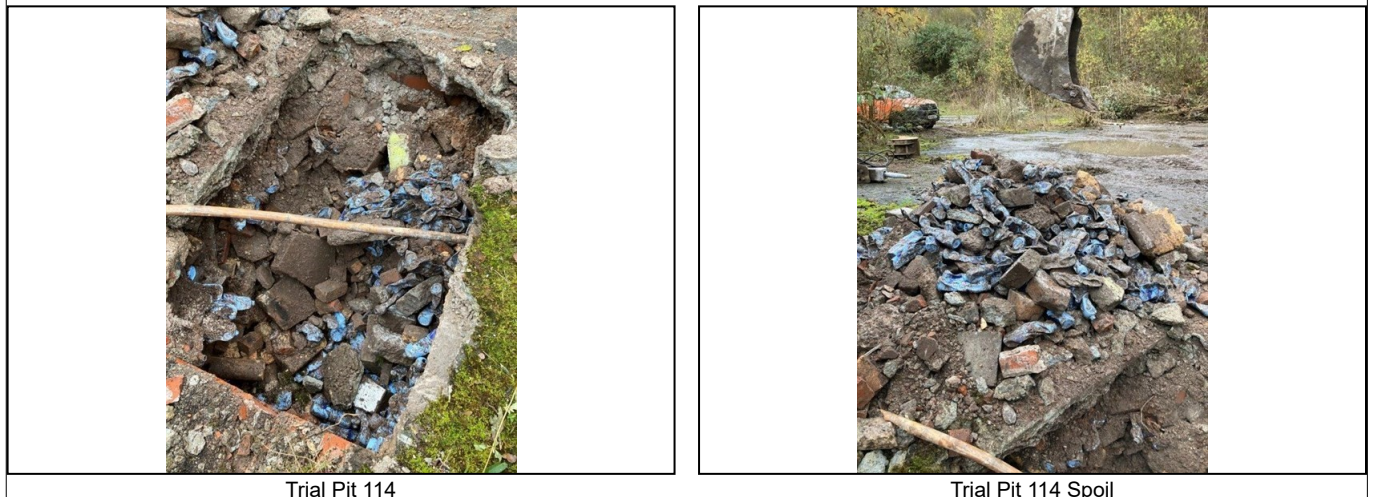
| Water<br>Strike | Samples & In Situ Testing | | | Depth<br>(m) | Level<br>(m) | Legend | Stratum Description | |
|---|---|---|---|---|---|---|---|---|
| | | | | | | <div></div> | MADE GROUND: Dark brown sandy gravel with occasional cobbles. Gravel is fine to coarse subangular to subrounded of sandstone, mudstone, brick, and concrete with frequent plastic bottles. Cobbles are angular of concrete. | |

Trial Pit 114 Spoil

Remarks: 1. Terminated due to instability. 2. Water strike encountered at 1.50 m bgl. 3. Brick wall in the south of the trial pit.
