Lancashire Dog Training

Preliminary Roost Assessment (PRA)

241737

30<sup>th</sup> August 2024

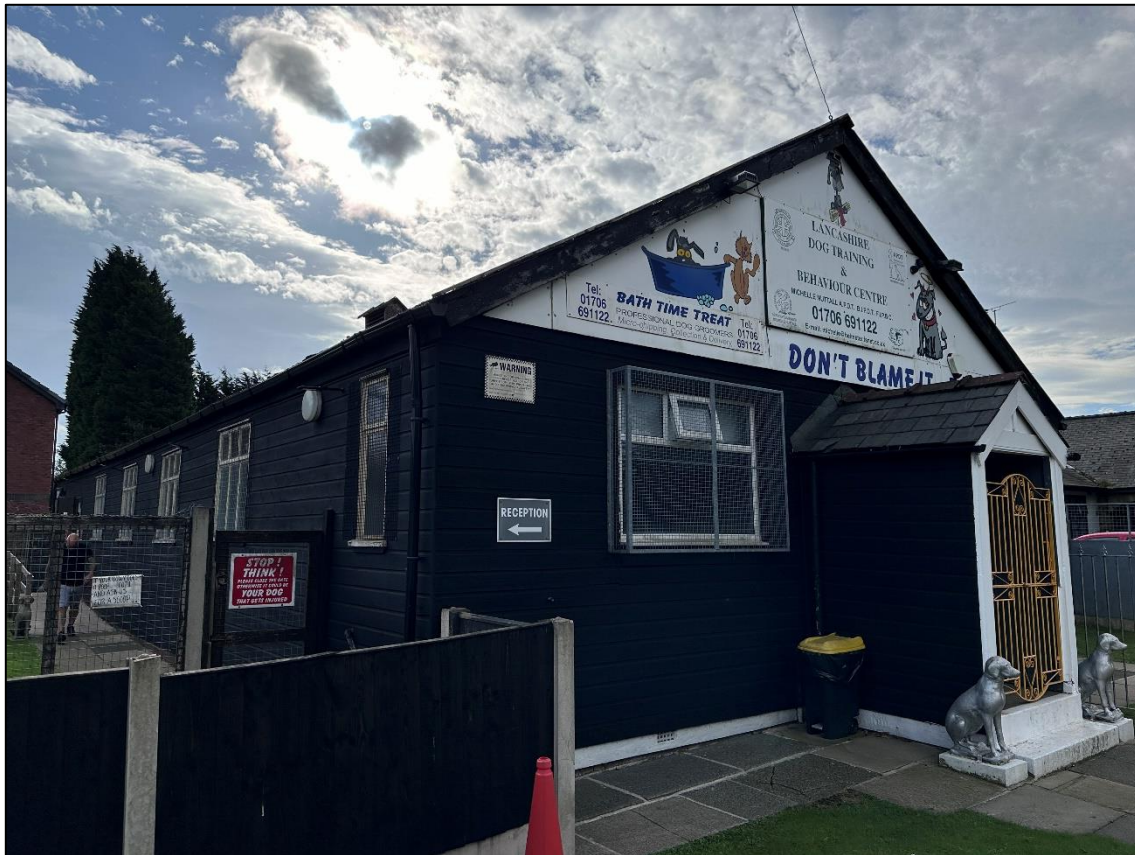
2.2.3. The building is timber framed with the walls comprising wood cladding with wooden single glazed windows and a small wooden fascia board along the eaves. A small porch is present on the western elevation of the building and two lean-to brick structures are present to the east.

Figure 2: The west and north elevations of the building.

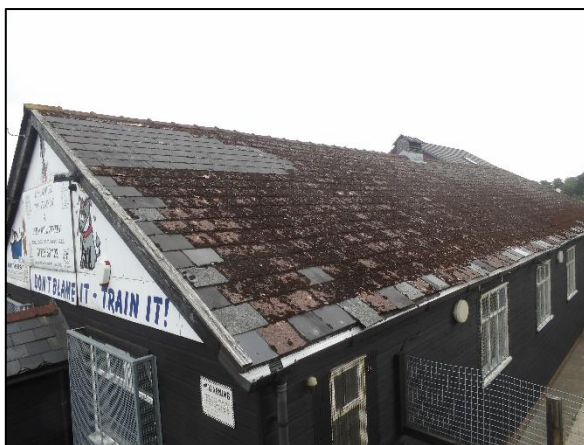
2.2.4. The roof of the building comprises a tiled pitched roof with a wooden vent in the centre of the ridge.

Figure 3: The roof of the building.

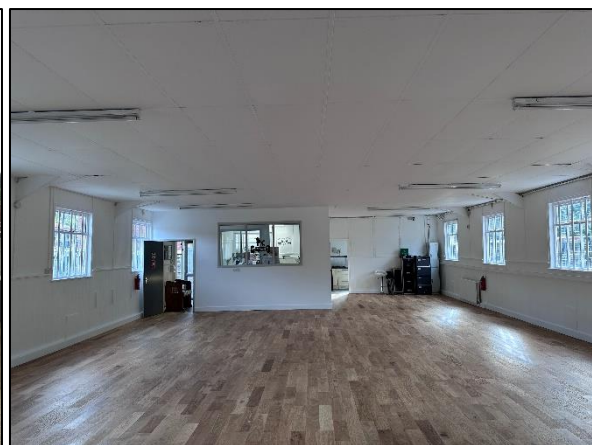
2.2.5. Internally, the building has a loft space throughout the entire roof void. The space comprises two small, separated loft spaces at either end of the building with a suspended ceiling in the main space of the building, creating a void above.

Figure 4: The interior of the building.

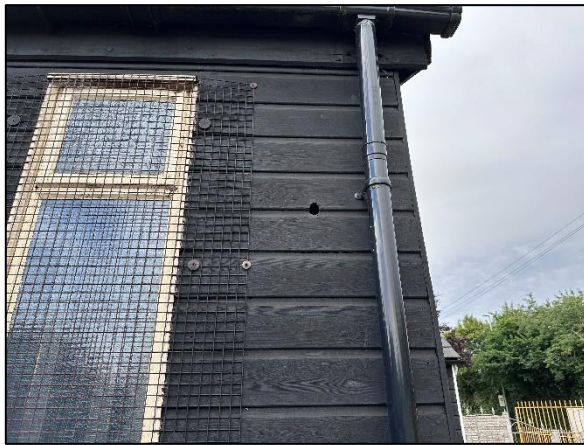
4.2.1. The walls of the building were found to be in a generally good condition with the windows and doors intact and sealed. Occasional small services holes and areas of damage were identified in the wood cladding and a louvred vent was identified in the eastern elevation of the building, providing potential access to the roof void.

Figure 6: Holes in the wood cladding.

5.1. It is recommended that no works commence on the building prior to a further bat survey being carried out, in line with the Bat Conservation Trust (BCT) Good Practice Guidelines (2023). Further recommendations should be made on completion of the survey.

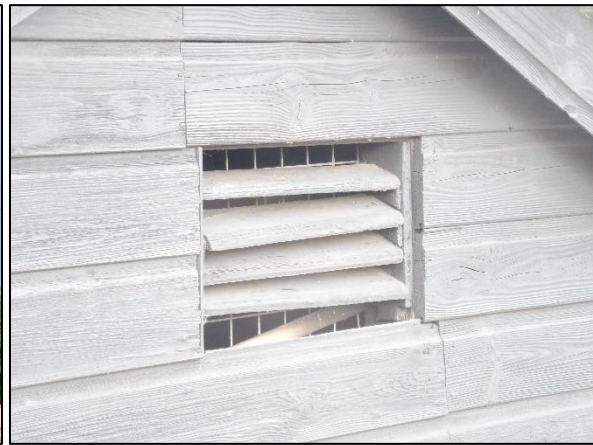
Figure 7: The louvred vent in the eastern gable end.

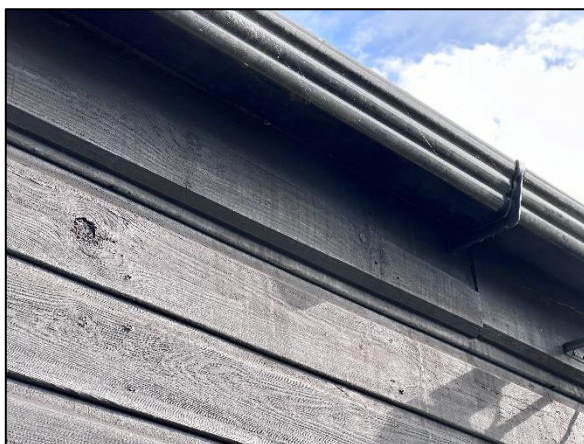
4.2.2. The fascia boards to the north and south of the building were found to be tight to the wood cladding. Shallow voids were present along the top edge of the boards in places, although the voids were inspected and no significant cavities were identified.

Figure 8: The tight-fitting fascia board.

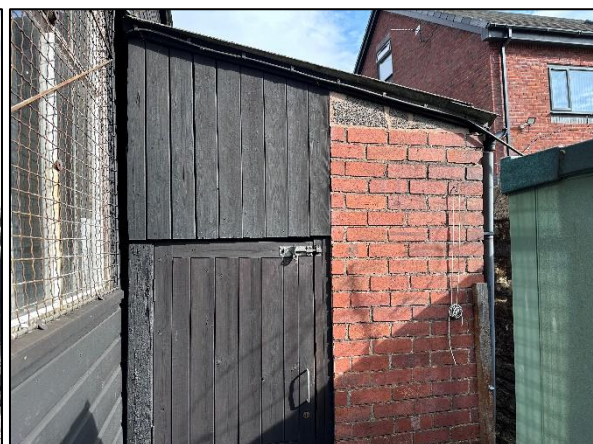
4.2.3. The brickwork of the lean-to buildings to the east was found to be in a good condition although a void was present between one of the buildings and the wood cladding of the main building.

Figure 9: The lean to building to the east.

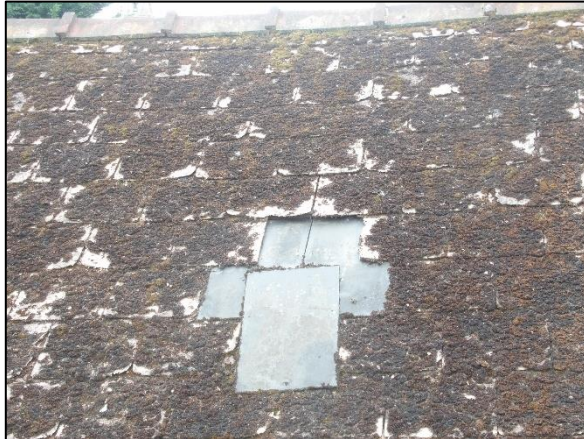
4.2.4. The roof of the building was inspected and found to be intact but to display abundant missing or slipped tiles and high levels of moss. Due to the presence of internal sarking the voids from the slipped tiles were minimal and not assessed to provide significant cavities.

Figure 10: Slipped tiles on the roof of the building.

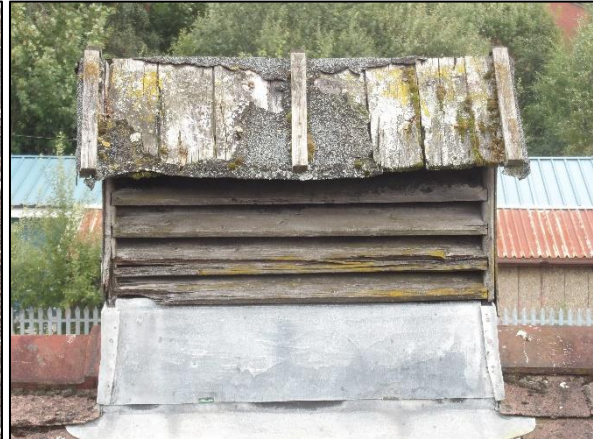
4.2.5. The vent structure on the roof of the building was inspected and found to display openings providing potential access to the interior of the vent structure and the roof void.

Figure 11: The vent structure.

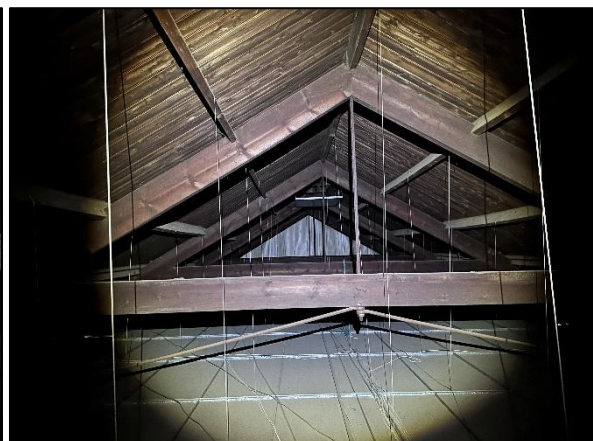
4.2.8. The central void over the suspended ceiling was visible from the western end of the building. The void displays exposed timbers with metal tie rods and wires supporting the suspended ceiling. The opening for the roof vent was visible but could not be directly inspected.

Figure 13: The void over the suspended ceiling.
