**A HISTORIC BUILDING  
RECORDING AT  
MOORGATE EAST FARM,  
THE OLD STABLE,  
BROAD LANE,  
ROCHDALE,  
GREATER MANCHESTER**

**PCA REPORT NO: R15158**

**Moorgate East Farm, The Old Stable, Broad Lane, Rochdale, Greater Manchester:**  
**Historic Building Recording**

Historic Building Recording

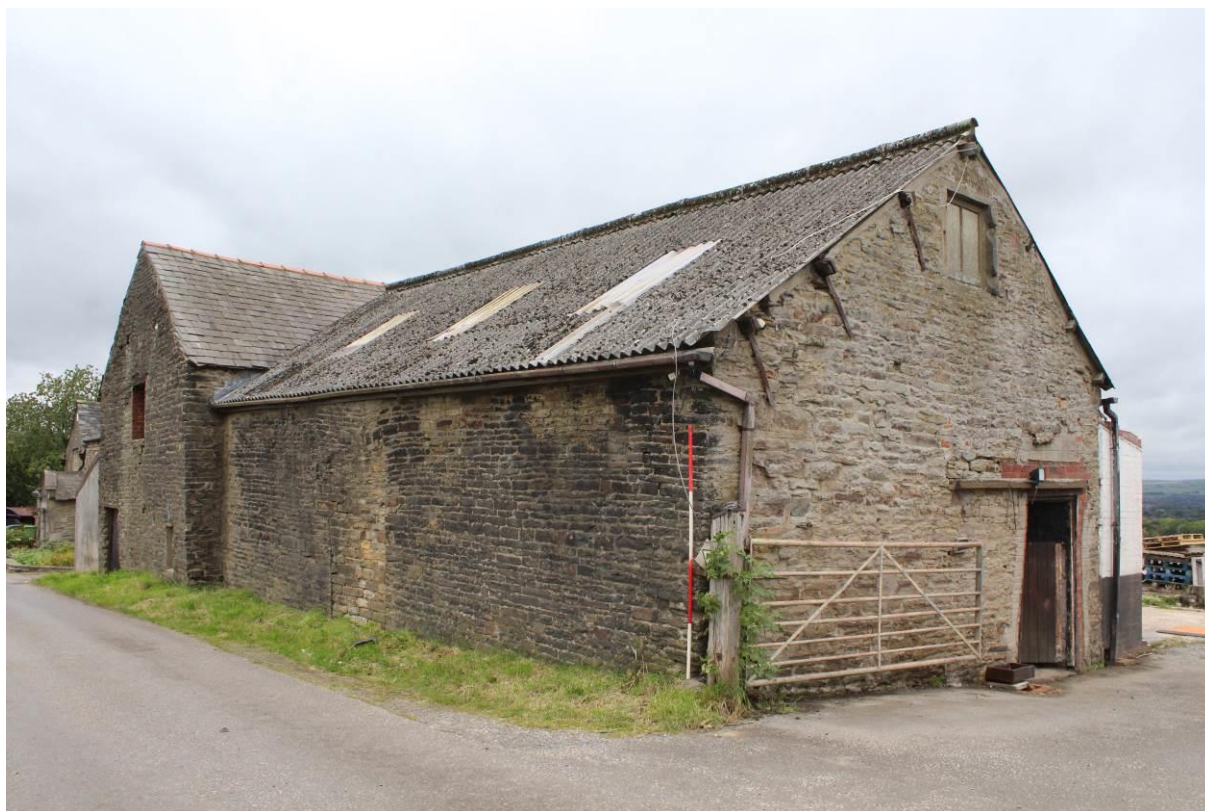
**Photo 1:** General view of Barn B (left) and A (right), looking E

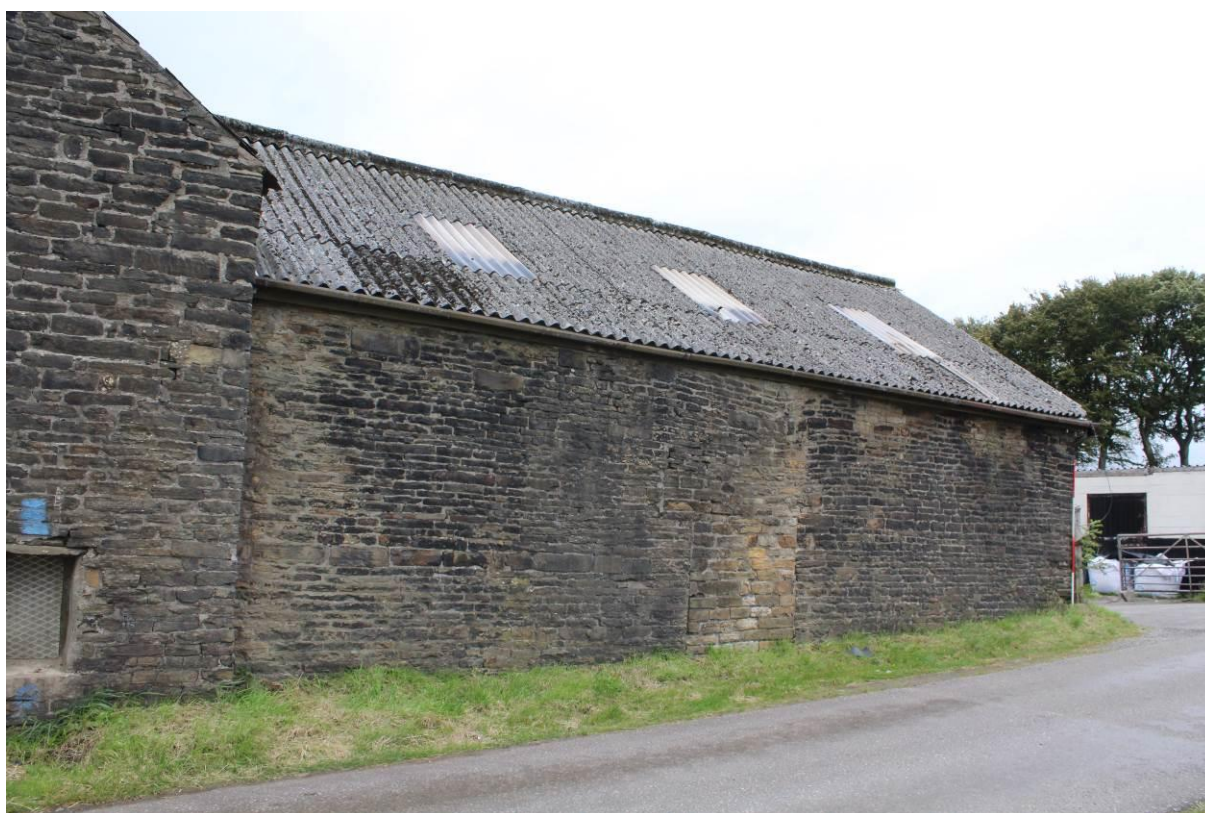
**Photo 2:** Front elevation of Barn A, looking N.

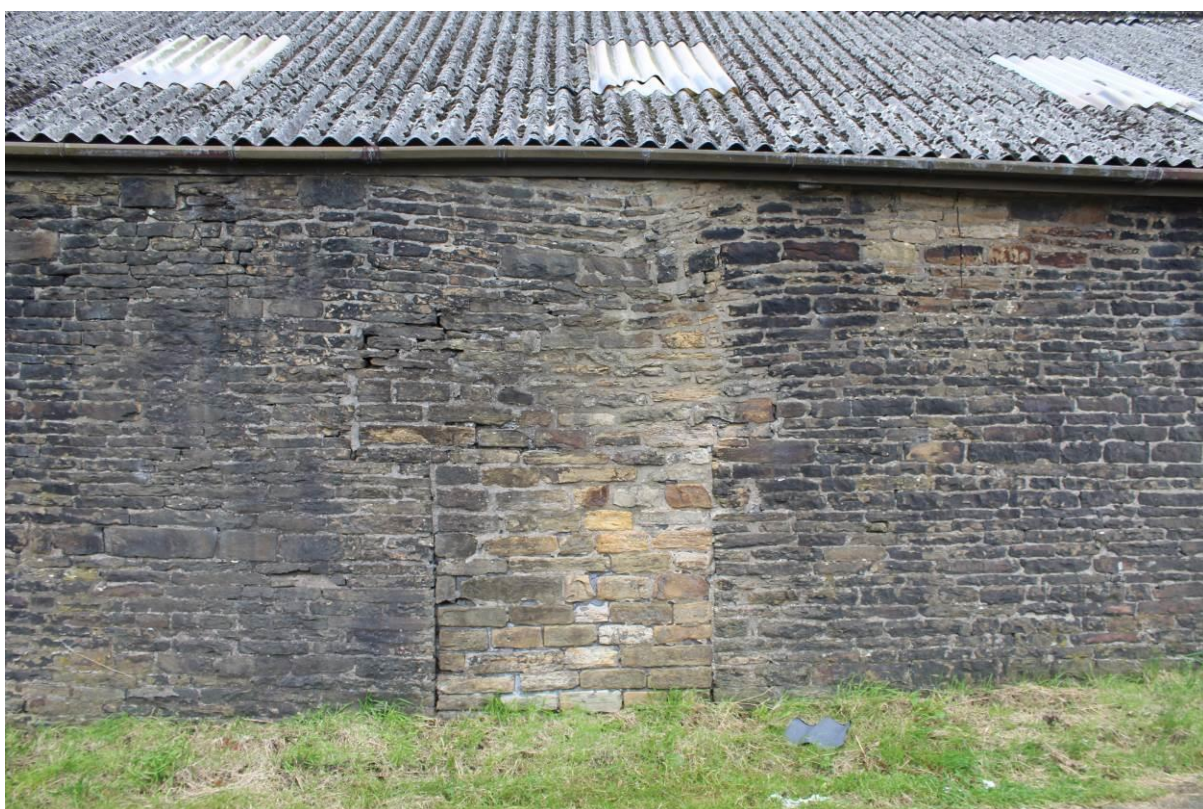
**Photo 3:** Front elevation of the Barn A, note blocked up doorway, looking NW

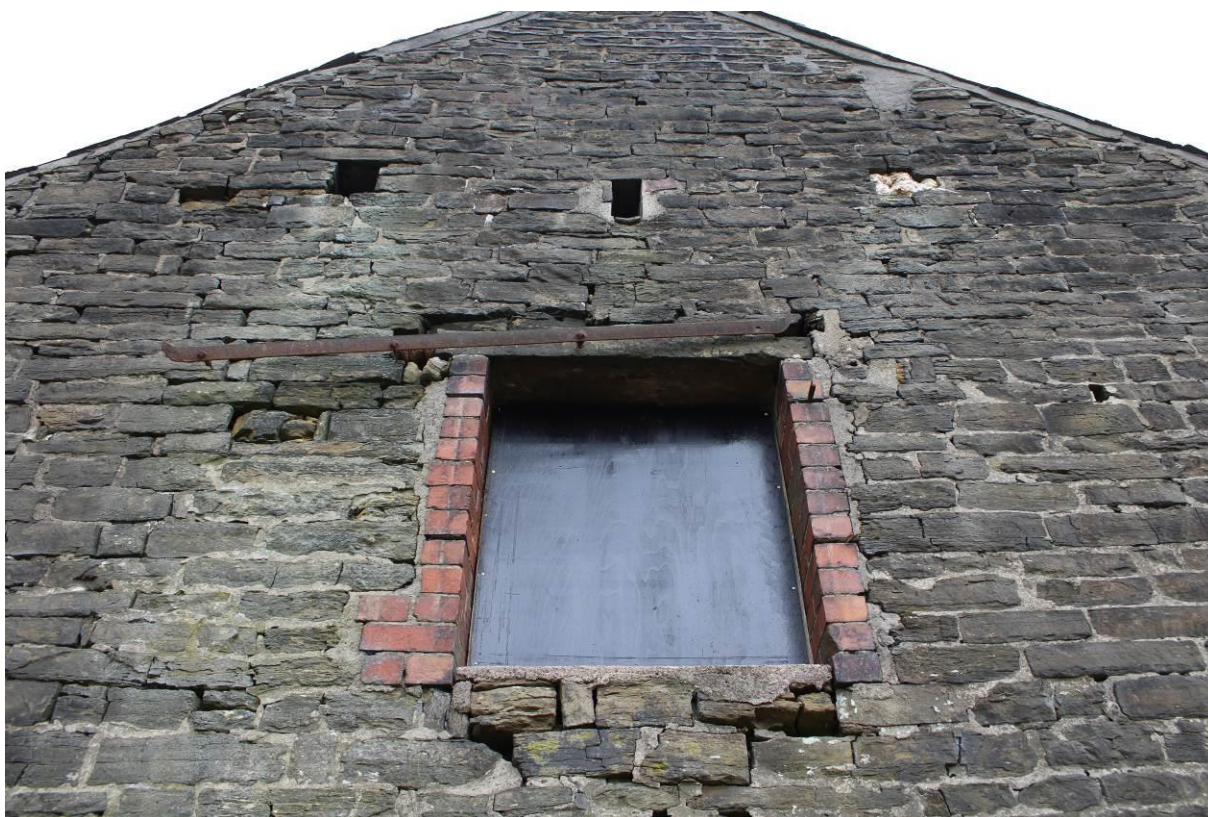
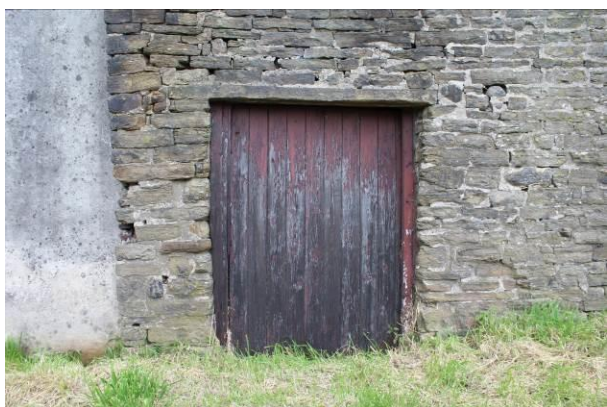
**Photo 5:** Detail on front elevation of Barn B; a row of ventilation holes, a boarded-up sliding door hatch, a window and a planked door, looking NW

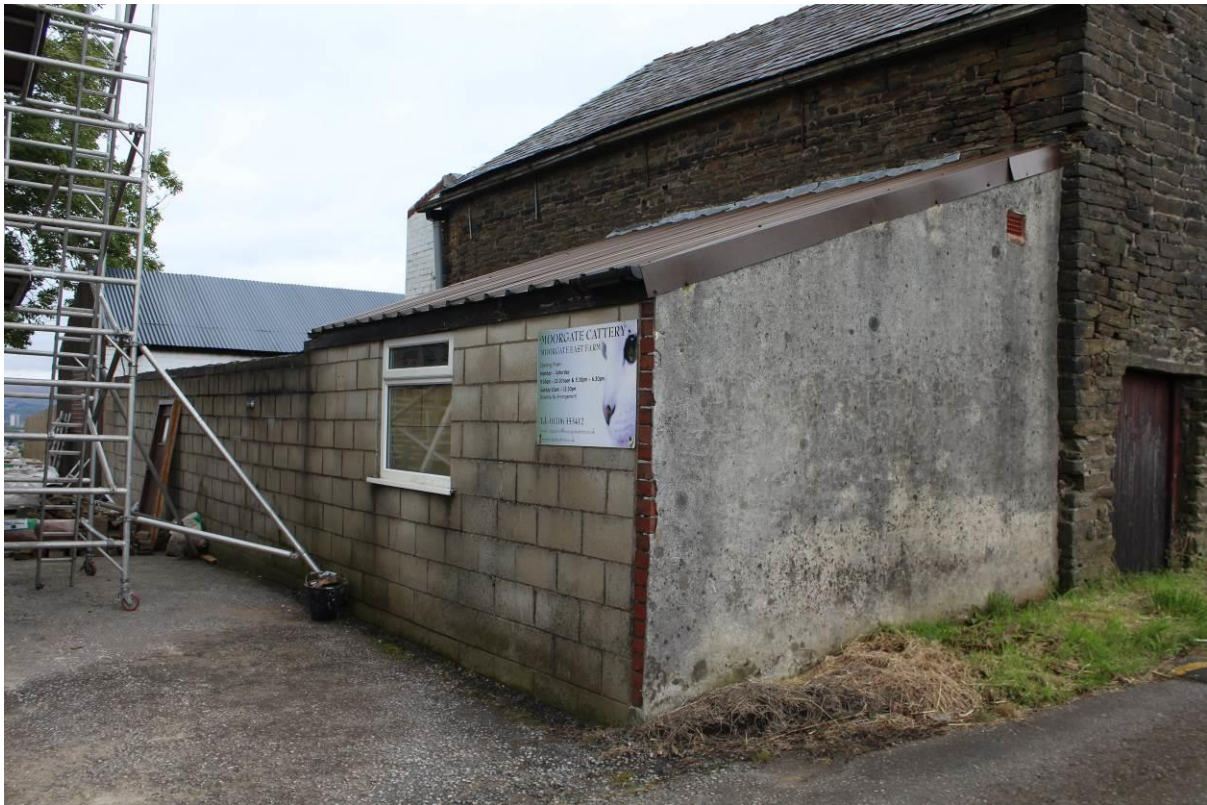
- 8.4.5 The southwest elevation was largely concealed by a 20<sup>th</sup> Century lean-to structure, constructed from red brick, fully rendered and breeze blocks, and is first depicted on the 1954-6 Ordnance Survey (**Figure 12**). However, this structure replaced an earlier, larger building; there is no indication of its location on the stone wall but it is first depicted on the 1928 Ordnance Survey (**Figure 10**).

**Photo 6:** Front and side elevation of Barn B, and a 20<sup>th</sup> Century lean-to, looking N

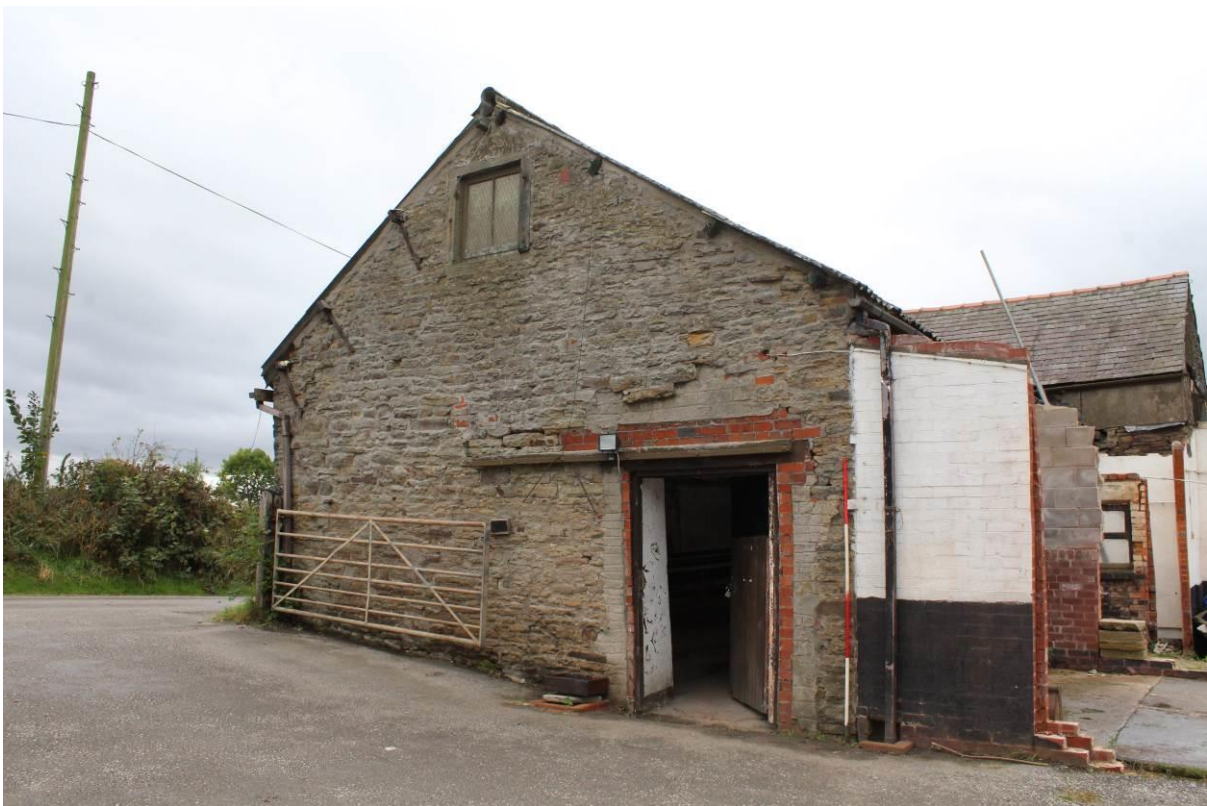
**Photo 7:** Detail side elevation of Barn A; a window, beams support and doorway with remnants of a sliding door brackets, looking S

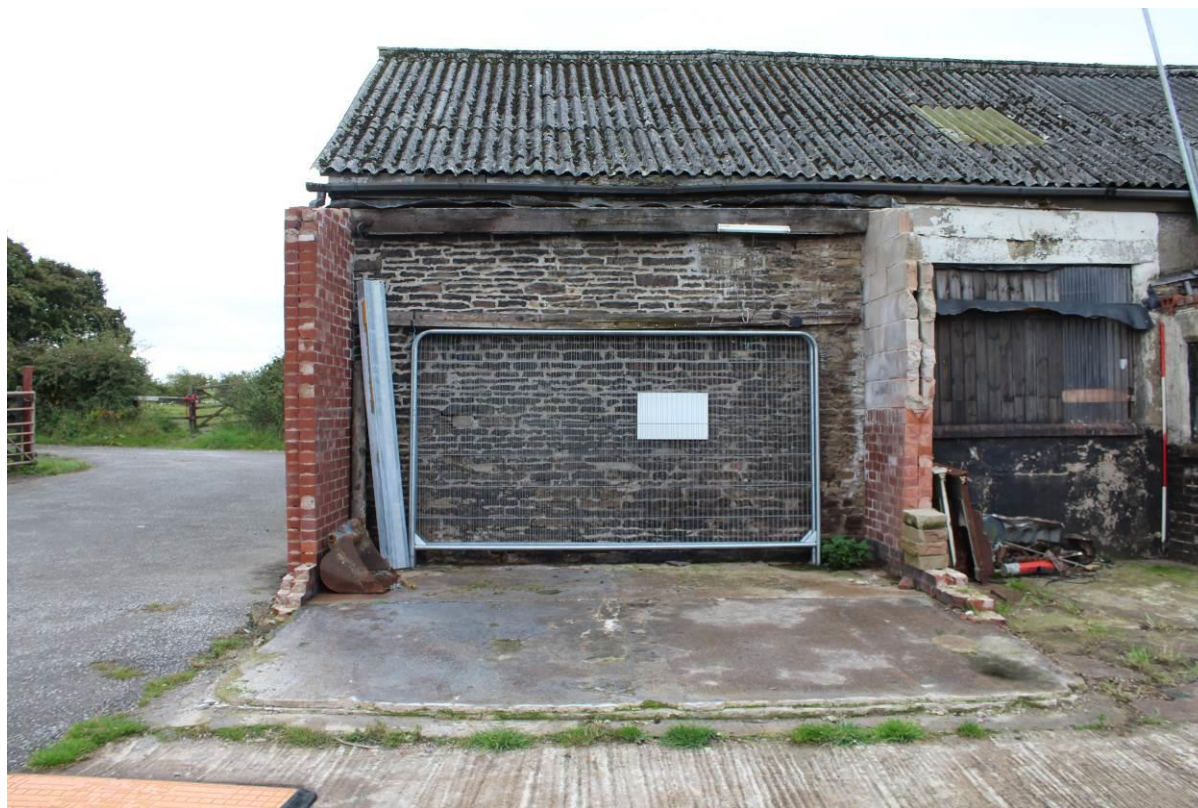
**Photo 9:** Rear elevation of Barn A; showing extensions partially demolished, looking SE

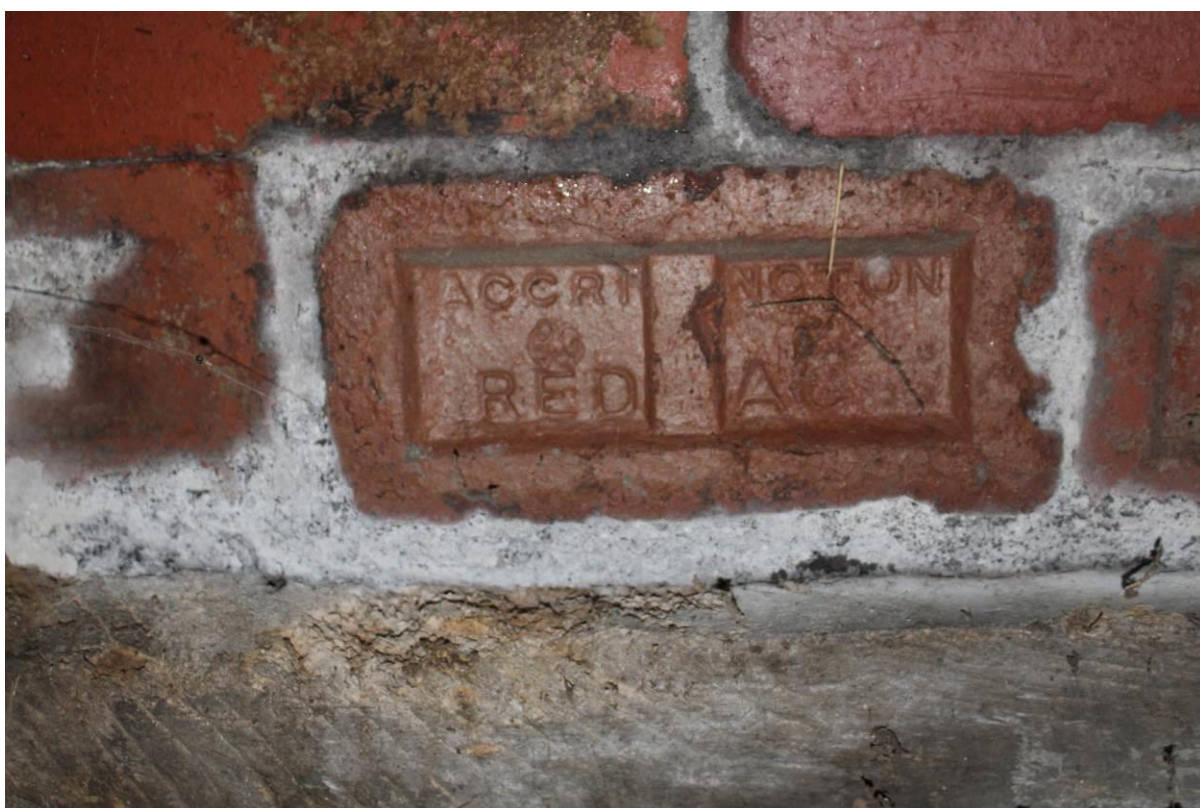
8.5.2 There is a blocked-up doorway with a stone lintel on the northeast elevation; the blocking uses mass-produced red bricks, with the uppermost course moulded with the makers' stamp 'ACCRINGTON REDAC', these being produced locally by the Redac works at Huncoat, Accrington, which closed in 1992. An embedded wooden lintel with void peg holes and protruding nails was noted in the centre of the elevation.

**Photo 24:** Interior of Barn B; blocked door detail with closeup of the upper course of bricks, looking NE (lower image inverted for clarity of inscription)

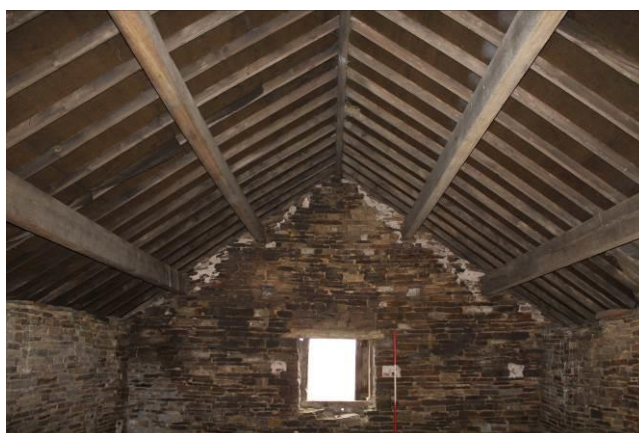
- 8.5.10 A line of protruding stone plinths was noted above the southeast elevation hatch door, most likely to have held a mezzanine of sorts.
- 8.5.11 The roof anatomy comprises of rectangular machine-cut underpurlins and rafters. The original roof structure was destroyed by a fire in the latter part of the 20<sup>th</sup> Century.

**Photo 26:** Interior of Barn B: General view of First Floor; showing roof detail, looking NW

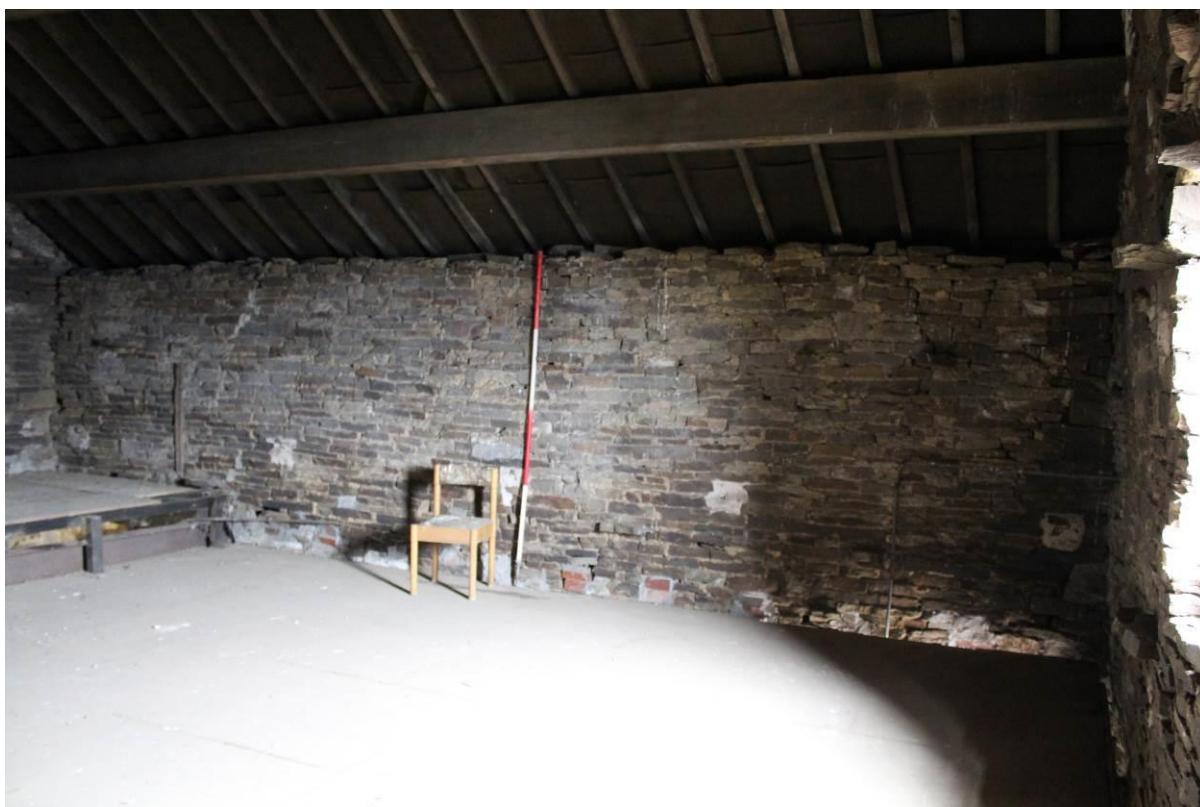
**Photo 32:** Interior of Barn B: General view of First Floor; showing blocked up beam slots, and protruding stone plinths, looking S

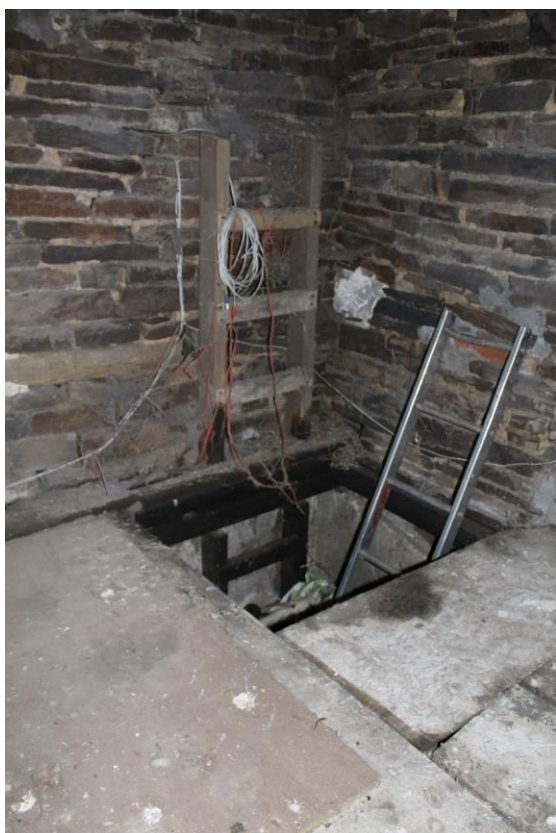
**Photo 33:** Interior of Barn B: General view of First Floor; showing access point; hatch and ladder, looking E

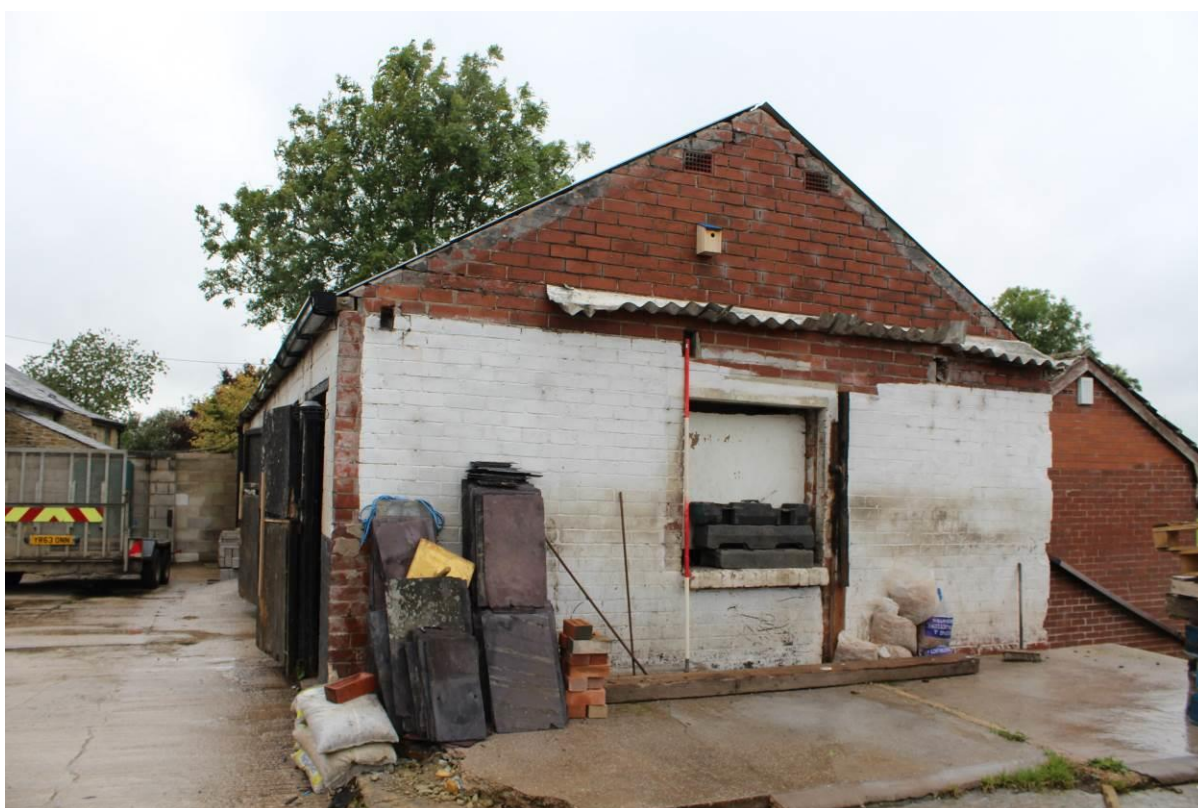
**Photo 35:** Side elevation of Stable Block A; showing extensions partially demolished looking W

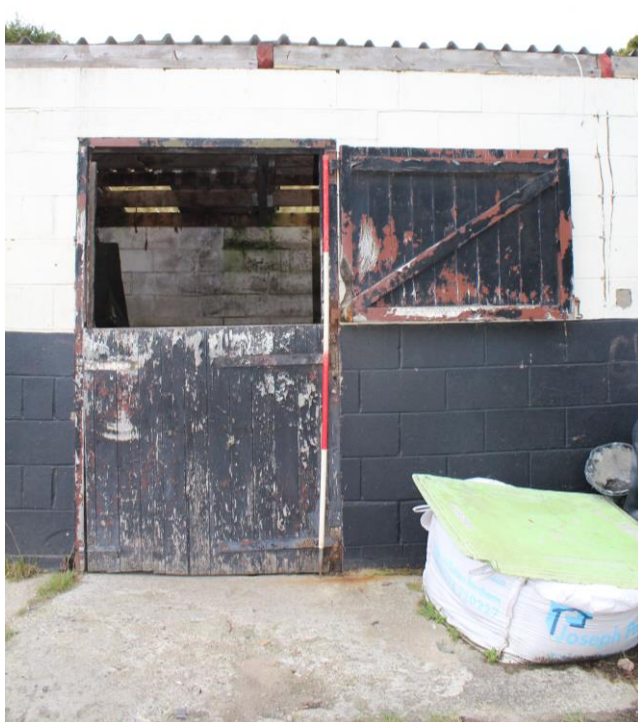
**Photo 45:** Stable B; Detail of stable doors, looking NE
