**The Former Marina  
Ropeworks,  
Brunswick Street, Heywood  
Greater Manchester**

Archaeological Strip, Map and  
Plan

Report no. 4212  
November 2024

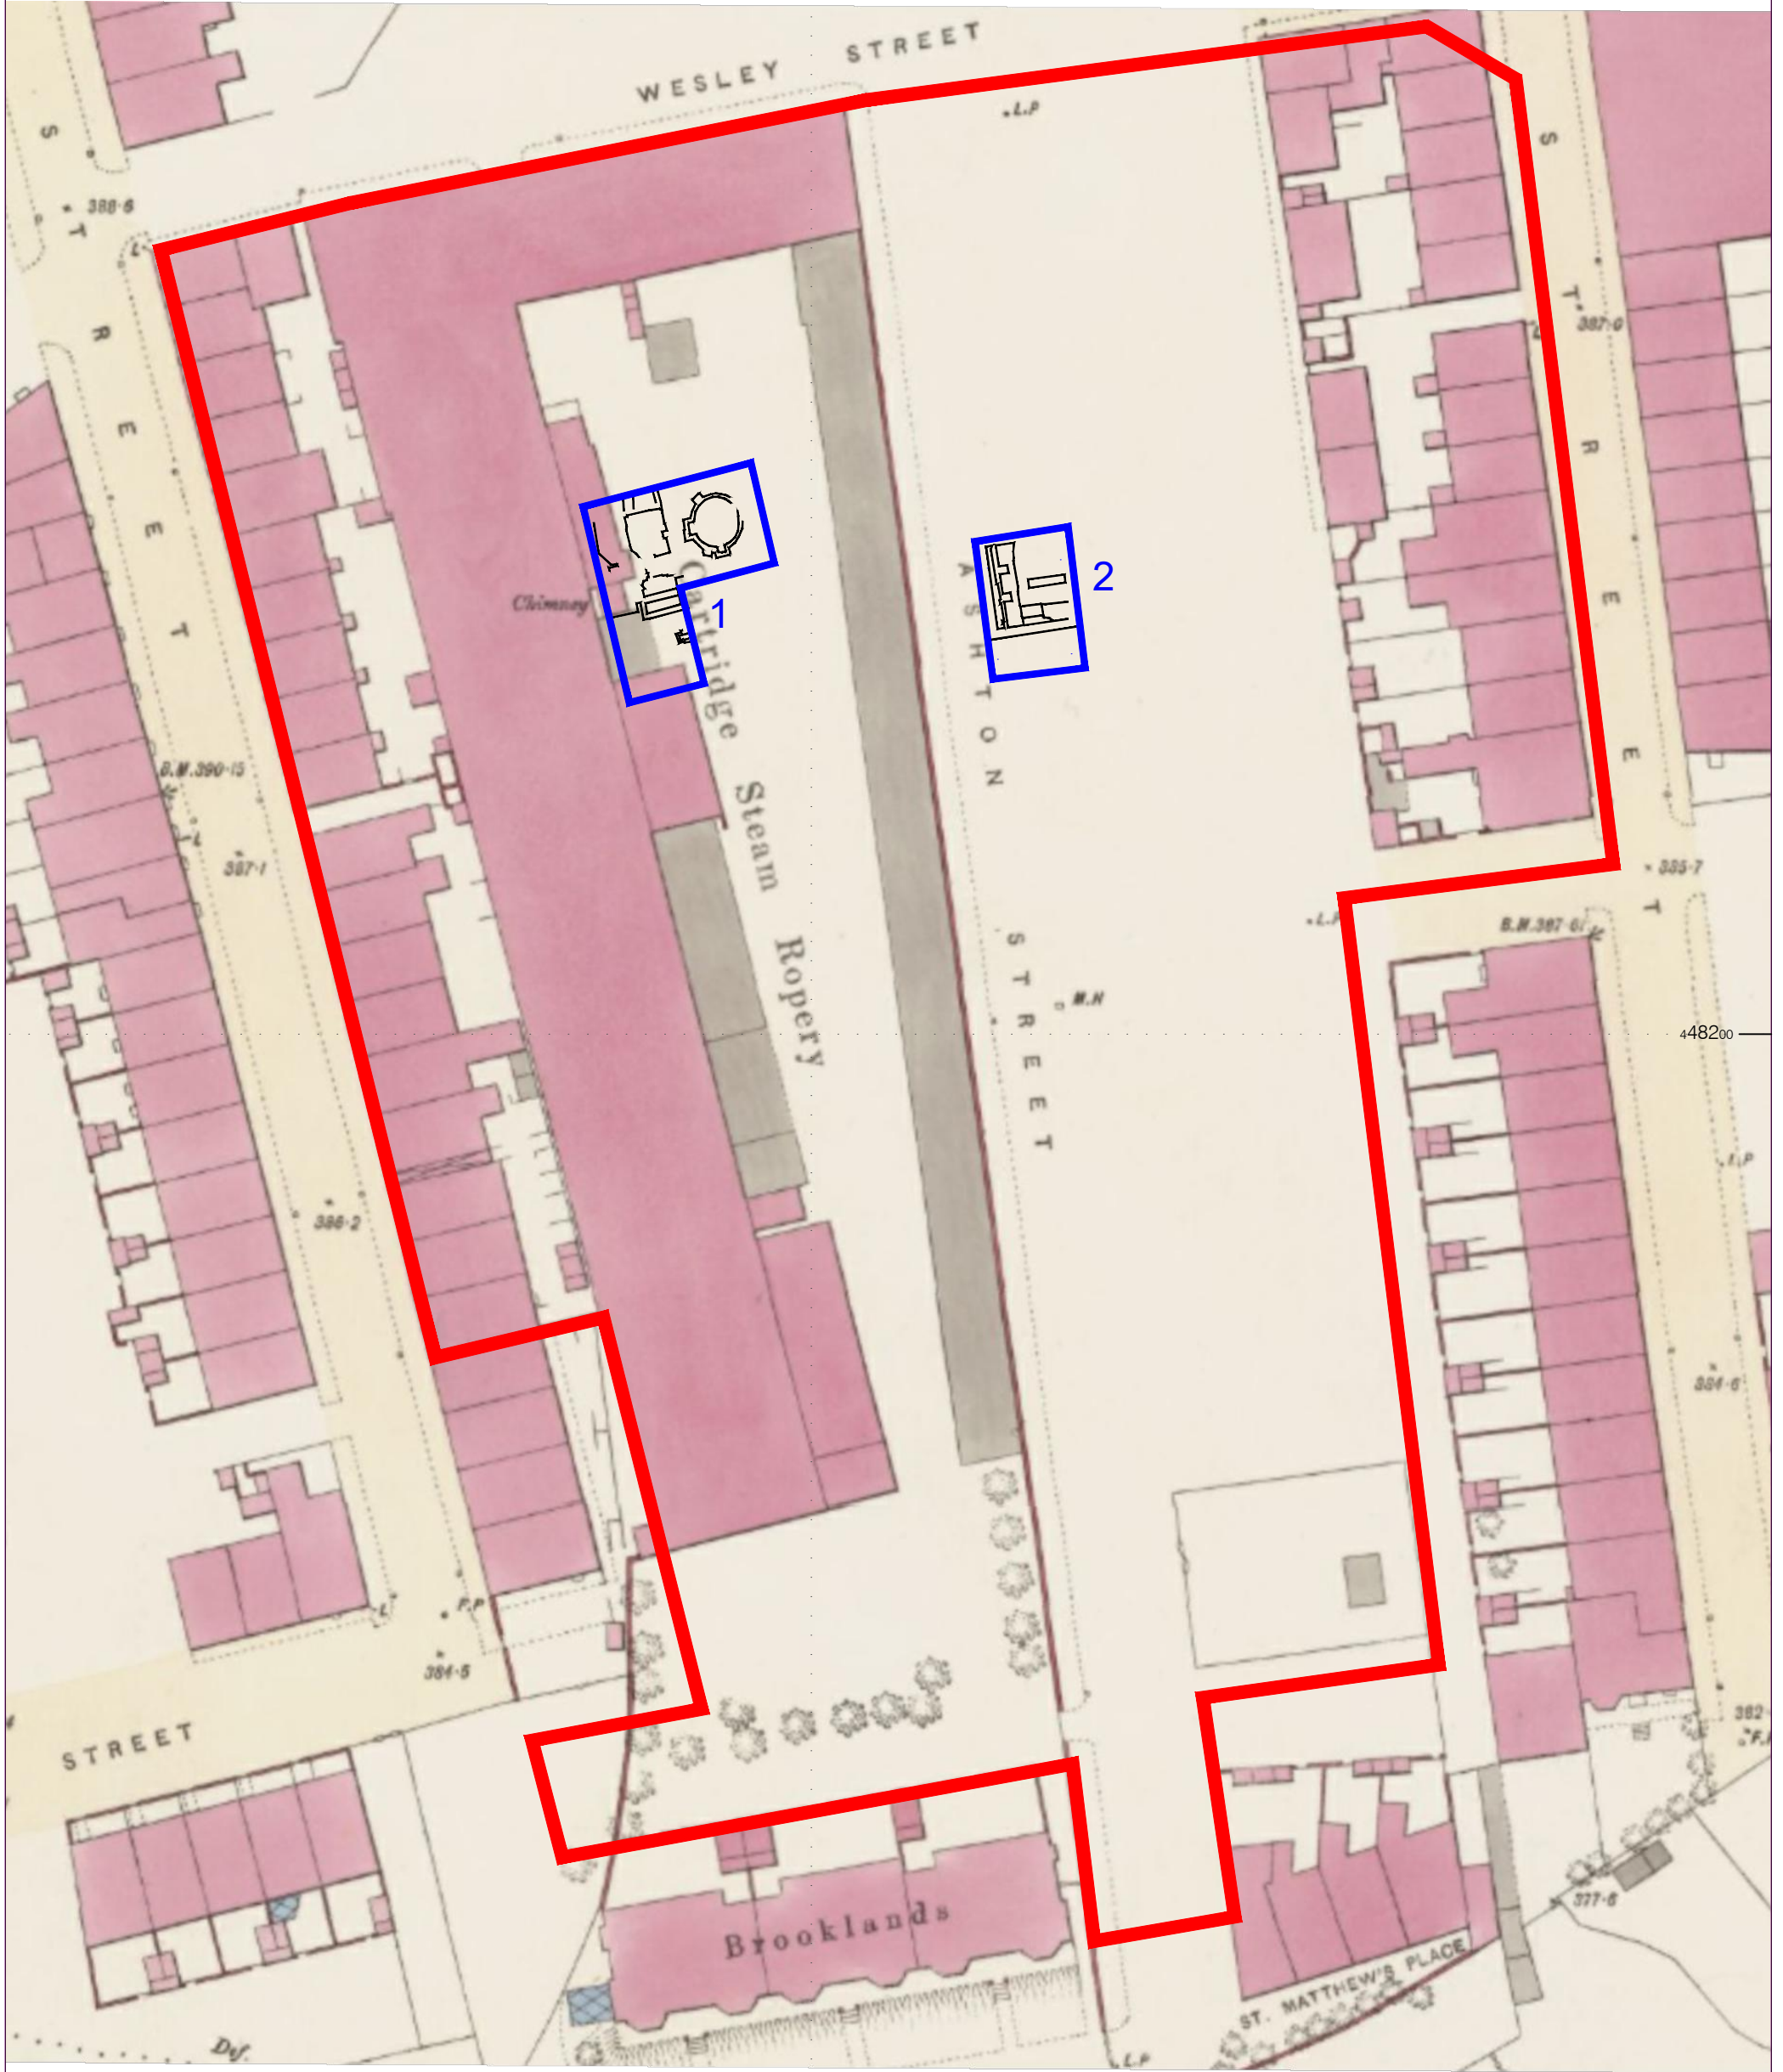
| | Site plan overlaid on the Heywood Town Plan of 1891 | ARCHAEOLOGICAL FEATURE | |

Chimney 104 (Plate 3) correlates with a square chimney depicted on late 19th and 20th-century mapping (Figs 3-6). The southern, western and northern sides of the chimney were exposed, stepping out towards its base on the southern side where it measured at least 2.40m wide and was 1.08m tall (Plate 4). In total, the chimney base was square and measured c. 2.40m across. It was constructed from red bricks bonded with a very light yellowish-grey mortar. Flue 105 (Plate 5) extended eastwards from the centre of the chimney, then to the north. It was constructed with a mixture of standard red brick and light yellow refractory bricks bonded with light grey mortar. The bricks were heavily sooted, suggesting it drew smoke from the east and/or north. A square concrete surface (106) partially sealed flue 105. It may have either formed a covering for the flue or a floor surface which existed following the disuse of at least this part of the flue. It was constructed from a light grey concrete and measured at least 1.63m long and 1.43m wide.

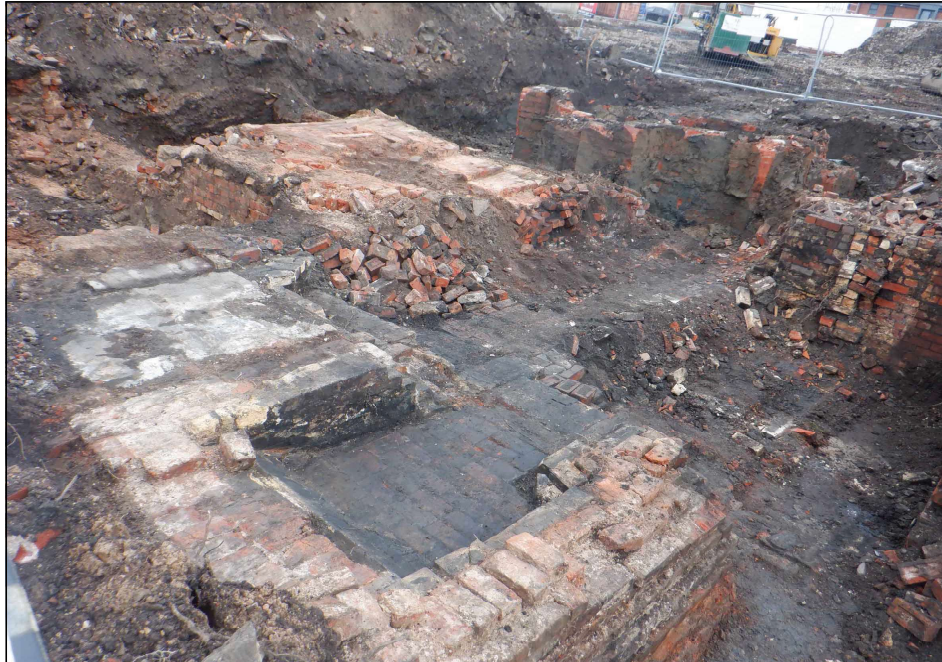
Trench 1 (Plates 1 and 2) measured 154m<sup>2</sup> in total. Overburden was machine excavated down to the uppermost archaeological horizon. The upper surfaces of the surviving structures were then hand cleaned. It rapidly became apparent that the lower deposits in the trench were widely contaminated with liquid elemental mercury, hydrocarbons and suspected asbestos containing materials. It was not possible to safely enter the excavation to further define the structures. It was also important not to spread any contaminants to the surrounding land and air and to avoid negative health effects for ASWYAS staff, local residents and other contractors on site by any further exposure. As such, the following represents a description the exposed structures based on the limited observations it was possible to carry out safely. Fortunately, the majority of the remains correlate with structures depicted on historic mapping which provides invaluable evidence on the date and, in some cases, the purpose of the structures.

*Plate 1. Trench 1, general photo, looking north-east*

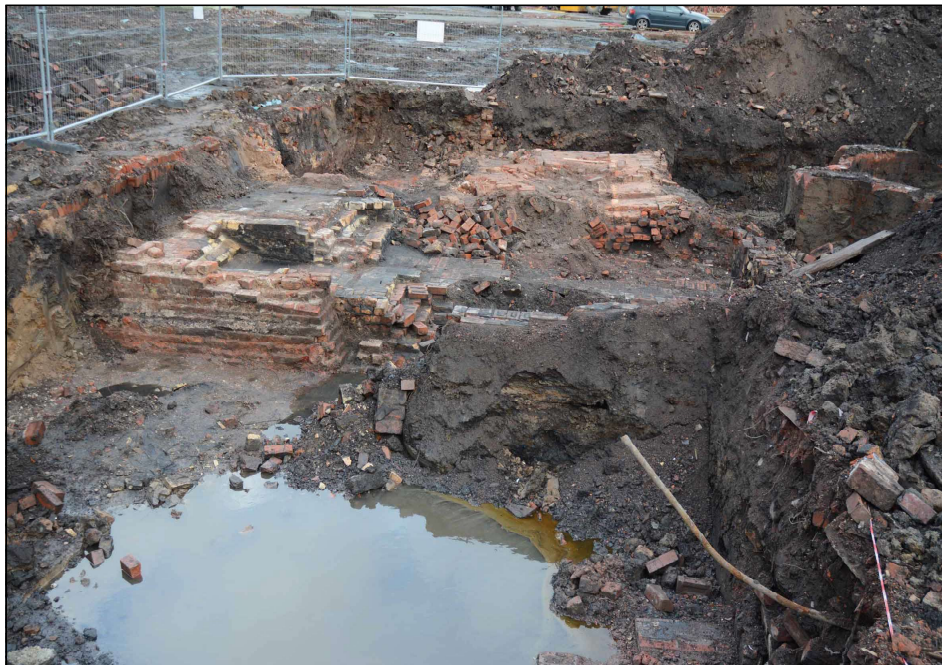
*Plate 2. Trench 1, general photo, looking north*

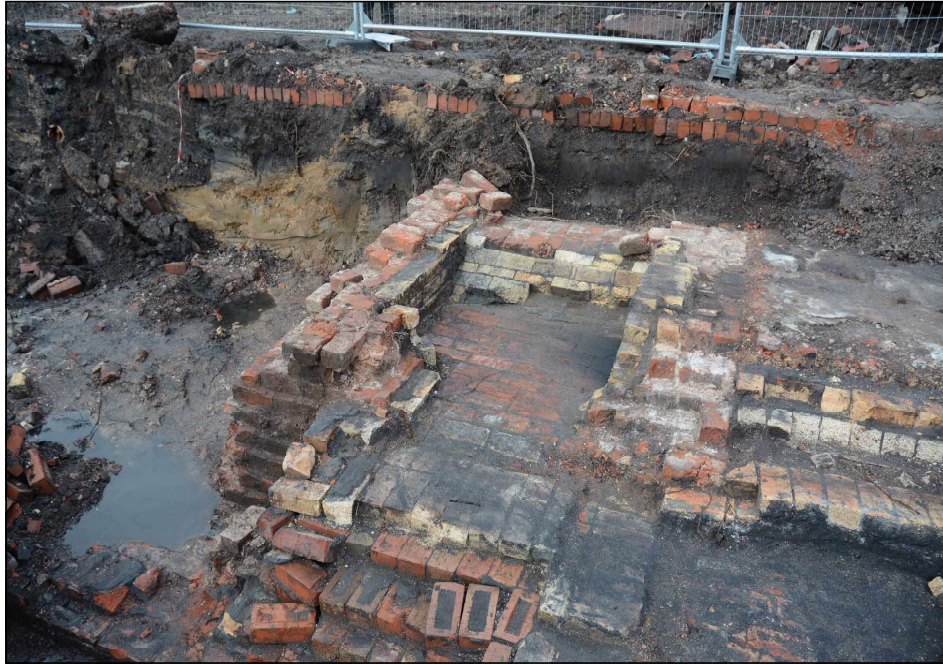
*Plate 3. Trench 1, chimney 104, looking west*

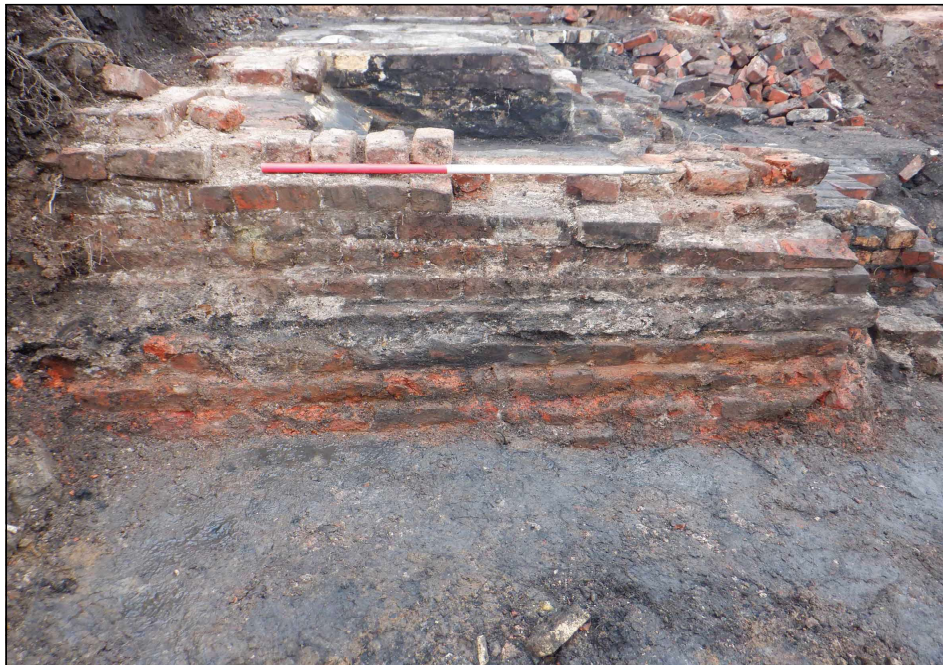
*Plate 4. Trench 1, chimney 104, looking north*

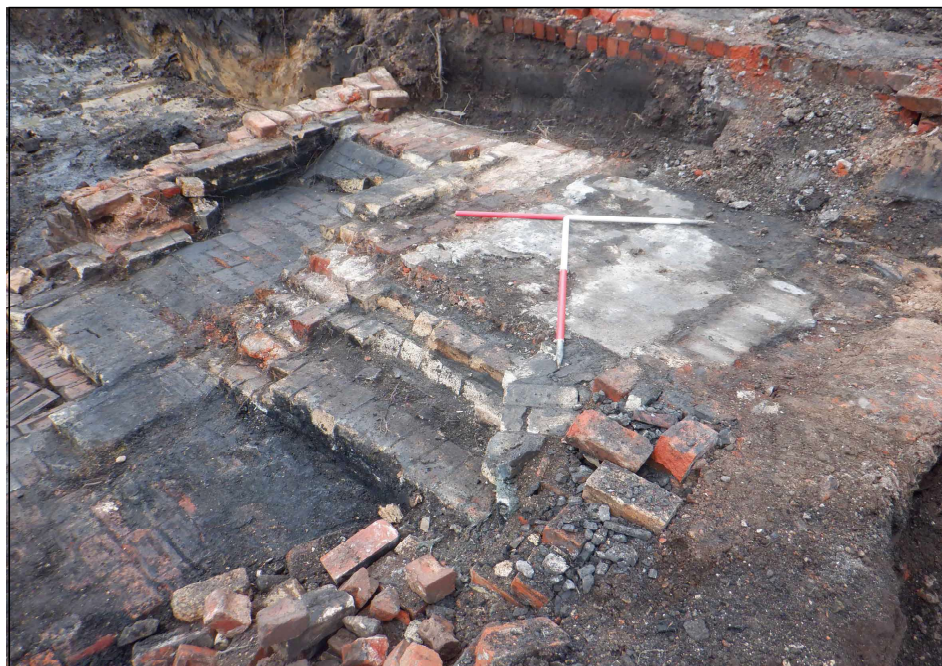
*Plate 5. Trench 1, chimney 104, flue 105 and surface 106, looking south-west*

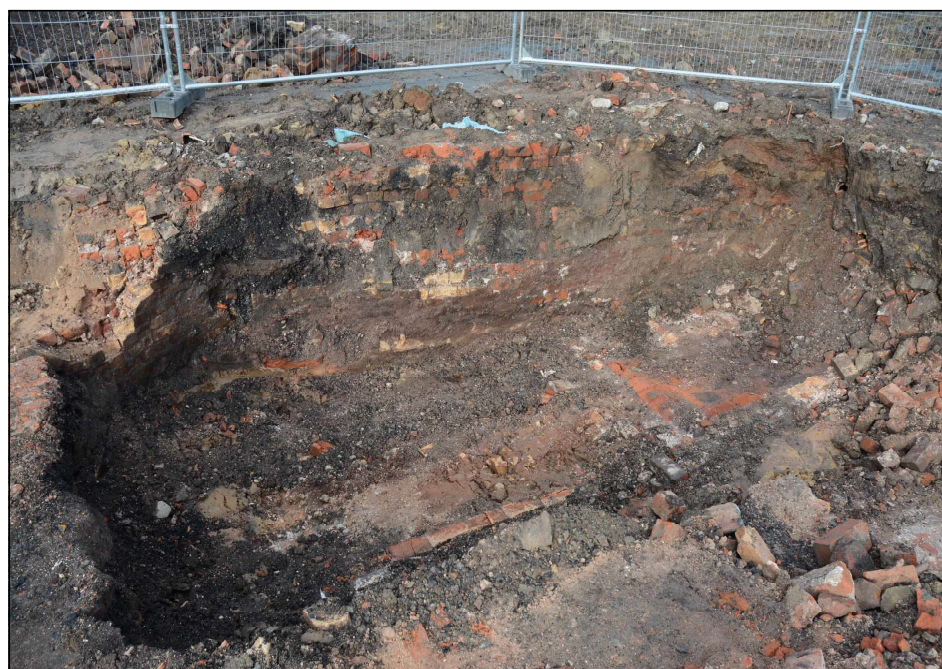
The north-western corner of the trench contained structures that were not fully characterised (Plate 6), but clearly form a cellar of some kind, bounded by a set of brick walls (107, 116) and containing a brick surface (117), many of which were heavily truncated, likely during

later demolition. Wall 106 was bonded by a dark grey mortar and exposed along the western edge of the trench for a length of 3.50m, turning south-eastwards for 1.30m, and then eastwards along the northern edge of surface 106. A trace of the eastern end of the cellar (116) was likely marked by another brick wall, abutted by a trace of a brick surface (117), with a cut into natural clays visible on its eastern side. Given the proximity to the chimney and direction of the flue, these remains likely represent a boiler house. The concentration of suspected asbestos containing materials in demolition deposits here adds weight to this interpretation. By 1929 (see Fig. 5), this building no longer existed.

*Plate 6. Trench 1, structure 107, looking west*

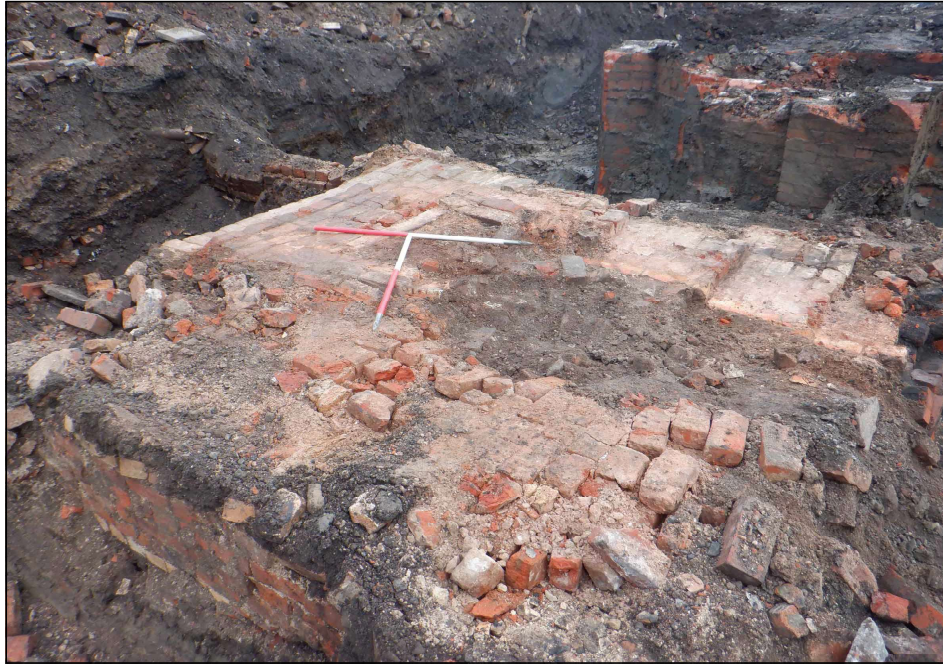
By 1910 (Fig. 4) a further structure of similar proportions had been constructed immediately adjacent to the putative boiler house on its eastern side (111, Plate 7). In total, this surface measured 3.59m long and 3.10m wide. It was heavily truncated but best preserved on its eastern edge where the surface had three clear steps, descending to the south. It was constructed of both un-frogged and frogged bricks (L: 230.00 mm, W: 120.00 mm, H: 80.00 mm) bonded with a friable light pink mortar. By 1929 (see Fig. 5), this building no longer existed.

*Plate 7. Trench 1, surface 111, looking north-east*

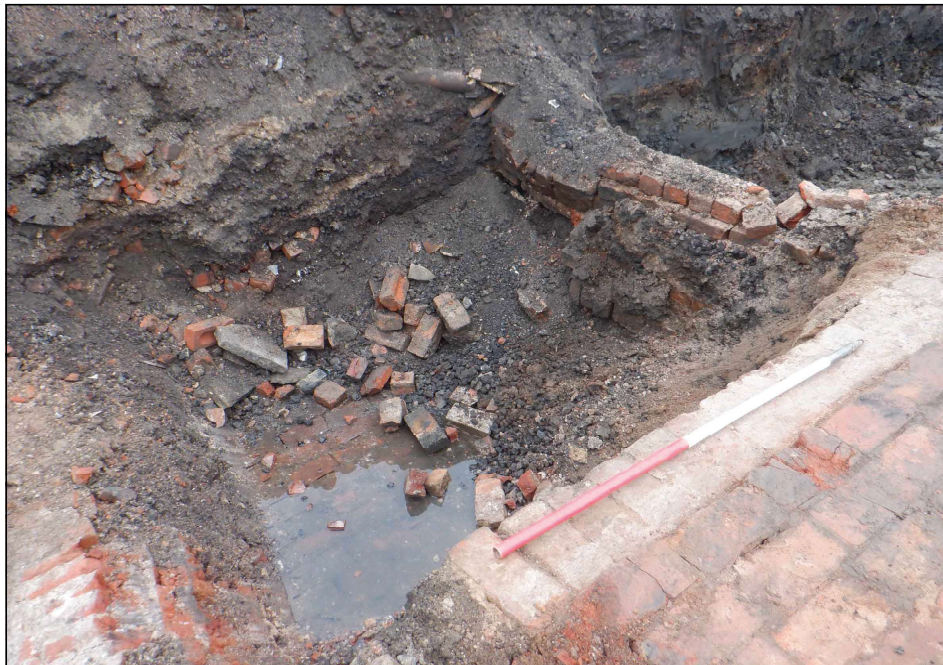
To the north of surface 111, a series of likely related structures (Plate 8) were recorded none of which are depicted on historic mapping suggesting they were remains associated with a structure after the site was surveyed by the Ordnance Survey in 1910. Wall 114 extended northwards from the north-east corner of surface 111 and beyond the edge of the trench. It was constructed from bright orangey-red bricks bonded with mid-whitish-grey mortar, laid in header bond. It measured 0.41m wide and 0.55m tall. Wall 112 extended northwards from close to the north-west corner of surface 111, separated by a gap of c. 0.35m. It was constructed from red bricks bonded with a mid-whitish grey mortar, laid in stretcher bond. It stepped out eastwards towards its base whilst its western side was vertical and it extended northwards beyond the trench. To its immediate east was a brick floor surface (113) constructed from bright orangey-red bricks.

*Plate 8. Trench 1, wall 112, surface 113 and wall 114, looking north-east*

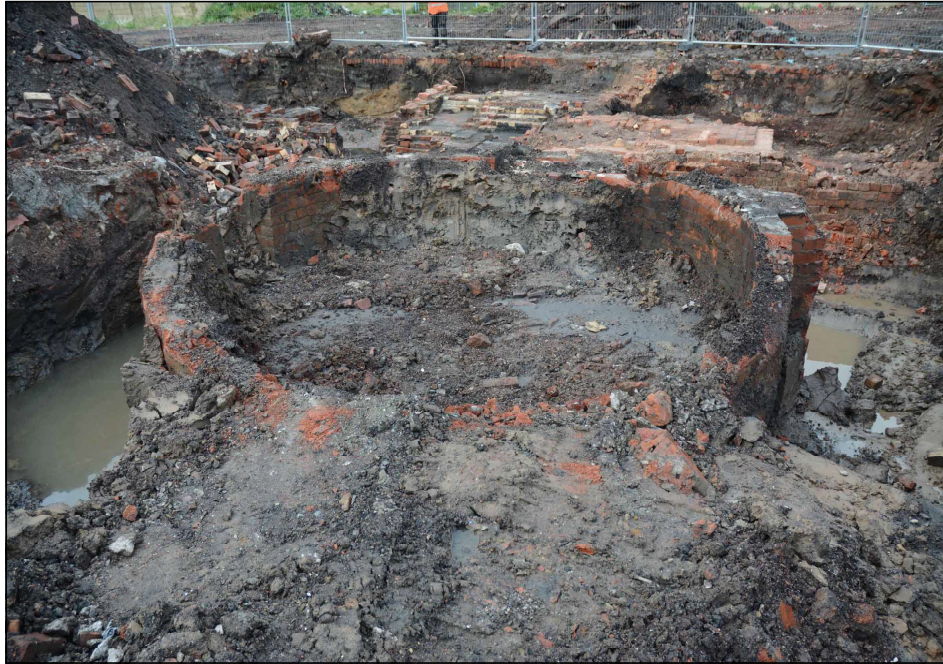
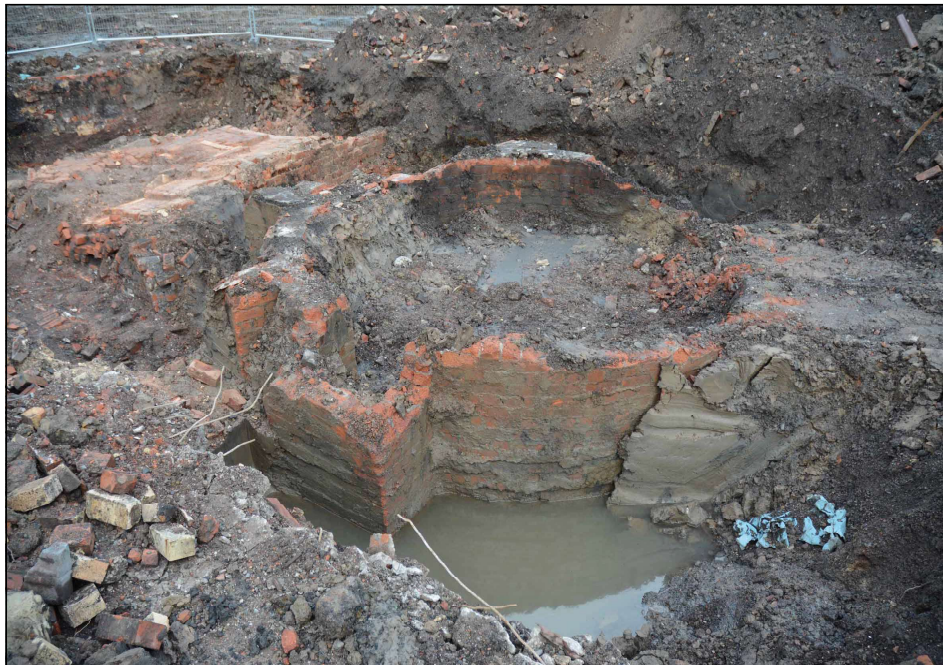
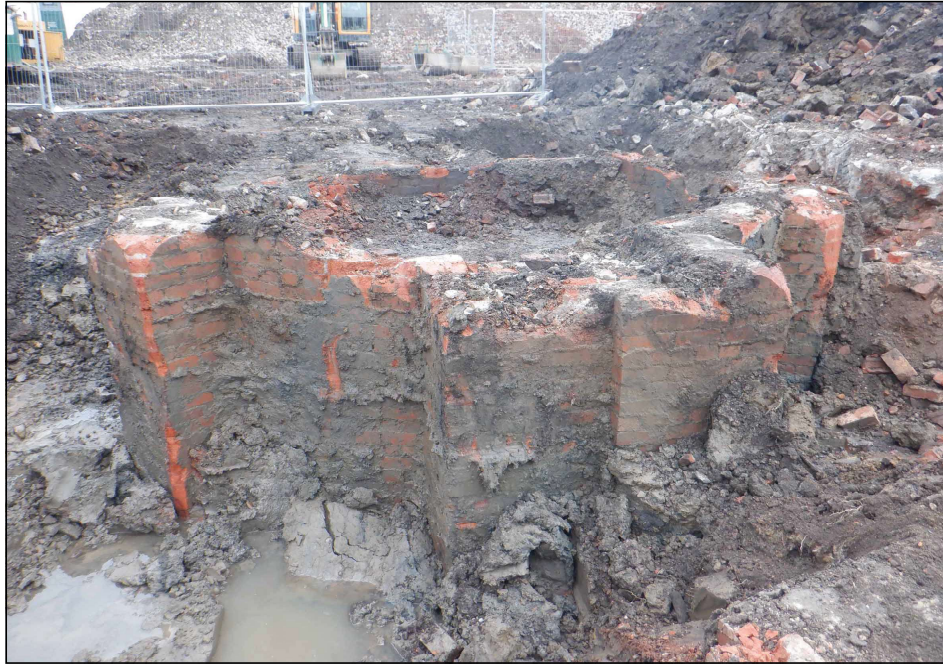
Historic mapping illustrates that the gasometer (115) was added by 1929 (Fig. 5; Plates 9-11). The gasometer was circular in plan, 4.05m across, and was exposed during the excavation to a depth of at least 2.25m. It was formed by a brick wall, 0.50m wide, constructed with frogged red bricks (L: 230.00 mm, W: 120.00 mm, H: 70.00 mm) bonded with a light grey mortar. The circuit of the wall was broken by two brick niches, which stepped outwards from the centre. One lay to the west and one to the south. These represent the likely location of the gas inlet and outlet pipes. A pair of large cast iron pipes were removed from the overlying demolition material, thought most likely to represent one or both of the gas inlet or outlets (Plate 12). Neither pipe was *in-situ* when encountered. Two external brick buttresses lay on the exterior side of the gasometer, one facing north-west and one south-west. By 1973 (see Fig. 6), this building no longer existed.

*Plate 9. Trench 1, gasometer 115, looking west*

*Plate 10. Trench 1, gasometer 115, looking north-west*

*Plate 11. Trench 1, gasometer 115, looking east*

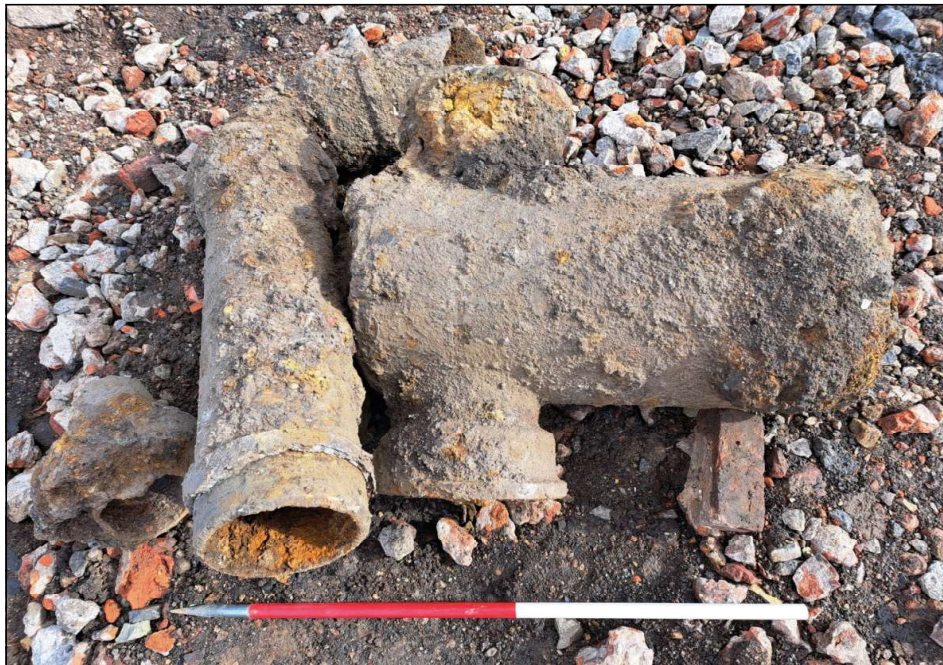
*Plate 12. Trench 1, cast iron gas pipes associated with gasometer 115*

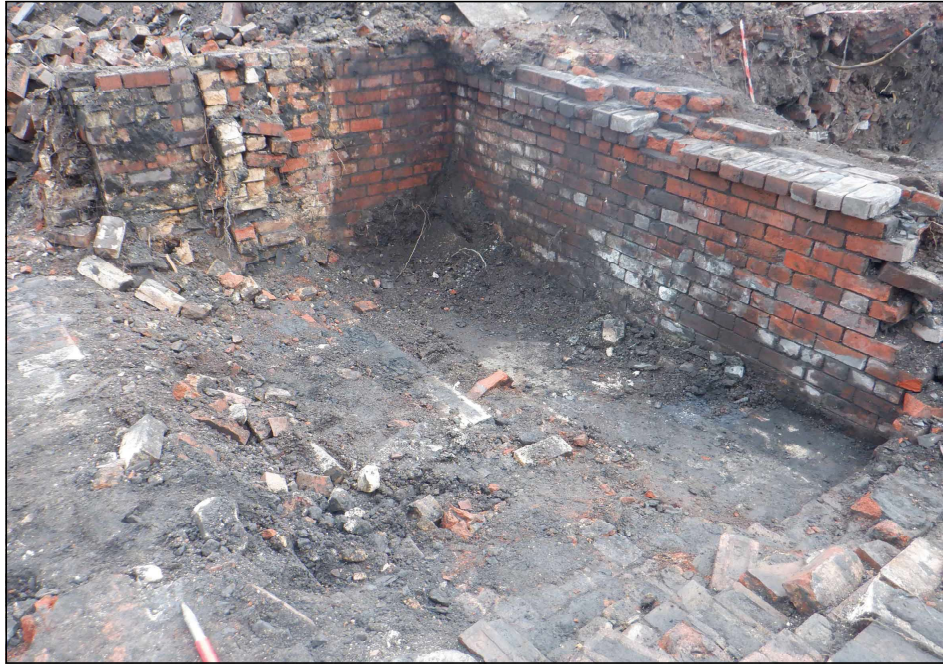
Further structures depicted on later historic mapping from 1929 to 1973 (Figs 5 and 6) correlate to some degree with other remains encountered in the trench. Surface 108 was only

exposed over a small 1.50m long and 0.83m wide area and was constructed in red bricks (L: 230.00 mm, W: 120.00 mm, H: 70.00 mm). Whitish material facing the bricks may be an asbestos containing material or lime deposits, indicating a sub-surface structure such as a flue was more likely than a floor. By 1973 (see Fig. 6), no buildings in this location existed. To the south of surface 108, wall 110 (Plate 13) formed a rectangular area measuring 3.68m long and 1.75m wide, constructed with red frogged bricks bonded with dark grey mortar laid in common bond. Wall 110 bounded surface 109 and may form part of a cellar or flue. This was constructed in a light grey cement. Demolition deposits here contained high concentrations of elemental mercury forming beads throughout the overlying demolition deposits. This building may either relate to structures depicted on 1929 (Fig. 5) mapping to the east of the chimney or structures to the south of the chimney depicted on 1973 mapping (Fig. 6), though neither fully correlate with the form of the excavated remains.

*Plate 13. Trench 1, surface 108 and wall 110, looking south-east*

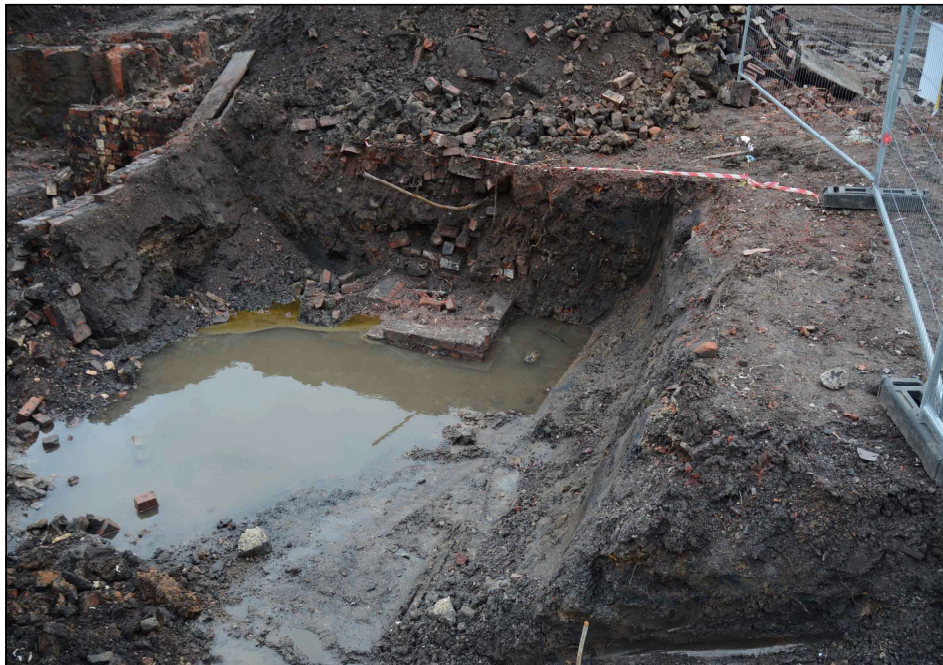
No archaeological features were found in the southern part of the trench, south of wall 110 (Plate 14) aside from drain 103. This measured 1m wide and at least 0.86 long and formed the truncated base of a drain or manhole. It was constructed with two courses red frogged bricks, bonded with a very light grey mortar.

*Plate 14. Trench 1, drain 103, looking east*

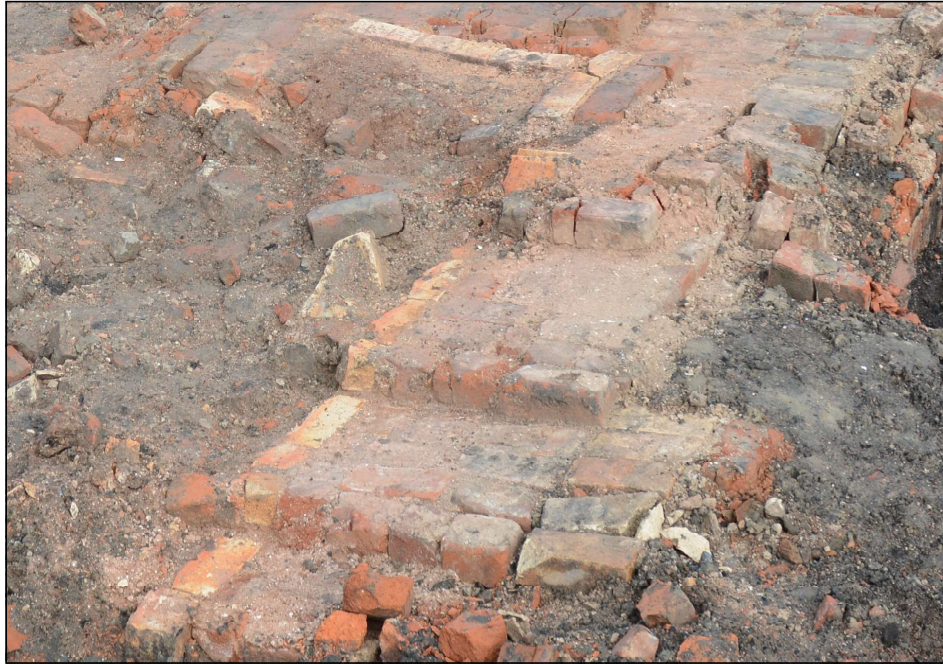
Demolition deposits (101) sealed the archaeological features in the trench. They largely comprised contaminated ash with brick, concrete and mortar rubble. One pipe boiler or support brick was noted in material overlying surface (111, Plate 15). This was not retained due to contamination potential but may indicate either a boiler or pipes carrying steam, water or gas.

*Plate 15. Trench 1, ceramic pipe or boiler support in demolition deposits looking north*

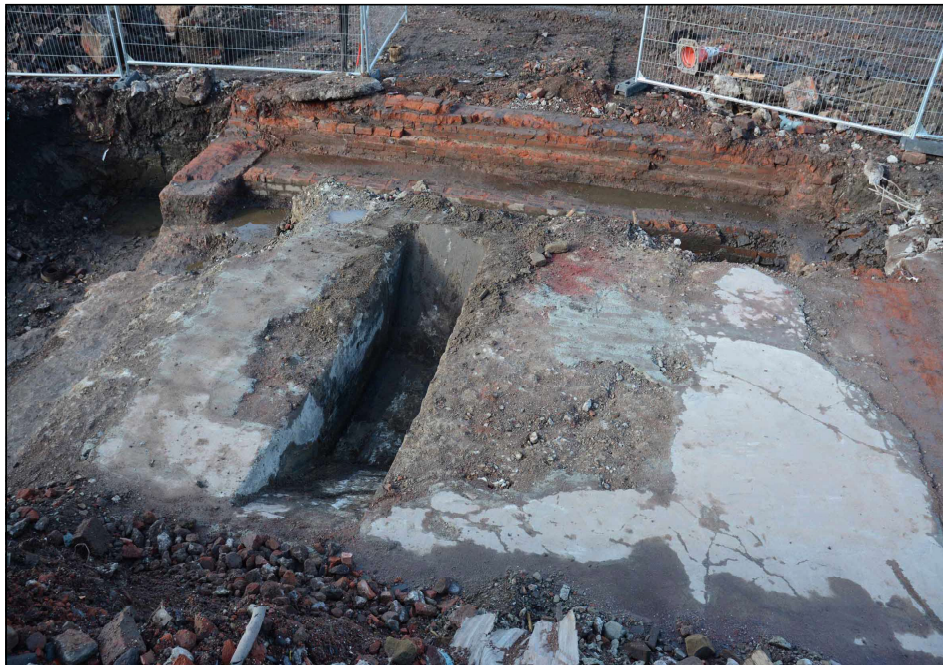
Trench 2 (Plate 16) measured 80m<sup>2</sup> in total. In contrast to Trench 1, no contaminants were found and the structures were hand cleaned and recorded sufficiently to fully characterise the remains and their stratigraphic relationships.

*Plate 16. Trench 2, general photo, looking south*

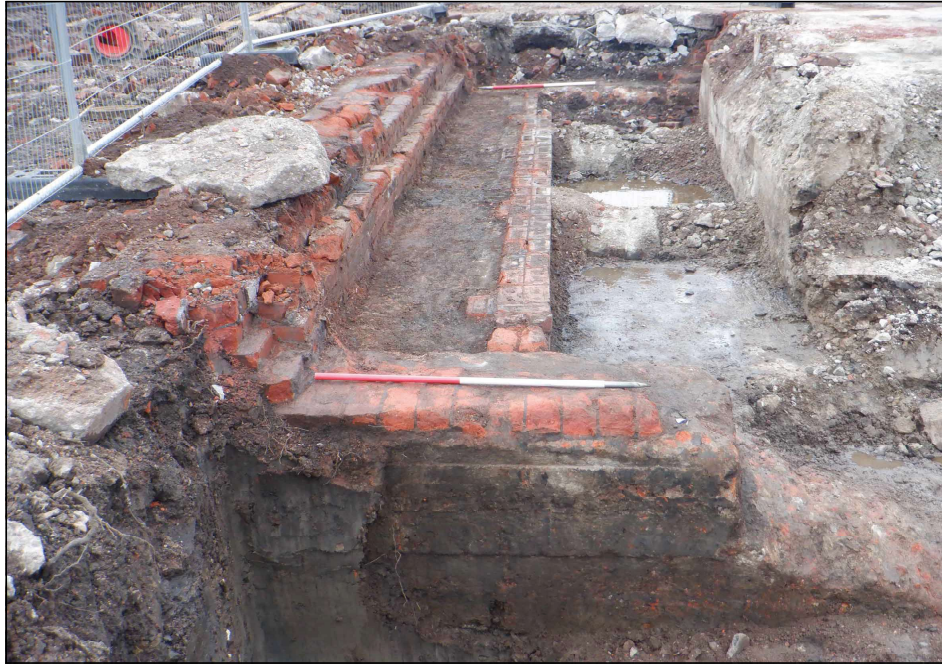
The earliest structures in the trench comprised two east-west oriented walls crossing the centre and northern edge of the trench (Plate 17). The central wall survived as footing (209) constructed with light grey concrete with crushed brick aggregate (*c.* 70mm). The footing measured 0.6m wide and 0.8m deep. The footing was overlain with a brick wall (207/208), up to nine courses in height. Both walls were constructed in red bricks (L: 0.23 mm, W: 0.11-0.12 mm, H: 0.08 mm) bonded with a dark greyish-brown mortar. Wall 207 was laid in header courses whilst wall 208 (Plate 18) was laid in common bond dark grey mortar.

*Plate 17. Trench 2, walls 203, 207, 208, 209 and 213, looking north*

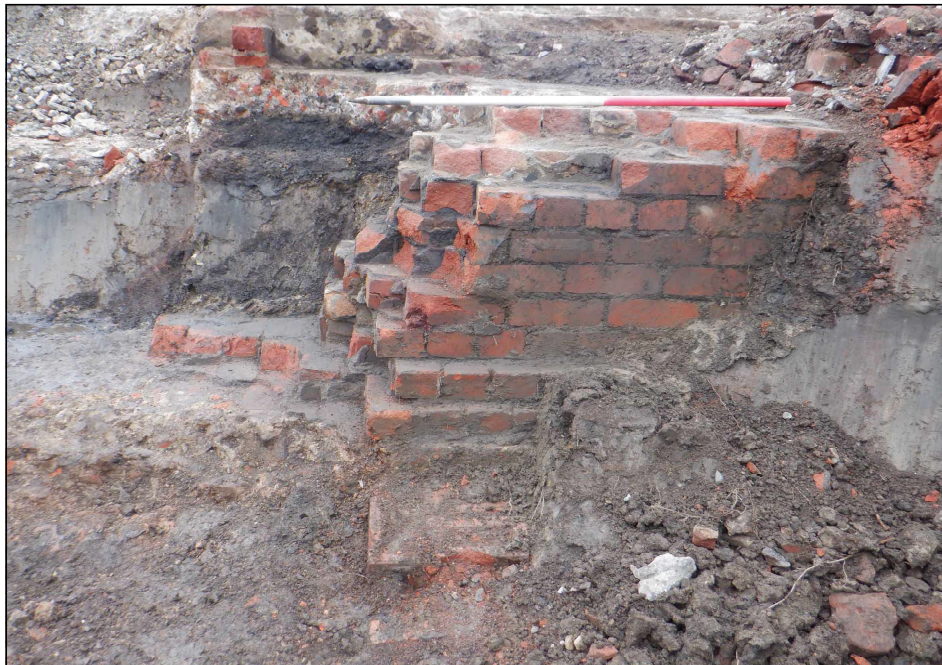
*Plate 18. Trench 2, wall 208, looking north*

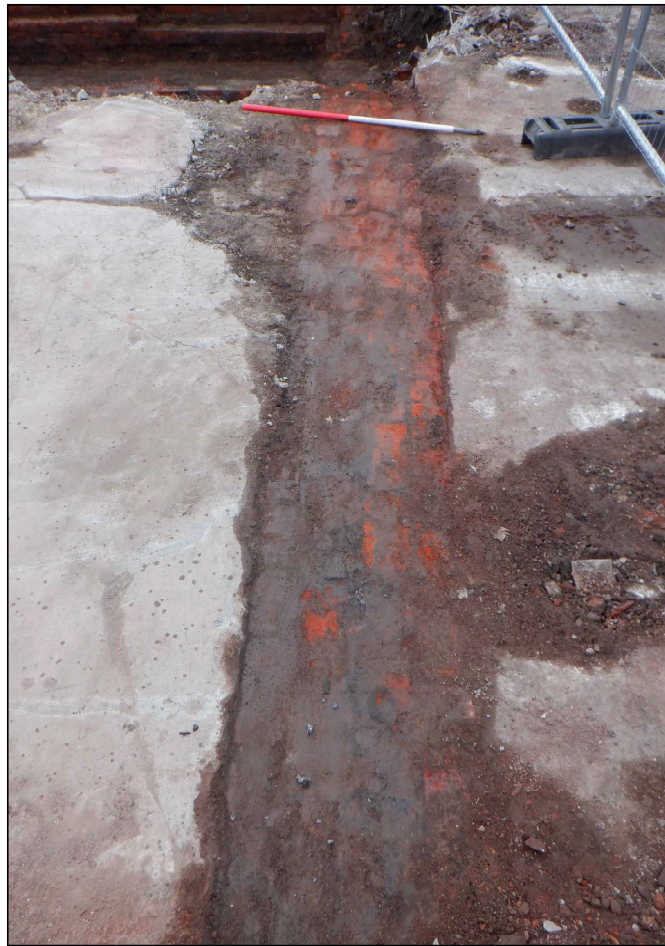
At the northern limit of the trench a concrete footing (213) was formed with a light grey concrete with crushed brick aggregate (*c.* 50mm). It measured *c.* 0.50m wide and at least 0.20m deep. This was overlain by brick wall 203 (Plate 19), constructed with up to seven

courses of red frogged bricks (L: 240.00 mm, W: 130.00 mm, H: 70.00 mm) bonded with a dark grey mortar. Only stretcher bond was observed. The exposed section of the wall measured at least 0.5m wide and 1m in height.

*Plate 19. Trench 2, wall 203, looking west*

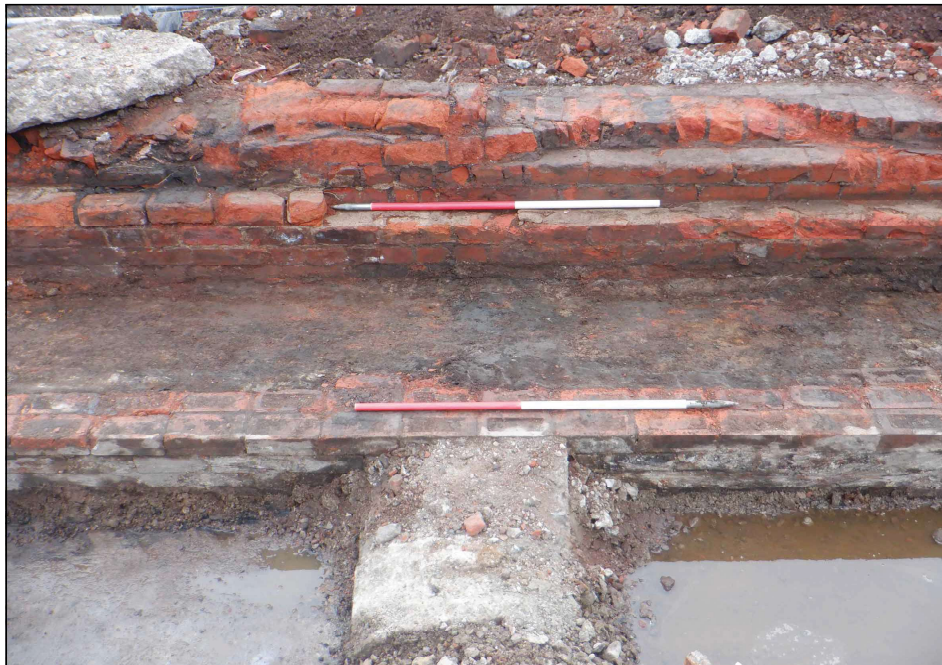
Contexts 212, 214 and 215 (Plate 20) abutted walls 207 and 213 and may represent several phases of construction. The stratigraphic relationships between these structural elements was unclear. Wall 212 was an irregularly coursed brick wall, found along the western edge of the trench. It was constructed with a mix of frogged and unfrogged red bricks (L: 110.00 mm, W: 230.00 mm, H: 80.00 mm), bonded with dark grey mortar. Wall 215 lay to its east and was constructed with frogged red bricks (L: 110.00 mm, W: 230.00 mm, H: 80.00 mm) and bonded with a dark grey mortar. It was laid in stretcher bond. The gap between the walls comprised a light grey concrete (214) which may represent a wall footing or a walkway.

Abutting wall 212 was a surface (206) and two rectangular plinths or buttresses (204 and 205, Plate 20). Each structural element was formed from a light yellowish-grey concrete with stone aggregate (c. 50mm). Plinths 204 and 205 measured approximately 0.6m long, 0.55m wide and 0.25m in height. Surface 206 may represent a walkway.

*Plate 20. Trench 2, wall 212 and 215 and wall/surface 214, looking west*

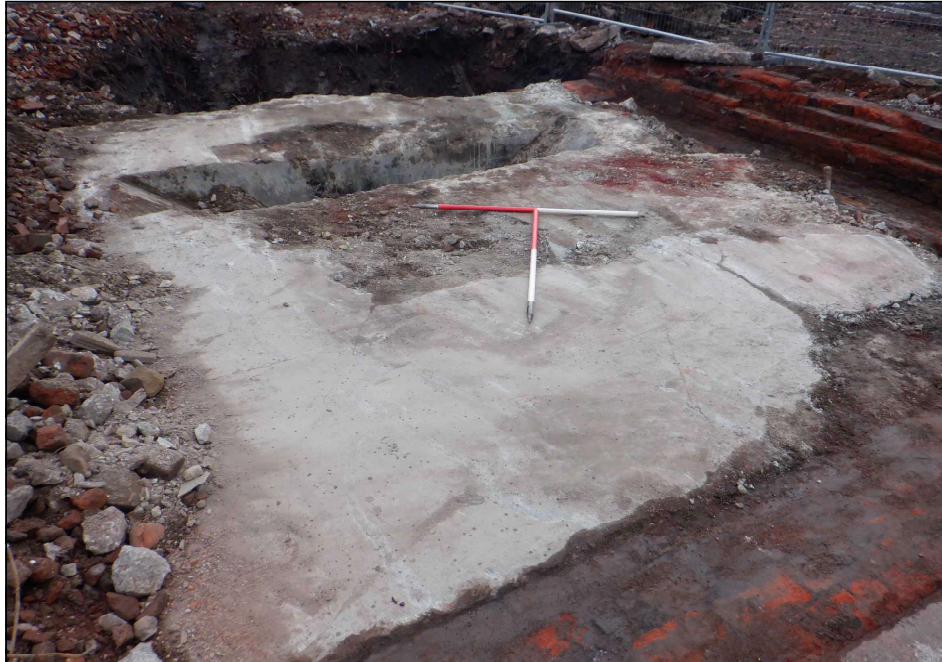
Abutting wall 203 and surface 206 was engine bed 202 (Plate 21), constructed in a light yellowish grey concrete with angular stone aggregate (up to 0.05m). The bulk of this structure was formed by a deep rectangular foundation extending eastwards beyond the edge of the trench, measuring 3.63m long, 4.5m wide and c. 1.1m deep. The northern edge of the engine bed was much shallower and, visible in the west-facing elevation, was seen to be constructed above a dark greyish-brown silty-clay levelling deposit (216). It was itself constructed above the natural geology. It was not visible at the surface. It is possible that this represents a later shallow surface abutting the large concrete engine bed but the concrete of the two surfaces appears continuous, albeit with cracks. Similarly the southern extent of the deposit is much shallower and forms an apparently contemporary low surface. In the centre of the engine bed, a trapezoid-shaped wheel pit was aligned west-south-west to east-north-east (Plate 22). It measured 3.04m long and 0.77m wide and was 0.70m deep. In profile, it sloped steeply down from each edge at an angle of c. 45° with a flat base.

*Plate 21. Trench 2, engine bed 202, looking south*

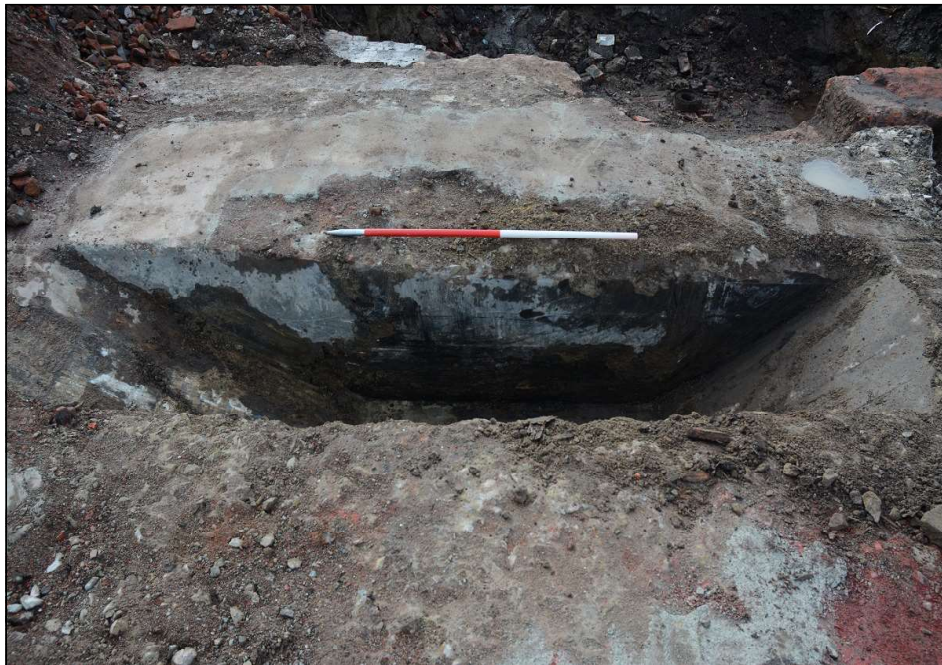
*Plate 22. Trench 2, wheel pit, looking south*
