**ARBORICULTURAL METHOD STATEMENT  
to BS 5837:2012  
at  
610 Bury Road  
Rochdale  
Lancashire  
OL11 4AU**

18189a/PH

22/00078/FUL

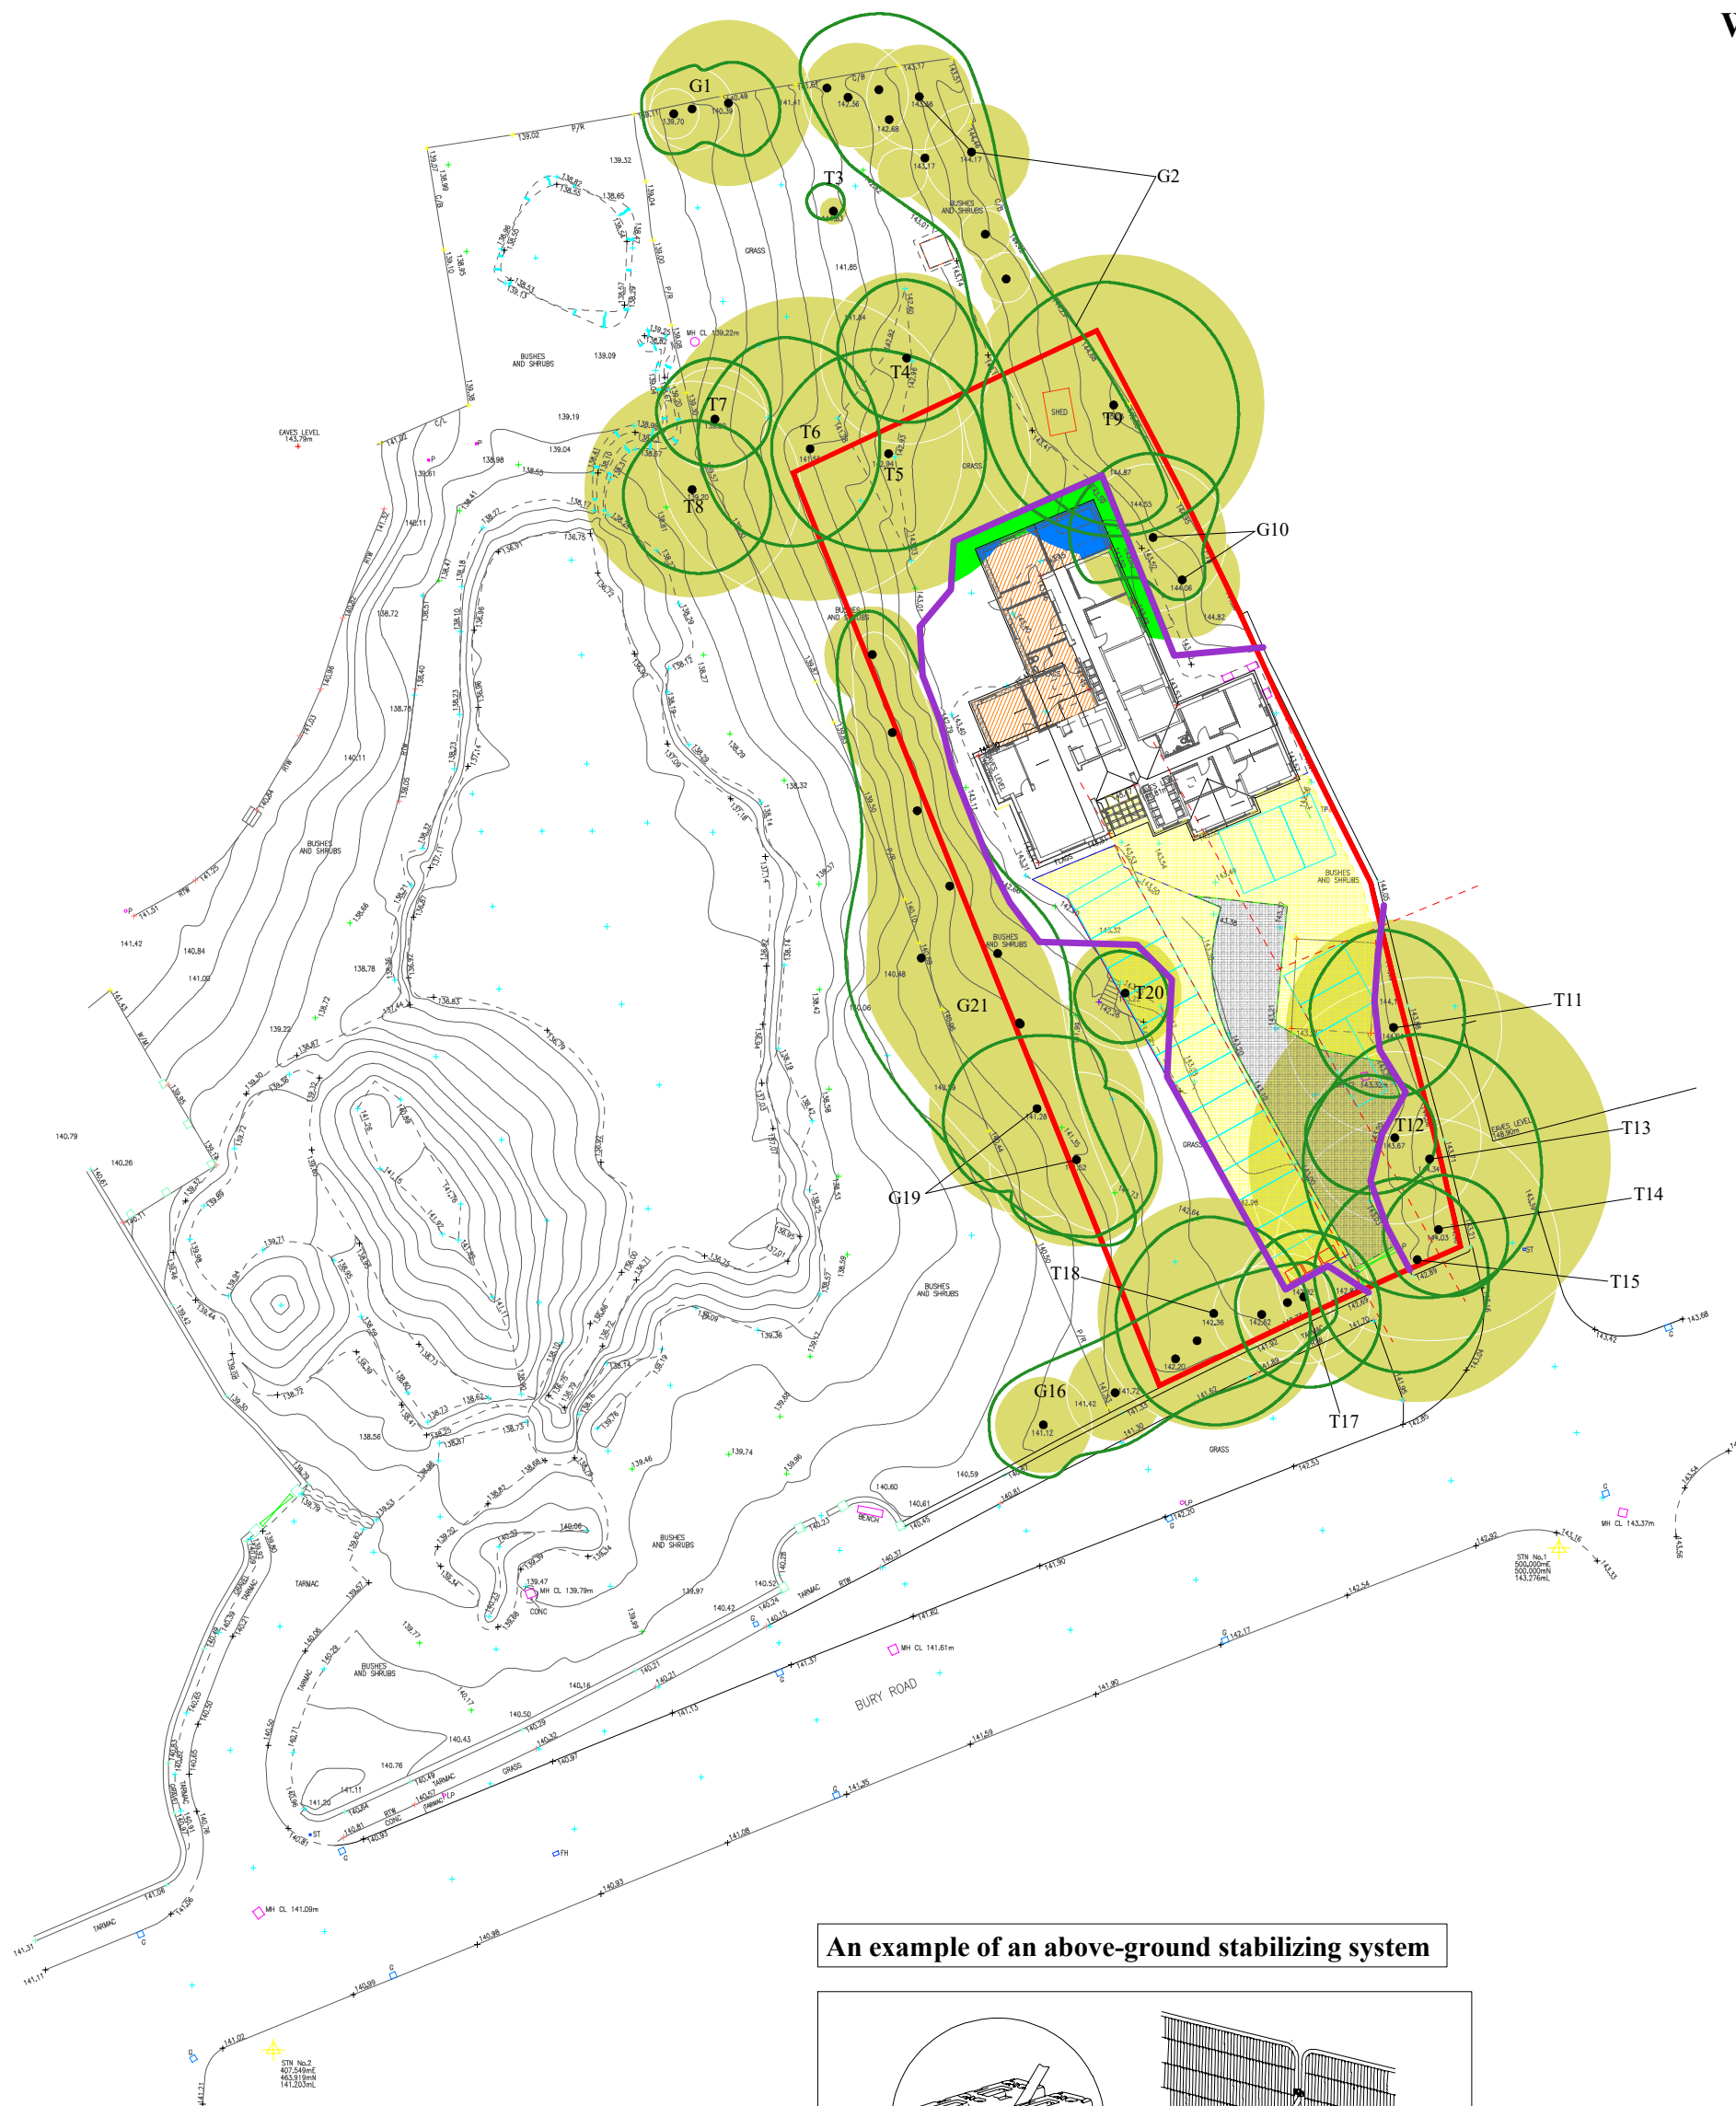
THIS PLAN IS TO BE PRINTED IN COLOUR  
AND READ IN CONJUNCTION WITH THE  
JCA AMS REPORT  
(JCA REF: 18189A/PH)

- 3.1.2 The protective fencing must be constructed in accordance with BS 5837: 2012 *Trees in relation to design, demolition and construction - Recommendations* and will be located as shown on the Tree Protection Plan at **Appendix 4**. Where possible, the protective barrier will enclose the entire Root Protection Area (RPA) of the trees to make a Construction Exclusion Zone (CEZ); **this area is to be considered a restricted area; no pedestrians, vehicles, equipment or machinery are allowed within the CEZ and the storage of materials is not permitted, unless specified within this Method Statement.**
