# Pile Design Contamination Risk Assessment

Site: Land at Greenbooth Road and Edenfield Road, Norden

Reference:16-465-R6

Date: January 2024

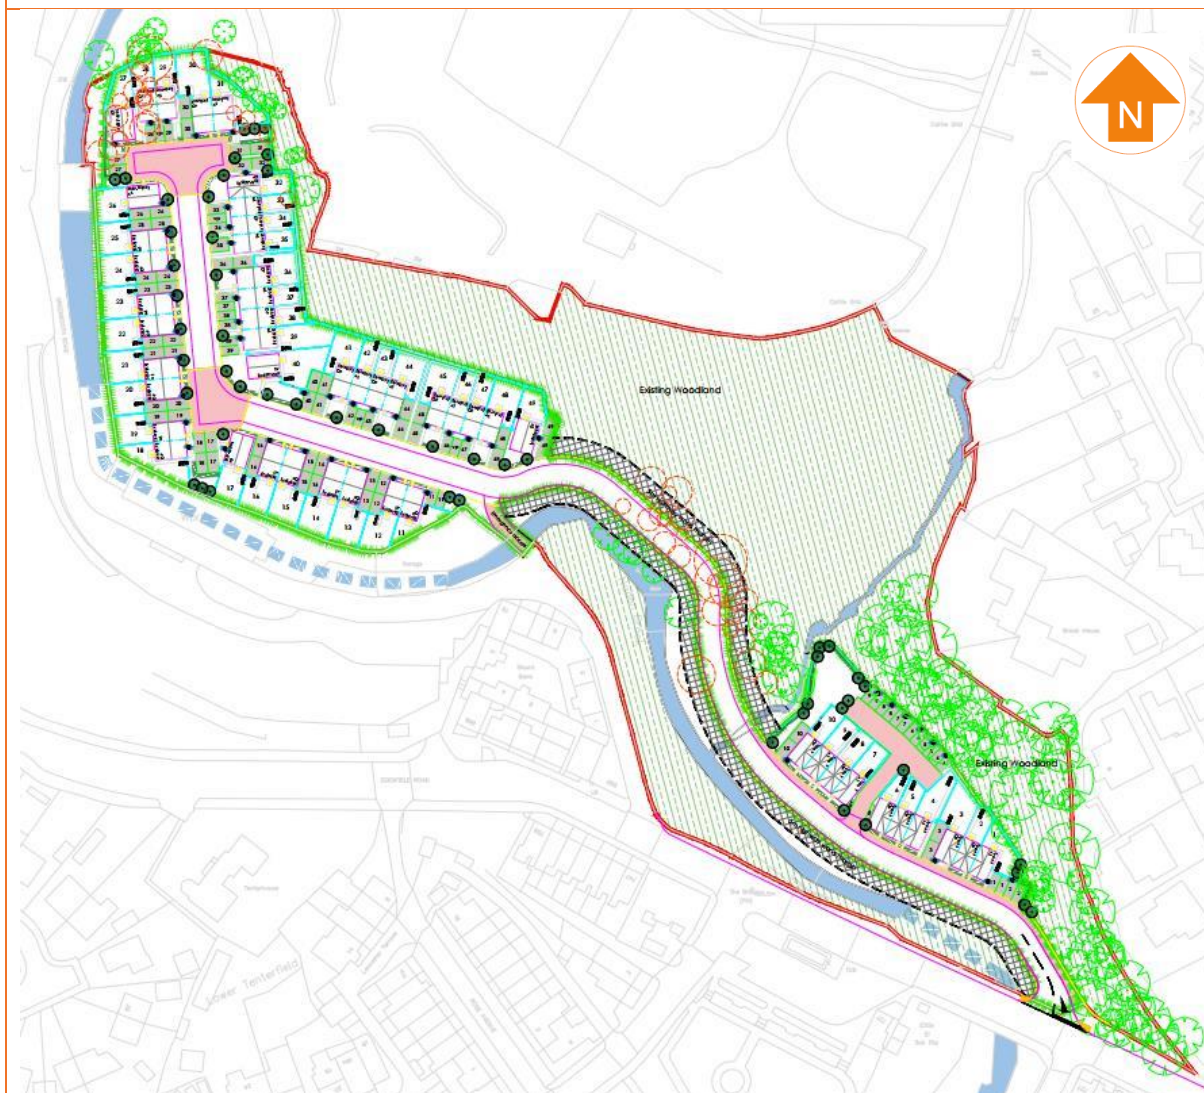
FIGURE 1.1 SNAPSHOT OF PROPOSED DEVELOPMENT

A snapshot of the proposed development layout is indicated in Figure 1.1 below, with the full drawing presented as Drawing 16-465-002 in Appendix III.

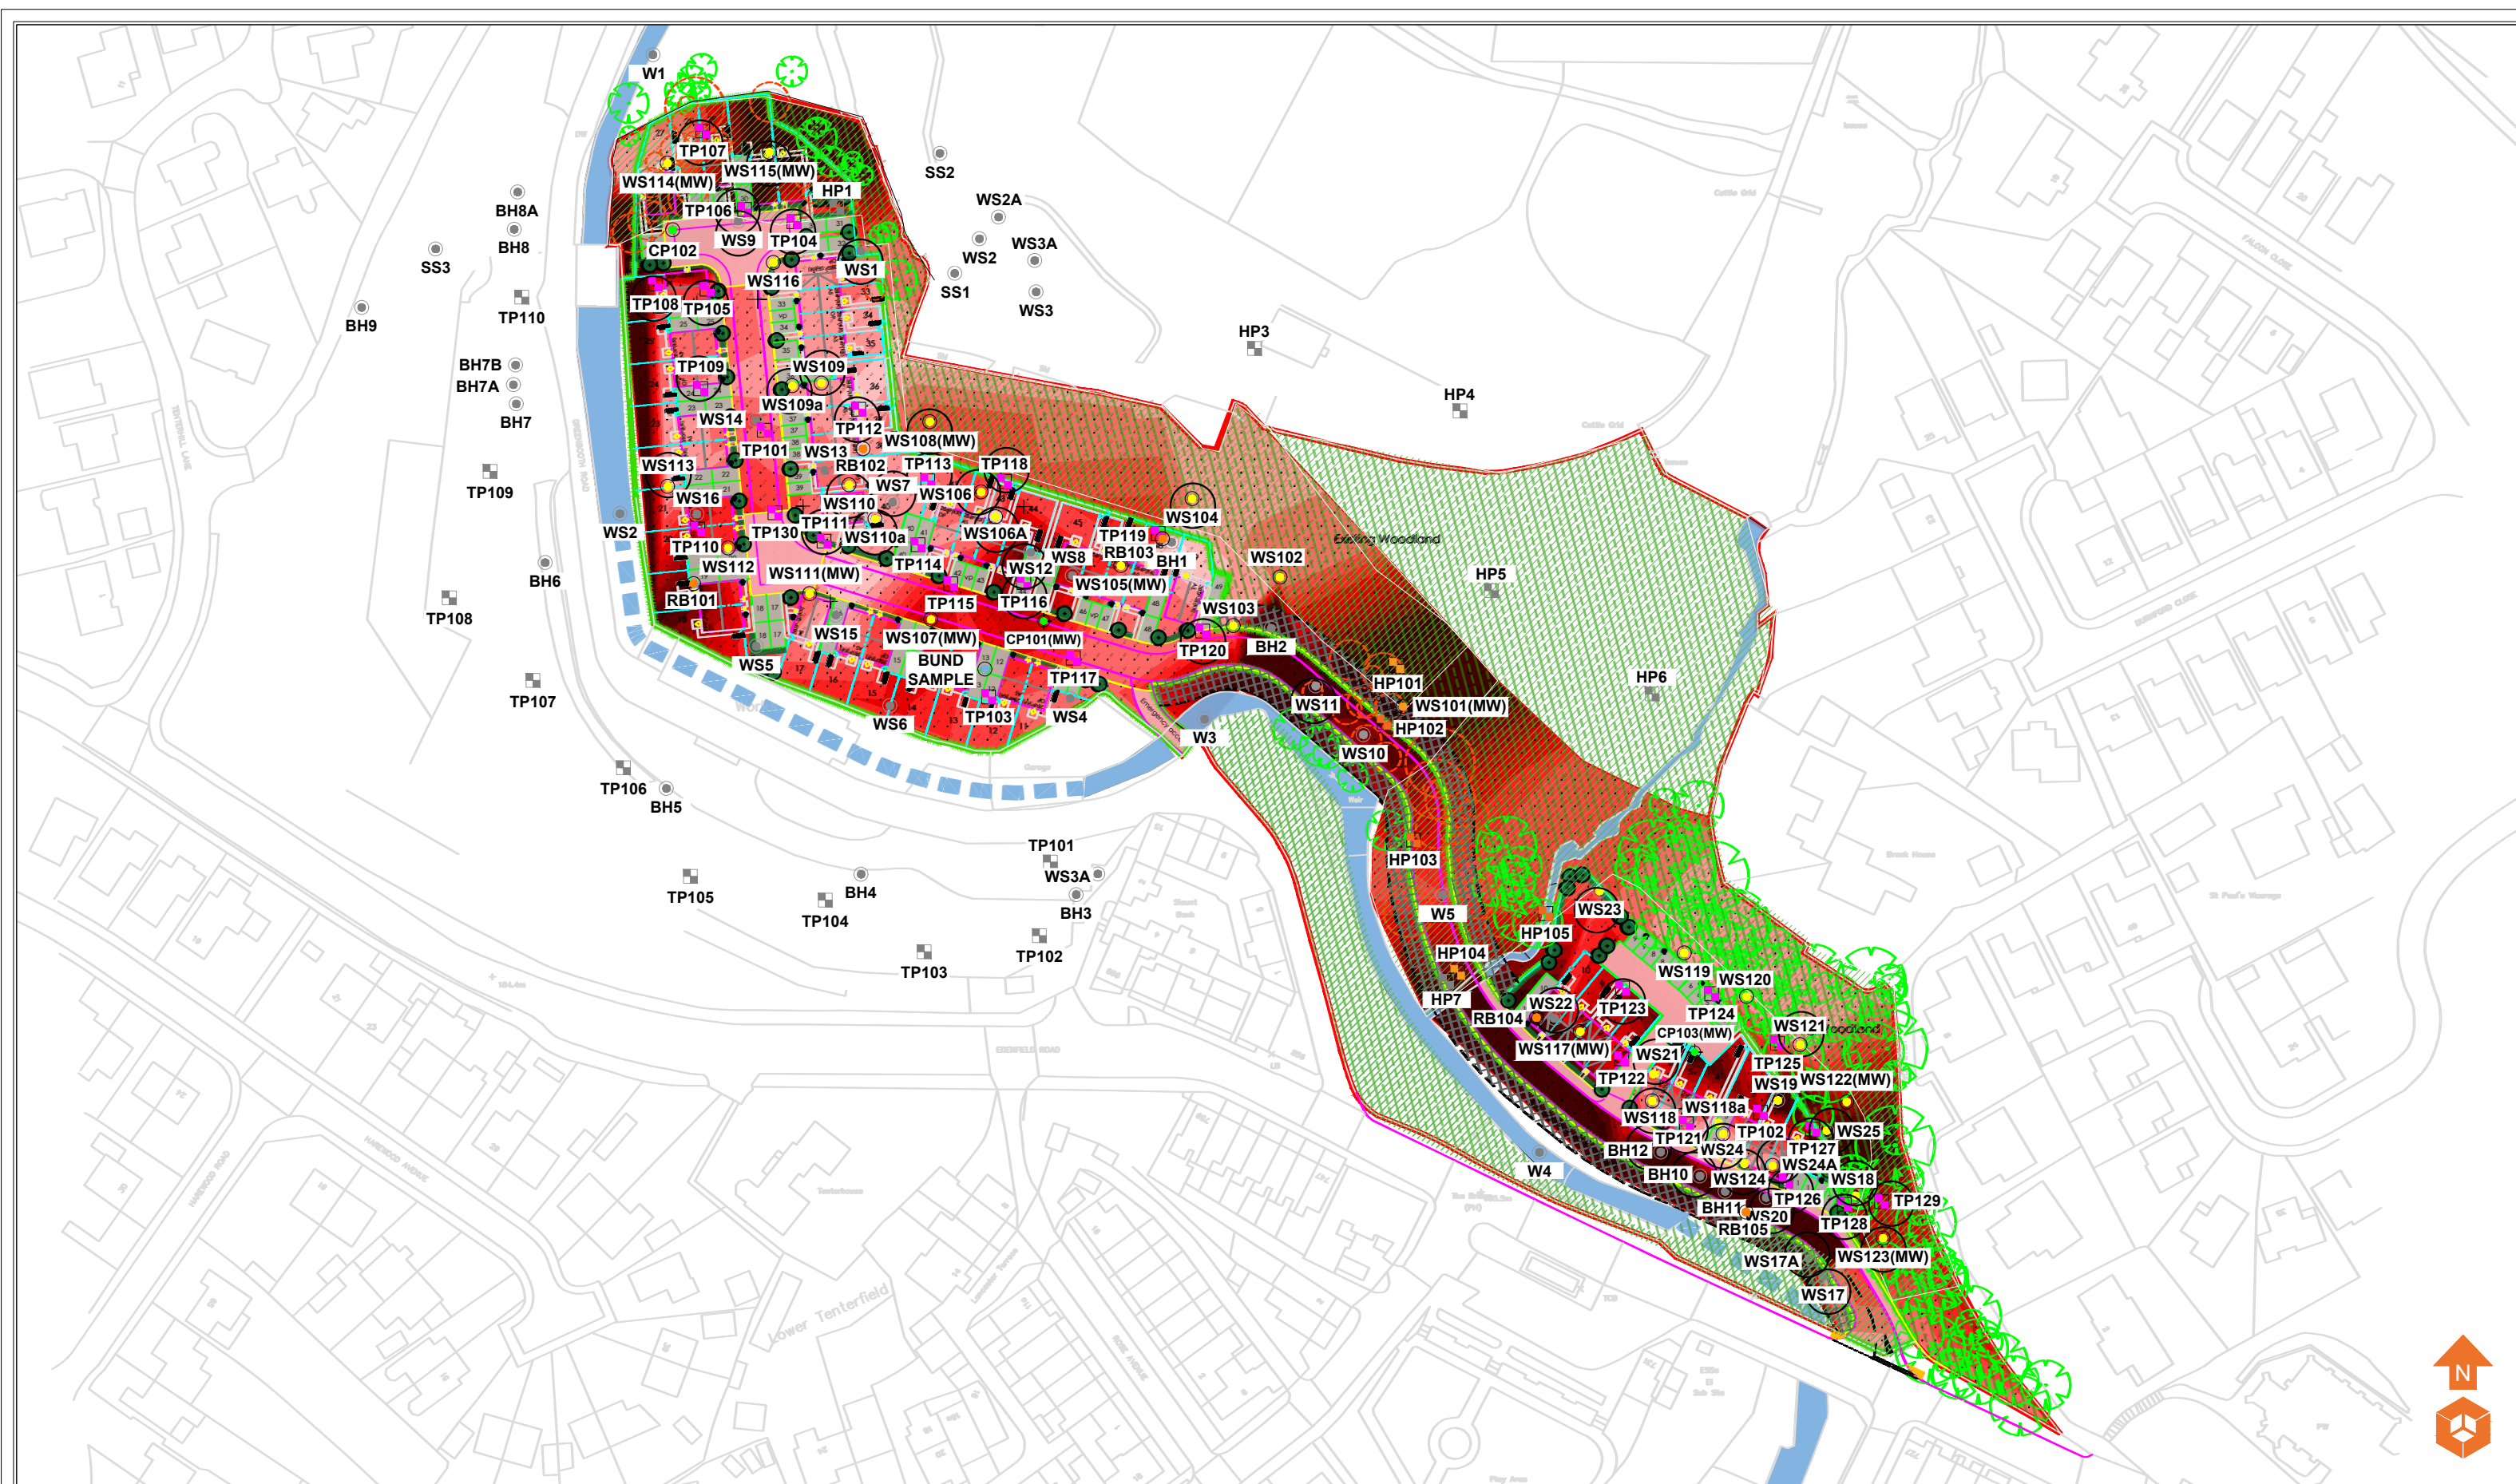
In the Tack Lea Works area, Made Ground deposits were generally encountered between 1.00 m and 2.00 m bgl, with shallower deposits (< 1.00 m bgl) located along the northern boundary (i.e. closer to the valley edge). Deeper Made Ground deposits, ranging between 2.00 m and 5.80 m bgl, were encountered in the northwest part of the site (associated with the infilled sandstone quarry), the central part of the site (associated with infilled reservoirs) and the eastern part of the site (associated with the filter tanks, reservoirs and historical landfill).

In the Sheppard Mill area, Made Ground deposits were generally encountered between 2.00 m and 5.10 m bgl, with shallower deposits (< 1.00 m bgl) located along the northern boundary (i.e. closer to the valley edge). The deepest Made Ground deposits were encountered along the southern boundary associated with the former buildings and infilled reservoirs.

The E3P Depth of Made Ground Plan is presented as Drawing 16-465-006 in Appendix III.

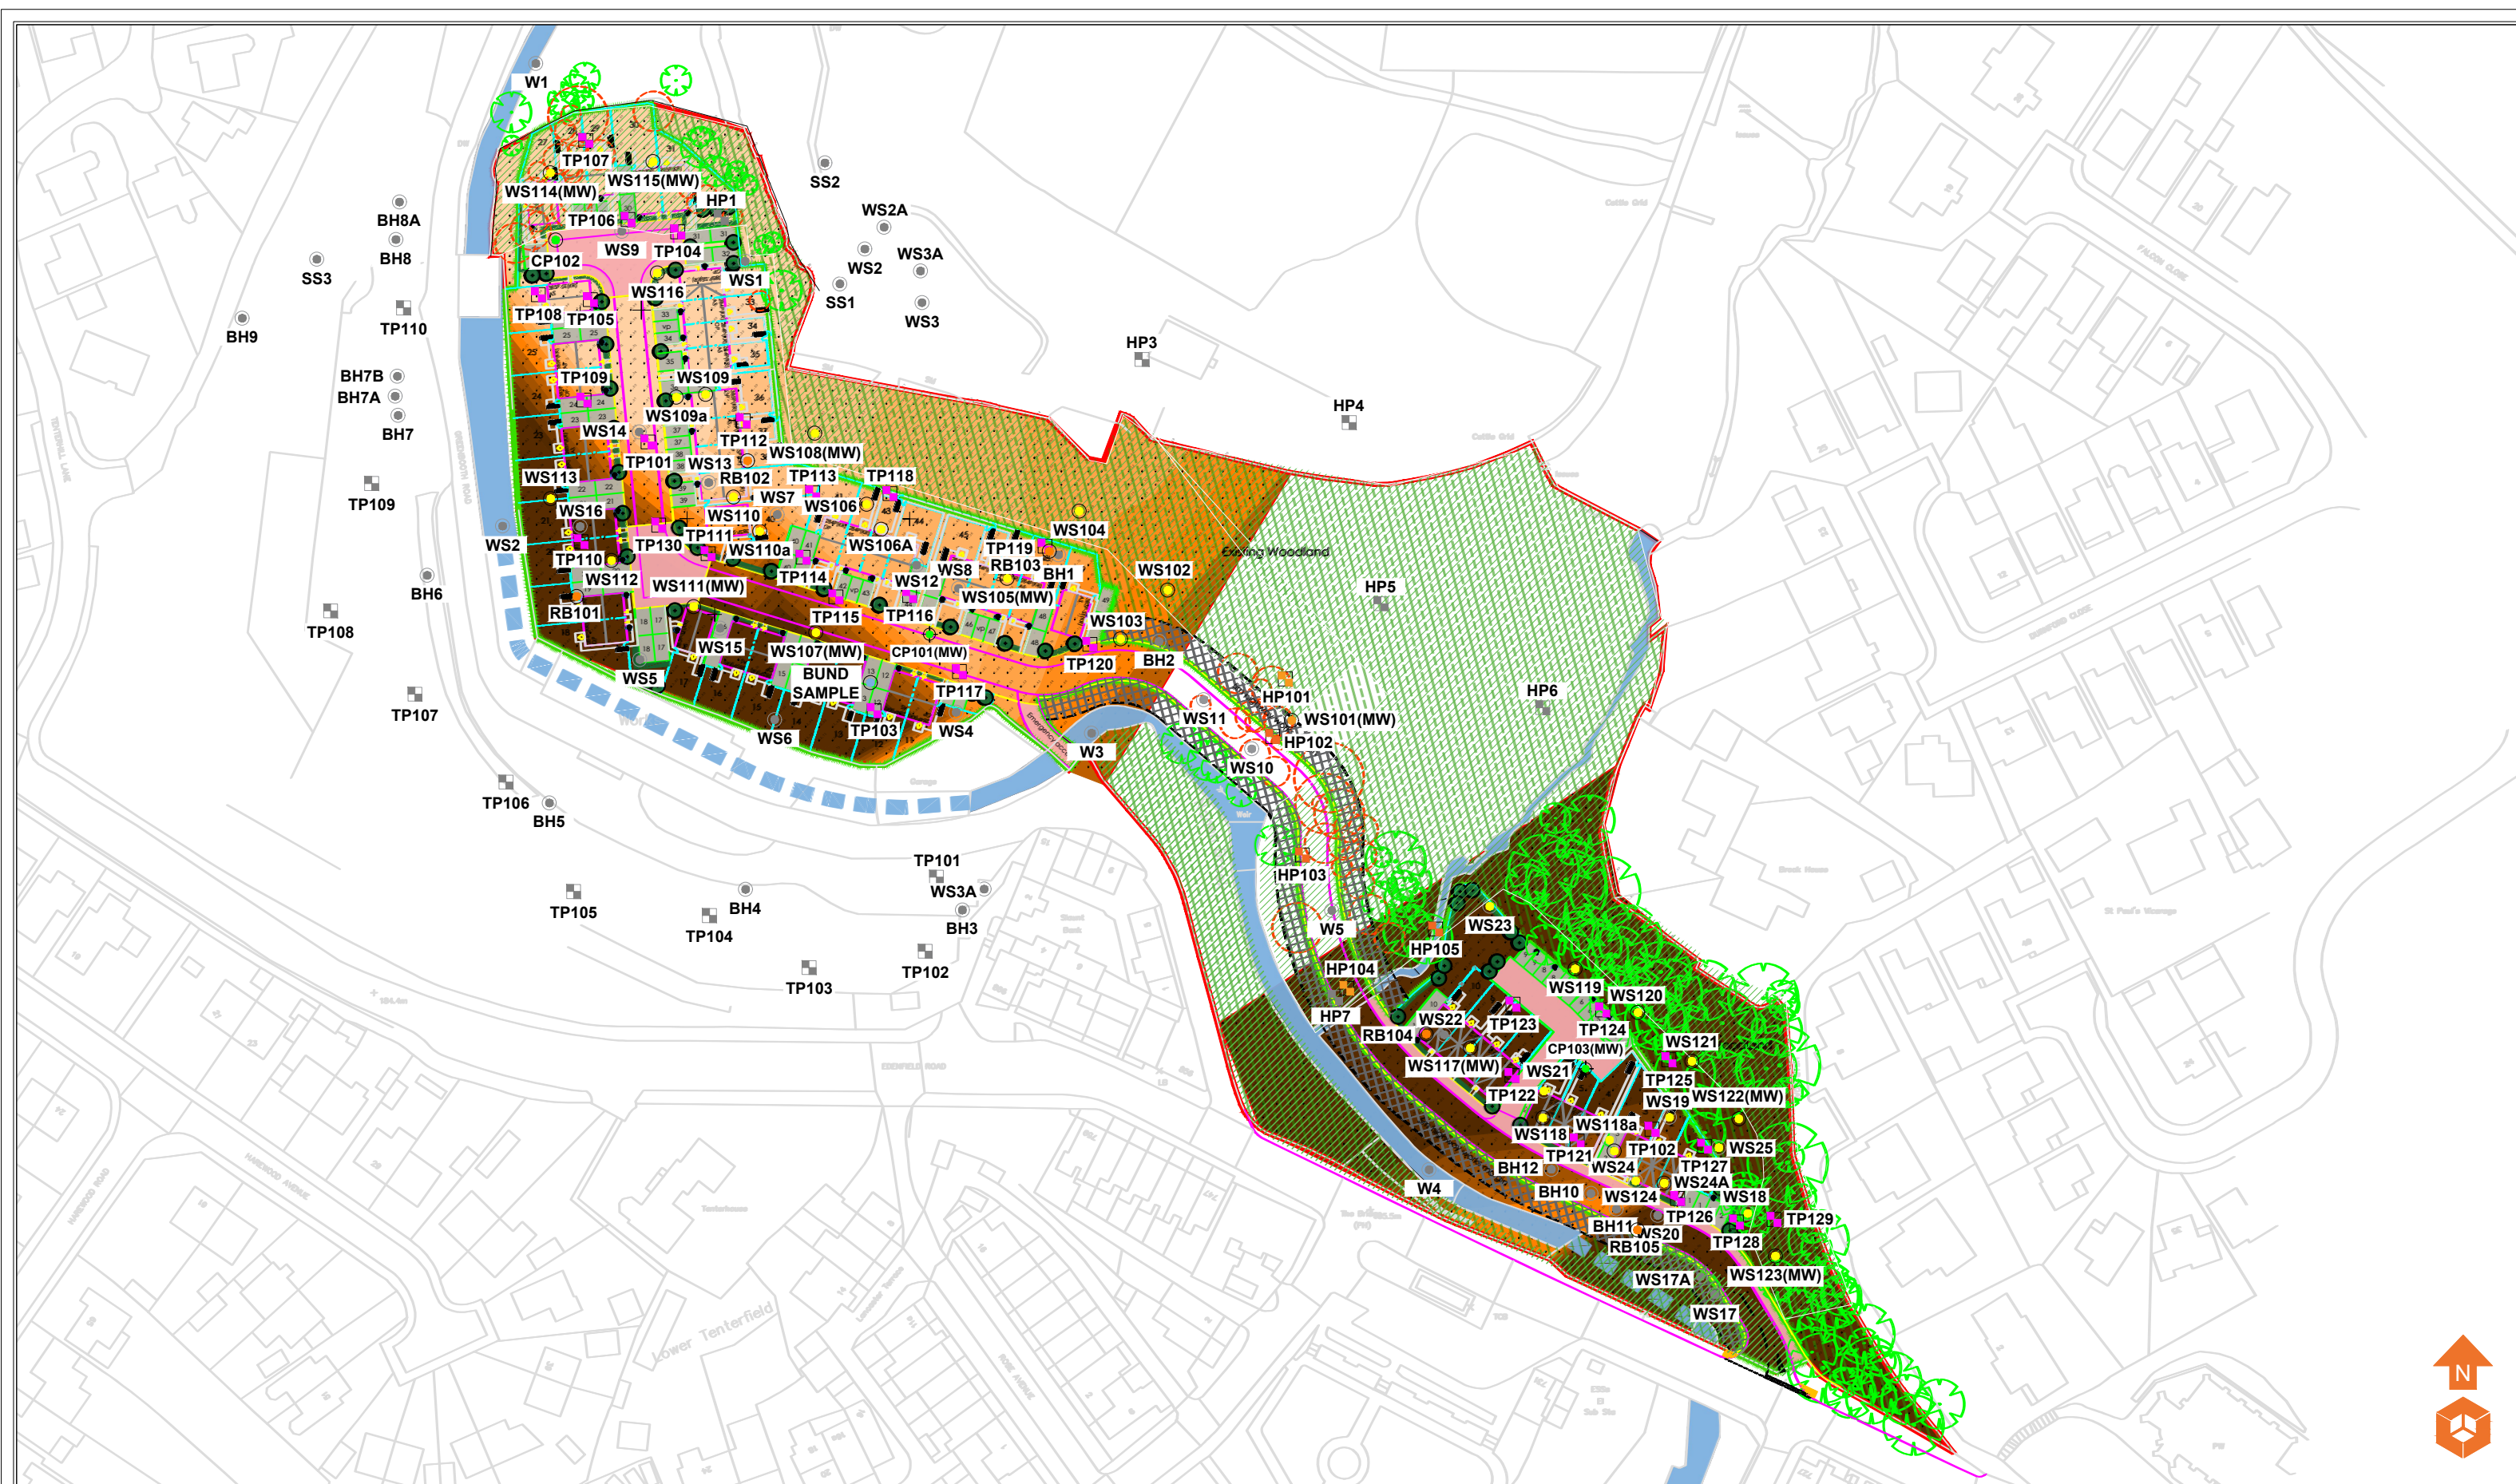
The solid bedrock geology was encountered within five exploratory hole locations. Shallow bedrock was encountered between 1.60 m and 2.90 m bgl along the northern part of the Tack Lea Works area (i.e. closer to the valley edge). Along the southern boundaries of the Tack Lea Works area and Sheppard Mill area (i.e. towards the centre of the valley), deep bedrock was encountered between 11.60 m and 13.80 m bgl. The bedrock generally comprised of a greyish brown SANDSTONE. Outcrops of bedrock were also noted to be present in the northwest part of the Tack Lea works area and along the northern boundaries of the Tack Lea Works area and Sheppard Mill area.

The E3P Depth of Bedrock Plan is presented as Drawing 16-465-012 in Appendix III.

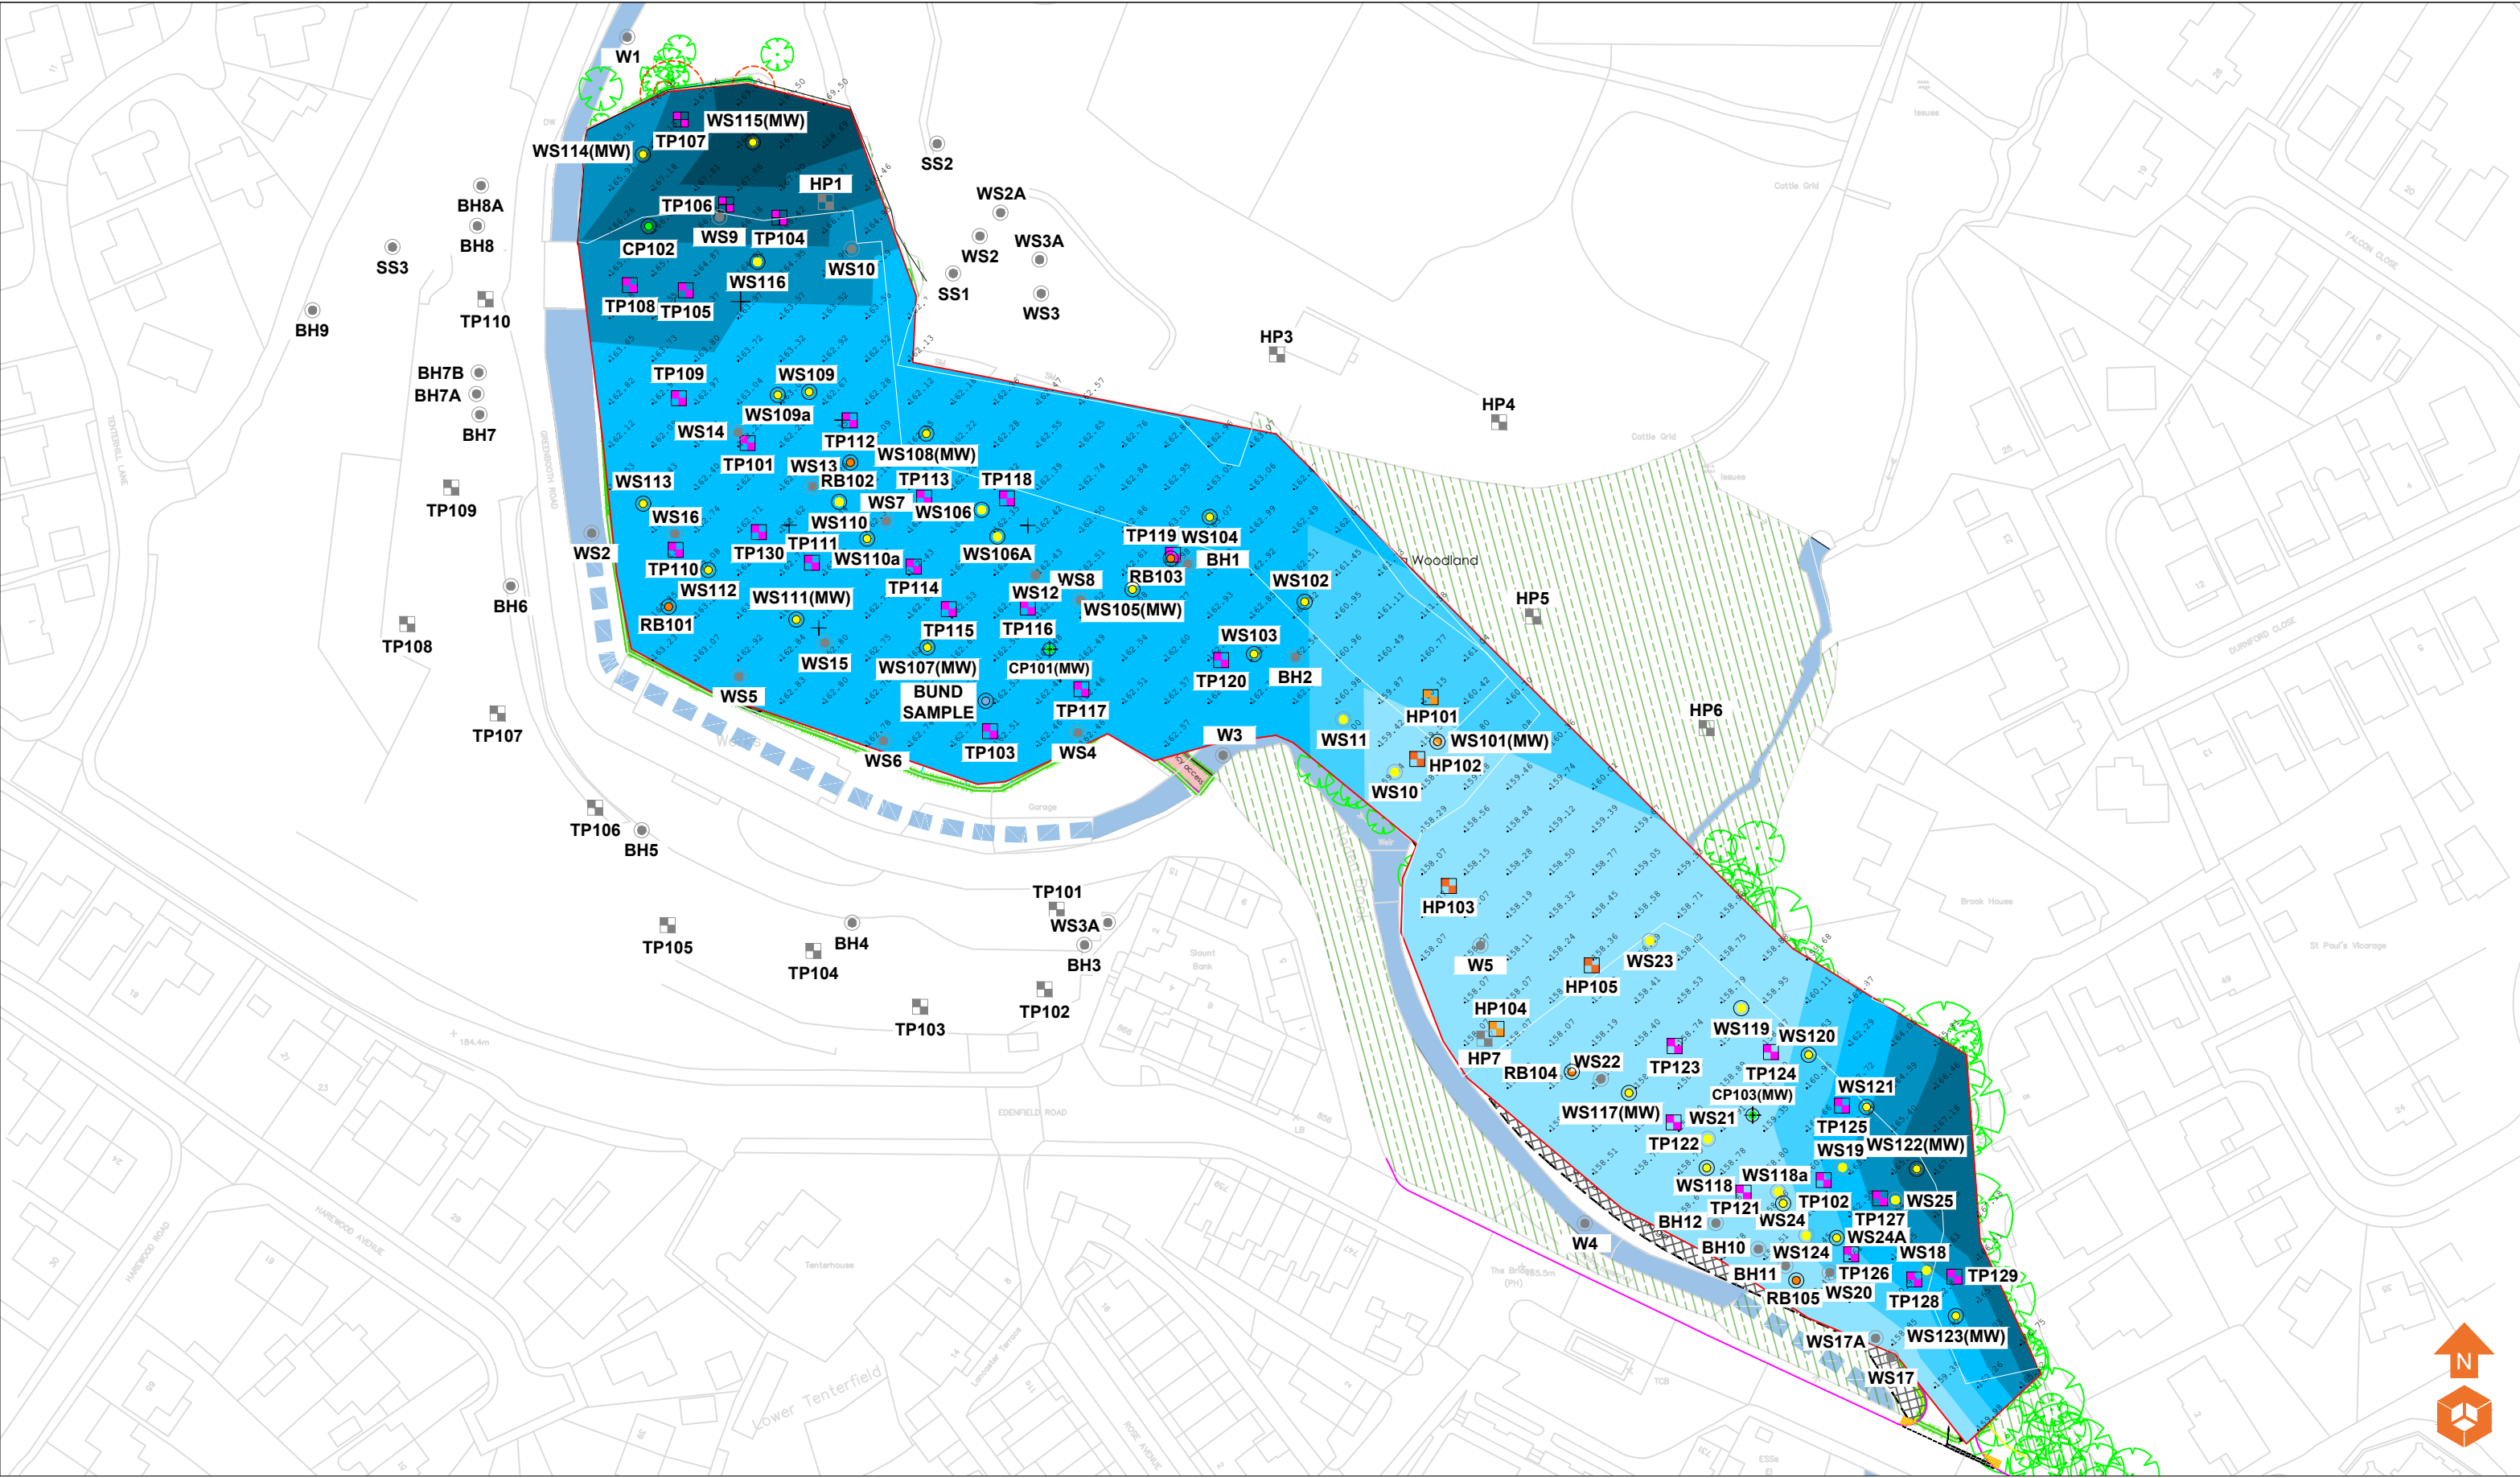
Perched groundwater was encountered during the ground investigation in one location in the Tack Lea Works area at 1.50 m bgl. Groundwater was encountered between 1.40–3.90 m bgl during the ground investigation, with deep groundwater encountered in one location within the Sheppard Mill area at 12.10 m bgl. During the monitoring, groundwater levels were recorded between 0.59 m and 4.89 m bgl.

The E3P Groundwater Flow Plan is presented as Drawing 16-465-040 in Appendix III.
