# Hilltop Natural Roofing Slate EN 12326 Testing

**IBIS Report 2493-A, March 2017**

## EN 12326 Testing

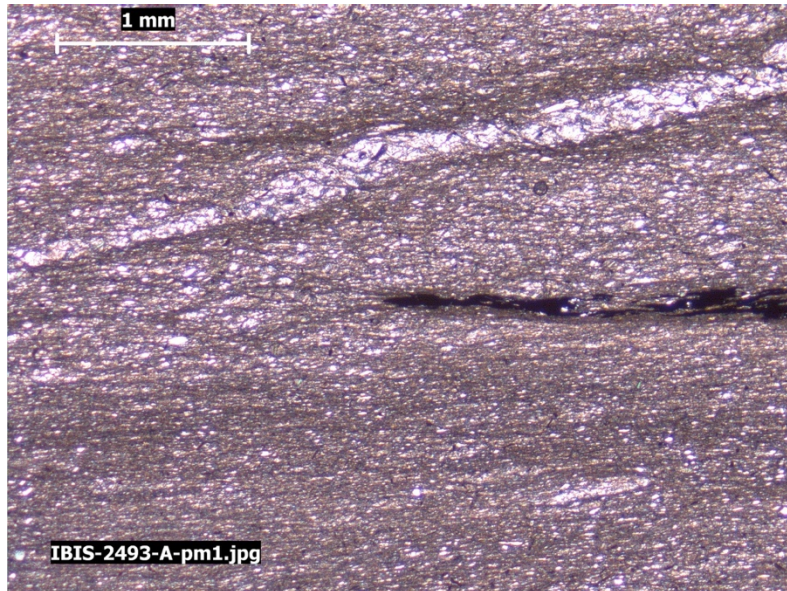
**Photomicrograph 1**

The cleavage plane runs left-right in this view. The light coloured feature is rich in quartz and other minerals and likely reflects former bedding structures, these at an angle of around 20°.

Opaque material has concentrated along the cleavage plane, which thus must have developed as part of the slate formation process.

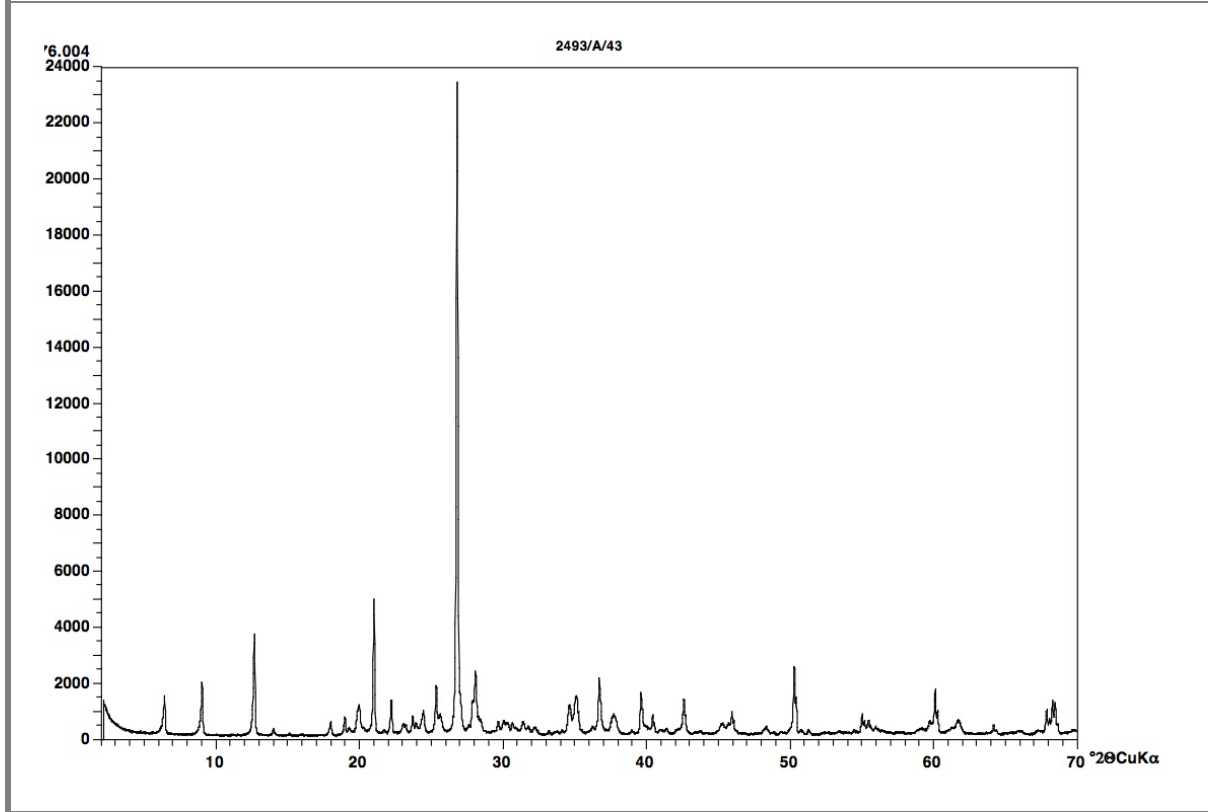
**XRD Output**

**Certificate of Testing & Analysis**  
**Qualitative X-Ray Diffraction Analysis**  
**BS EN 12326-2:2011**

| Material Component | Petrographic Details <sup>3</sup> |
|---|---|
| Illite/Muscovite | Flaky crystals of white mica forming the bulk of the rock fabric. The X-ray diffraction found that this comprised illite and/or muscovite, which are difficult to distinguish because there is a transitional series between these two minerals. |
| Feldspar | The XRD identified mostly plagioclase but also some alkali feldspar to be present. Only obvious plagioclase fragments were observed due to the presence of multiple twinning. |
| Carbonates | Scattered crystal grains visible throughout the rock fabric and sometimes more concentrated within some of the quartz-rich former sedimentary structures. The XRD identified siderite as a minor mineral, though this was not observed as obvious crystals in thin-section. |
