# HOLY TRINITY CHURCH MIDDLETON ECOLOGICAL ASSESSMENT REPORT

| Document Title | Ecological Assessment Report |
| Prepared for | Buttress Architects |

| Date | August 2022 |

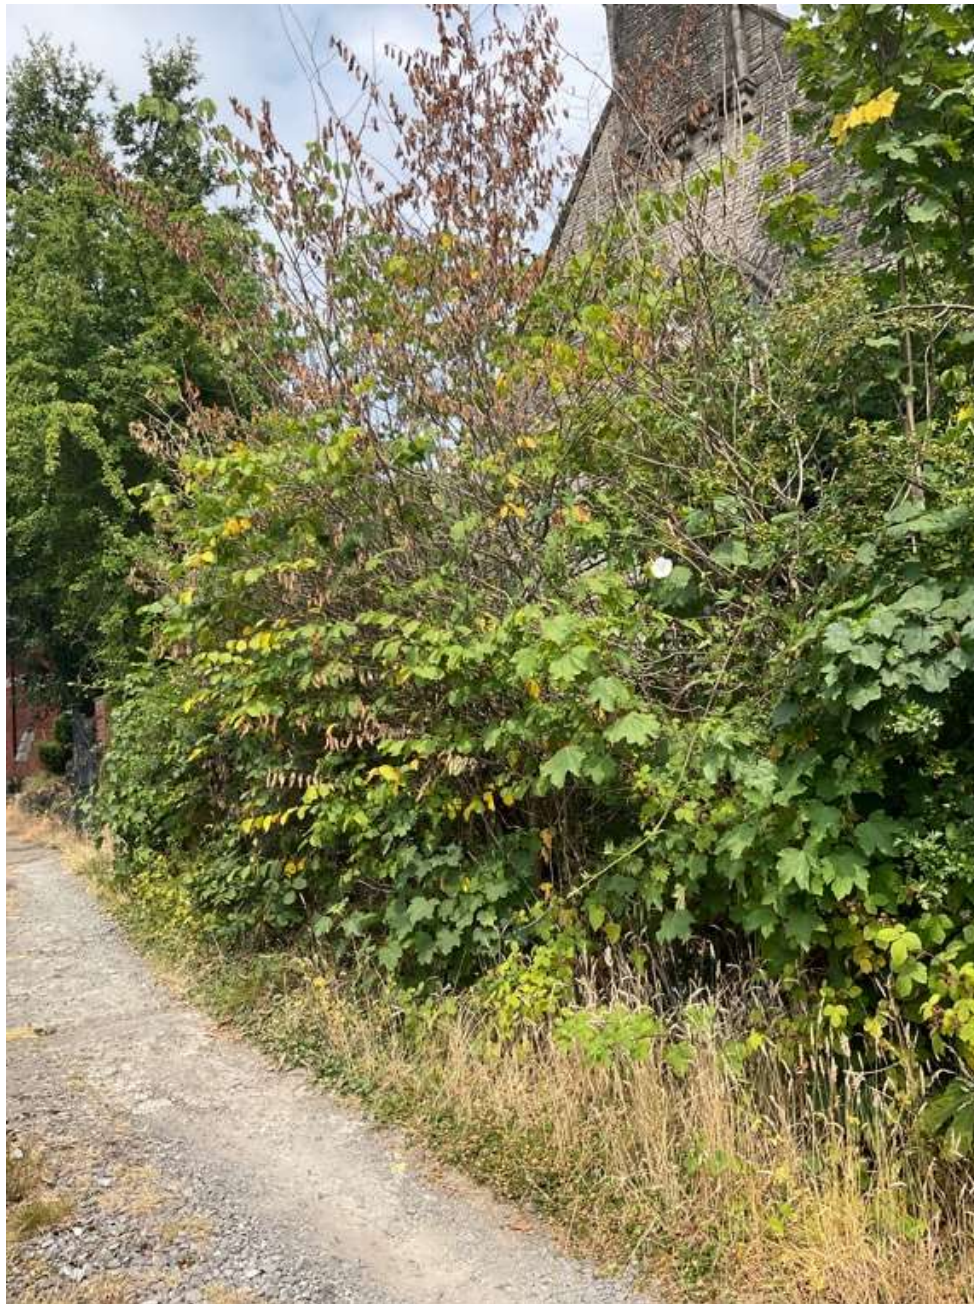
Figure 1: Target Note 1

Three dead, mature elm *Ulmus* species trees at the south west corner of the site. Below the canopy inside the site there is a patch of bramble scrub interspersed with sycamore *Acer pseudoplatanus* and ash *Fraxinus excelsior* saplings with hedge bindweed *Calystegia sepium* and cleavers *Galium aparine*.

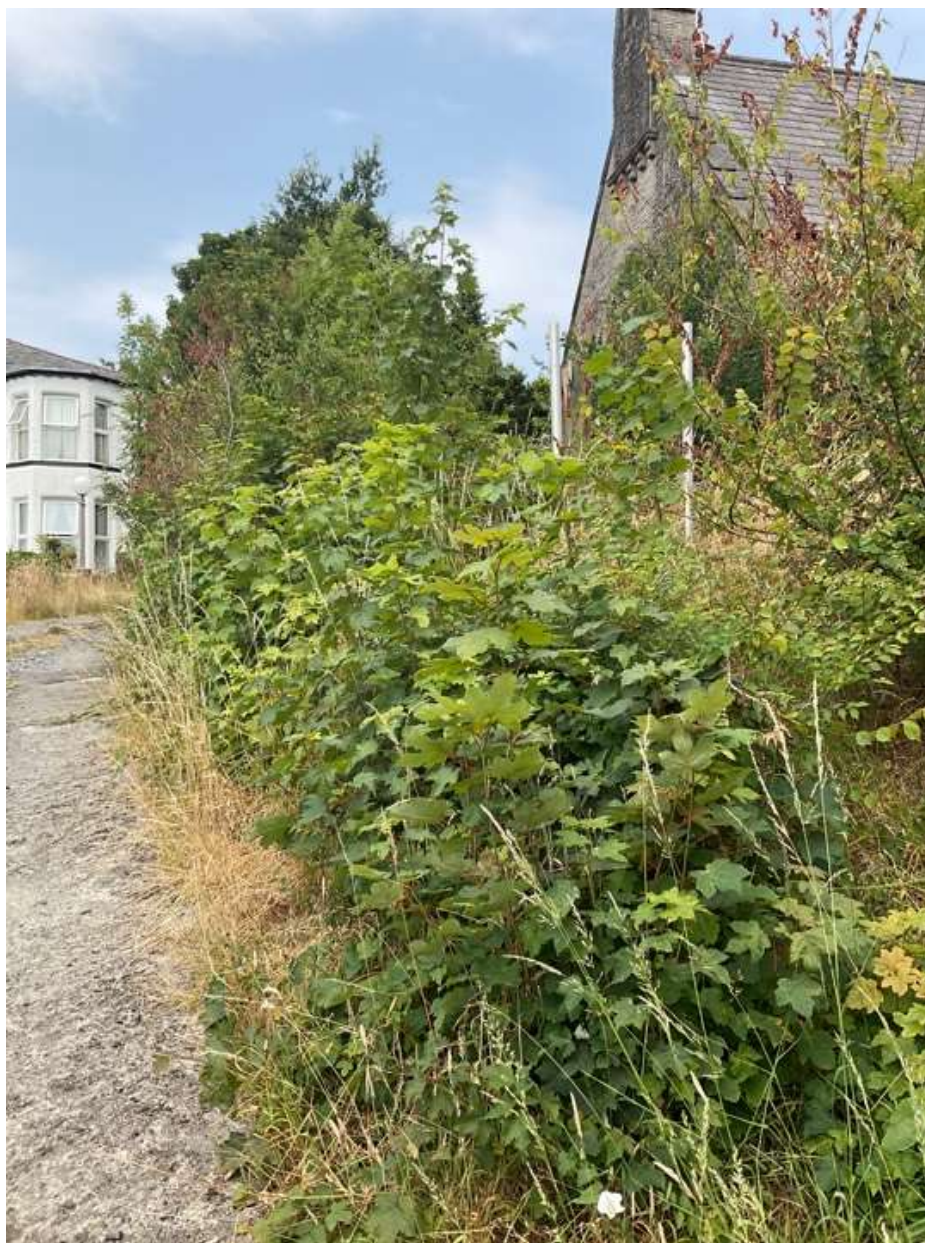
Figure 2: Target Note 2

Row of sycamore *Acer pseudoplatanus*, ash *Fraxinus excelsior*, common elm *Ulmus procera* and hawthorn *Crataegus monogyna* saplings along western boundary.

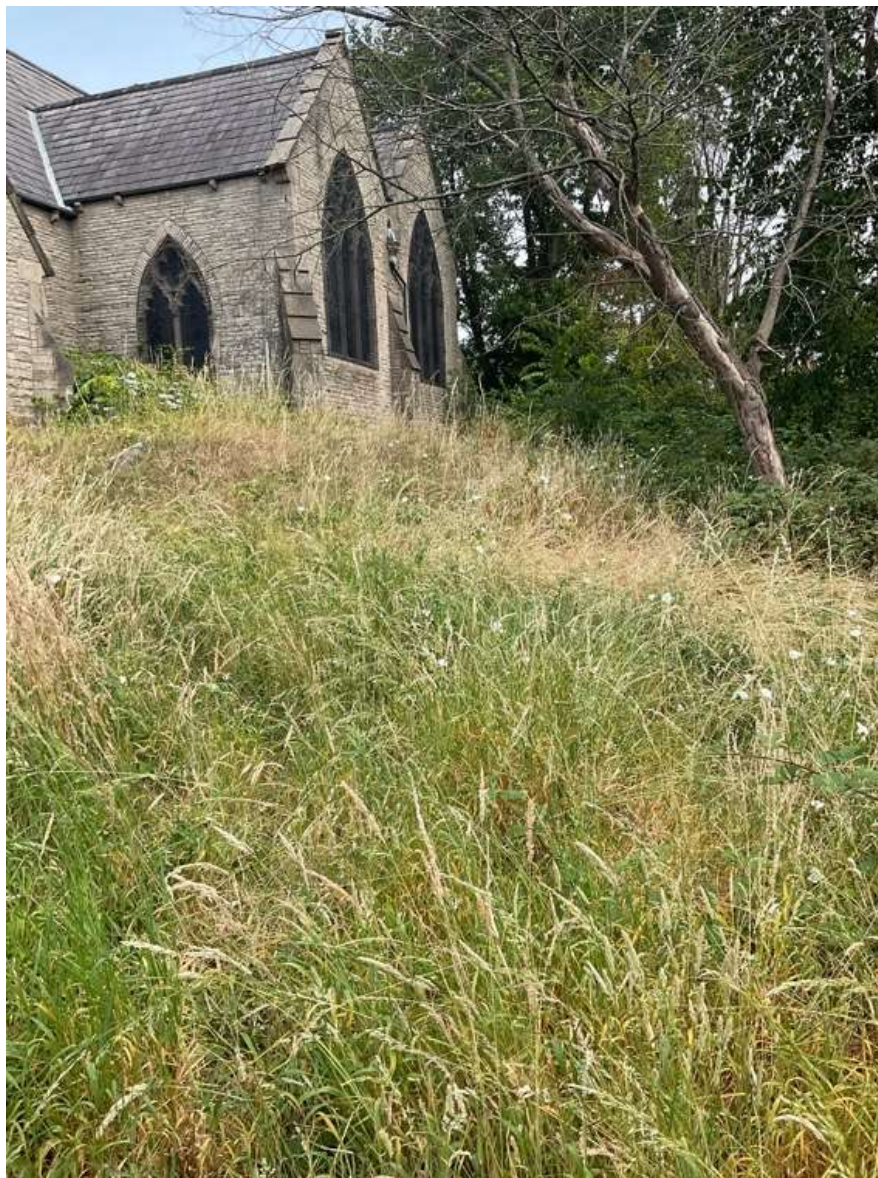
Figure 3: Target Note 3

Poor semi-improved grassland on the south side of the church, dead elm present within the grassland. Grassland dominated by false oat grass *Arrhenatherum elatius* and Yorkshire fog *Holcus lanatus* with frequent common bent *Agrostis capillaris*, occasional cock's-foot *Dactylis glomerata*, sweet vernal grass *Anthoxanthum odoratum*, frequent hedge bindweed, occasional white clover *Trifolium repens*, bramble *Rubus fruticosus*, tree saplings, ragwort *Senecio jacobaea* and curled dock *Rumex crispus*.

Ornamental hydrangea and fuschia plants are present along the southern church wall alongside common grasses, nettle *Urtica dioica*, bramble and tree saplings. Wood avens *Geum urbanum* also noted.

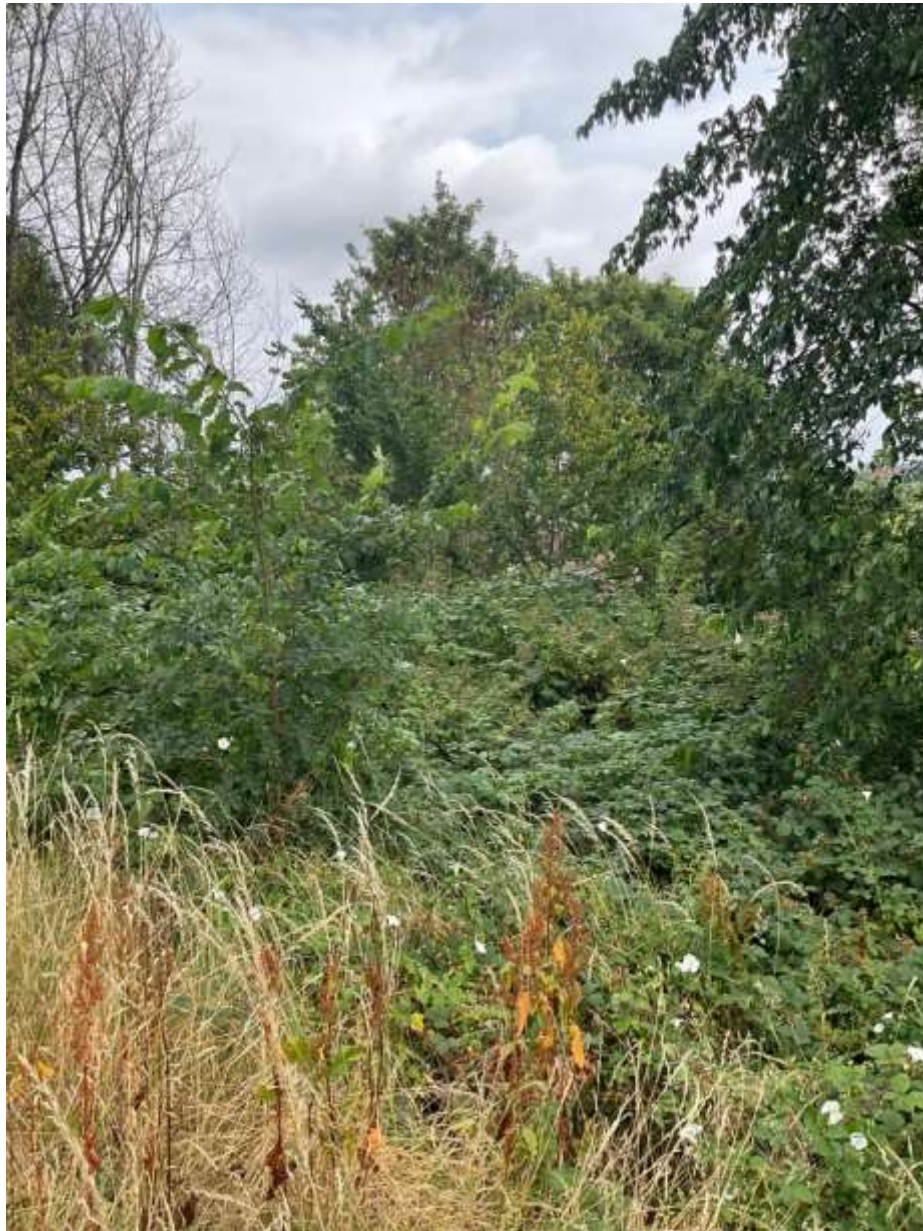
Figure 4: Target Note 4

Southern boundary comprises bramble scrub with bindweed and tree saplings. Mature American elm *Ulmus americana* present near southern boundary within scrub.

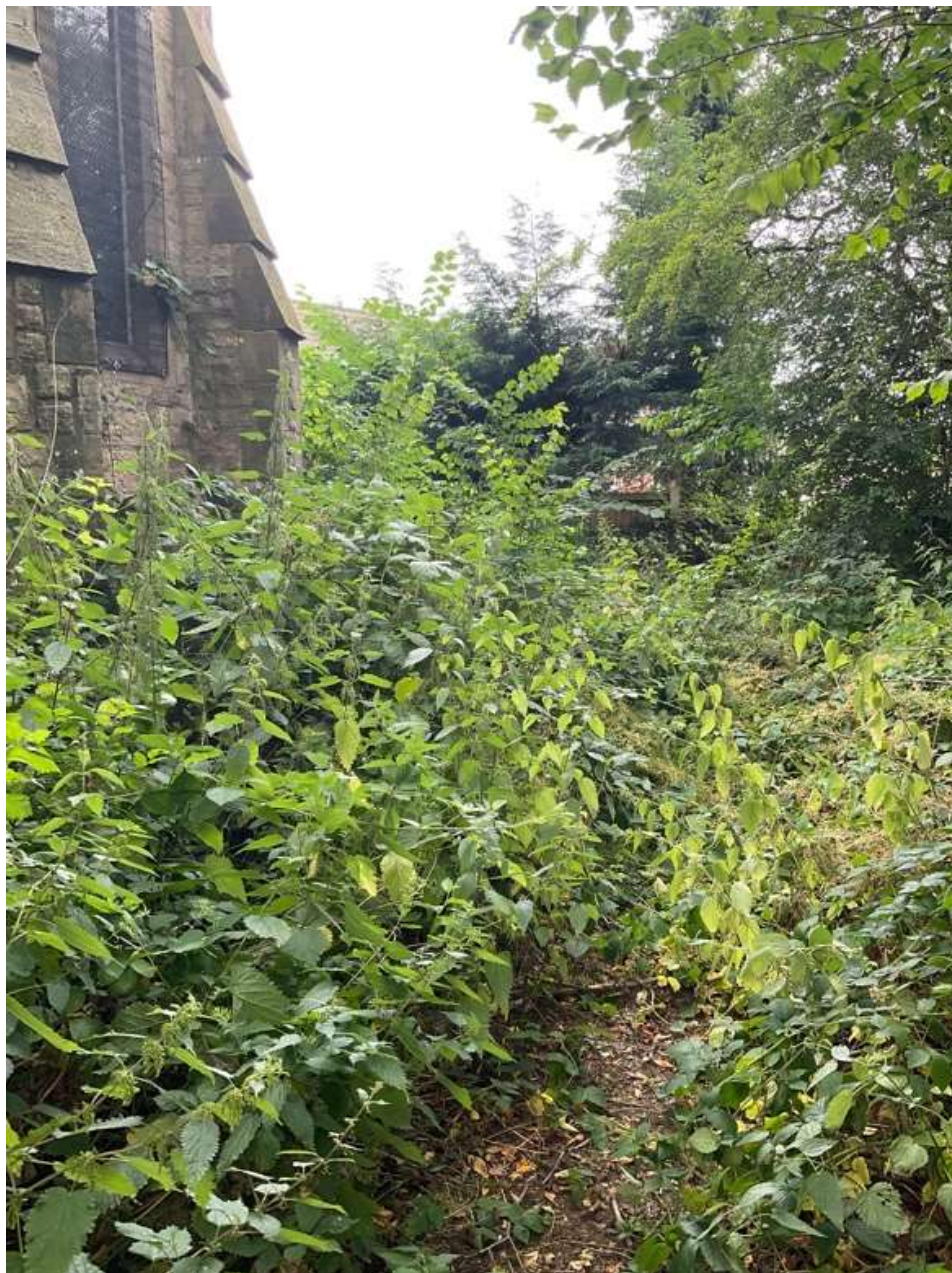
Figure 5: Target Note 5

South eastern boundary comprises several mature common elm in good condition with no bat potential features. The habitat alongside the church comprises common nettle, bramble and elm saplings. Beyond the healthy elm trees towards the boundary there are several dead elms which are also set amongst bramble scrub and cleavers. Nearer the church there are hawthorn saplings and wych elm *Ulmus glabra*.

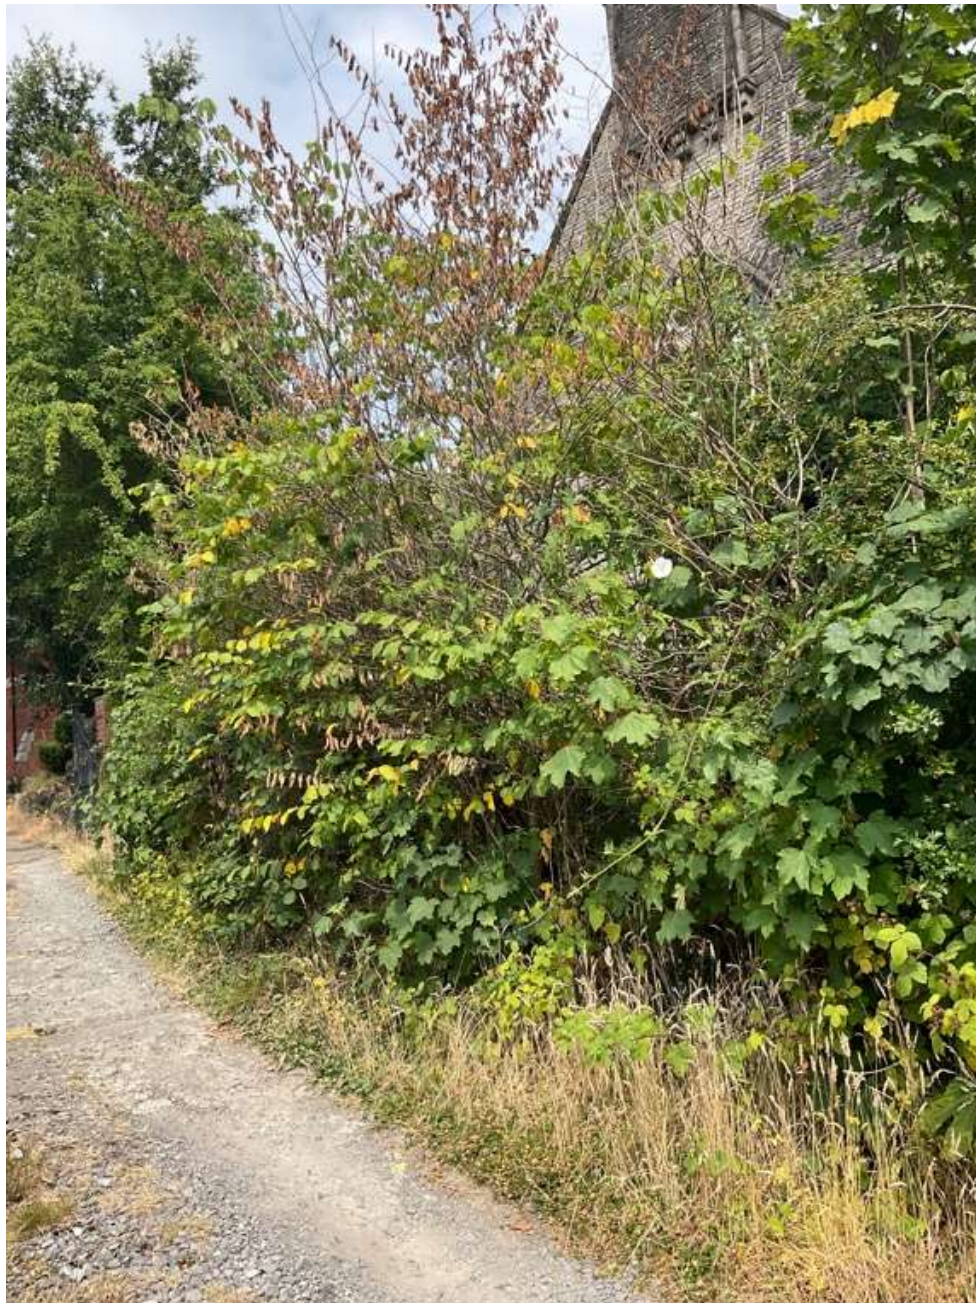
*Figure 6: Target Note 6*

Row of sycamore, ash, wych elm, ash, hawthorn saplings along western boundary.

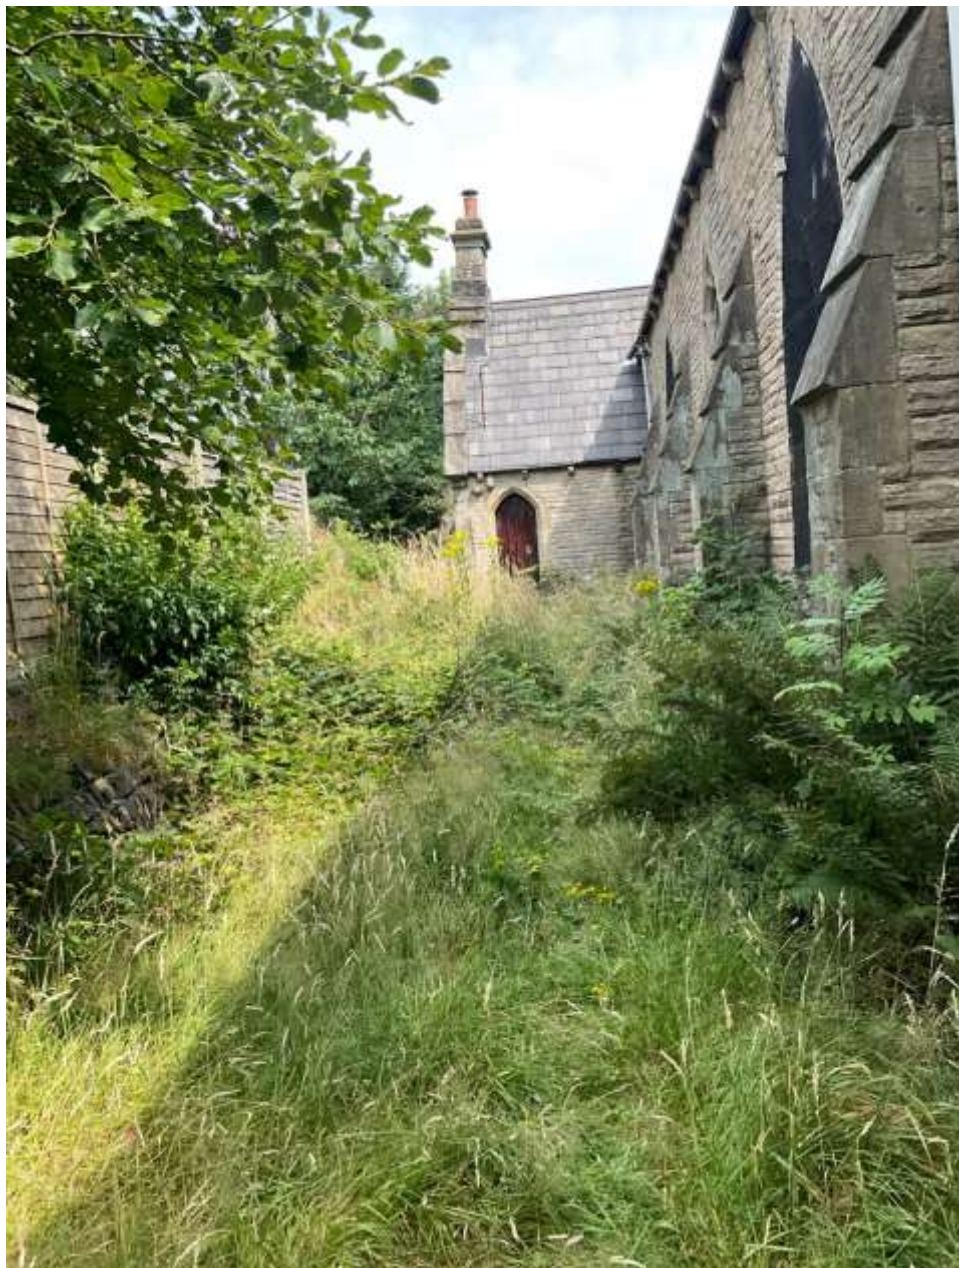
Figure 7: Target Note 7

Northern boundary comprises poor semi-improved grassland, along the church wall there is lady fern *Athyrium filix-femina*, ash saplings, bramble, American willow herb *Epilobium ciliatum*, cleavers, Yorkshire fog, common bent, meadow buttercup *Ranunculus acris*. There are patches of holly *Ilex aquifolium* and green forsythia *Forsythia* species on the boundary with the adjacent land. There is a patch of buddleia in the north eastern corner.

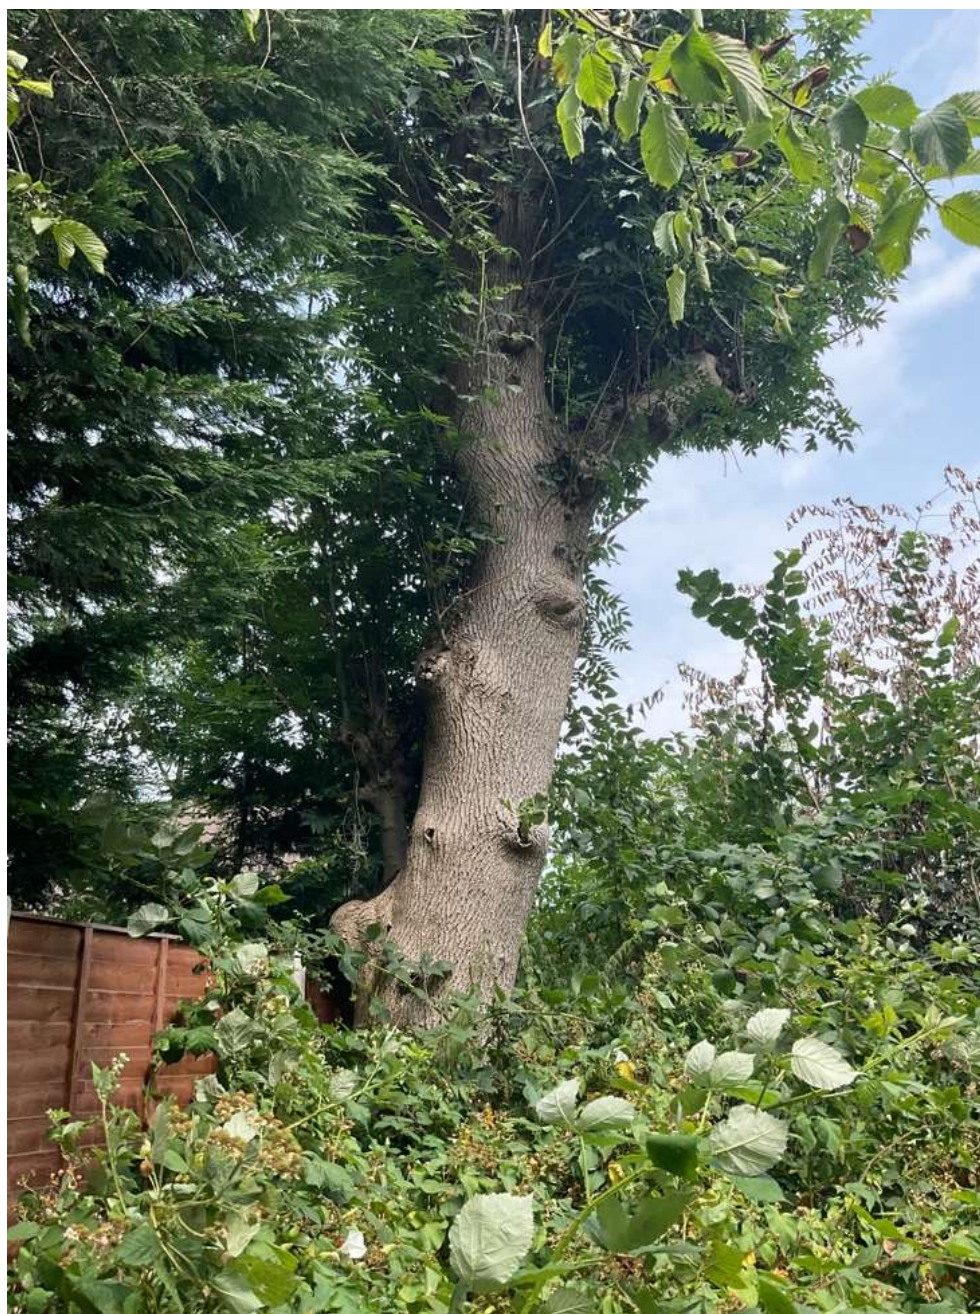
*Figure 8: Target Note 8*

Old, mature ash in the north east corner, previously pollarded and new growth at the top. A few cracks and fissures are present but cannot view entire tree due to scrub and boundary location.

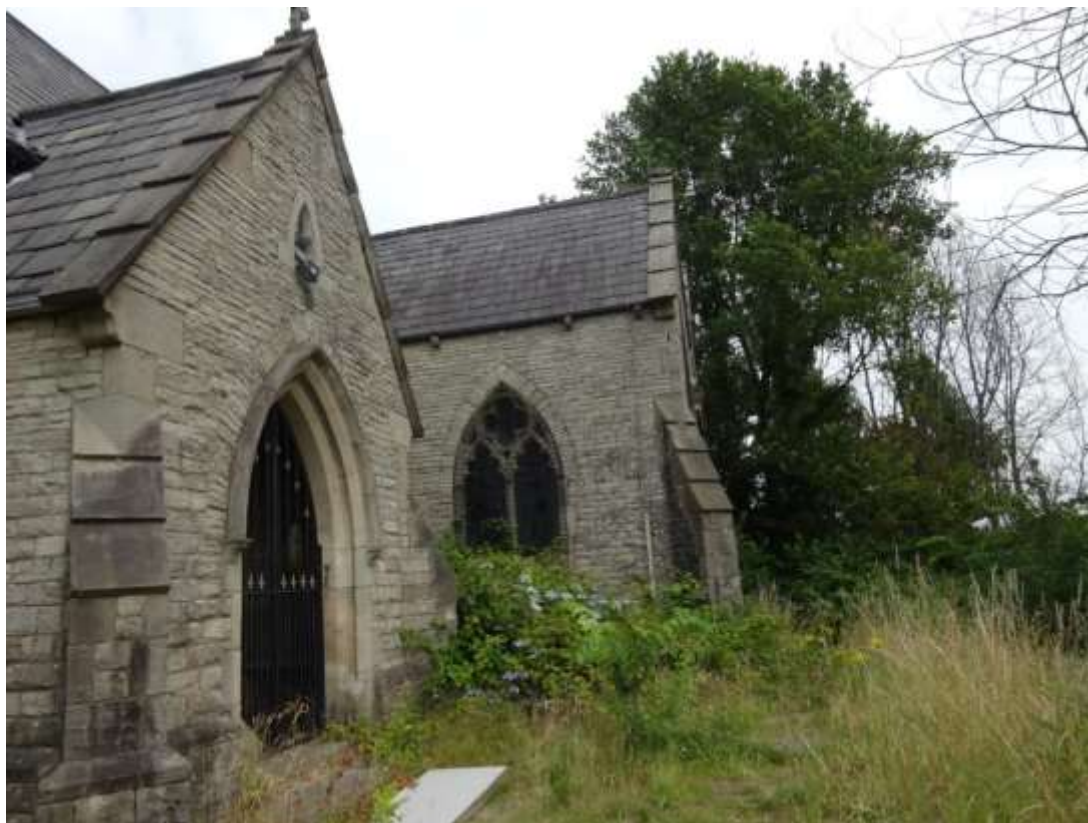
*Figure 9: Target Note 9*

- 3.22 The external bat scoping assessment of Holy Trinity church identified multiple PRFs with 17 locations/areas recorded as PRFs which are shown on Figure 2. PRFs include:

- Gaps formed where mortar is missing between brickwork;
  - Missing brickwork;
  - Cracks in brickwork or gaps between brickwork;
  - Gaps under slate tiles; and

- Gaps under edge stones.
- 3.23 Internally, it was evident that the church has been disused for several years and there are several areas in disrepair. No evidence of roosting bats was identified although due to the large extent of cobwebs and dead invertebrates present made looking for bat droppings difficult. However no bats, bat droppings or feeding remains were found during the survey.

- 3.24 Due to the number of features identified, this building is assessed to have High potential to support roosting bats and a confirmed pipistrelle roost was recorded in 2016.

Holy Trinity Church, the church is currently disused and has not been occupied for several years. It is of stone construction with stained glass windows and a complex, pitched roof comprised of slate tiles.

- 5.1 It is recommended that bat emergence surveys are undertaken to obtain further information on the use of Holy Trinity Church by bats. This will provide important information on the potential impacts of any future development and identify mitigation requirements. The surveys should comprise at least three surveys, two weeks apart during the active bat season of May to August.

- 5.3 Any future development should include a sensitive lighting scheme for bats is incorporated so that they can continue to use the site. Should the church be renovated or converted into another use, proposals should be discussed with an ecologist to ensure the design will not negatively impact bats and continue to provide opportunities for them to roost.
