OUR REF: A5182/22 27<sup>th</sup> April 2023

**Soil Contamination Delineation Letter Report**  
**Dobfield Road, Rochdale**

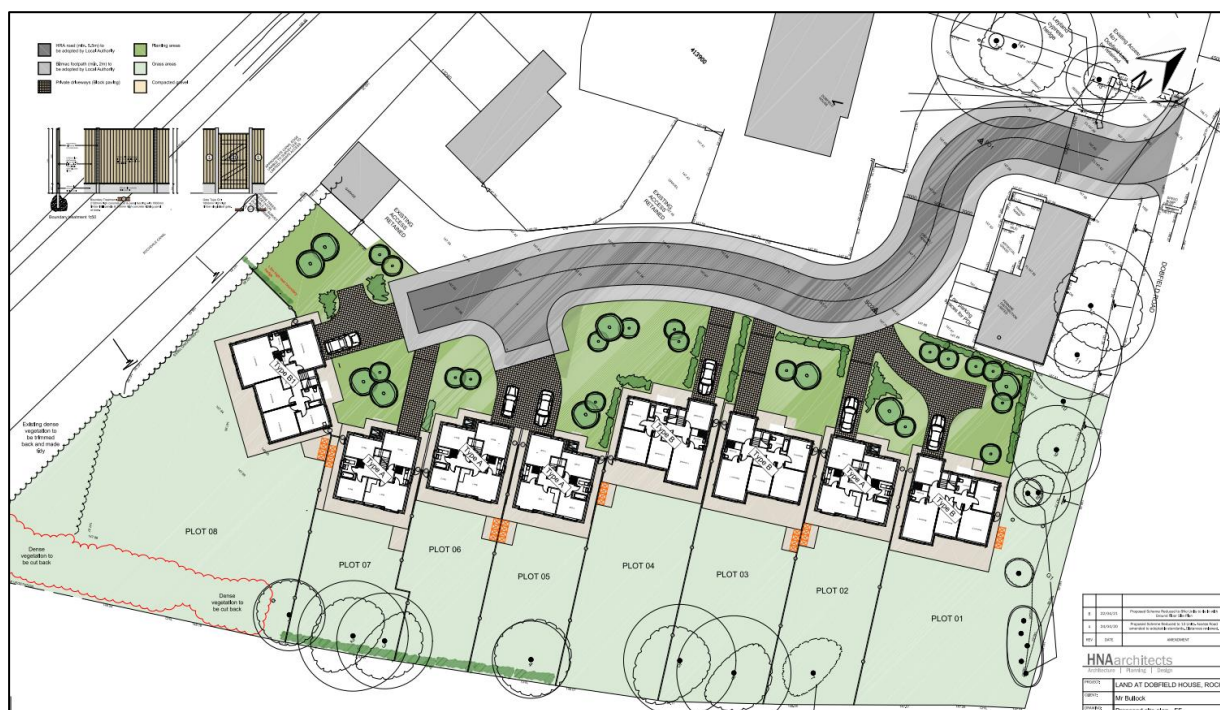
### Figure 2 Development Layout Plan

It is understood that the client intends to demolish all existing structures on-site and construct eight new detached residential properties.

The development will include private gardens and parking for each property, along with slight alterations to the existing access.

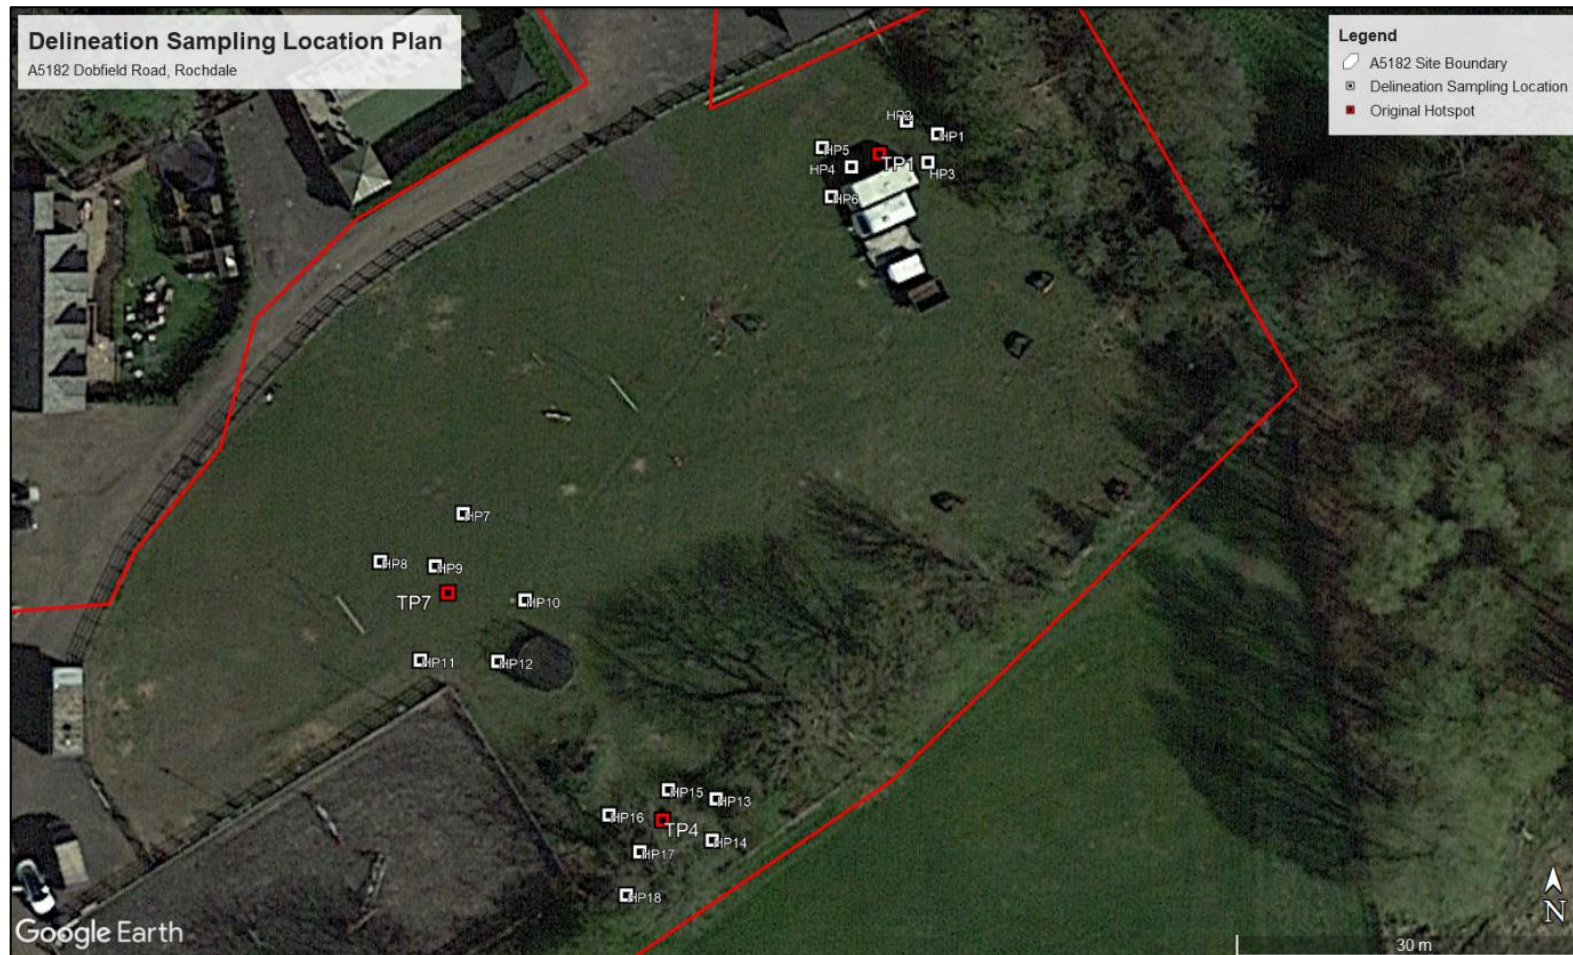
**Figure 3 Exploratory Hole Location Plan**

Eighteen hand dug pits (designated HP1 to HP18 inclusive), six around each hotspot location, were excavated to depths of between 0.20m - 0.50m bgl, at distances between 2.50m - 7.00m from the original hotspot location.

All locations were surveyed by use of a Trimble GeoXH GPS instrument that is capable of the measurement of positional accuracy of less than 10cm depending on proximity to trees, structures, and satellite coverage.

Sampling locations are shown in Figure 3 below.
