# Townhead, Rochdale

## Bat Survey Report

18<sup>th</sup> July 2023

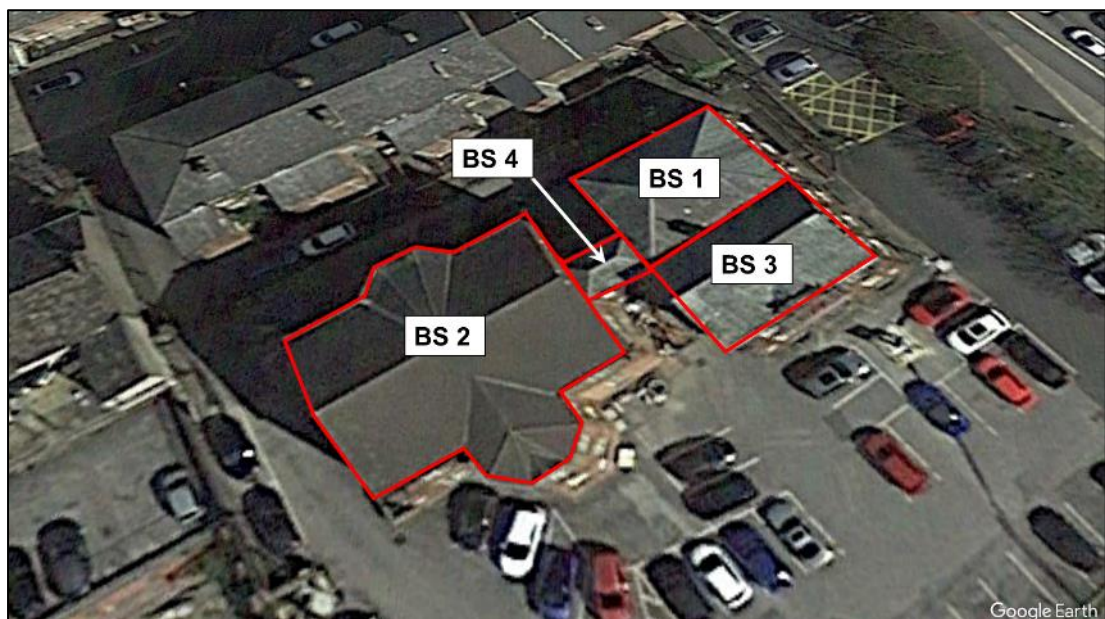
**Figure 3. Building sections**

- 5.2.1 No signs of bat presence were recorded from the site, however, the building was considered to display a moderate level of bat roost suitability.
- 5.2.2 To aid building description, it was split into sections as shown in Figure 3.

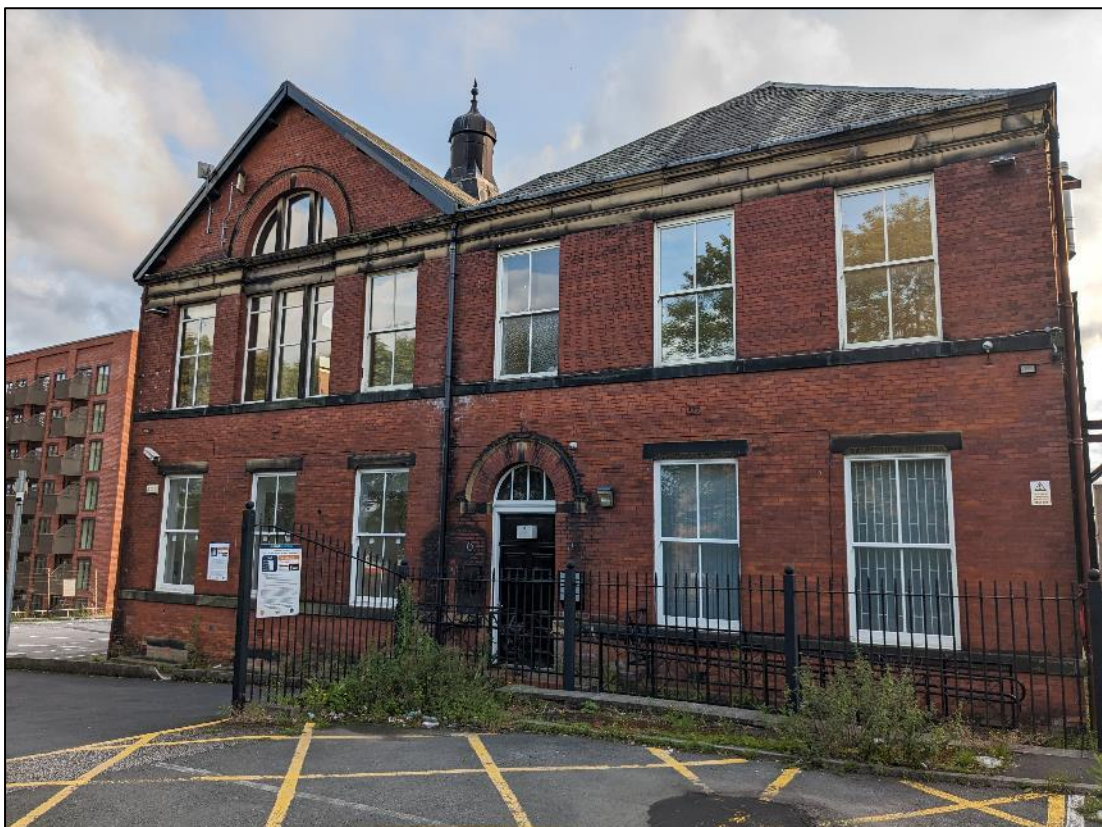
- 5.2.3 The surveyed building was Grade II listed and comprised an early C19<sup>th</sup> two-storey structure with some decorative stone sections (i.e. banding course) (Plate 1). The roof was dual-pitched and hipped with a Westmorland slate covering. Hip coverings comprised a mix of flashing and felt, with internal rainwater goods behind parapets. Windows mainly comprised new wood-framed double-glazed units with occasional single-pane units remaining.

- 5.2.4 On the exterior of the building, potential bat roosting features were mainly associated with the roof and comprised crevices between slates and gaps below lifted sections of flashing on the hips and parapet wall tops. A shallow crevice (c.20 mm wide x 30 mm deep) was present between an original wooden single-pane sash window and a stone lintel on the northeast elevation (Plate 2). Two probable bat droppings (which could not be safely accessed to confirm their status) were recorded from the glass pane below this gap. The gap between the window frame and lintel was fully inspected from the ground using binoculars and a high-power torch, with no bat/s present or droppings visible in this crevice.

**Plate 1. Northeast elevation of building, with Building Section 1 on right of image (hipped roof) and Building Section 3 on left of image (gable)**

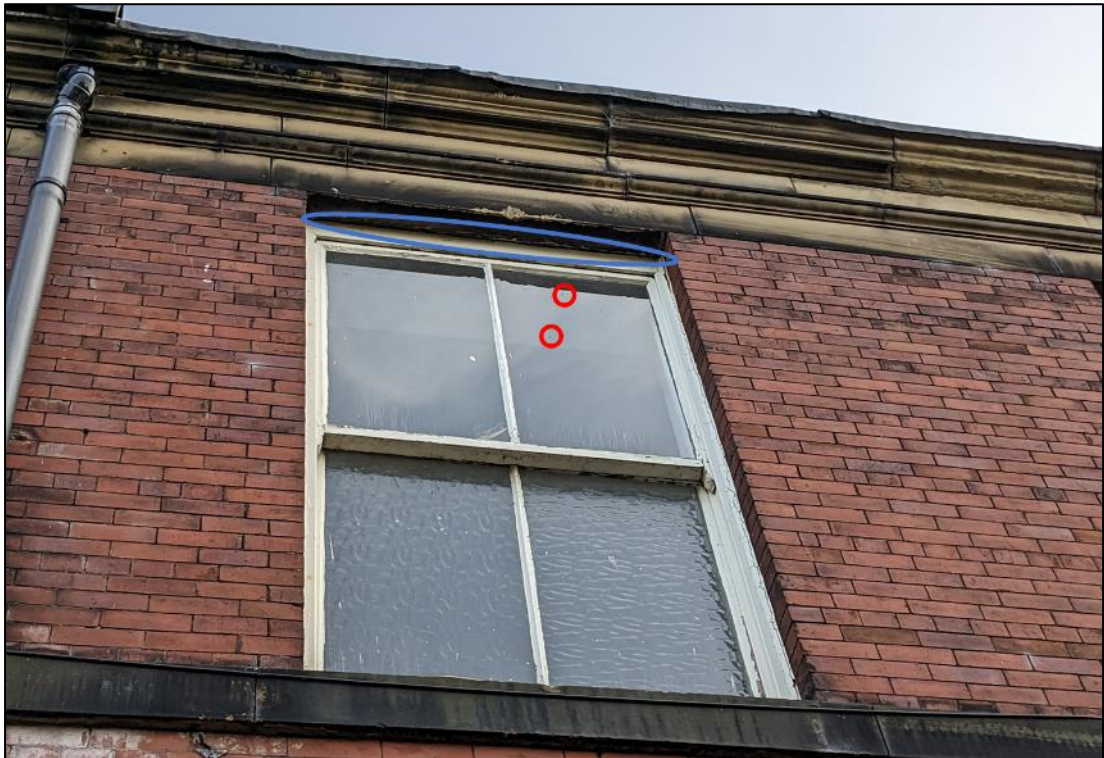
**Plate 2. Original sash window on northeast elevation of Building Section 1. With crevice between frame and lintel circled in blue with probable bat droppings circled in red**

- 6.1.1 No historic bat records relating to roost presence in Townhead were received from GMEU.
- 6.1.2 No bats were found roosting in building during the preliminary daytime assessment. Two probable bat droppings were identified near a potential roost location (gap between window frame and lintel) on the northeast gable of Building Section 1, however, presence of a roost in this location was not confirmed and is considered a possibility only.

- 6.3.2 It is noted that a bat roost may be present in association with the sash window in the northeast elevation of Building Section 1 (Plate 2), however, it is proposed to retain this window. If proposals change and this window is to be replaced, then a consultant ecologist must be contacted in order to provide further advice in relation to further survey and supervision/licensing requirements in relation to this work.

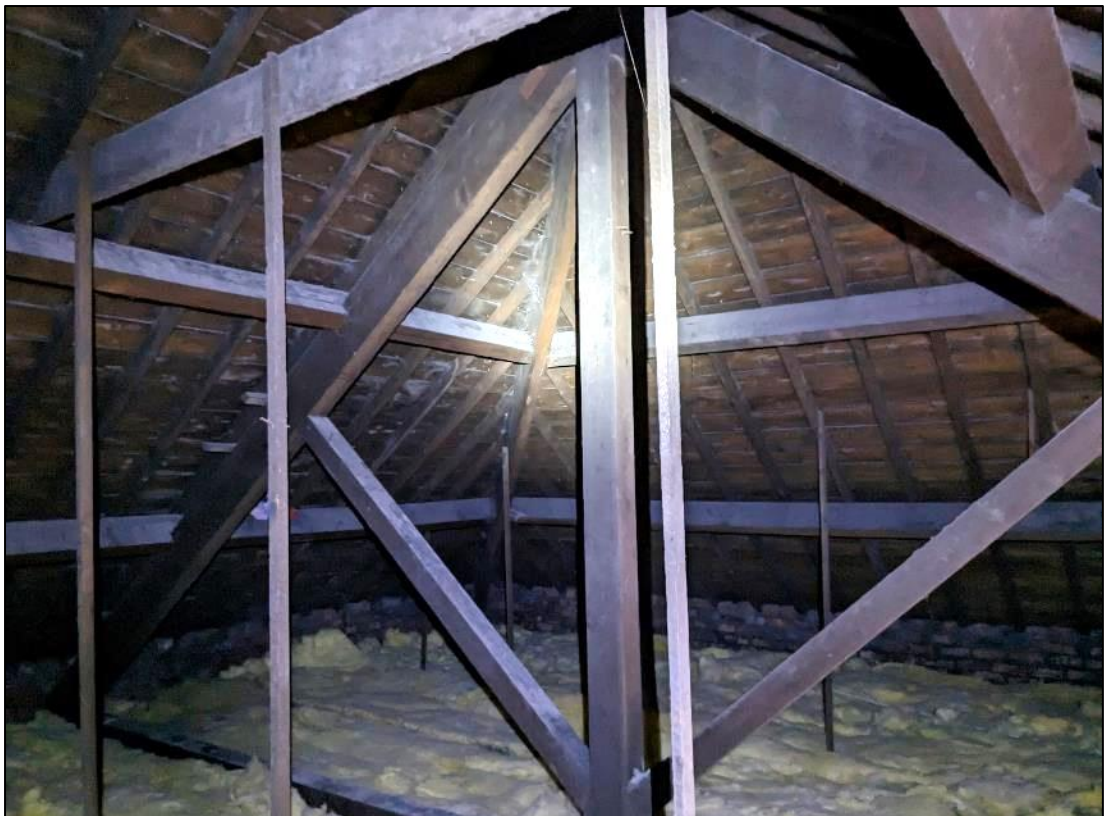
- 5.2.5 The wood sarking lined roof was suspended on king-post roof trusses, a ridge beam, purlins, rafters and battens. The floor/ceiling was insulated with c. 200 mm of glass fibre insulation and the void was very dusty (Plate 3). No potential bat access points or signs of bat presence were recorded.

**Plate 3. Roof void of Building Section 1**

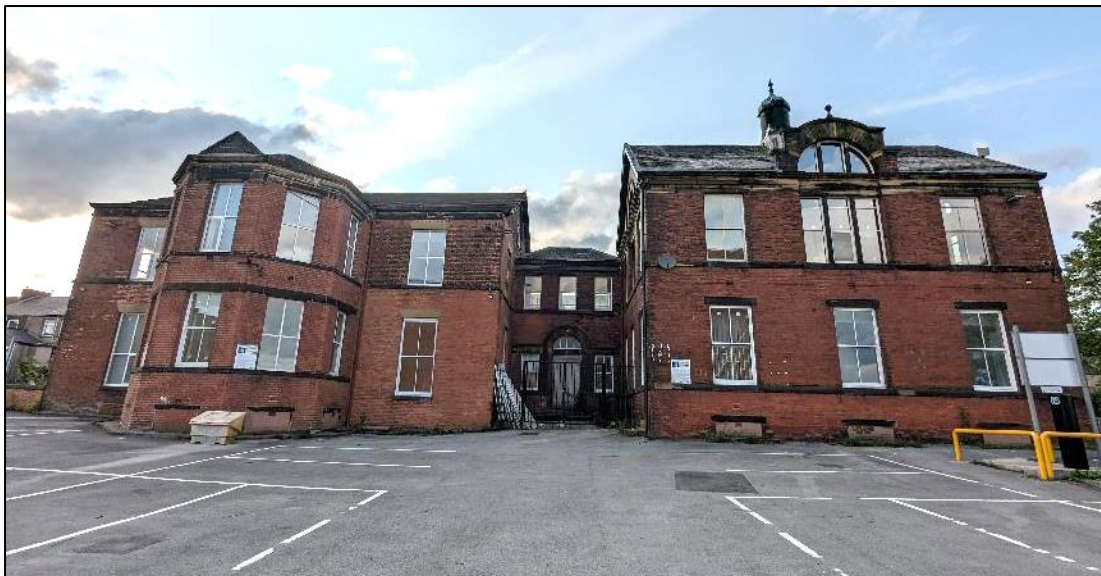
- 5.2.6 The surveyed building comprised an early C19<sup>th</sup> two-storey brick-built section of building with some decorative stone sections (i.e. banding course) (Plates 4 & 5). The roof was multi-pitched with two large bays and gables, and it had been re-covered with concrete roof slates and a concrete ridge. Gable verges were predominantly mortar filled, with a section of dry verge present on the southeast pitch of the southwest gable. Rainwater goods were internal and located behind parapets. Windows mainly comprised new wood-framed double-glazed units with occasional single-pane units remaining.
- 5.2.7 On the exterior of Building Section 2, potential bat roosting locations comprised missing sections of verge mortar and lifted sections of flashing along parapet wall tops.

**Plate 4. Building Section 2 on left of image, Building Section 4 (entrance) in centre, with Building Sections 3 on right of image**

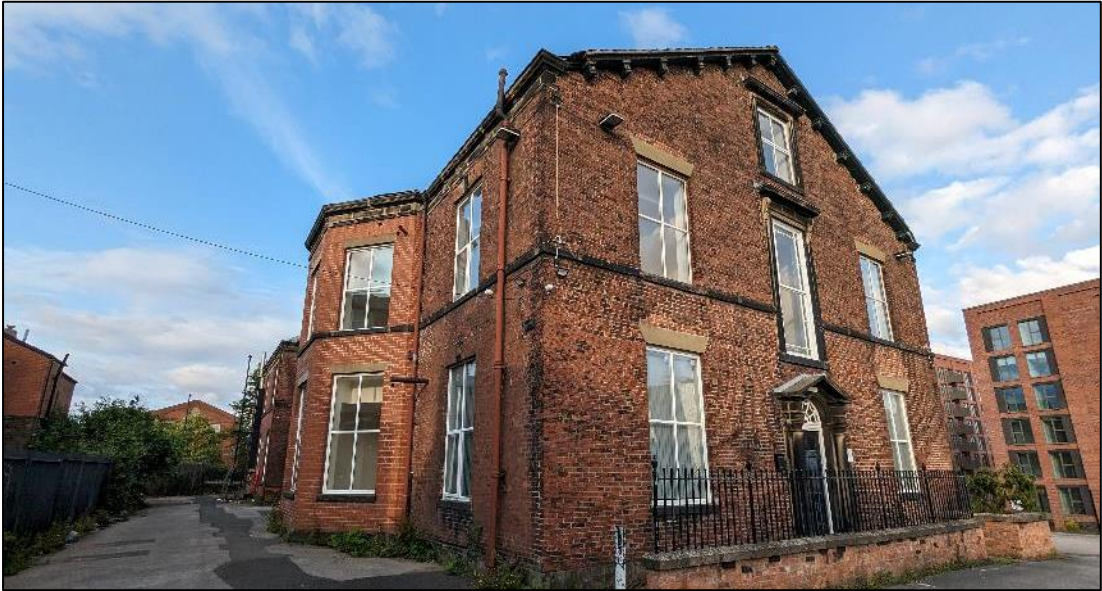
**Plate 5. Southwest gable and northwest elevation of Building Section 2**

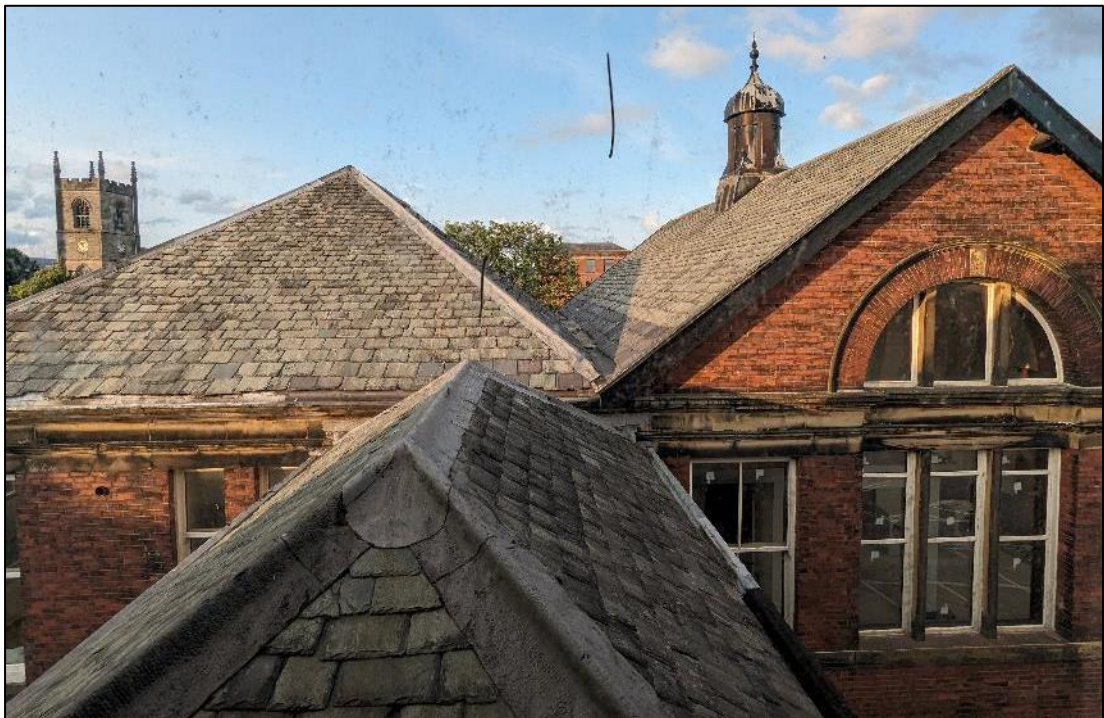
- 5.2.9 The surveyed building sector comprised an early C19th two-storey brick-built section of building with some decorative stone sections (i.e. banding course) (Plate 4). The roof was dual pitched with a dormer in the southeast elevation. The roof was covered with Westmorland slates, with a central tower present (Plate 7). The tower had a lead topped roof and metal sides. Gables were present on the roof, with wooden barge

**Plate 7. Looking northeast across roofs of Building Section 4 (in foreground) and Building Sections 1 (rear left) and 3 (rear right)**

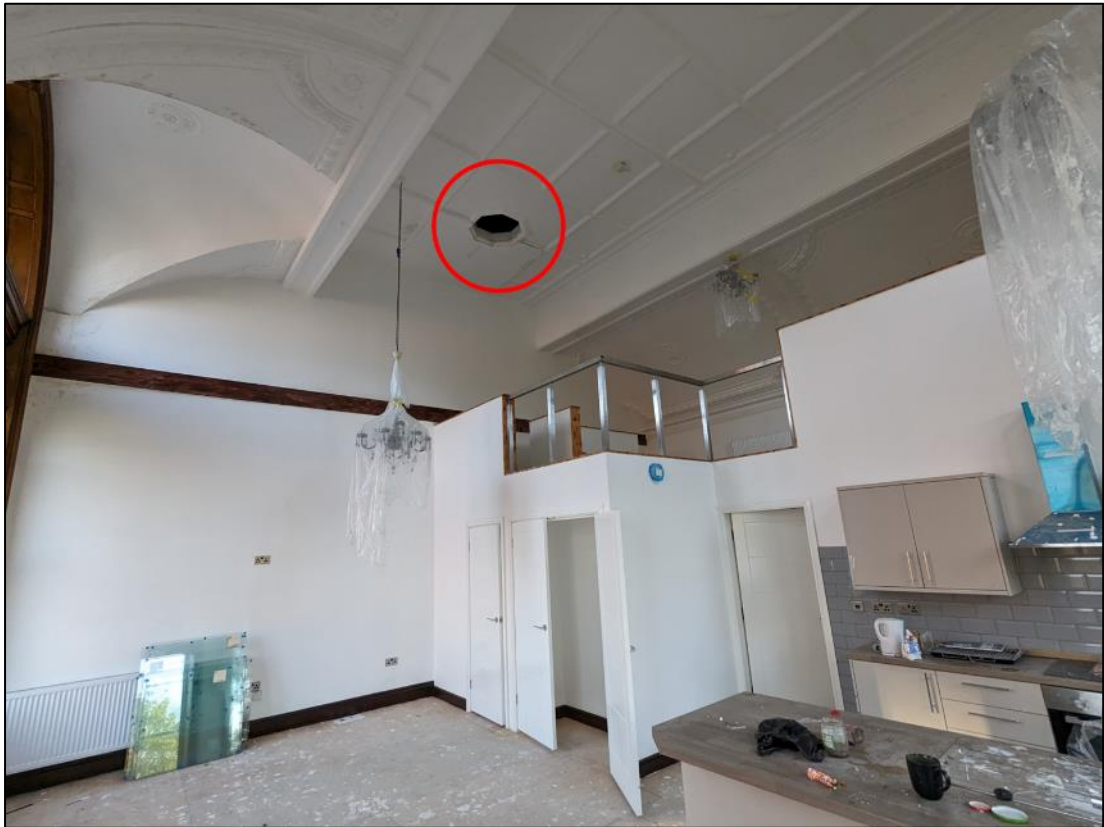
- 5.2.11 Much of what would be roof space comprised a living area. A small void (approximately 2 m high) was present beneath the tower (Plate 8), however, this could not be safely accessed. It could however be seen that the roof was lined with sarking in this area.

**Plate 8. Entry hatch to roof void in Building Section 3**

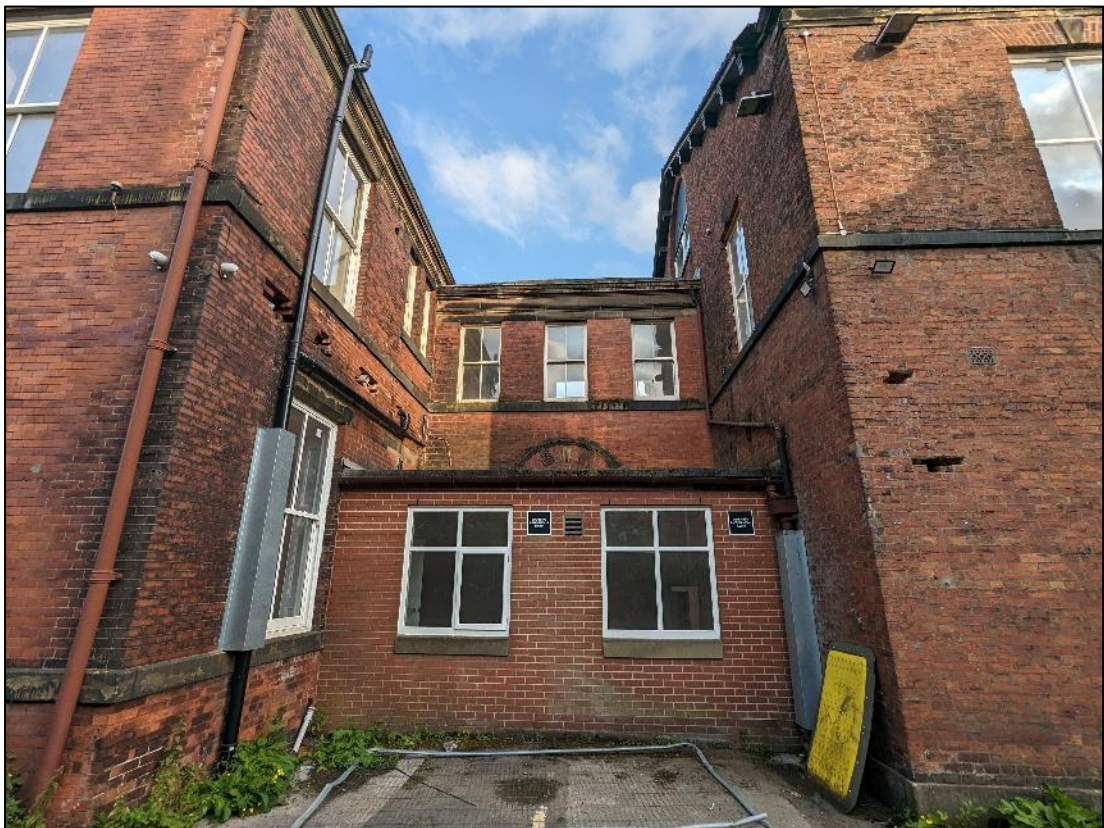
- 5.2.12 Building Section 4 comprised an entrance and connecting corridor between the northeast (Building Sections 1 & 3) and southwest (Building Section 2) wings of the building. Building Section 4 was brick-built and mainly two storey, with a single storey extension present on the northwest elevation (Plate 9). The two-storey section had a dual-pitched and hipped Westmorland slate covered roof with lead and felt ridge and hip coverings. The single-storey section had a flat roof. rainwater goods were internal and behind stone parapet wall tops. Windows comprised wood-framed sash units.

**Plate 9. Northwest elevation of Building Section 4**
