### Phase 1 Geo-Environmental Assessment and Coal Mining Risk Assessment

Land South of Hanson Close,  
Middleton, M24 2HD

Report Ref:  
19060-PWAG-00-ZZ-RP-G-1000-P01

Prepared for:  
Middleton Sheet Metal Co Ltd

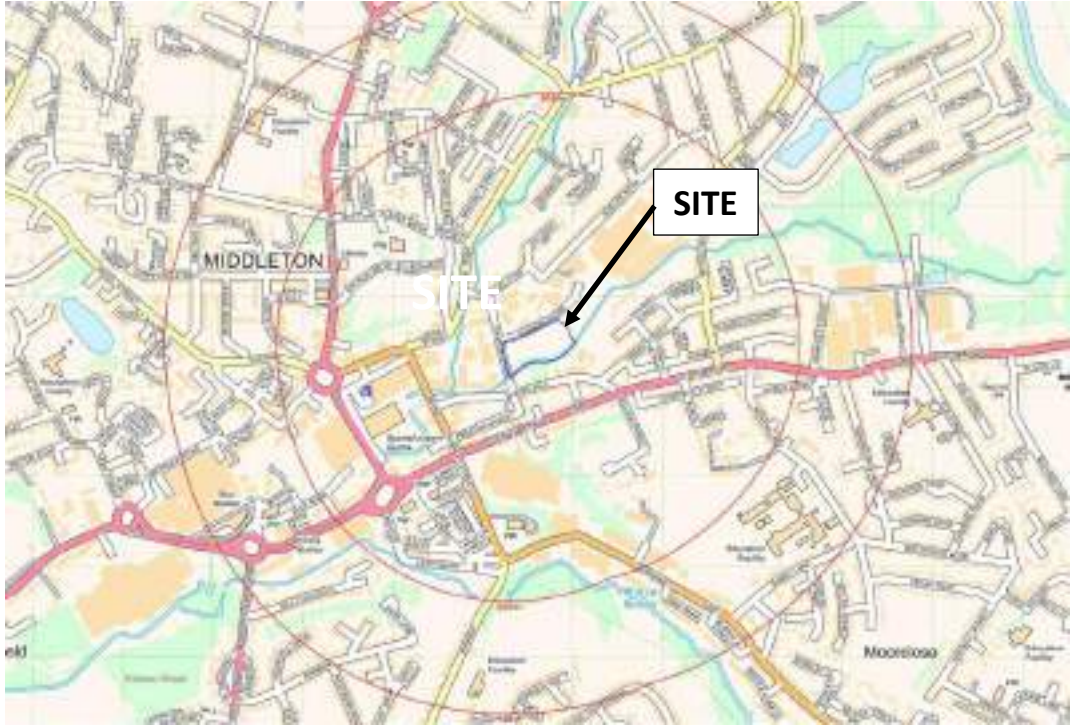
| Table 1. Site Location and Details | | |
|---|---|---|
| Location | <p>The site is located approximately 500 m north east of Middleton Town centre. <b>Figure 1</b> (reproduced from the Groundsure Report) is included as a site location plan.</p> | |

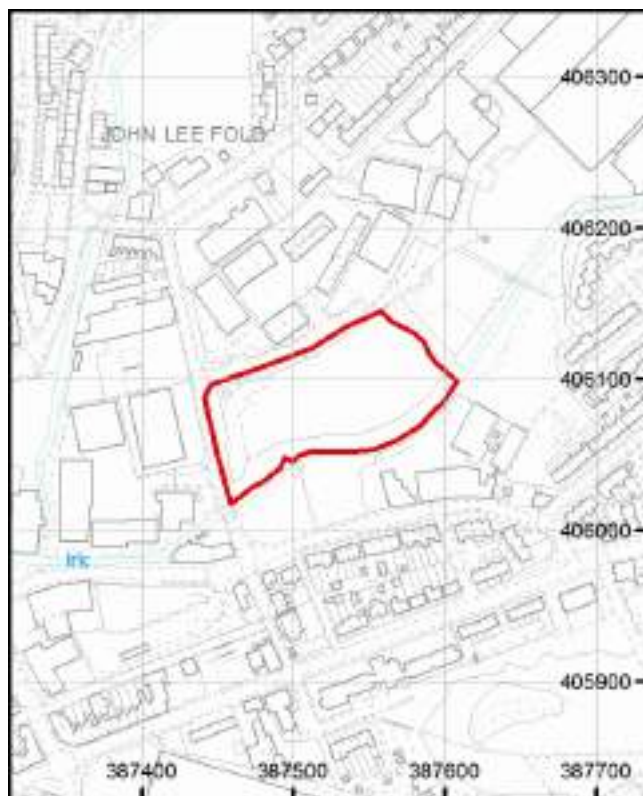
Approximate position of enquiry boundary shown

We can confirm that the location is  
**on the coalfield**
