REPORT NO: ZZ24035-2 REVA  
DATE: FEBRUARY 2025

LAND TO THE REAR OF  
19-47 KENYON LANE  
MIDDLETON

CONTAMINATED LAND  
ASSESSMENT

PREPARED FOR  
GR JONES PROPERTY LTD

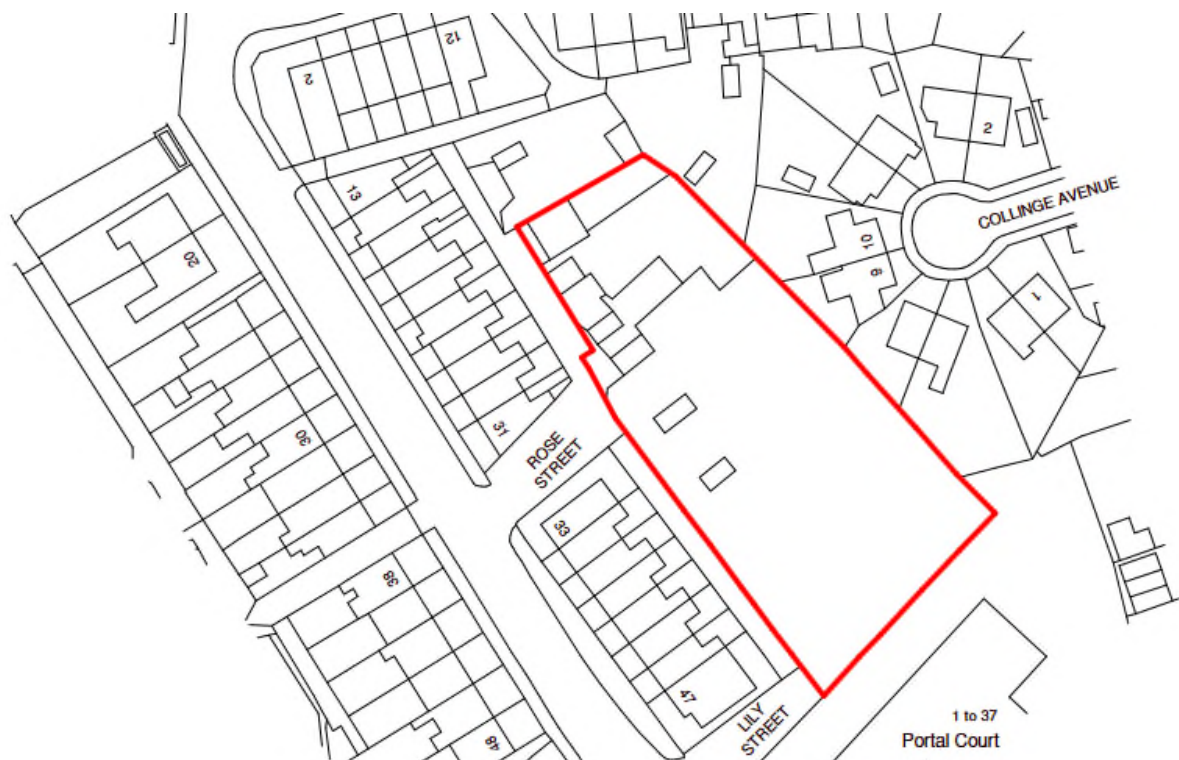
**Figure 1 - Site Layout**

The existing site layout is illustrated on Figure 1, an extract from Whitebox Architecture Drawing No 2693-100 Rev B.

According to Sub Surface the garages shown in the northern and western parts of the site were removed prior to its walkover survey in January 2023. At Section 1.3 of the desk study report Sub Surface reports that '*general waste (including asbestos cement sheeting) found in the southwest that we understand from the Client is derived from the removal/clearance of the former garages on site*'.

The site is surrounded on all sides by residential properties, as illustrated in Figure 1 above.

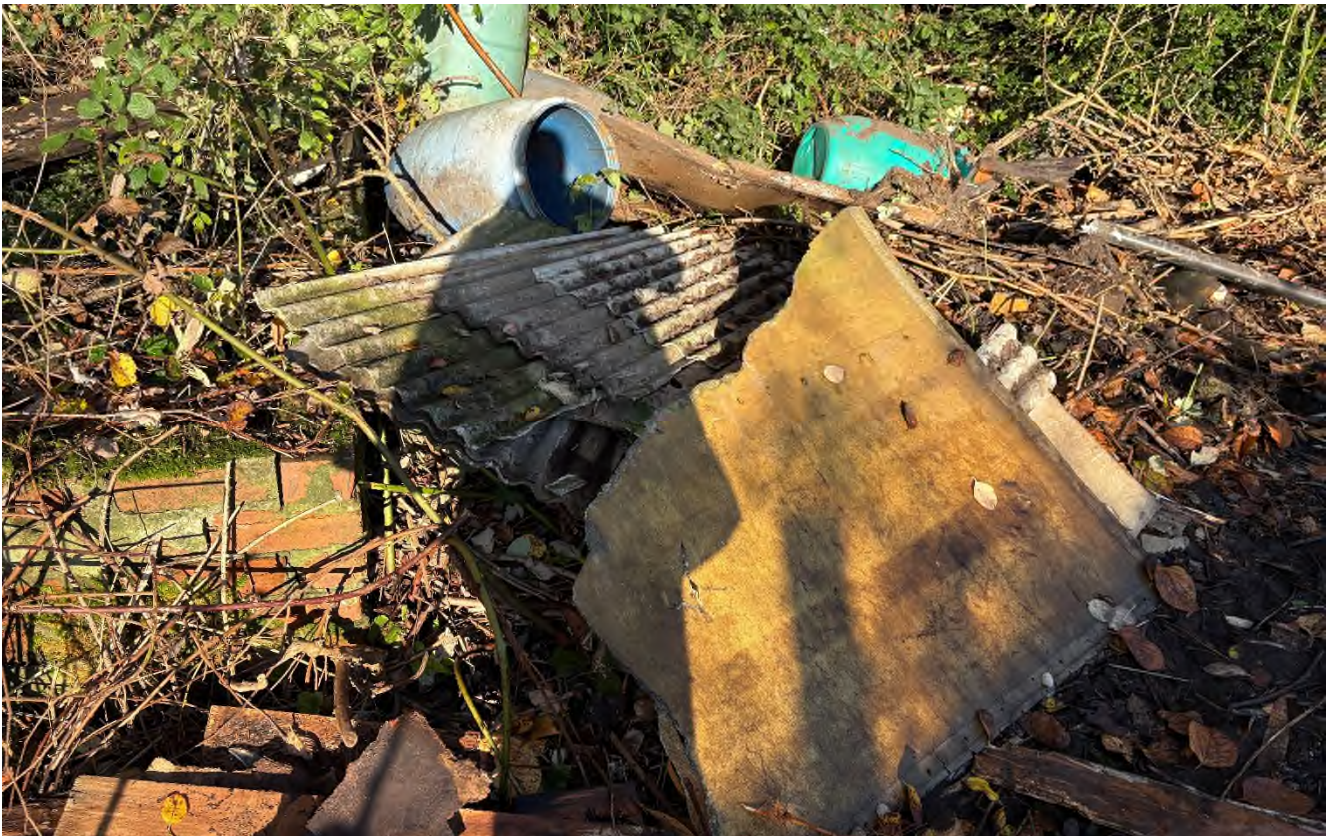
**Figure 2 – Asbestos Cement Panels**

The engineer supervising the trial pit excavations observed asbestos cement panels at the site in the north-east section of the site close to Trial Pit No 2 during the works. The panels were stacked together with some broken pieces, as shown in Figure 2 below.

The site has remained like this until present time, although the garages have been removed, although some debris, including asbestos cement panels remain on site.

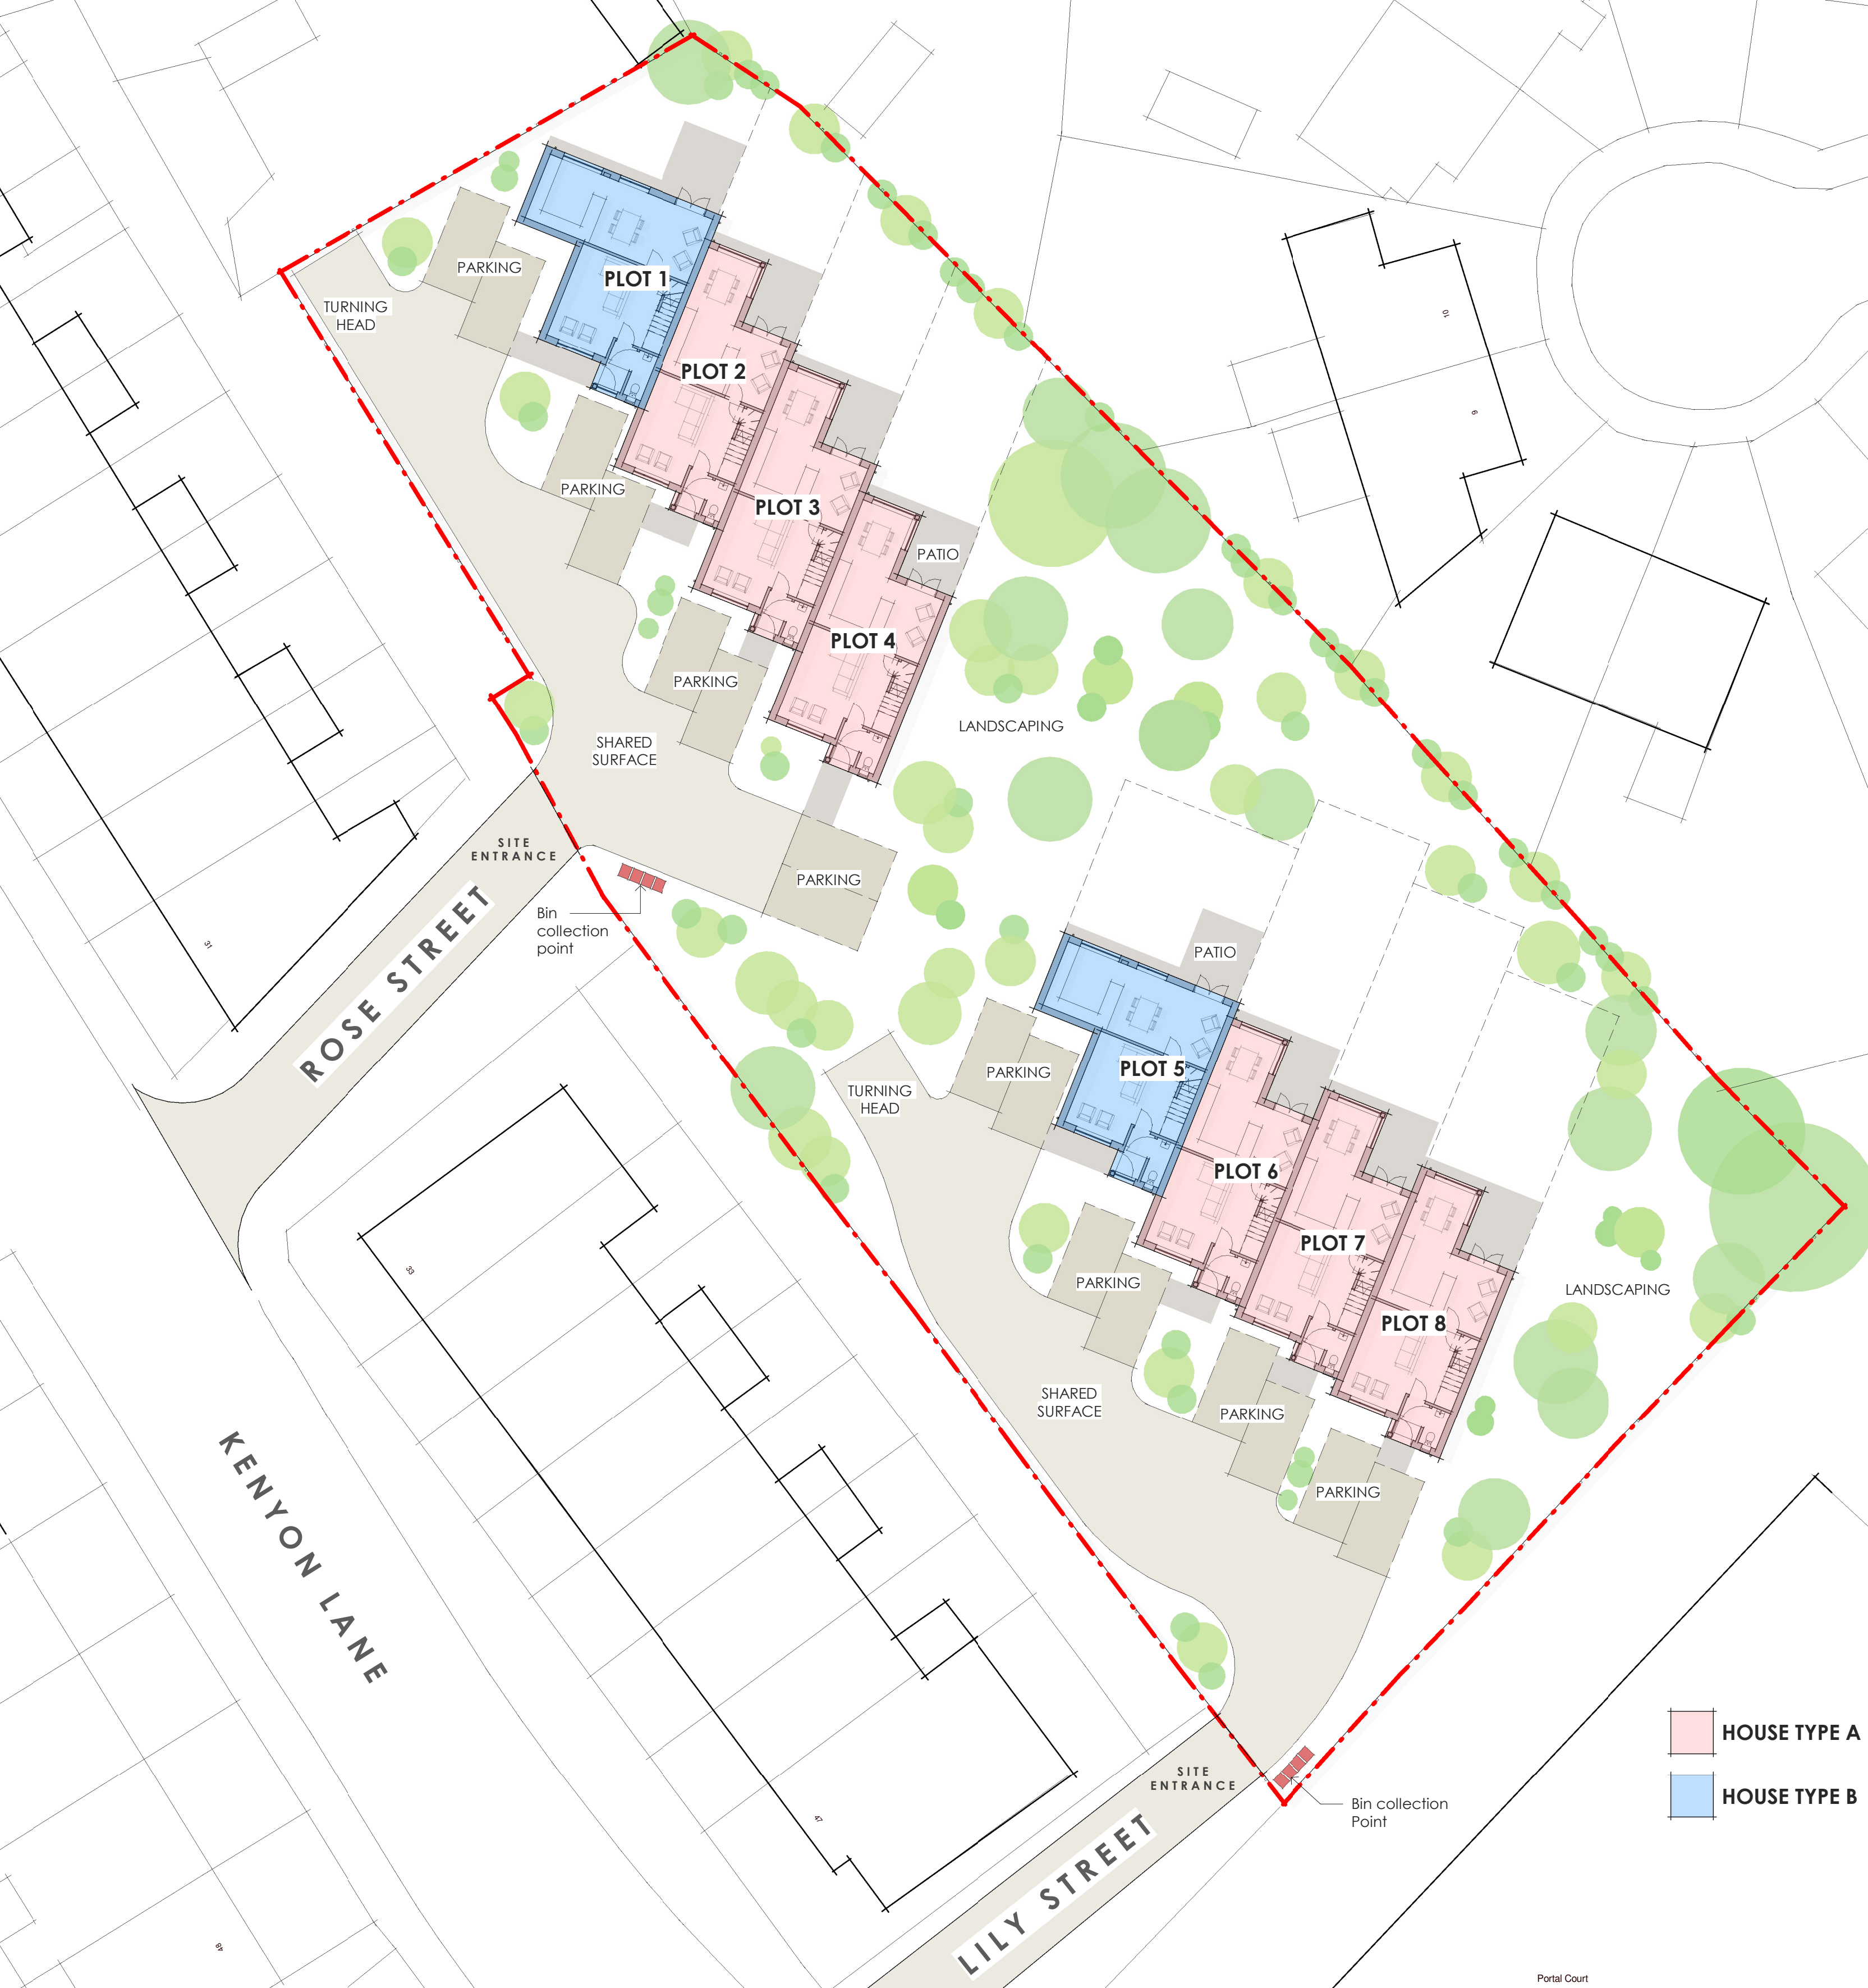
2693      200      C

**Proposed Landscaping Plan**  
1 : 200

The development proposals are illustrated on White Box Architecture Drawing No 2693-200 Rev C, presented at Appendix F.

The approved development comprises:

- two blocks of 4 residential dwellings with car parking, front and rear gardens
- two separate accesses one off Rose Street and the second off Lily Street and private roads/cul-de-sacs accessing the individual properties
- areas of landscaping, which appear to be outside of the proposed gardens
