# GEO-ENVIRONMENTAL AUDIT

PHASE 2 Site Investigation & Risk Assessment

PHASE 3 Remediation Statement

Former Sladen Mill

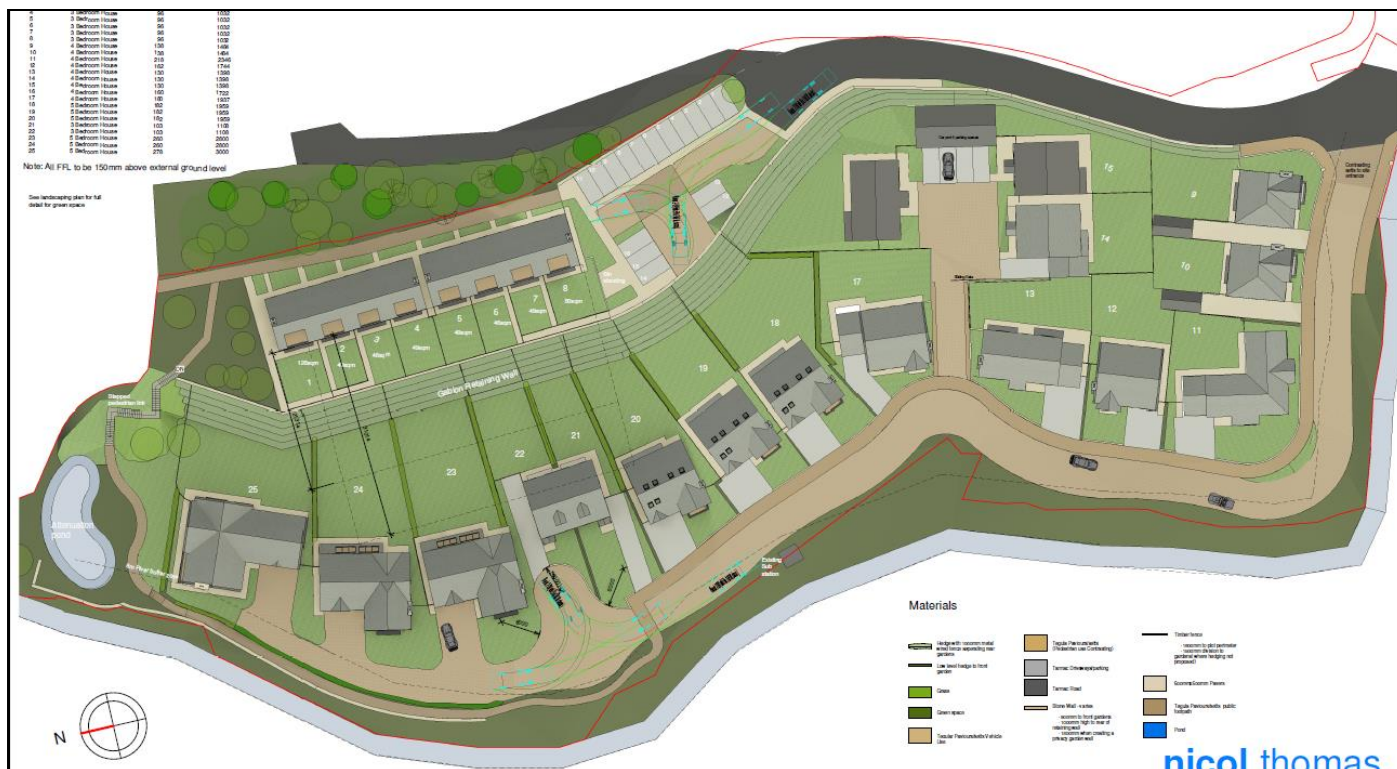
## 4.2. Proposed Development.

The proposed development has been revised in the reserved matters application to comprise 25No. residential dwellings. Rochdale MBC in particular have specified changes in the layout as well as insisting on the pond to the north side of the development.

The Site is split into upper and lower parts: The upper part is accessed via an existing lane, and will have 8No. terraced dwellings with associated communal parking area and private gardens. The lower section of the Site will have 17No. detached residential dwellings with private parking/drives & garden areas. This part of the Site will be accessed via a new access road.

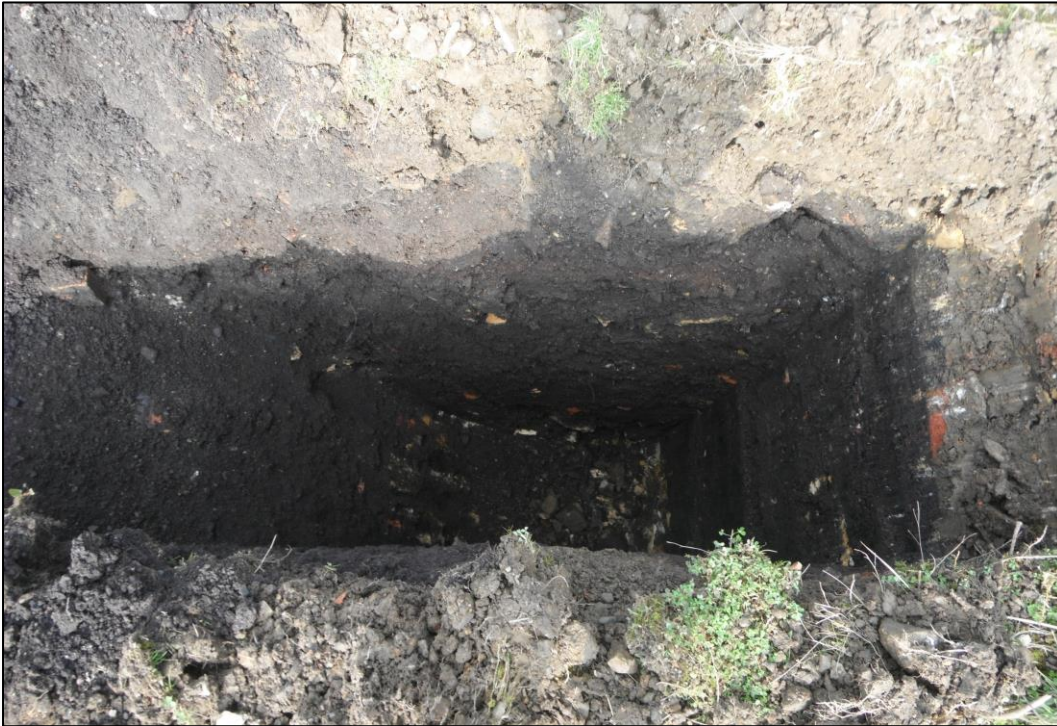
Trial Hole 1.

- TH1 (around the old refuse tip) where the made ground was made up predominantly of gravel & sand sized brick, stone, glass & ash.
- TH4 around the location of the historic part of the mill where depths in excess of 4m of brick & stone rubble fill was noted without reaching bedrock noted everywhere else across the Site. The depth is assumed to be due to basements

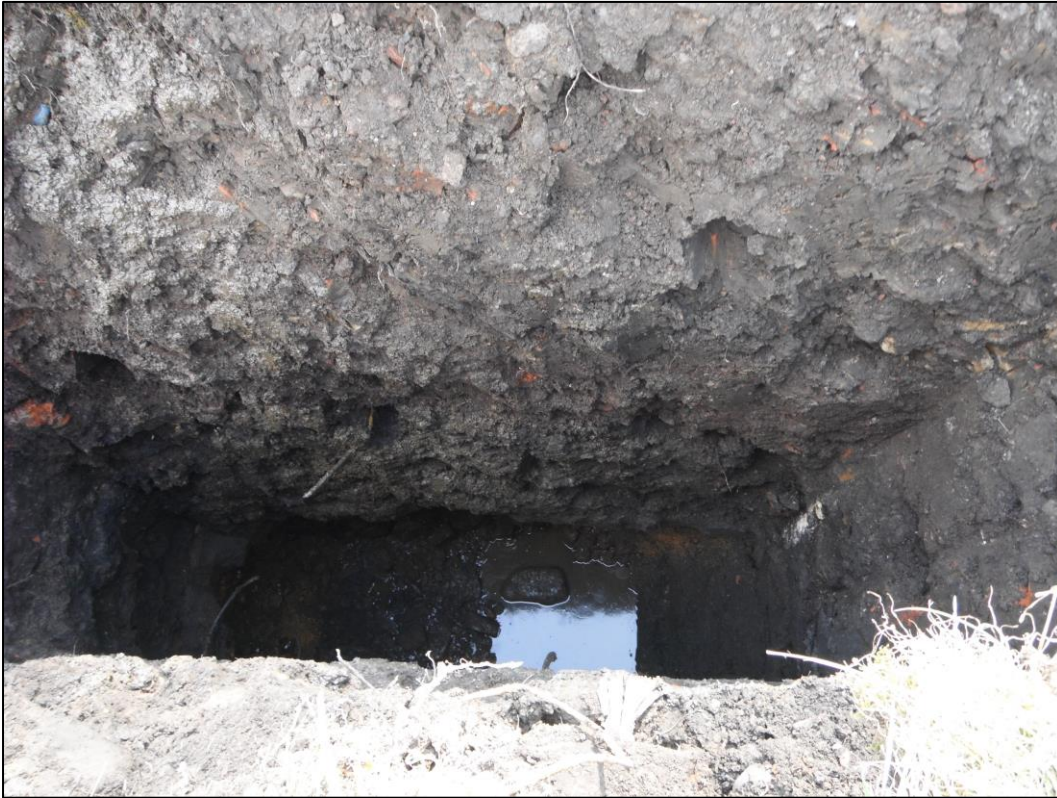
Trial Hole 7.

- TH7 to the north corner of the Site (lower section) noted hydrocarbon contamination at depth which appeared to be local only. No contamination was noted in either TH6 or TH8, both close by. The location is of TH7 was local to the former tanks.

General made ground across the Site has proven to be mildly contaminated with metals & PAHs, and asbestos which could be a risk to human health. In the location of TH7 at the far northwest corner of the Site, there is also some localised hydrocarbon contamination nominally 2.7m deep which could be a risk to controlled waters. No such material was noted in both trial holes closest (TH6 & TH8), so the contamination is considered to be localised, and most likely associated with former tanks noted on historic maps in this area

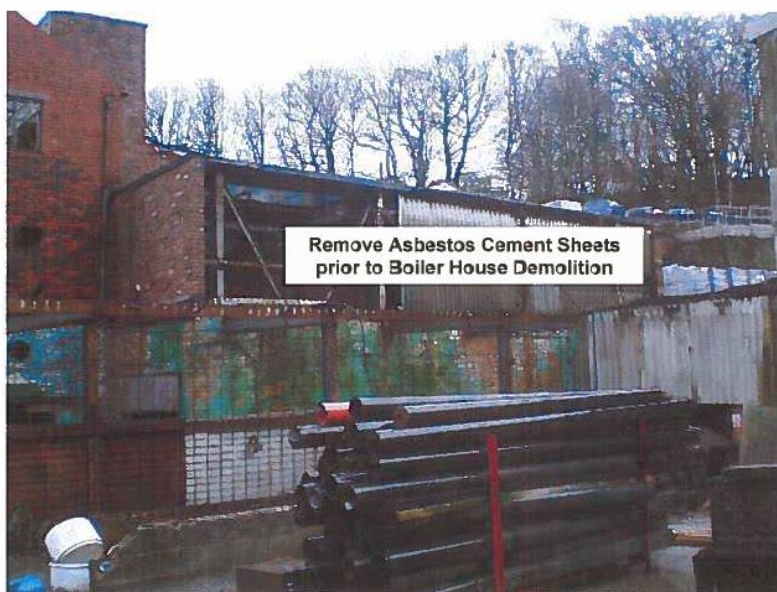
**Asbestos Cement Sheets to be removed prior to Boiler House Demolition**

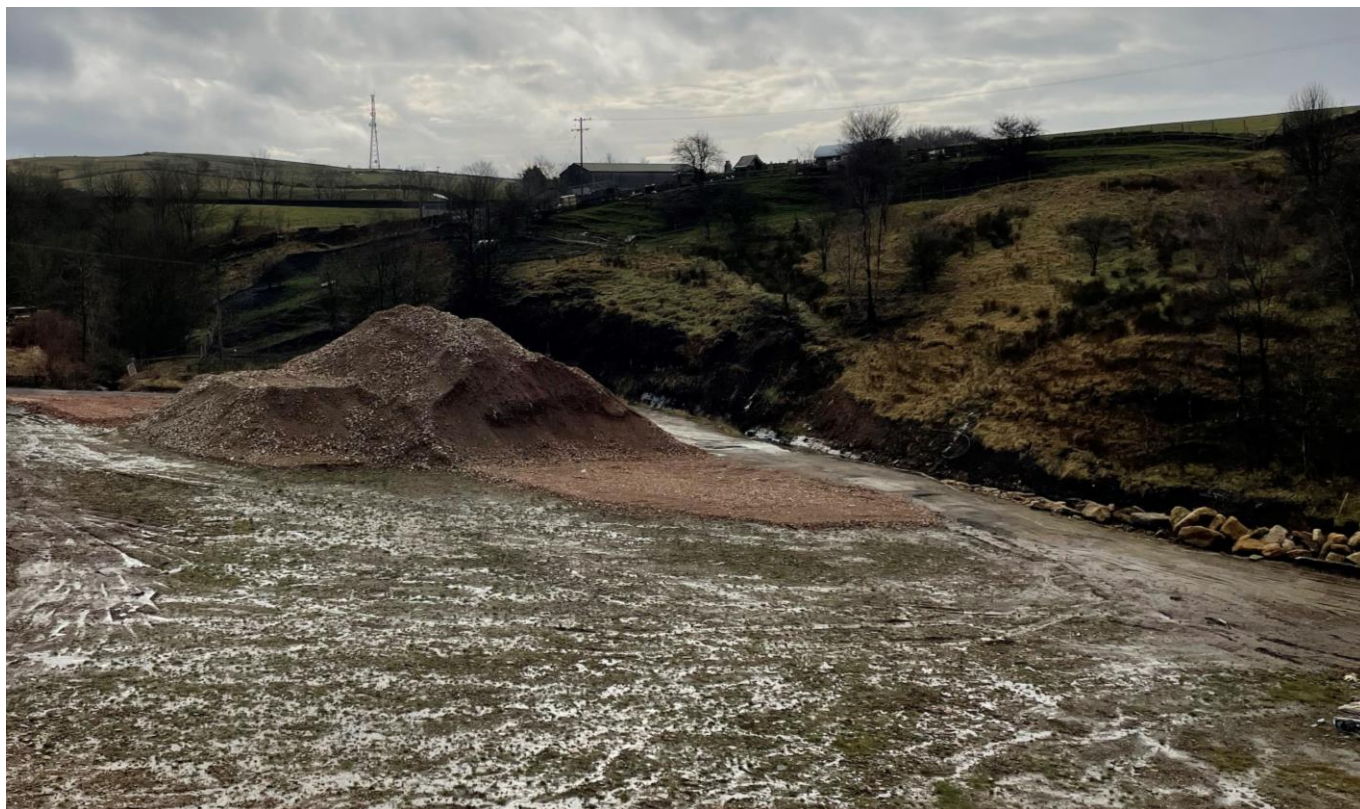
Remaining demolition material was crushed on-site and stockpiled close to the Site entrance to the south corner of the Site for later removal (supported by photographic evidence in the Appendix C).

Demolition crush which has now been removed from Site.

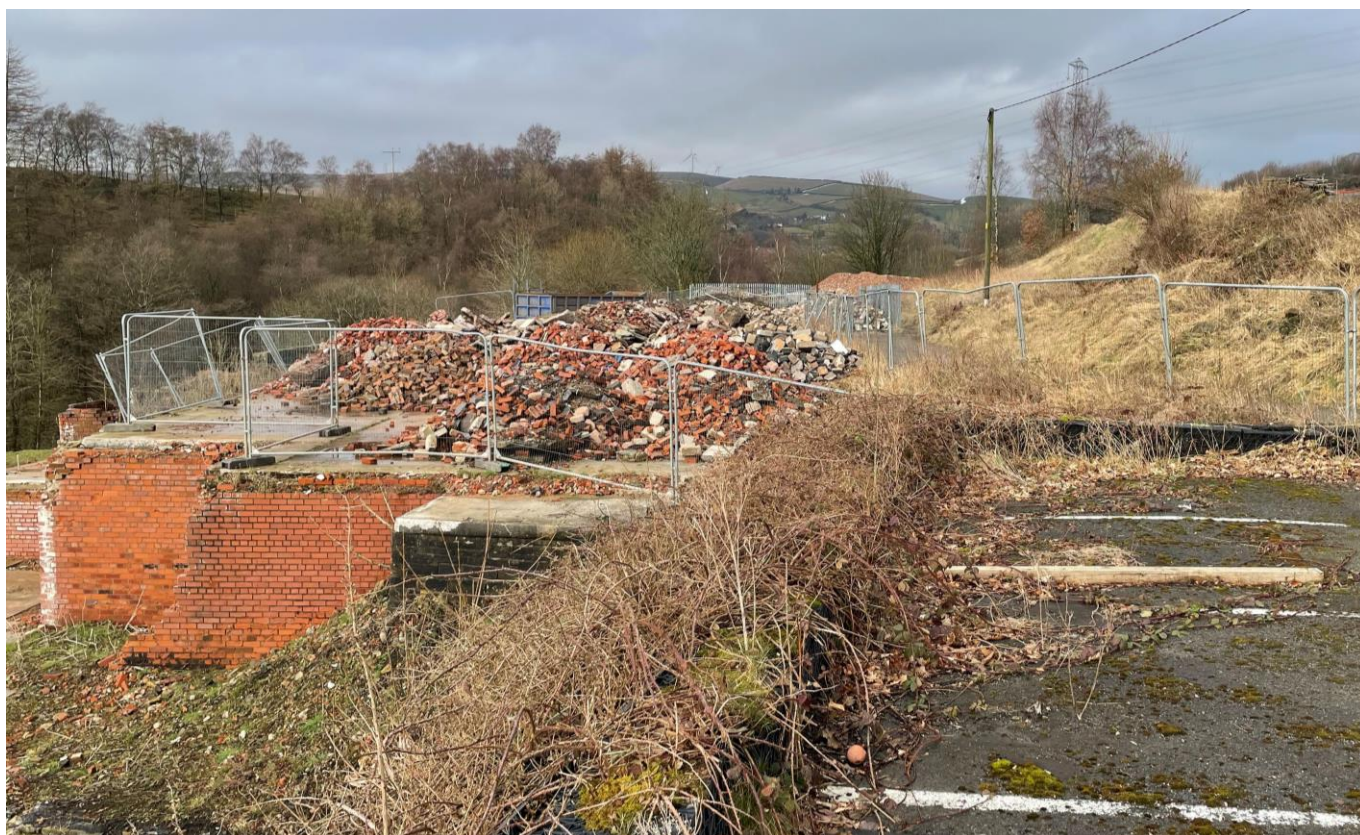
Demolition materials separated for removal.
