**Stables,  
Higher Moorgate Cottage,  
Gristlehurst Lane, Heywood,  
Manchester.  
OL10 4BJ**

**Survey & Assessment in Respect of Bat Species  
and Nesting Birds (including Barn Owl).**

**Echo Calls Bat Surveys**

**13<sup>th</sup> March 2022**

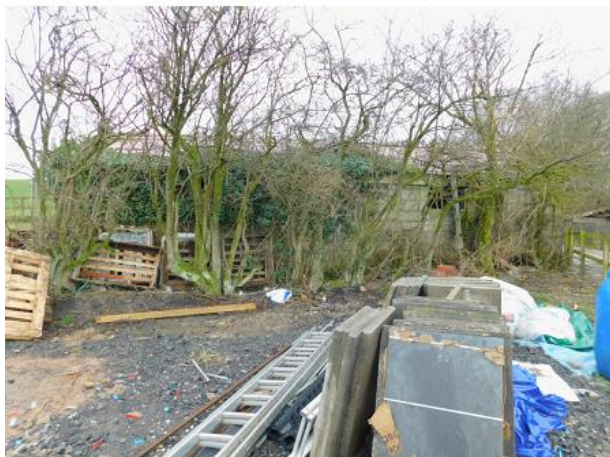
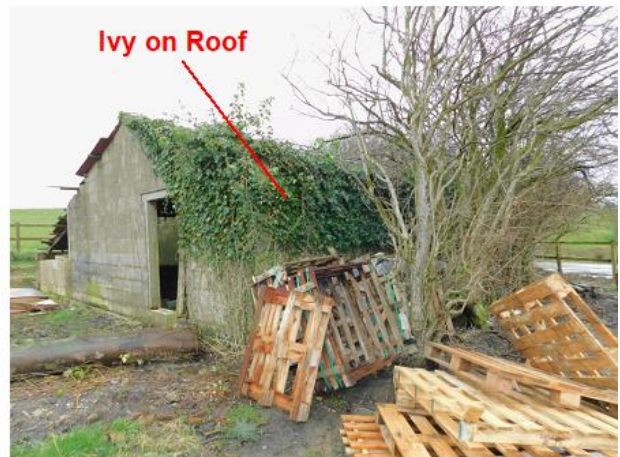
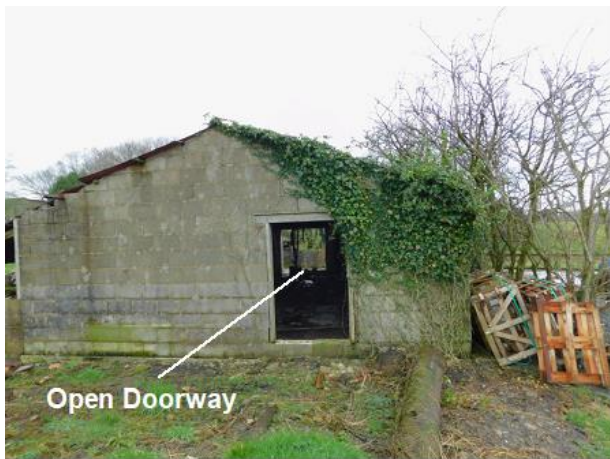
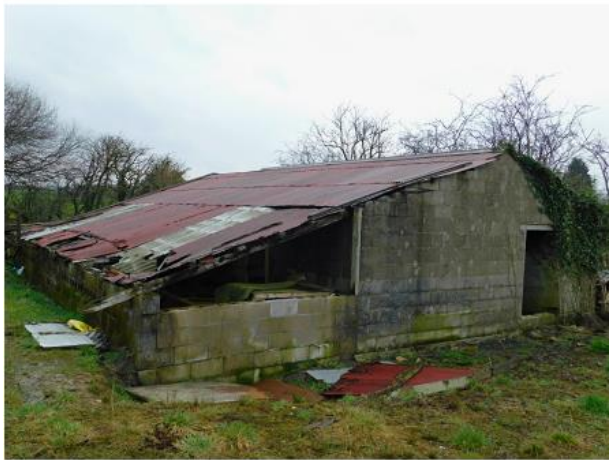
- There were several holes within two of the stable window shutters, positioned in the western elevation, but a search of the areas around the shutters, both internally and externally and the walls beneath them, and also a search of the holes themselves, found neither droppings, invertebrate prey remains, nor urine staining, nor fur staining from continued passage of bats through the holes, (refer to **figs 3, 4 and 5** and **photos 5 to 9**).

**PHOTO 5**  
**Southern Elevation of Chicken Shack**

**PHOTO 6**  
**North-western Corner of Chicken Shack**

**PHOTO 7**  
**Western Elevation of Main Building**

**PHOTO 8**  
**North-western Elevation of Chicken Shack**

**PHOTO 9**  
**North-western Corner of Chicken Shack**

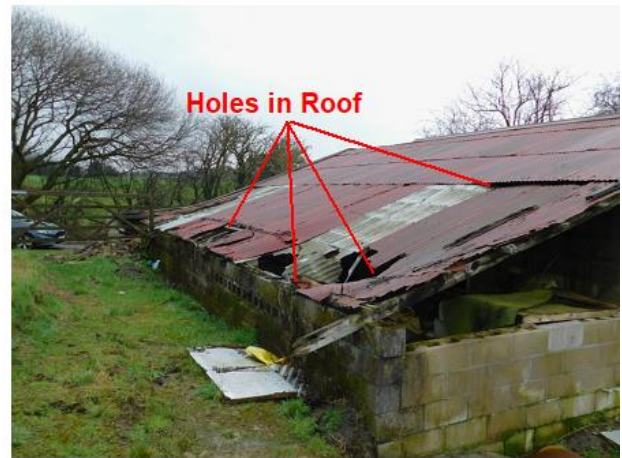
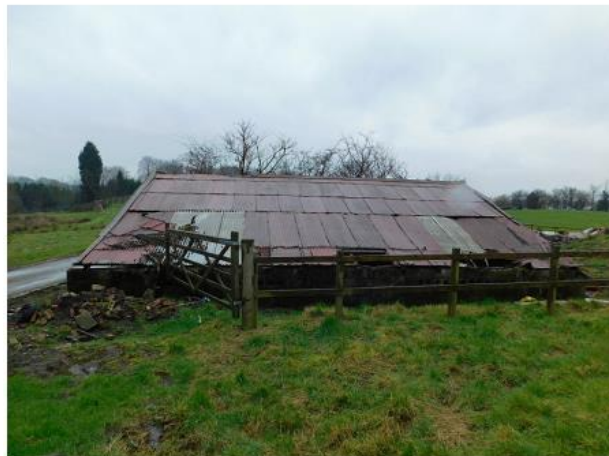
- The doorway at the south-eastern corner of the stables, and the western entrance to the porch were both open, but after a careful external and internal survey, no form of evidence of bat usage was found, (refer to **figs 3, 4 and 5** and **photos 9 to 11**).

**PHOTO 10**  
**View Along Northern Elevation**

**PHOTO 11**  
**Northern Elevation of Chicken Shack**

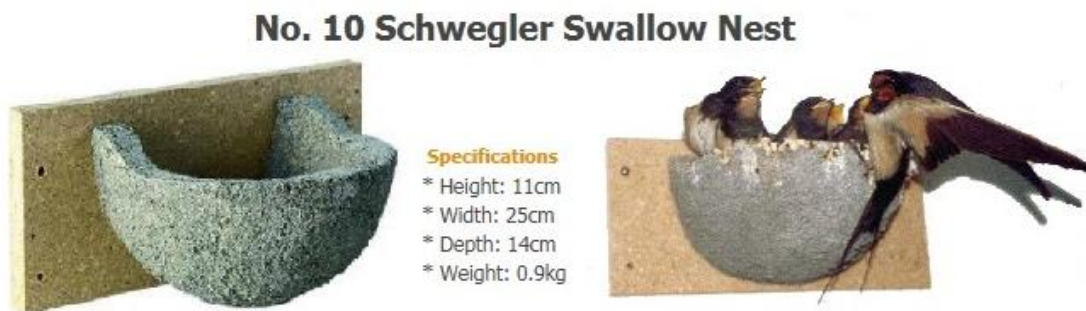
The Swallow Nest No. 10 consists of a woodcrete nesting bowl which is attached to a wooden panel of formaldehyde-free chipboard. The nest should be placed inside outbuildings such as sheds, barns or stables leaving a distance of at least 6cm between the top of the nest and the ceiling. You should ensure there is always access for the birds through an open window or sky-light. Swallows are sociable birds but multiple nests should not be placed at less than 1m intervals. Cleaning of the bowl is recommended, although not absolutely necessary.

These Woodcrete nest boxes are famous for their durability - lasting for at least 20-25 years. Woodcrete is a blend of wood, concrete and clay which will not rot, leak, crack or warp. They are backed by leading ornithologists, nature conservation organisations, government agencies and forestry experts. Schwegler boxes have the highest occupation rates of all nest boxes and are carefully designed to mimic natural nest sites and provide a stable environment for chick rearing and winter roosting.

To compensate for the possible disturbance, it is recommended that Schwegler No 10 woodcrete swallow nests are erected around the site.
