# Heritage Impact Statement

Client: Hopwood Hall College  
Project: Animal Management T Level Project  
Reference: HAT-SEV-XX-ZZ-RP-A-09100-P01  
Date: 30/01/2024

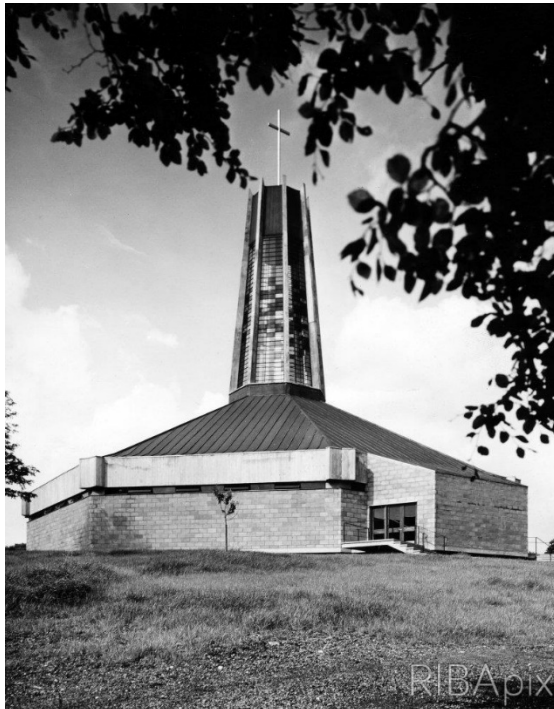
**Figure 3.11**

Photograph from 1965 towards the main entrance showing the overall building form and materials. (Source: [www.architecture.com/ribapix](http://www.architecture.com/ribapix), Ref RIBA11310, accessed 07<sup>th</sup> May 21)

The building was to be constructed using an in-situ concrete frame of concrete columns and pre-stressed concrete ring beams. The exterior walls were to be faced in functional concrete block, with a narrow clerestory window between the columns and below the eaves ring beam. The majority of the internal natural light was achieved through the dramatic coloured glass lantern at the centre of the structure. Glazed with clear, red, yellow and green glass, the lantern was designed by David Atkins. The design also incorporated underfloor heating.

The building was entered by a simple lean-to section to the south side of the building and was reached by a dramatic set of flying concrete steps.

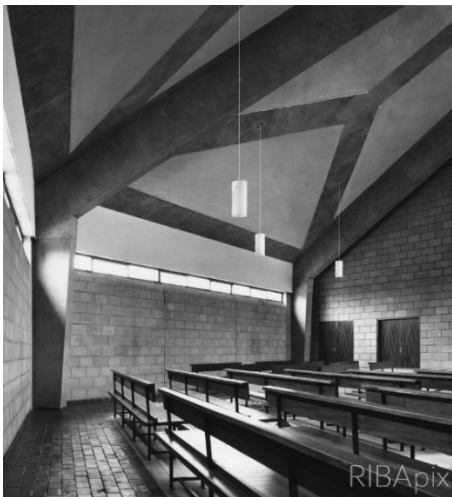
**Figure 3.14**

Photograph from 1965 showing the interior of the Chapel and the exposed materials.

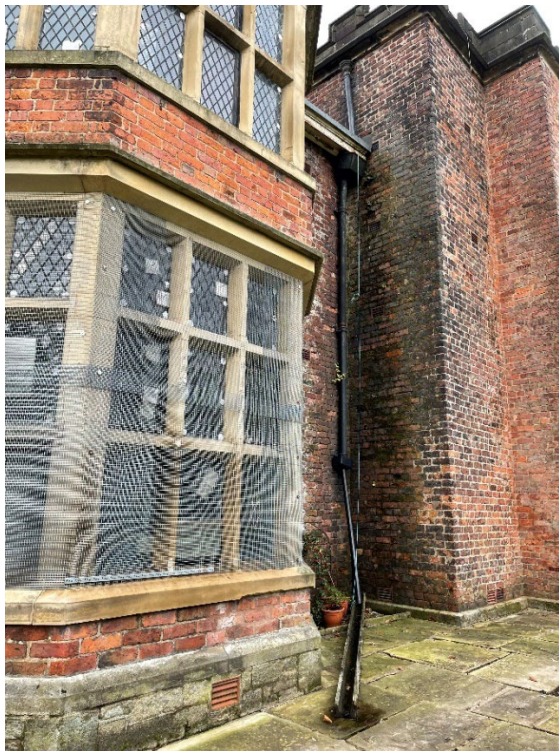
**Figure 3.21** Rainwater pipe failure affecting the brickwork to the south-east of the Hall.

There are multiple pressing issues contributing to the worsening condition of the Hall. One of the main substantial issues is the fact that the Hall is not watertight, with water ingress causing major damage to internal historic detailing as well as effecting the structural stability of the building. The West Wing of the building is currently in a very bad and unsafe condition, with some areas where the structure isn't sound and other areas where the stability of the structure is still unknown. It is assumed that the deterioration of the roof and chimneys over time, with the addition of lead being removed due to theft, has allowed for water ingress which has accelerated the decline of structural members. The west wing has been propped however there are still areas deemed unsafe to access without guidance from the onsite maintenance team due to the precarious nature of the structure. On the South and South-East elevations there is widespread rainwater pipe failure including leaks. Some areas of the brickwork have therefore deteriorated more than others due to water saturation. The inability to shed water effectively has led to the general decline of the structure. The lack of access to the roof has rendered maintenance troublesome and over time has led to the growth of vegetation from elevations and chimneys.

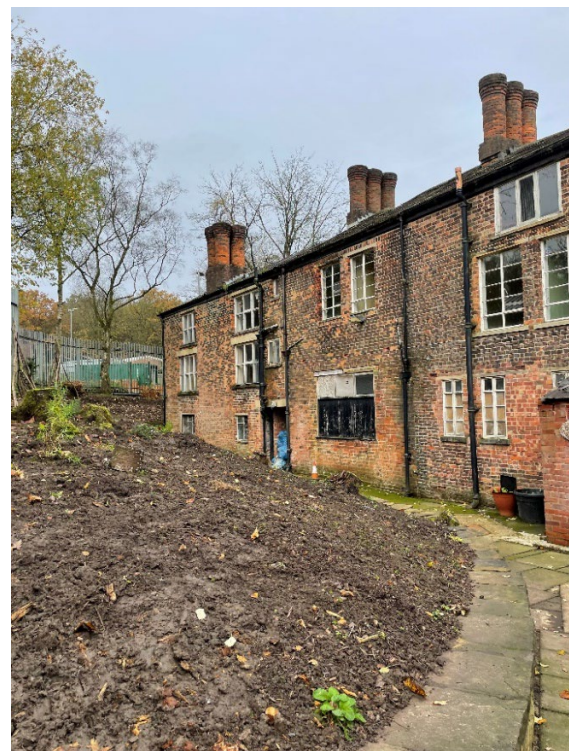
**Figure 3.22** West wing of the building which is in a very unsafe condition structurally.

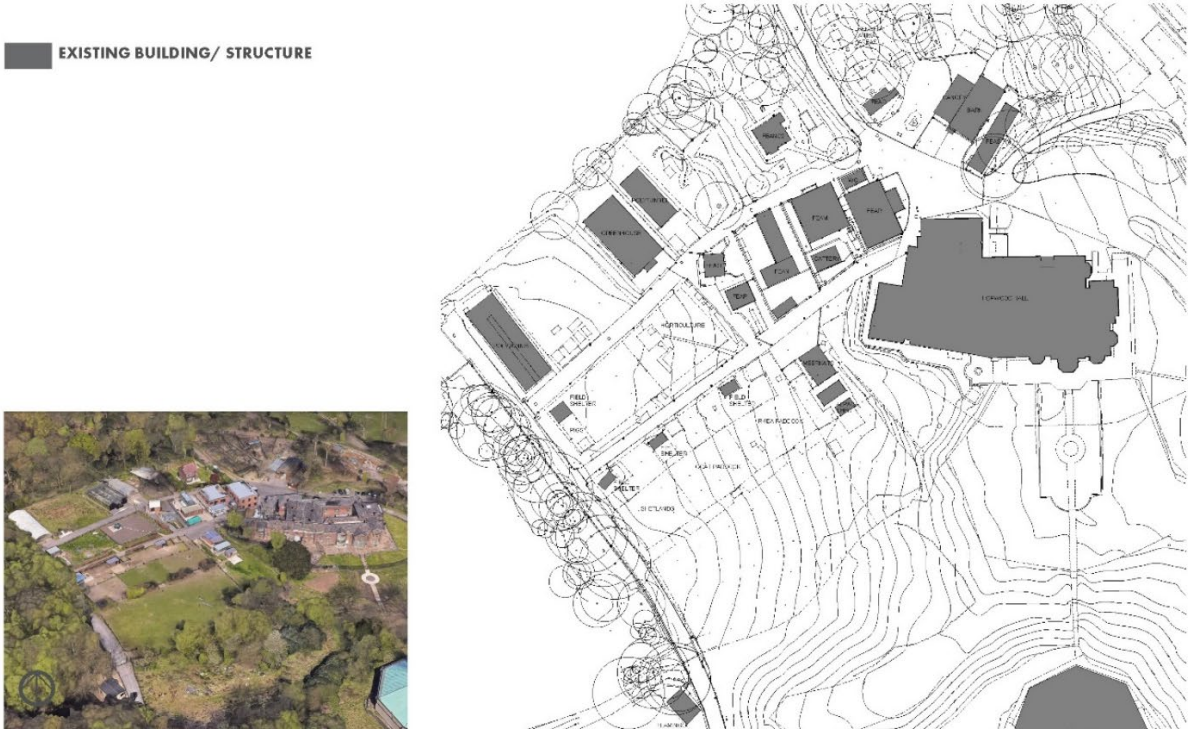
Figure 6.1  
Existing Site Plan  
(Seven Architecture, 2024)

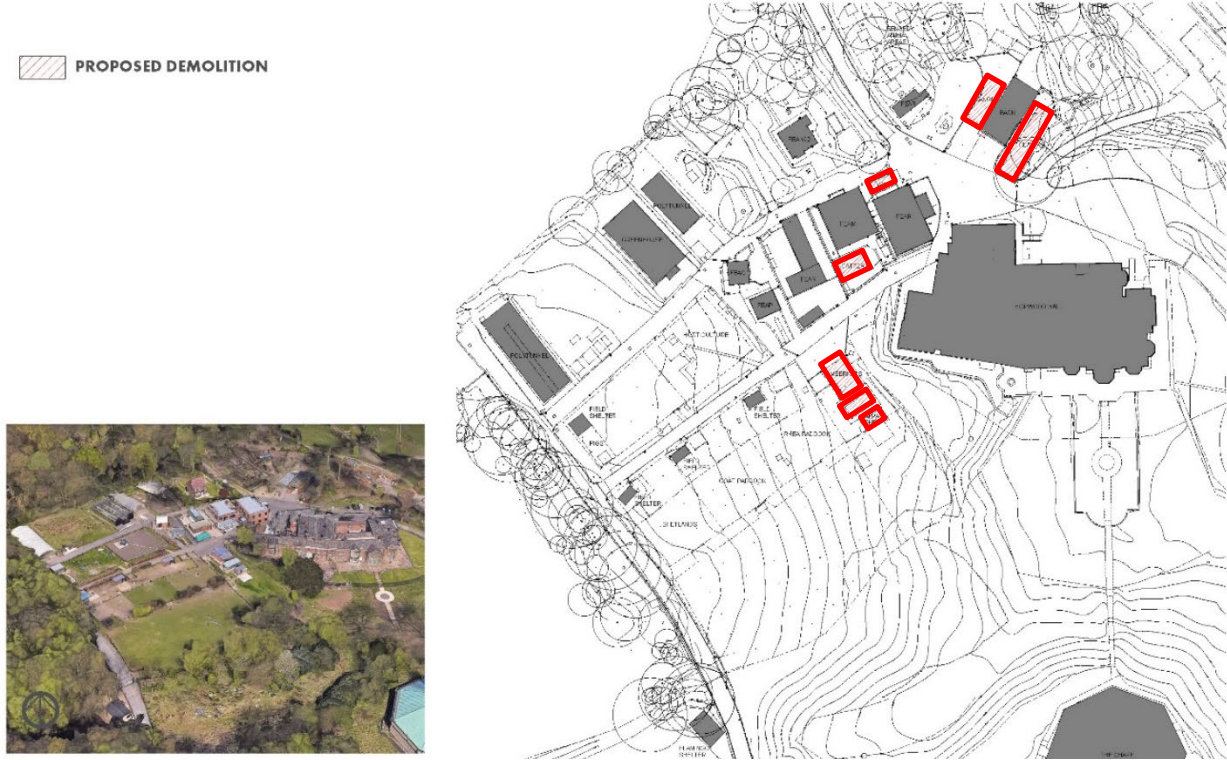
Figure 6.2  
Proposed Demolition Plan  
(Seven Architecture, 2024)

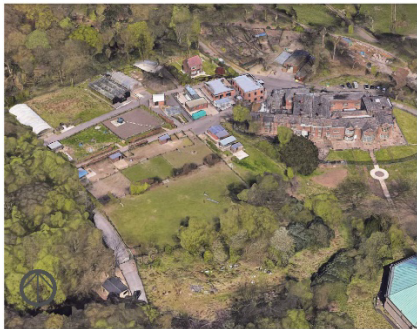
**Figure 6.3**  
Proposed Site Plan  
(Seven Architecture, 2024)

The above Proposed Site Plan (Figure 6.3), illustrates the proposed works to improve the quality and facilities within the existing buildings.

- Refurbishment and extension to the north of the double height barn to the north of Hopwood Hall (BARN)
- Single storey extension to the north of the Smallbridge building (FEAR) to provide WC and Locker storage for students.
- The refurbishment of the Smallbridge buildings (FEAM and FEAR)
- New Meerkat enclosure built to the south of Smallbridge (MEARKAT)
- Installation of a new Cattery building to the north-west of the existing two storey barn (CATTERY)
- Upgrade of the existing Polytunnel to reduce its visual impact
- Relocation of the Alpaca Shed and associated enclosure towards the far south-west of Hopwood Hall (ALPACA).

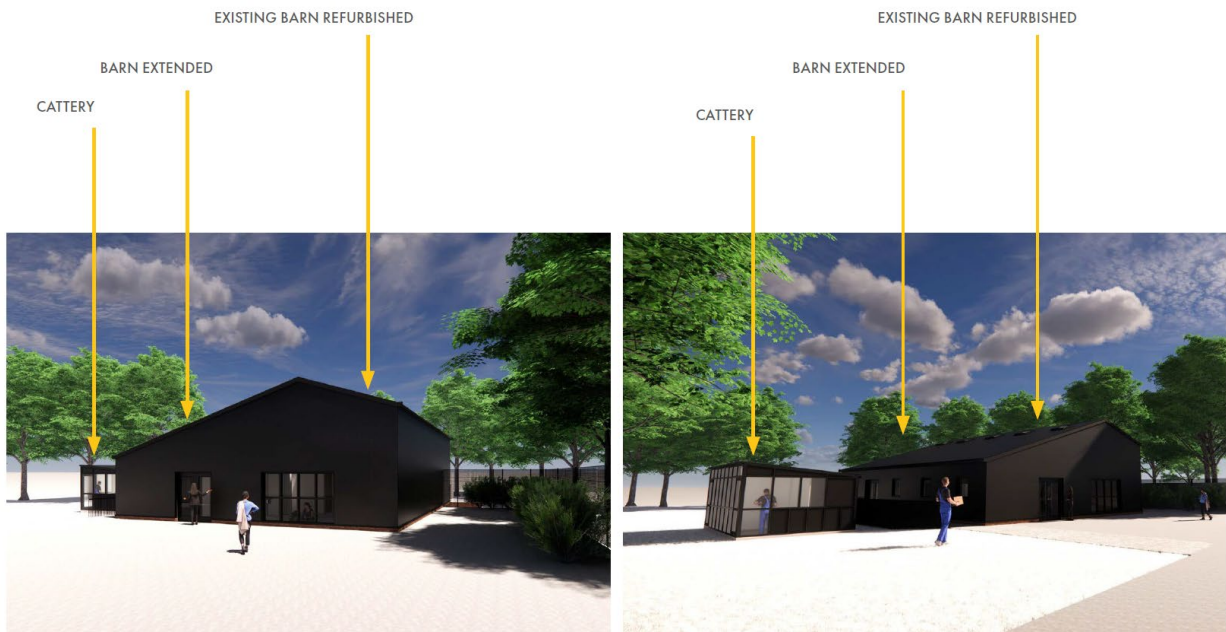
**Figure 6.5**  
Proposed indicative visuals showing the removal of the single storey barn and the extension of the retained barn  
(Seven Architecture, 2024)
