# GEO-ENVIRONMENTAL AUDIT

PHASE 1 Preliminary Risk Assessment

Proposed Residential Development

Woodheys Road

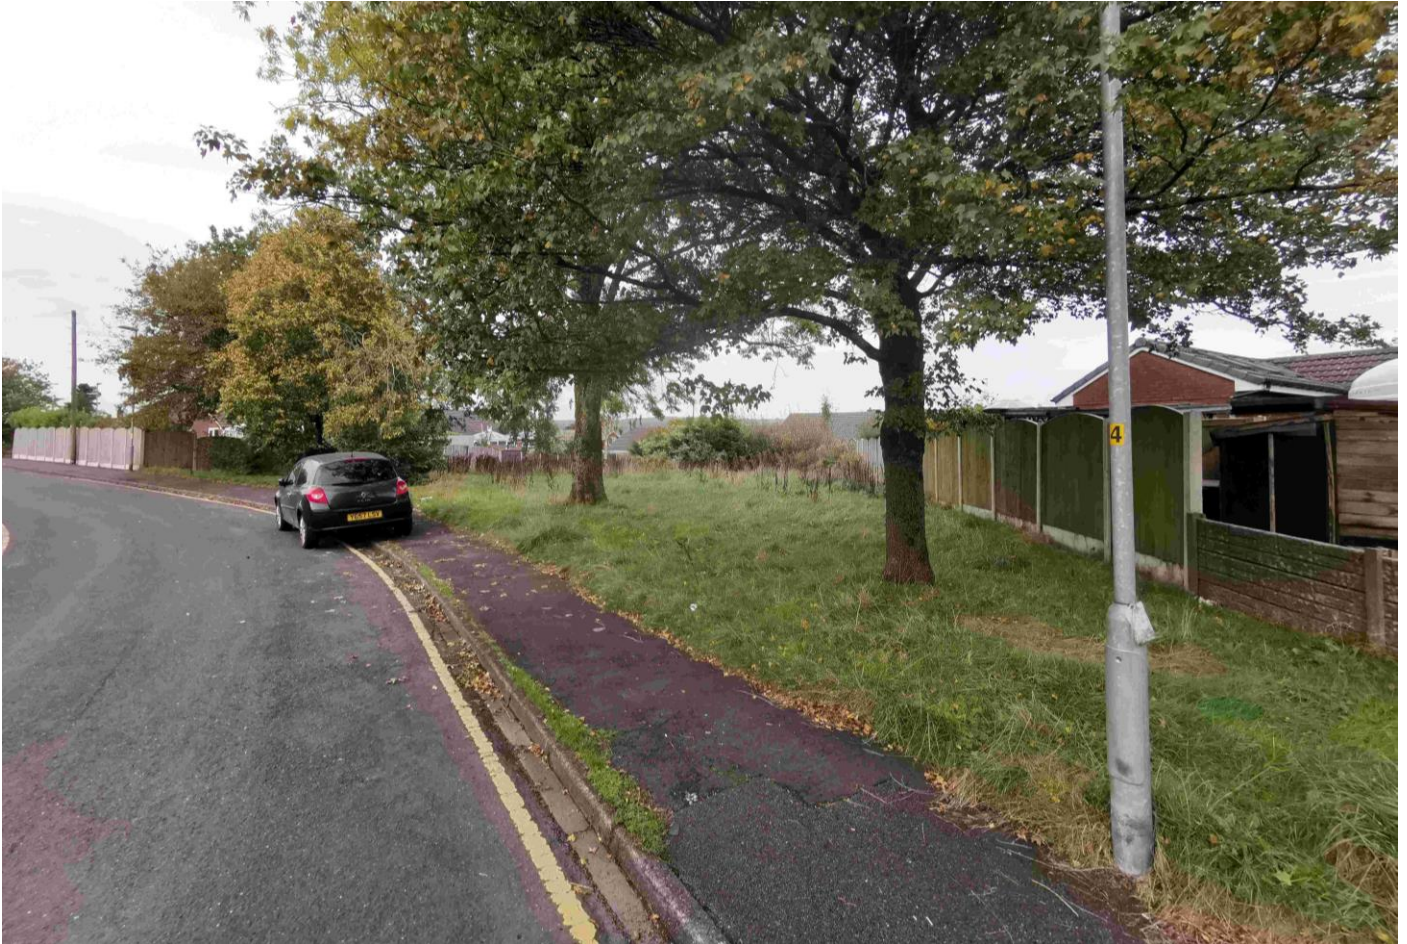
Site view from Woodheys Rd.

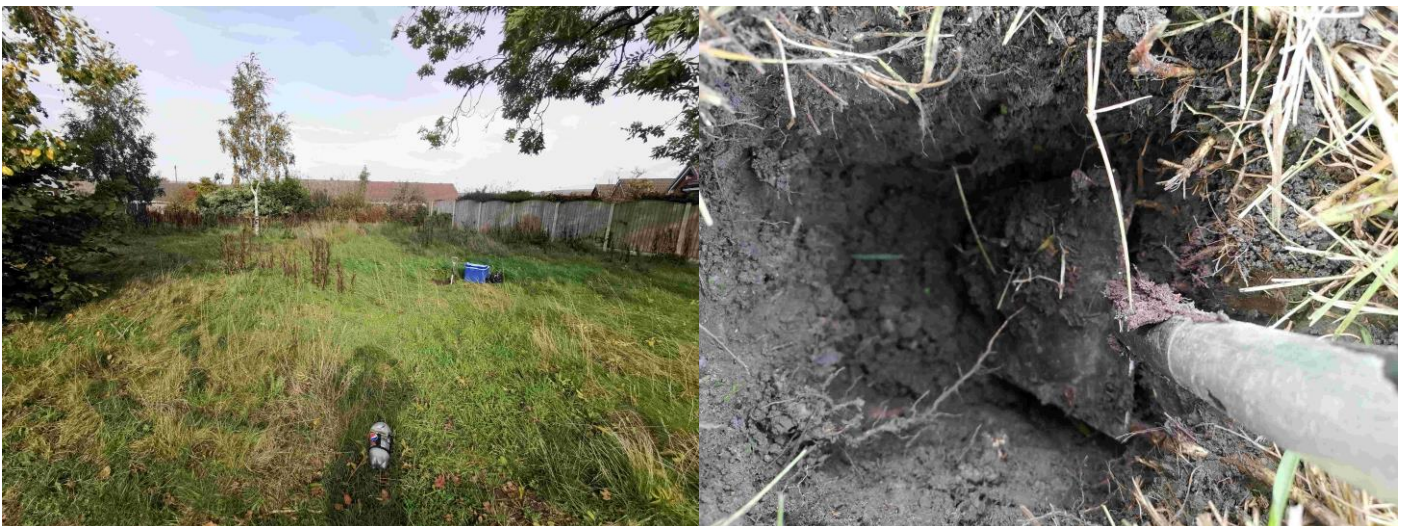
TP1/S1 location.

- TP1. GL: 177.76  
0-400 Soft dark brown very slightly sandy, slightly gravelly clay topsoil MADE GROUND (damp). Gravel is stone & rare brick. (S1)
- TP2. GL: 177.63  
0-400 Soft dark brown slightly sandy, gravelly clay topsoil MADE GROUND (waterlogged). Gravel is shale, stone & rare brick. (S2)
- TP3. GL: 177.75  
0-300 Dark brown slightly sandy, slightly gravelly silty TOPSOIL (dry). Gravel is stone & rare brick. (S1)  
300-350 Stiff orange/brown grey mottled CLAY
- TP4. GL: 177.15  
0-400 Soft dark brown slightly gravelly clay topsoil MADE GROUND (damp). Gravel is stone & rare brick. (S1)

The trial pit excavations albeit shallow, confirmed clayey fill in TP1, 2 & 4; and found what appeared to be topsoil over stiff clay (both suspected as virgin ground).
