**THE ARCHAEOLOGY CO.**

Dewhirst House, Rochdale  
Heritage Statement

December 2024

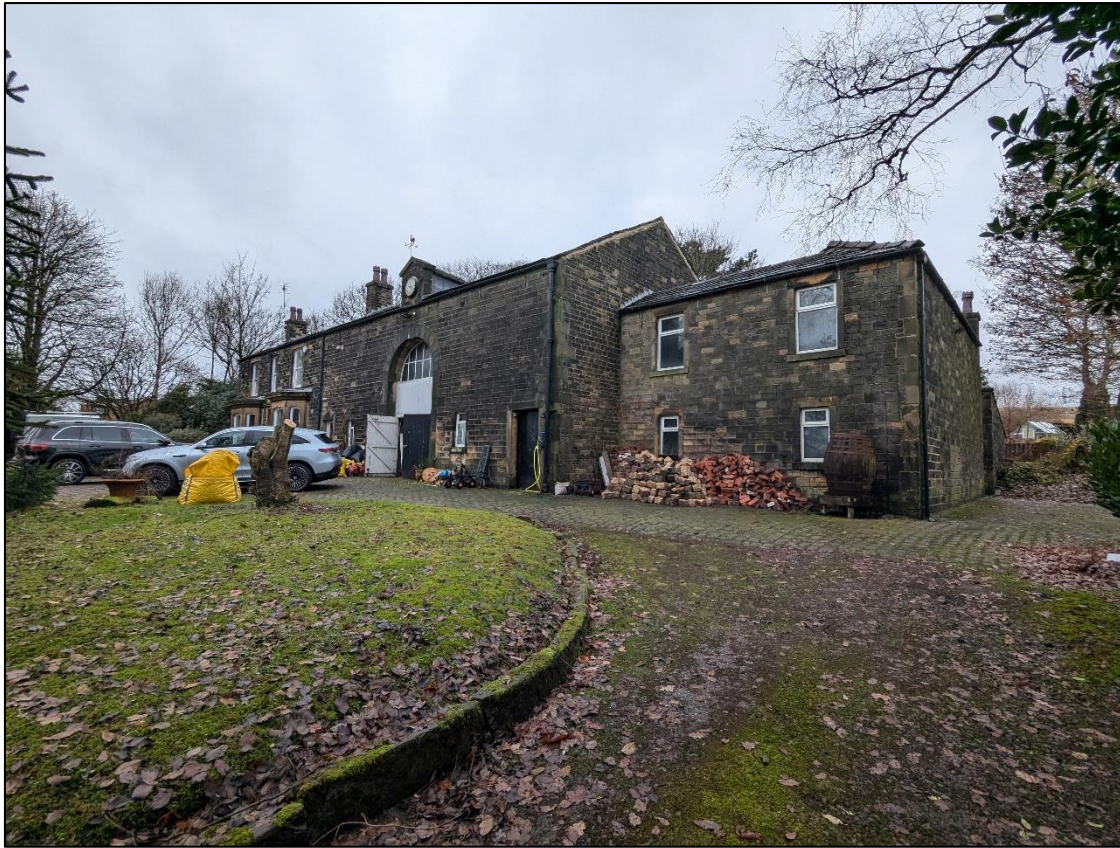
Plate 1: General shot of Dewhurst House

- 5.1 The site was visited on the 5th December when the buildings were inspected and photographs were taken.
- 5.2 The building comprises a two unit house, with extension to the rear, barn extension to the east and L-shaped stable extension to the east of the barn (plates 1 – 2).

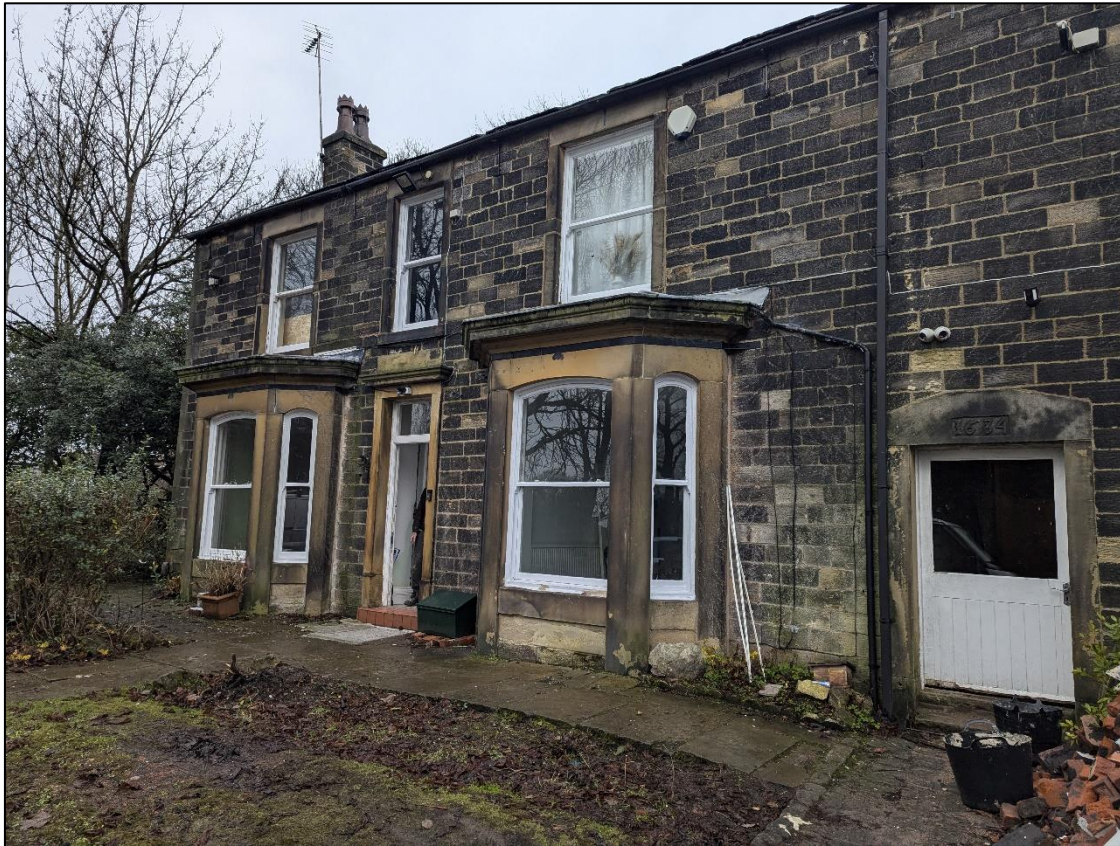
- 5.3 South elevation. This forms the main frontage of the range, with the house to the left (plates 3 – 5). This is three bays wide with a pair of sandstone bay windows flanking a central doorway, with sandstone surround. Timber framed sash windows with nibs are present to each of the bays at first floor level. The whole is constructed in watershot stone. A straight joint marks the end boundary between the house and the barn.

Plate 3: South elevation of house

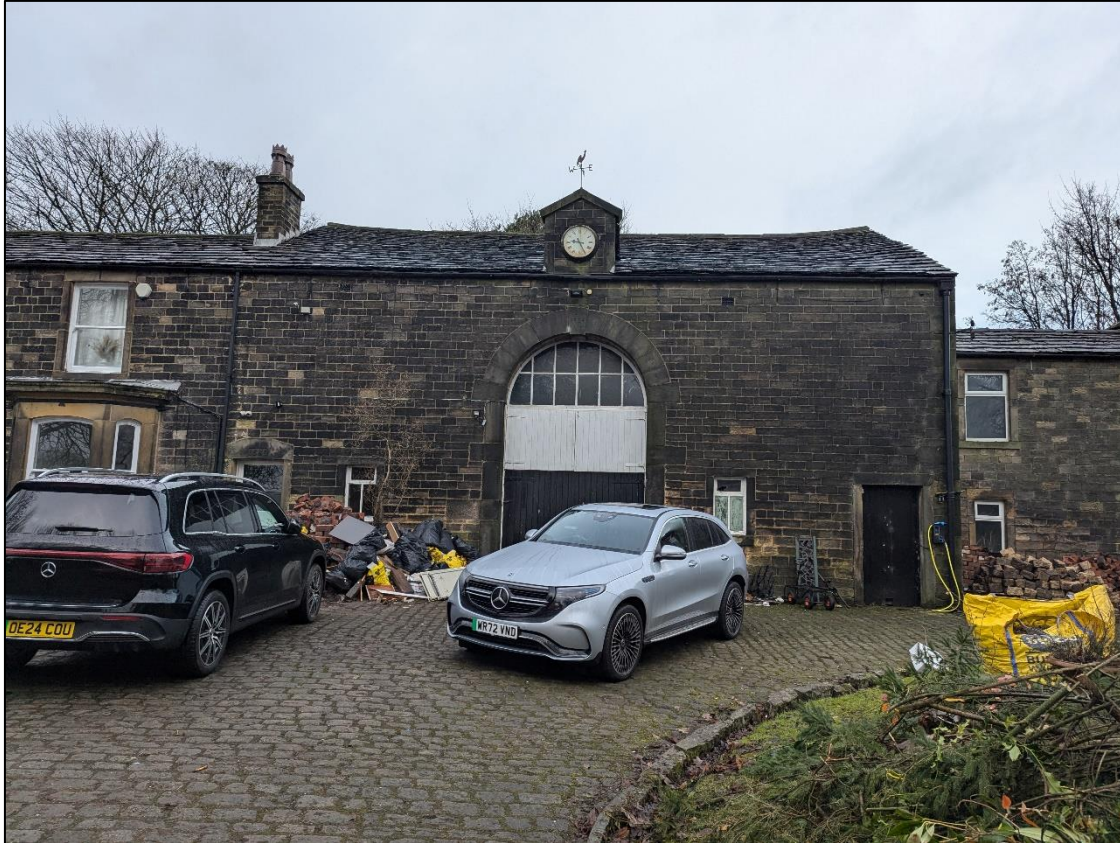
- 5.4 The barn (plates 6 – 11) is likewise constructed in watershot stone and the face is dominated by the large barn door to the centre, with rounded arch lintel with keystone. The keystone bears the engraving "Re Built 1894 A. F.". Large sandstone blocks form the jambs of the barn door. To the west of this is a small personnel doorway with solid sandstone jambs and a large sandstone lintel bearing the date 1684. The top of this lintel is not flat but chamfered to each side. A small set of sandstone steps lead up to it, showing the higher internal floor level. East of this is a small portrait window set within a sandstone surround. The window itself is modern. This arrangement of door and window is mirrored to the other side of the barn door, although here the doorway has a simple sandstone lintel to match the jambs. The first floor level is featureless, although above the barn door is a small gabled clock tower with weathervane above. Quoins line the eastern corner.

Plate 6: South elevation of barn

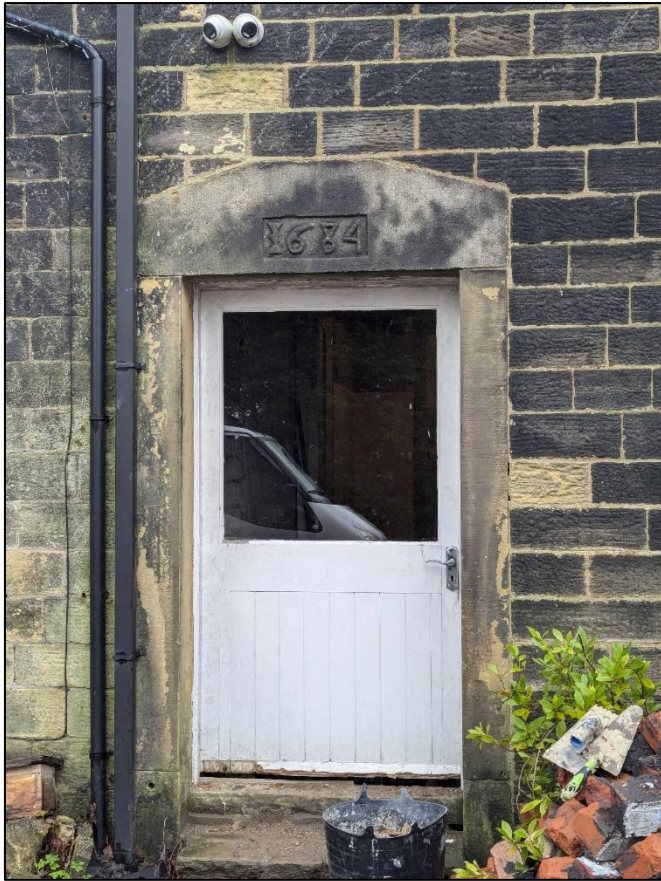
Plate 9: Western doorway with reused lintel bearing date 1684

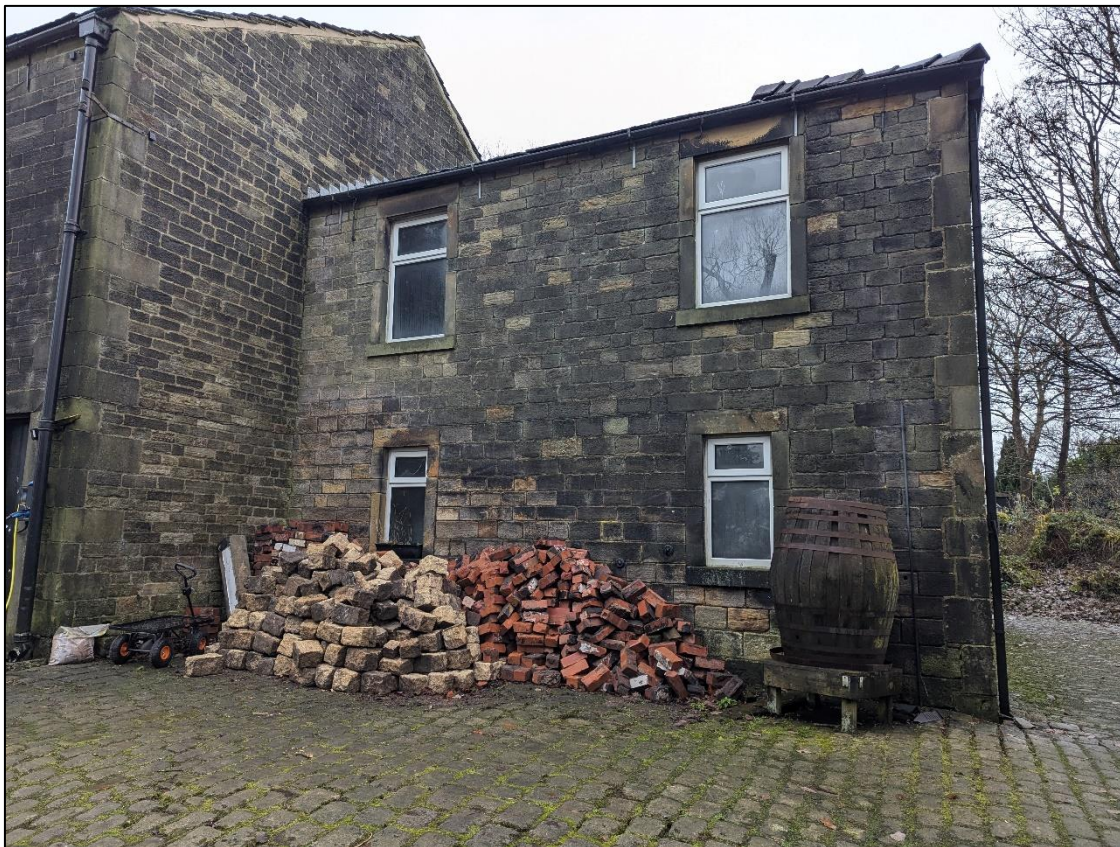
- 5.5 Set back from the barn face is the face of the stable block (plates 12 & 13). This contains a pair of small portrait windows at ground floor level, each with a sandstone surround and modern upvc frame. At first floor level are larger portrait windows, with similar surrounds and frames. The whole is constructed in regularly coursed stone with quoins to the west side.

Plate 12: South elevation of stable block

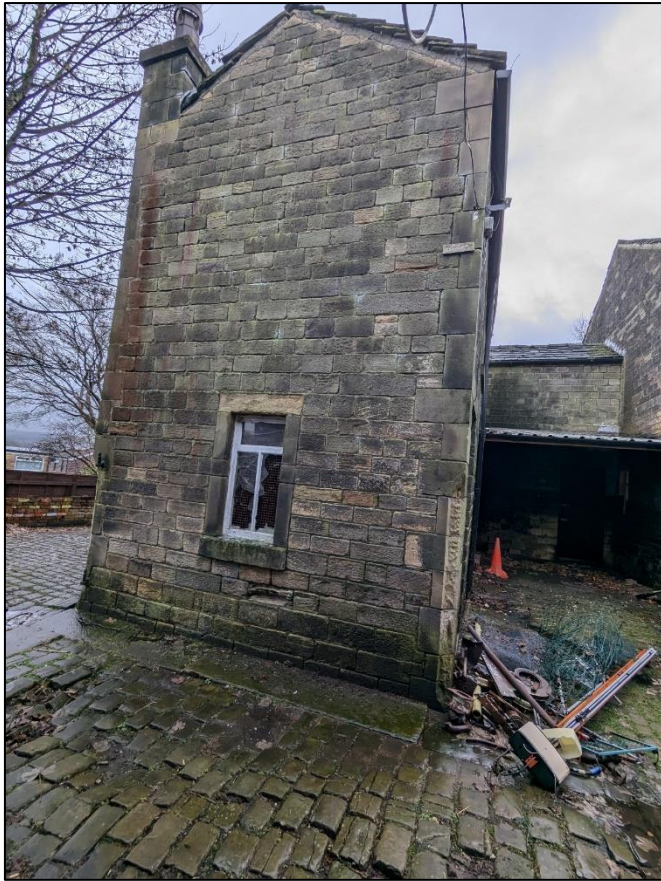
- 5.7 North elevation. This forms the rear elevation of the block. At the western end is the gable of the stable block (plates 15 – 17). This is narrow, with a portrait window at the centre of the ground floor with stone surround. Quoins line each corner and at ground floor level these have been chamfered. To the west side a sandstone

Plate 15: Northern gable of stable block

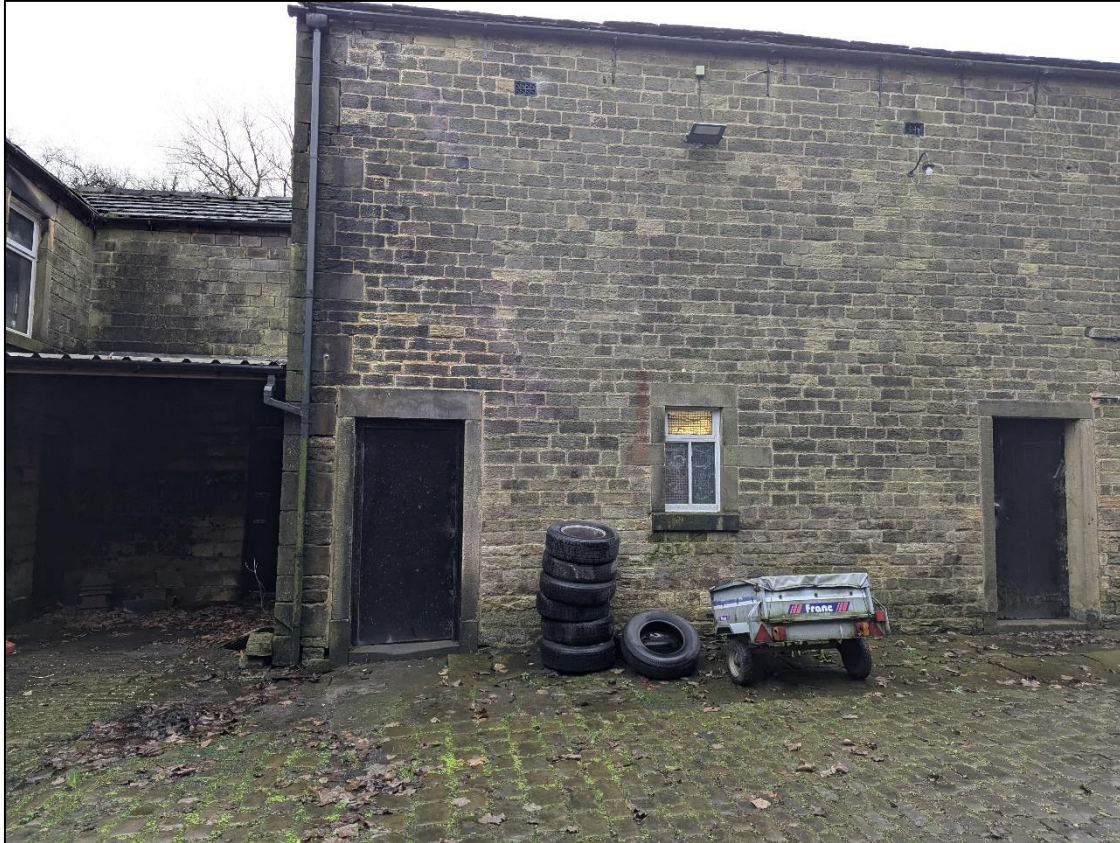
5.8 To the east of the stable is the rear elevation of the barn (plates 18 & 19). At the western end is a doorway with sandstone surround and timber door hung. East of this is a small portrait window with modern frame and sandstone surround. East of this is a further doorway, opposite the barn door, and likely a winnowing doorway. It likewise has a sandstone surround and a further small portrait window with modern frame and sandstone surround lies to the east of it. An additional window lies close to this, matching, but cleaner, suggesting it is a later insertion. Above it is a tall portrait window with sandstone surround and timber framed casements. This sandstone is again cleaner, suggesting it may be a later insertion. These windows mark the end of the barn, although no straight joint is present. This suggests that this part of the rear extension of the house was added at the same time as the barn.

Plate 18: Eastern end of barns rear elevation

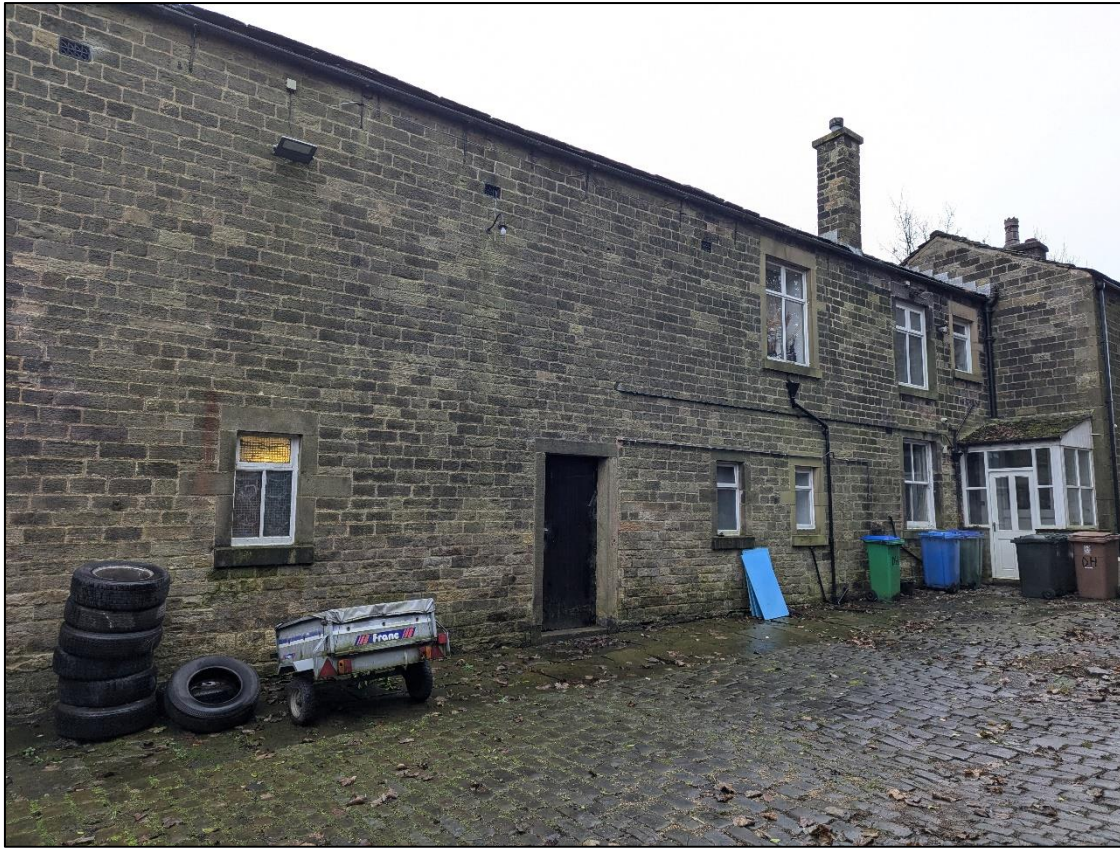
Plate 19: Rear elevation of barn and house extension

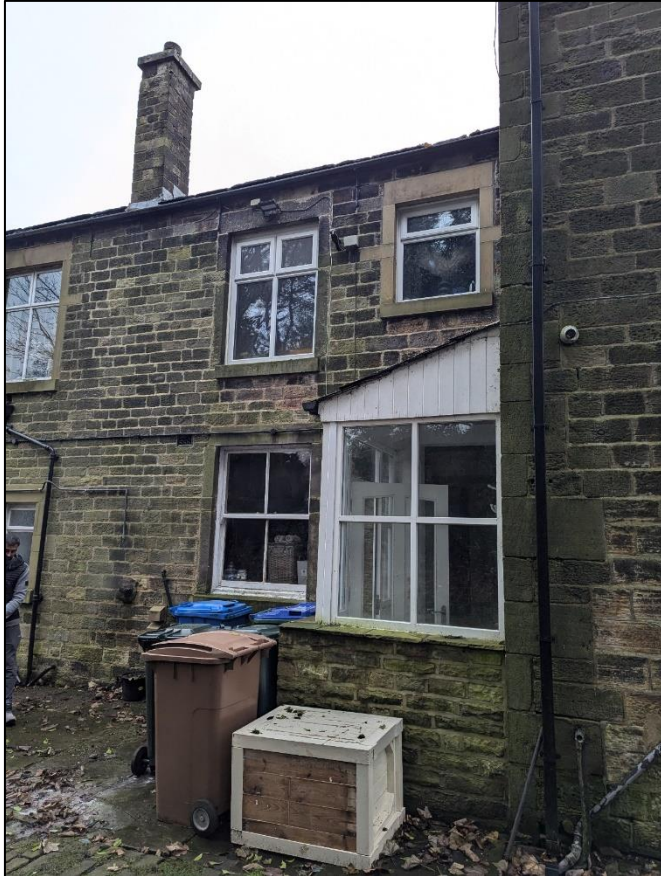
Plate 20: Rear elevation of house

5.9 At the eastern side of the house elevation is a tall portrait window with sandstone surround and timber framed sash window with nibs. A matching window lies above, although with a modern frame. East of this a modern porch has been added at ground floor level. At first floor level a smaller portrait window has been inserted, with matching sandstone surround. To the east the face steps forwards as the rear extension. This contains a large square window at ground floor level containing a six light timber framed window of three sashes, with nibs. Above is a portrait window with modern frame. Each has a sandstone surround (plates 20 & 21).

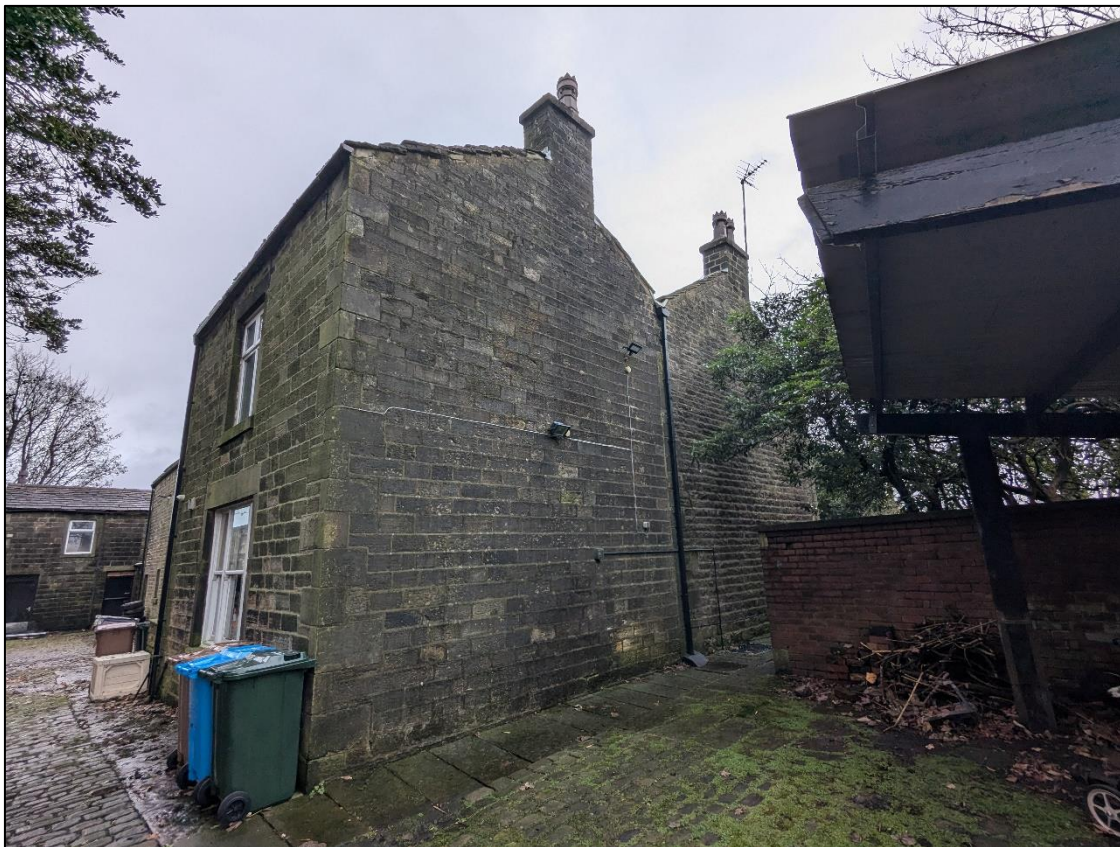
5.10 West elevation. This forms the side elevation of the house, formed of two gable ends (plates 22 & 23). Each has a stone chimney rising from the apex and a straight joint separating them but are otherwise featureless. The stonework differs slightly between the gables however, with the northern extension being much more regular in appearance and the original house gable being rougher and smaller stonework. Quoins are also present to the straight joint.

Plate 22: Double gable to west elevation of house

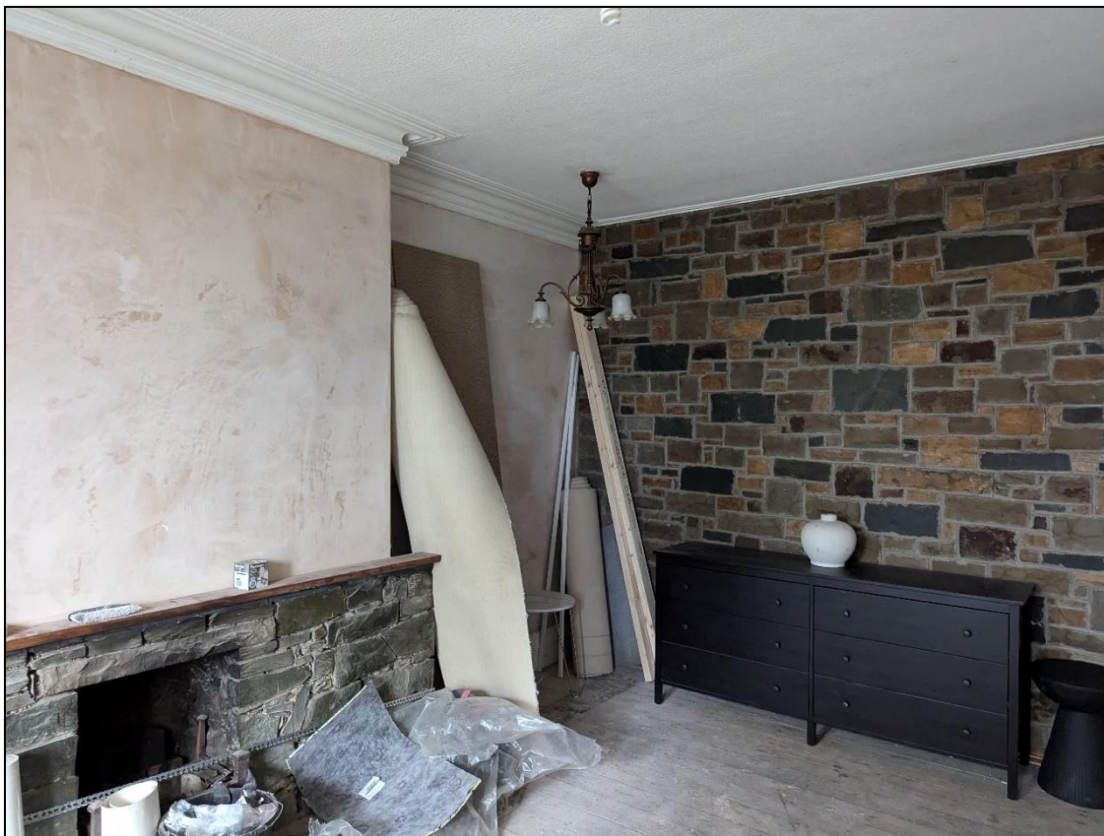
- 6.4 Internally the house has been considerably modernised, although still retains some late 19<sup>th</sup>/early 20<sup>th</sup> features such as plaster cornice and ceiling rose. The barn appears to have been built as a threshing barn, with large barn door to the south and smaller winnowing doorway opposite. It has been subdivided internally with a separate room added to the west and a first floor added to the central bay. The timbers to the eastern bay show soffits to the underside and the doorways suggest a feeding passage, indicating the area was likely used as a shippon. With the exception of the inserted bathroom to the northern stable, the stable block has been relatively unchanged, with the exception of modern replacement windows. A blocked doorway at first floor level suggests the first floor was used as storage.

Plate 24: General shot of living room showing plaster cornice and modernised walls and fireplace

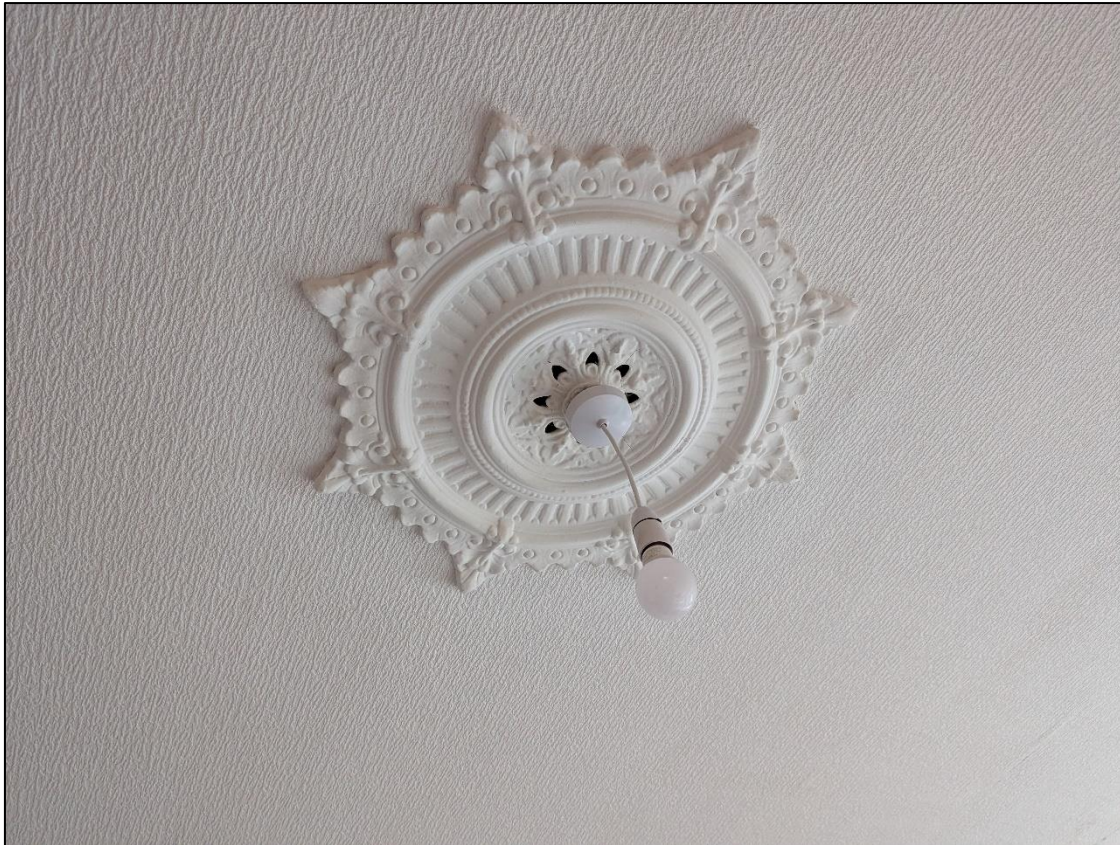
Plate 25: Ceiling rose to dining room

- 5.11 Interior. The house has been modernised internally, with several walls removed and other inserted (plates 25 – 30). However, the basic two unit plan form is still present. Although modernised, a few late 19<sup>th</sup> century features still remain, including some door frames, plaster cornices and a ceiling rose to the dining room. Within the rear extension, the quarry tile floor is also still present. A narrow cellar is located to the northern side of the original 2 unit house, with stone flagged floor and a low brick and stone thrawl to the south. The first floor has been modernised further, with 5 bedrooms and a bathroom inserted. The landing area has some late 19<sup>th</sup> cornice around. A doorway has been inserted in the east wall leading into the first floor of the western bay of barn (plate 31). This has again been modernised and converted into a large living room.

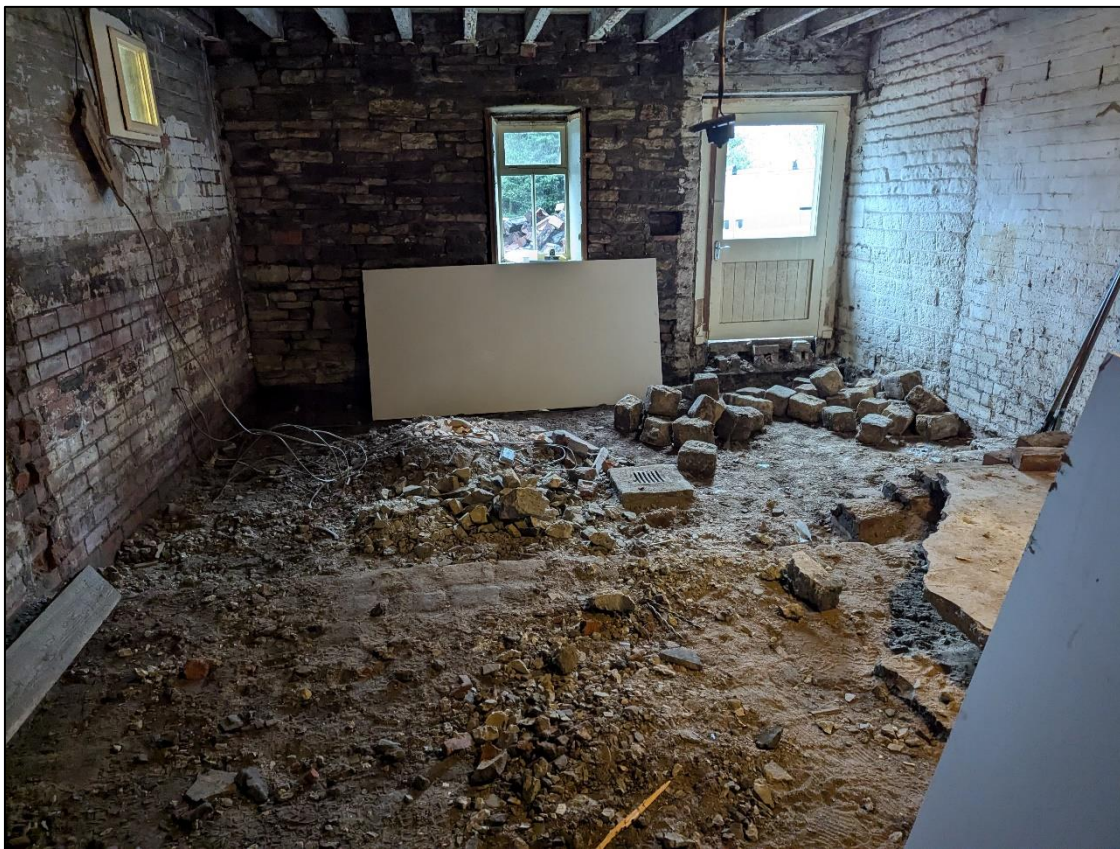
Plate 32: Ground floor of eastern bay of barn

- 5.12 At ground floor level the western bay of the barn has a cobble stone floor which has been partially removed (plates 32 – 37). It is separated from the rest of the barn via an inserted brick wall to the east, with personnel doorway within it. A further doorway has been inserted into the house in the western wall. The western wall is constructed of whitewashed stone to the southern end, with a rough joint to the north, from which the remaining wall is of whitewashed brick. This may mark where the previous barn joined to the house. A small shower room has been inserted to the northwest corner. The other two bays of the barn form a single open space (plates 38 – 45), with whitewashed stone walls. The floor is a mix of stone flags and concrete, with an inspection hatch inserted into the floor close to the barn door. A whitewashed timber beam spans the room north - south, supporting timber joist of the floor above. To the central bay these are modern and inserted. Those to the eastern bay are original, with soffits on the underside, suggesting downposts. These, along with the opposing doorways to the eastern end of the north and south walls suggesting a feeding passage, suggest the bay was used as a shippon. The first floor (plates 46 – 49) is accessed via a modern ladder and comprises a single open space. The inserted floor to the central bay cuts across the top of the barn door. The walls are all whitewashed rough stone. A doorway in the east wall leads through to the first floor of the stables.

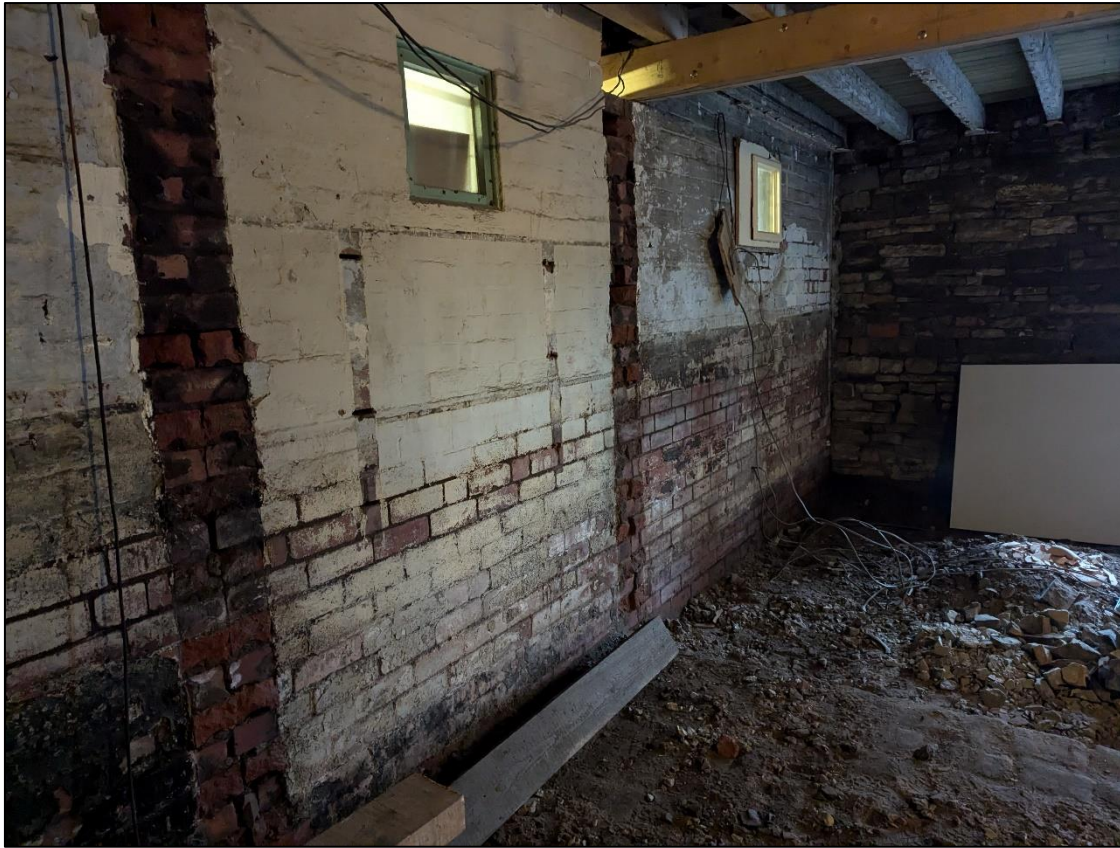
Plate 33: Inserted brick wall to central bay

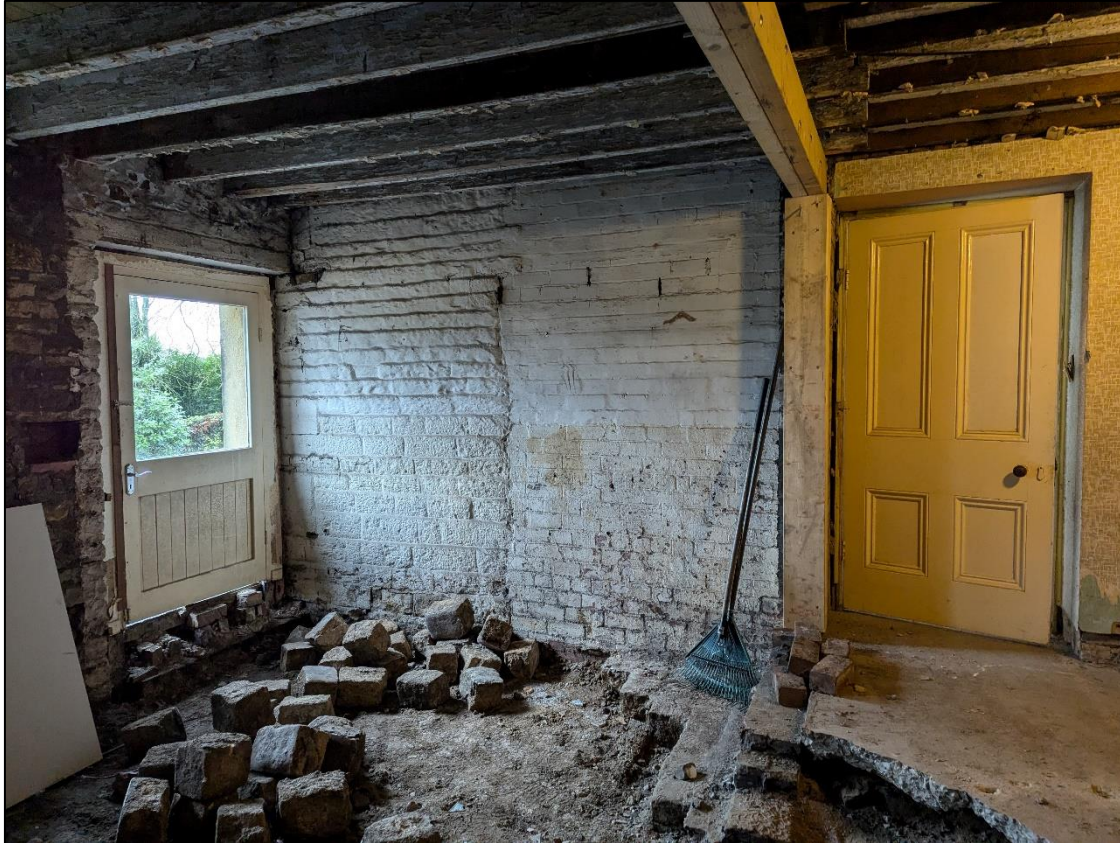
Plate 34: Eastern wall showing rough joint to stonework and inserted doorway to house

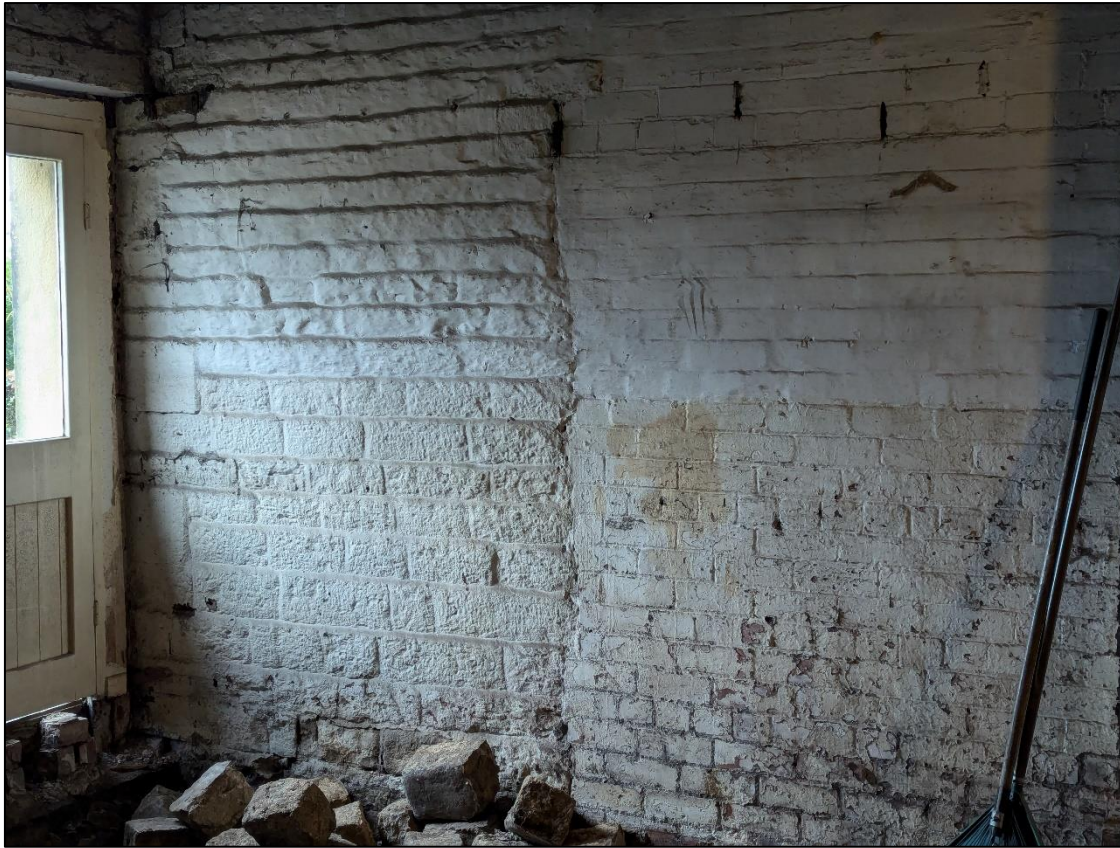
Plate 35: Detail of stonework with brick to the right

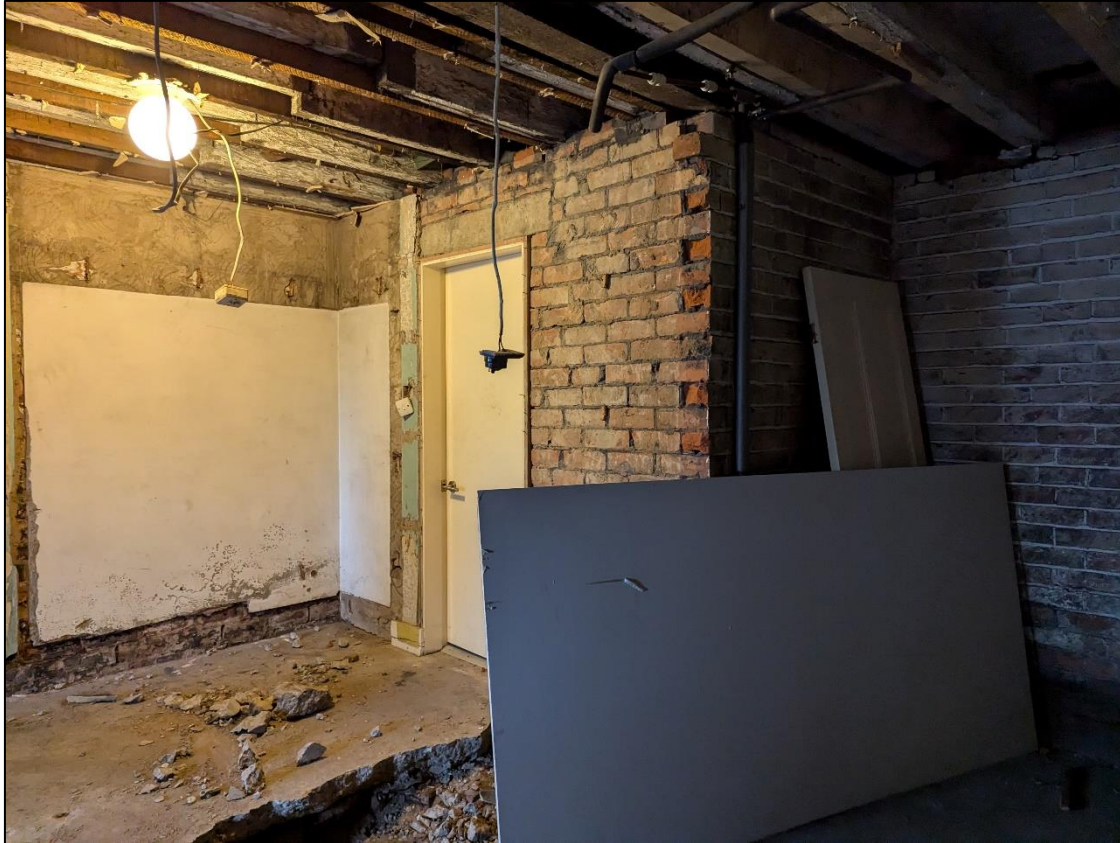
Plate 36: Inserted shower room to northern end

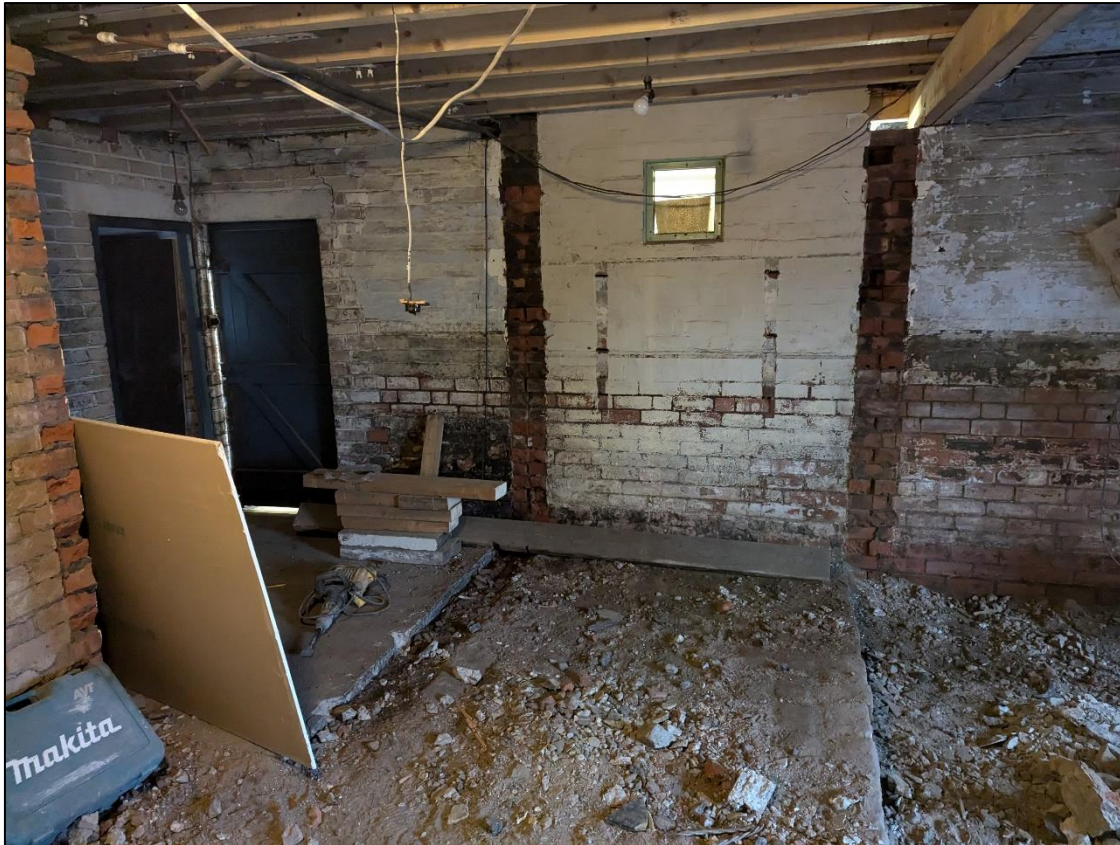
Plate 37: Inserted wall showing scars of removed walls

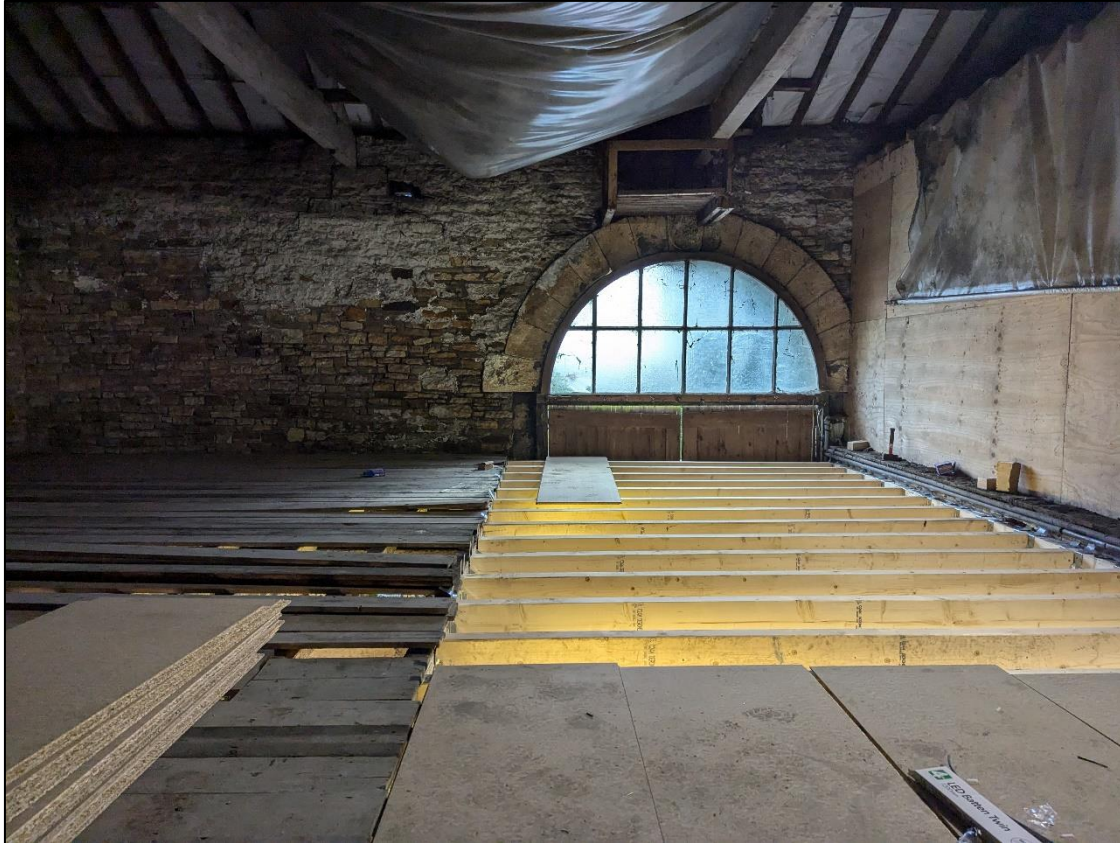
Plate 46: First floor of barn showing inserted floor cutting across doorway

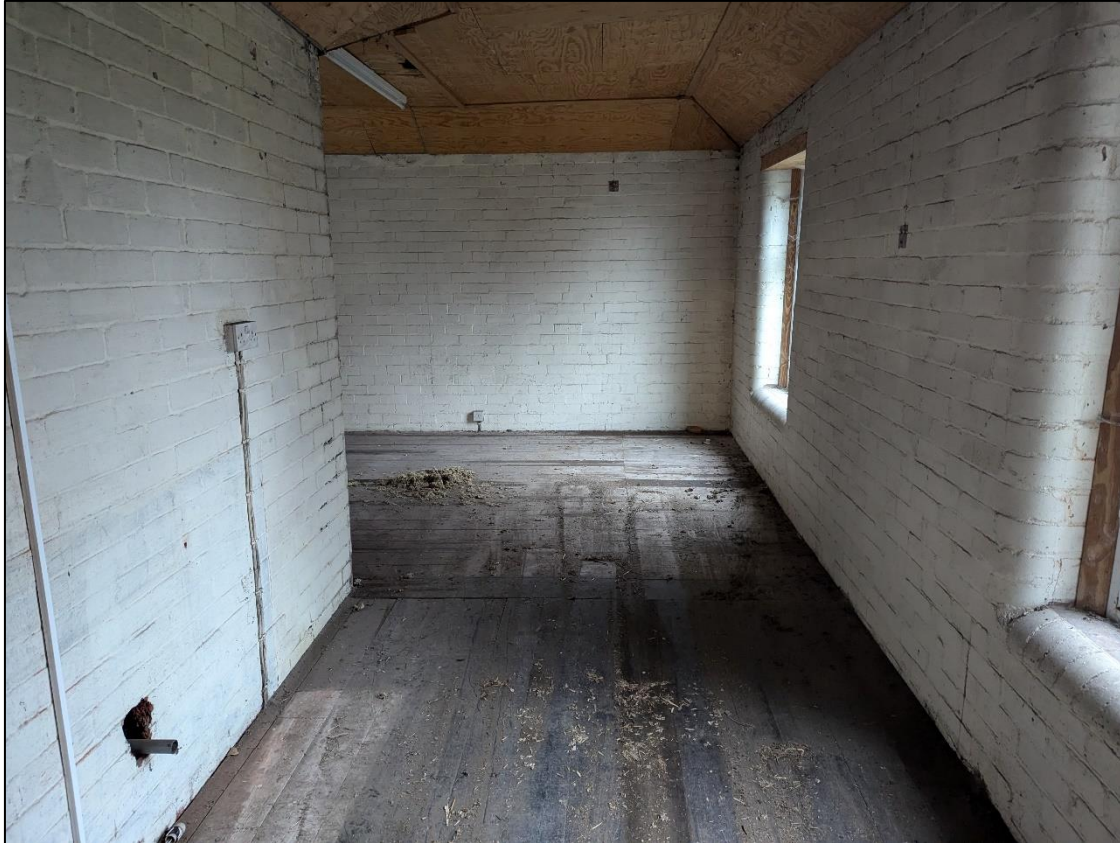
- 5.13 The first floor of the stables (plates 50 – 55) comprises a single open L-shaped space. The walls are all whitewashed brick and windows, with modern frames, all have bullnosed brick cills and jambs. A blocked doorway is present to the western wall, between the two windows. At the northern end of the room a set of timber stairs have been inserted, giving access to the northern ground floor room (plate 56). This has a stone flagged floor and the bricks have traces of whitewash remaining. A timber partition has been inserted with a modern bath and toilet inserted. A doorway lies in the west wall, and both the doorway and window have bullnosed brick jambs. The remaining ground floor rooms (plates 57 – 62) are accessed externally, all of which are stables. To the south of the inserted bathroom the floor is cobbled and the walls whitewashed, the window and doorway again having bullnosed brick surrounds, as are the remaining stables. Each has a metal hey trough mounted to the wall.

Plate 50: First floor of stable block showing brick construction

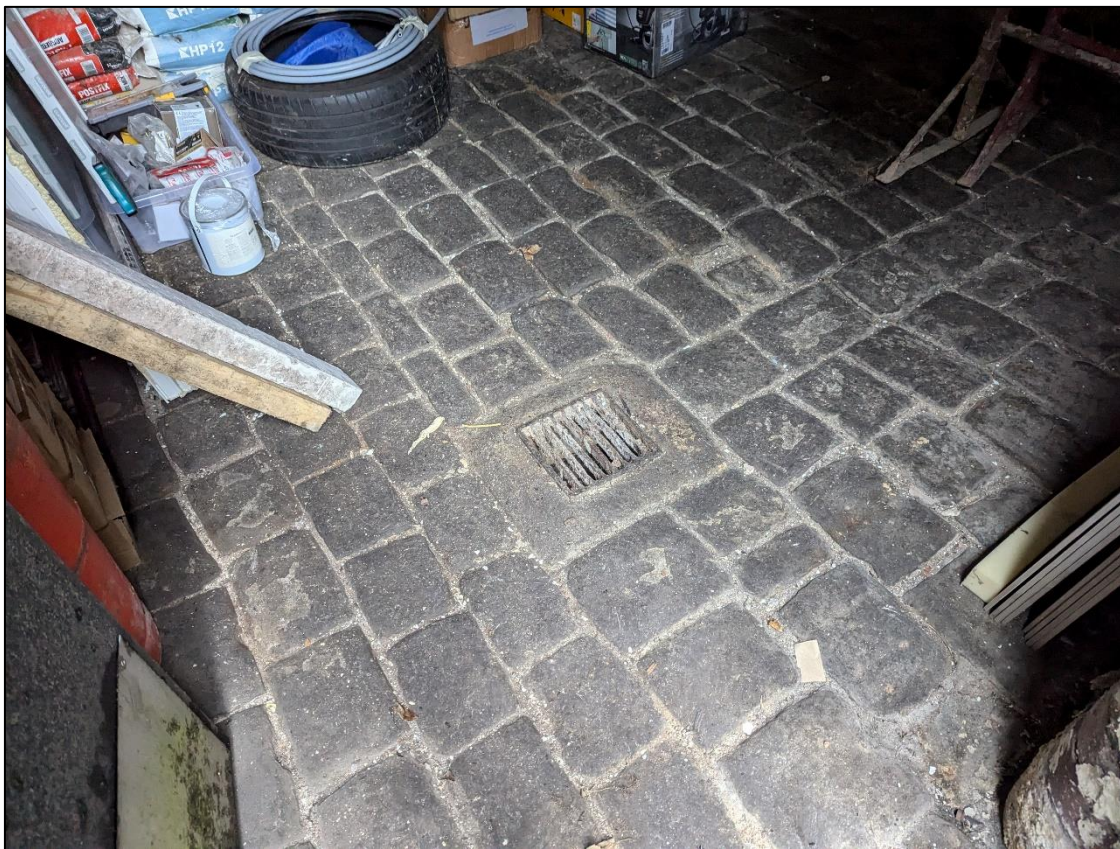
Plate 57: General shot of stable room showing metal hay trough

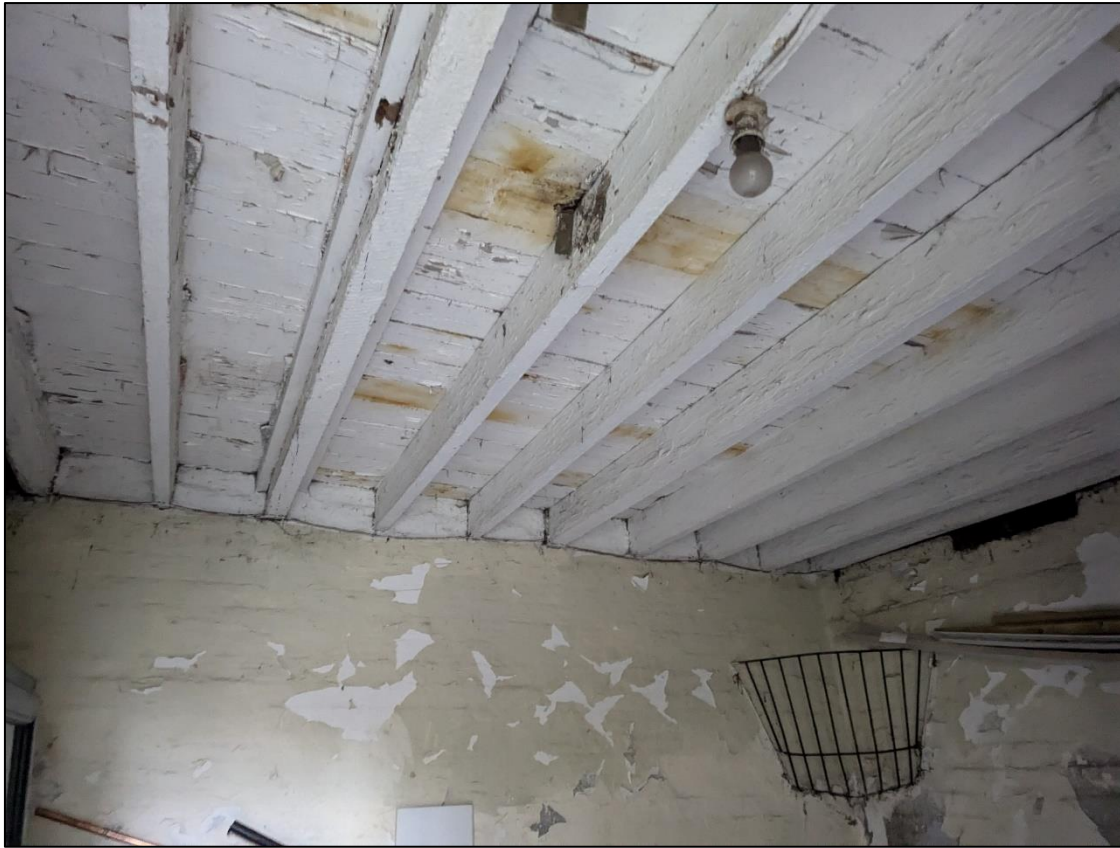
Plate 59: Ceiling detail
