**THE ARCHAEOLOGY CO.**

Dewhirst House, Rochdale  
Heritage Statement

December 2024

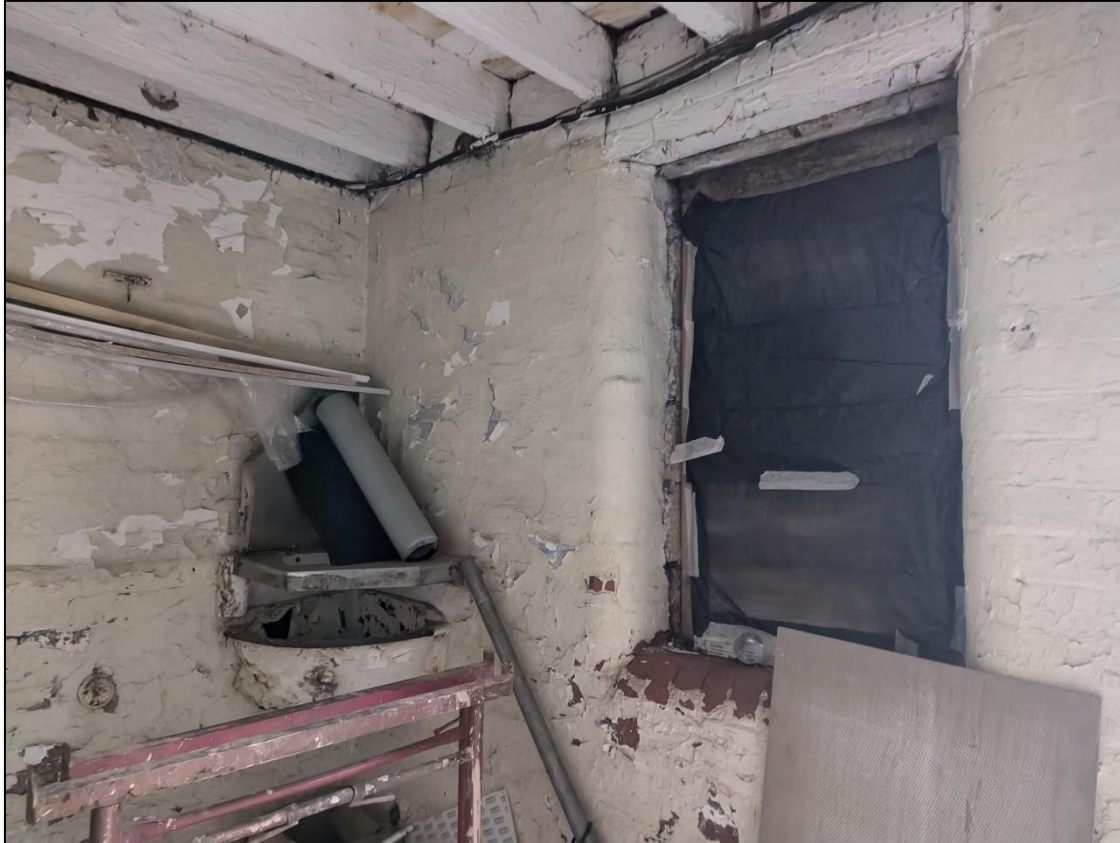
Plate 60: Bullnosed bricks to window surround

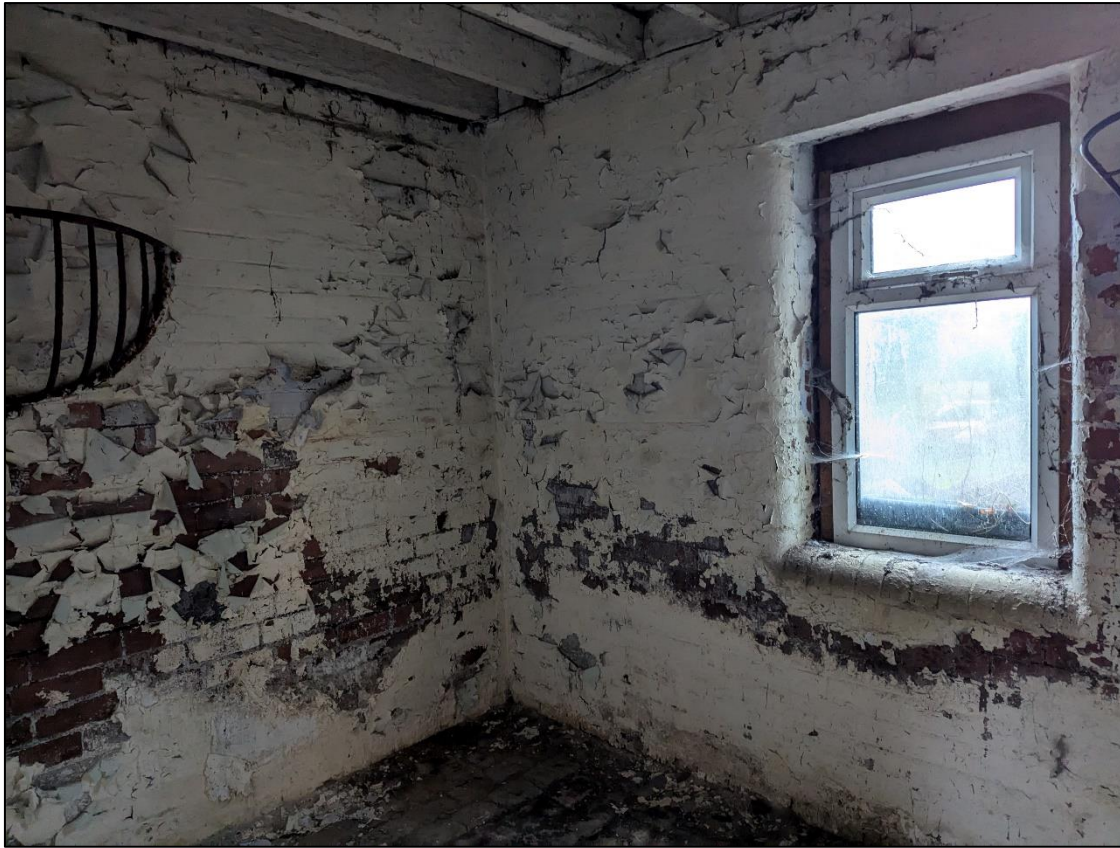
Plate 61: Southernmost stable

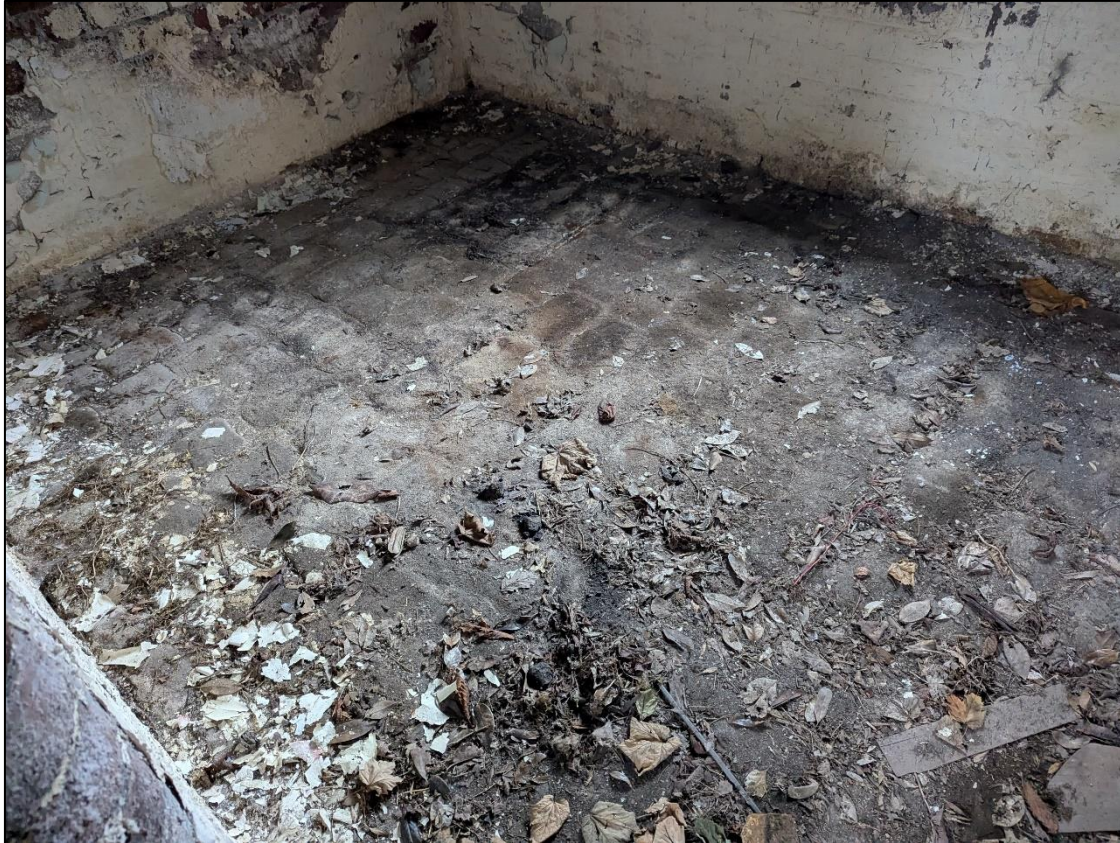
Plate 62: Cobbled floor
