Preliminary Ecological Appraisal Report

Station Road, Milnrow, Oldham

Reference: 81-470-R2-1

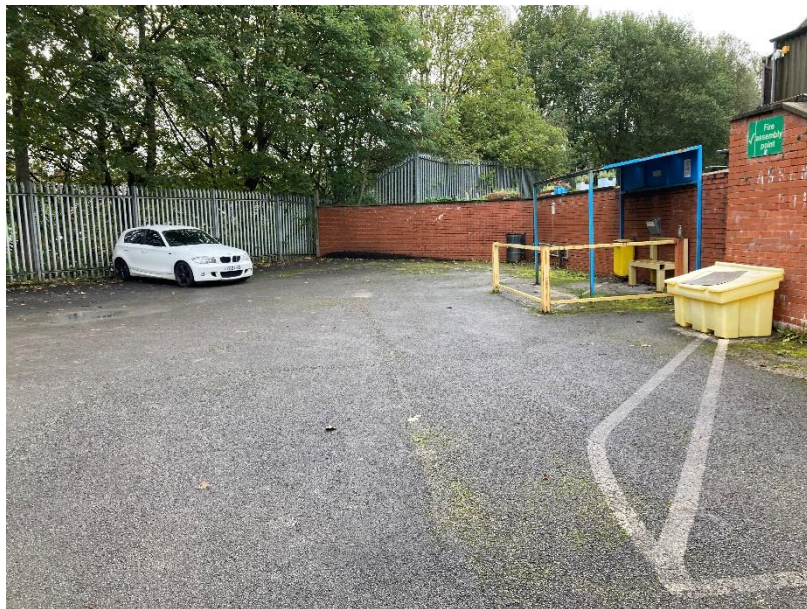
The office and warehouse building and a wall were both present within the site boundary. A detailed assessment and further photographs of the building and walls are outlined within Appendix II.

PLATE 1      SHOWING AREA OF HARDSTANDING

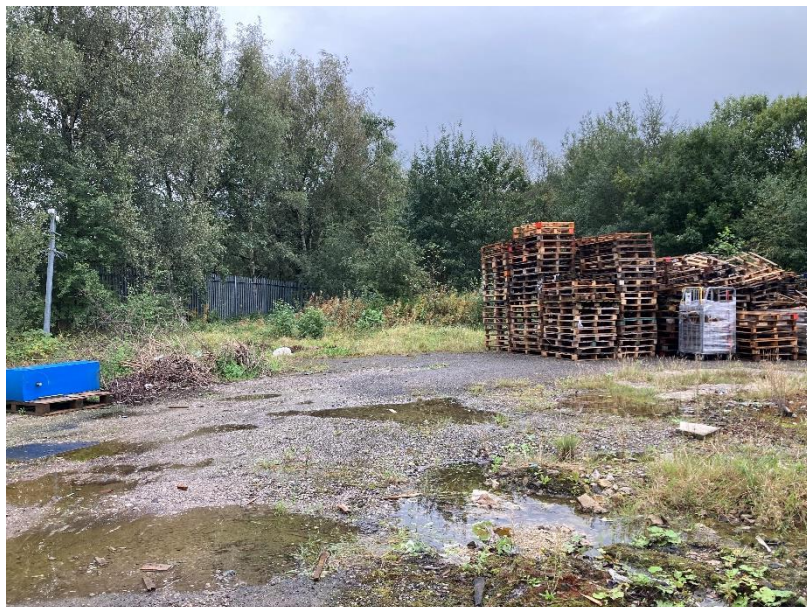
PLATE 3      SHOWING EPHEMERAL/SHORT PERENNIAL

Two areas of ephemeral/short perennial were present within the site boundary; one in the south of the site, and another on the northern boundary bordering hardstanding. Both parcels shared species, which included butterfly bush (*Buddleia davidii*), smooth sow thistle, broadleaved dock, bramble (*Rubus fruticosus* agg.), petty spurge (*Euphorbia peplus*), red clover and dandelion (*Taraxacum officinalis*).

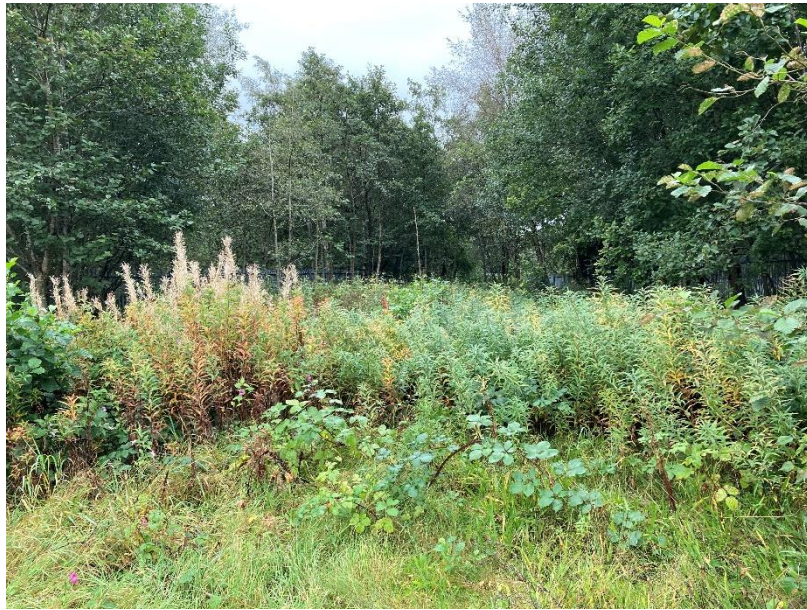
PLATE 4      SHOWING TALL RUDERAL

Two areas of tall ruderal were present; one in the south of the site, and the other bordered the warehouse building in the east. Species present included rosebay willowherb (*Chamaenerion angustifolium*), ragwort (*Jacobaea vulgaris*), red clover, perennial rye grass, bramble, alder (*Alnus glutinosa*) saplings, creeping buttercup (*Ranunculus repens*), ribwort plantain (*Plantago lanceolata*), false oat grass (*Arrhenatherum elatius*), greater plantain, herb Robert and broadleaved dock.

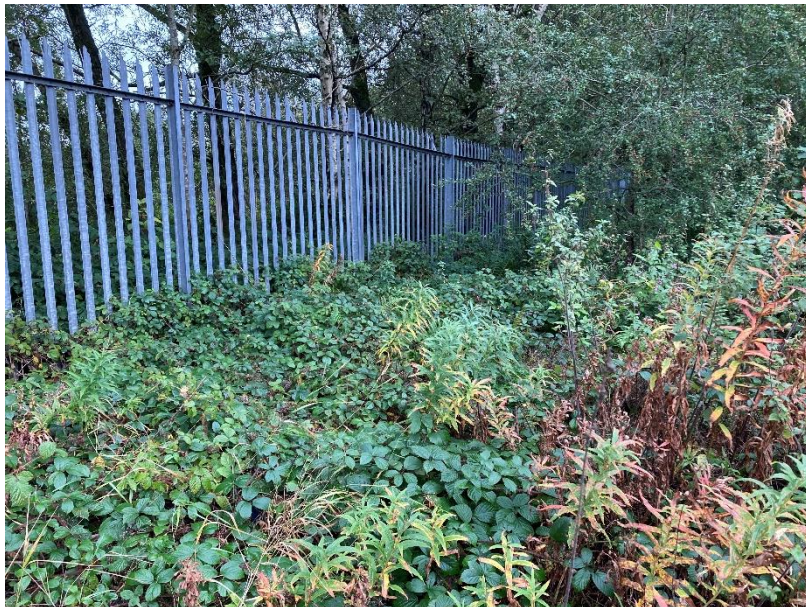
PLATE 5      SHOWING SCATTERED SCRUB

A large area of scattered scrub lay in the south-east of the site, and comprised bramble, bracken (*Pteridium aquilinum*), rosebay willowherb and perennial rye grass. Two small brash piles were also present in the scattered scrub, formed presumably from vegetation cuttings from the site.

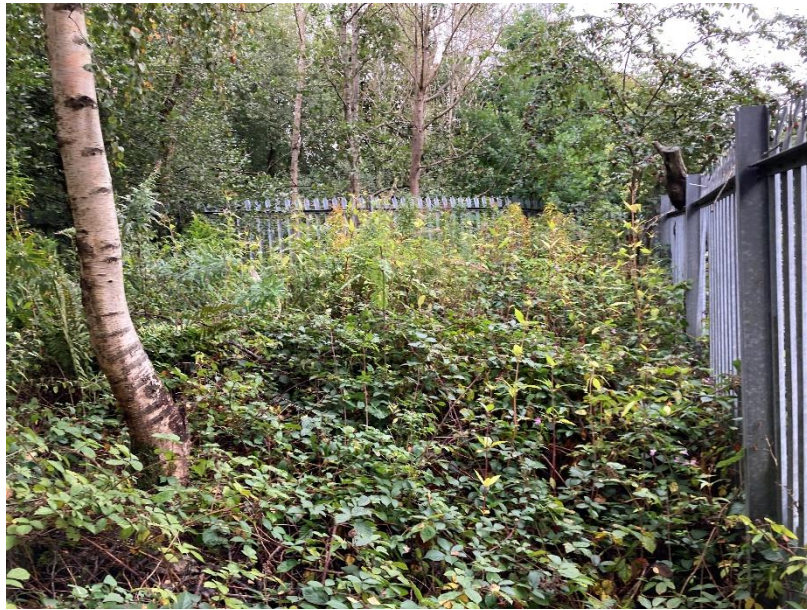
PLATE 7      SHOWING DENSE SCRUB

In the south of the site was an area of dense scrub. Present species included silver birch (*Betula pendula*) saplings, oak (*Quercus robur*) saplings, alder (*Alnus glutinosa*) saplings, bracken, nettle, hawthorn (*Crataegus monogyna*), Himalayan balsam (*Impatiens glandulifera*), goat willow (*Salix caprea*) saplings, wood avens (*Geum urbanum*) and herb Robert. A large rock mound was also present within the dense scrub, and had been covered by vegetation growth.

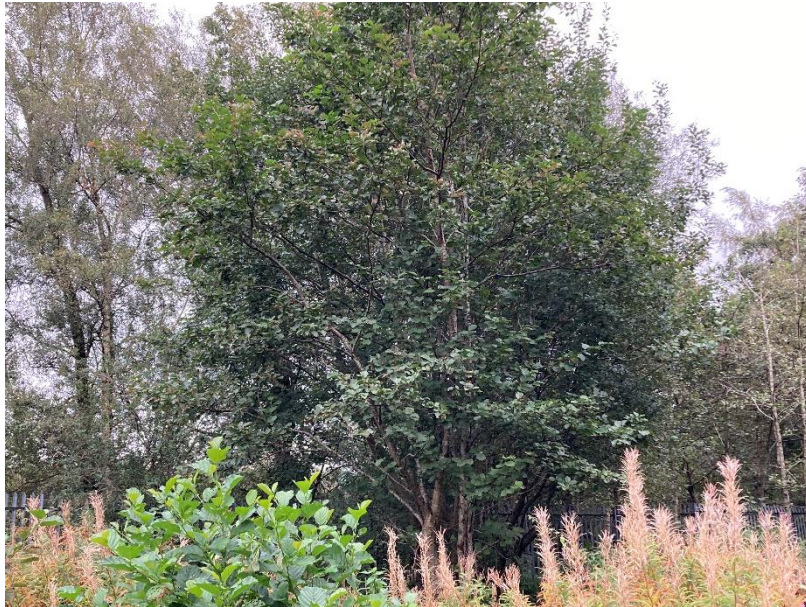
PLATE 9      SHOWING SCATTERED TREES

Several scattered silver birch trees were present in the dense scrub, while an alder was identified within the amenity grassland in the north of site.

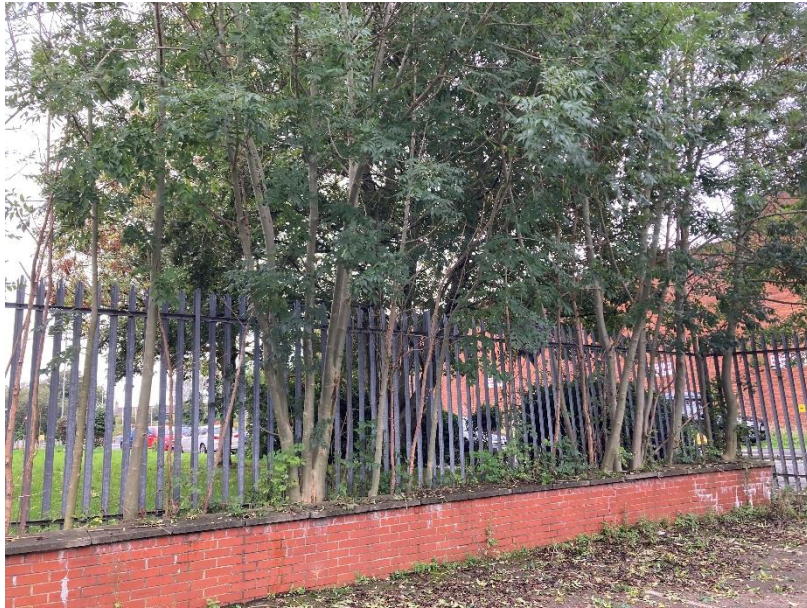
PLATE 10      SHOWING TREELINE

A line of ash (*Fraxinus excelsior*) trees was present in the north of the site and separated the hardstanding car park from the amenity grassland.

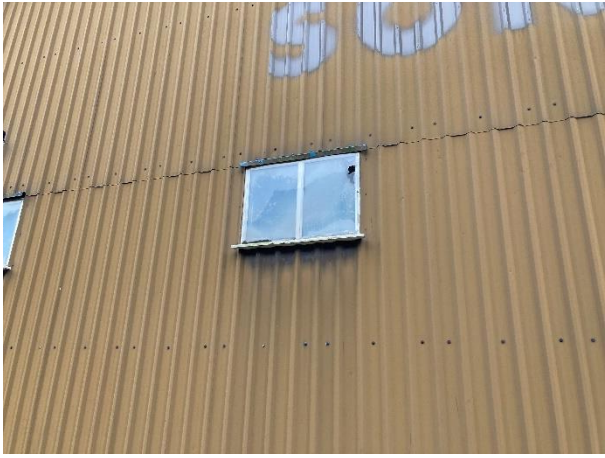
| FEATURE | DESCRIPTION | PHOTOGRAPH |
|---|---|---|
| F1 | Access point: A broken window on the western side of the warehouse, approximately 3 m high. No roost feature present. | |

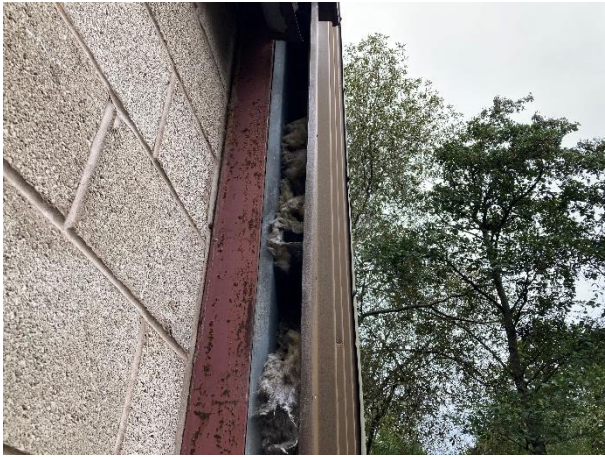
| FEATURE | DESCRIPTION | PHOTOGRAPH |
|---|---|---|
| F2 | Exposed insulation around a now bricked-up exit on the south-east of the warehouse, approximately 1.5 m high. Gaps between the wall and the old doorway could provide roosting opportunities for crevice dwellers on an occasional basis.<br><br>F2 was assessed as having <b>Low</b> potential. | |

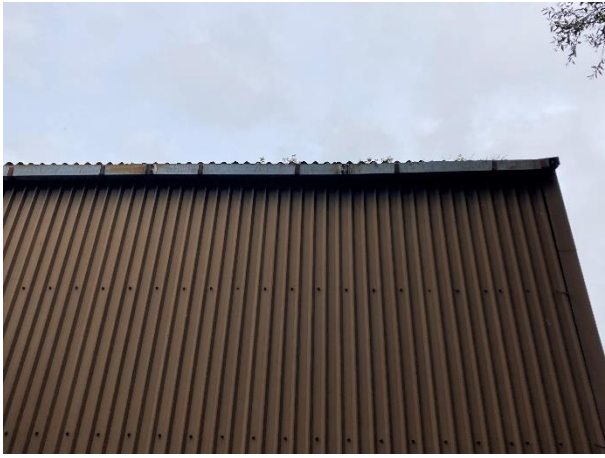
| FEATURE | DESCRIPTION | PHOTOGRAPH |
|---|---|---|
| <b>F4</b> | <p>Several gaps between the roof tiles and the warehouse, as well as lifted tiles, were observed on a south-facing aspect of the warehouse. Approximately 6 m high. Could provide roosting opportunities for crevice dwellers on an occasional basis.</p> <p>F4 was assessed as having <b>Low</b> potential.</p> | |

Due to the on-site building having Low bat potential for crevice-dwelling species, it is recommended that either one Nocturnal Bat Survey is carried out (see Section 5) **OR** an ecologist will attend site during the initial phases of the works to the warehouse roof, in which works affecting the sensitive areas will be supervised. This would comprise a search for bats prior to the works commencing, including the crevices in the brickwork and any damaged or lifted roof tiles.

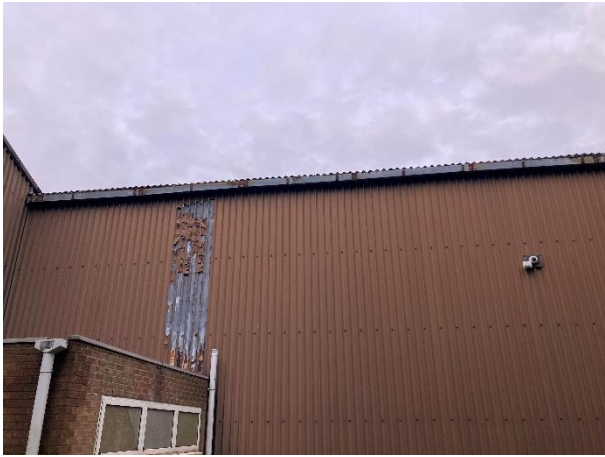
| FEATURE | DESCRIPTION | PHOTOGRAPH |
|---|---|---|
| <b>F5</b> | <p>Several lifted roof tiles were observed, as well as gaps between tiles and the underlying roof on a south-facing aspect of the warehouse. Approximately 6 m high. Could provide roosting opportunities for crevice dwellers on an occasional basis.</p> <p>F5 was assessed as having <b>Low</b> potential.</p> | |

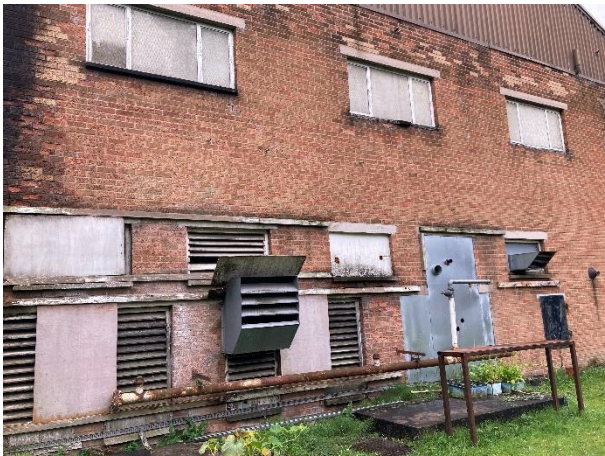
| FEATURE | DESCRIPTION | PHOTOGRAPH |
|---|---|---|
| <b>F6</b> | <p>Access point: Numerous ground-floor entrances into a currently disused room in the east of the warehouse, between 1-2 m high. No roost feature present.</p> | |

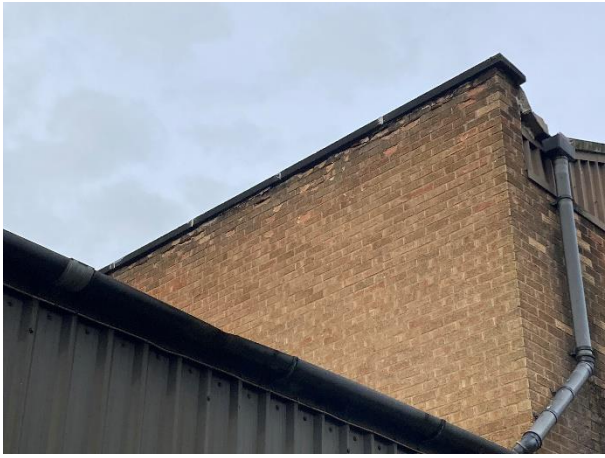
| FEATURE | DESCRIPTION | PHOTOGRAPH |
|---|---|---|
| <b>F7</b> | <p>Gaps between the wall ledge and brickwork on the eastern face of the office building, approximately 10 m high. Could provide roosting opportunities for crevice dwellers on an occasional basis.</p> <p>F7 was assessed as having <b>Low</b> potential.</p> | |

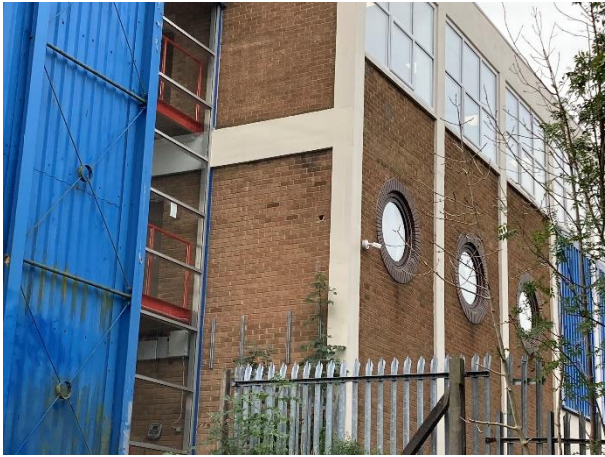
| FEATURE | DESCRIPTION | PHOTOGRAPH |
|---|---|---|
| <b>F8</b> | <p>Gaps in the brickwork and weep holes on the north-eastern corner of the building, approximately 4 m high. Could provide roosting opportunities for crevice dwellers on an occasional basis.</p> <p>F8 was assessed as having <b>Low</b> potential.</p> | |

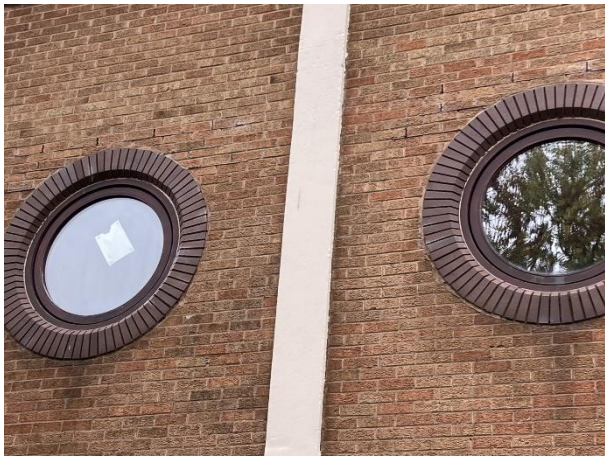
| FEATURE | DESCRIPTION | PHOTOGRAPH |
|---|---|---|
| <b>F9</b> | <p>Weep holes around the windows on the northern aspect of the office building, approximately 4 m high. Could provide roosting opportunities for crevice dwellers on an occasional basis.</p> <p>F9 was assessed as having <b>Low</b> potential.</p> | |

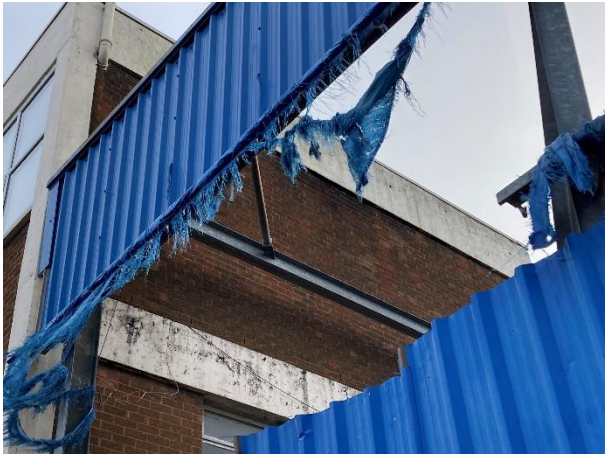
| FEATURE | DESCRIPTION | PHOTOGRAPH |
|---|---|---|
| <b>F10</b> | <p>Gaps between the soffit boxes and the wall, cracks in the brickwork and weep holes on the north-western corner of the building. Approximately 9 m high. Could provide roosting opportunities for crevice dwellers on an occasional basis.</p> <p>F10 was assessed as having <b>Low</b> potential.</p> | |

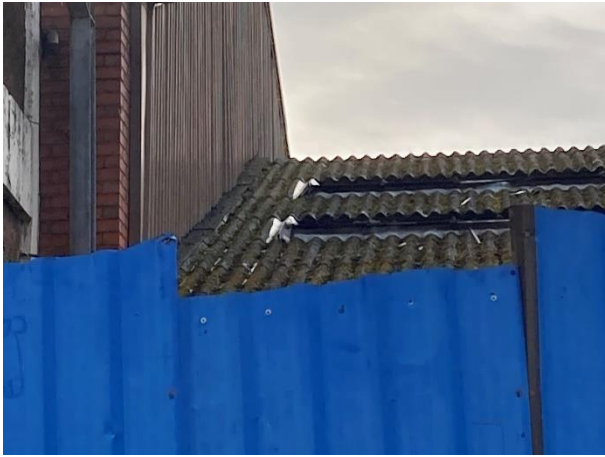
| FEATURE | DESCRIPTION | PHOTOGRAPH |
|---|---|---|
| <b>F11</b> | <p>Gaps underneath the roof and lifted lead flashing on the northern aspect of the warehouse, approximately 5 m high. Could provide roosting opportunities for crevice dwellers on an occasional basis.</p> <p>F11 was assessed as having <b>Low</b> potential.</p> | |

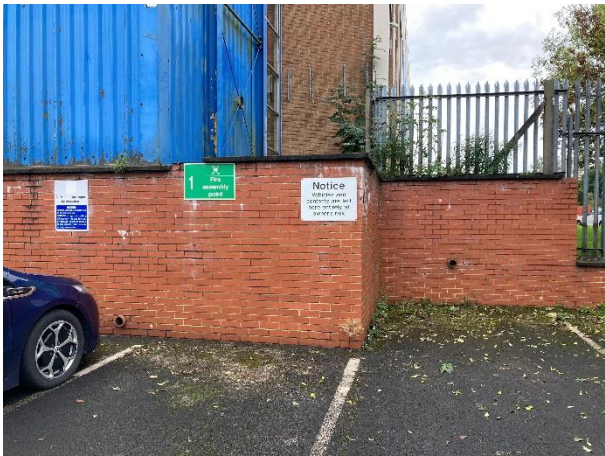
| FEATURE | DESCRIPTION | PHOTOGRAPH |
|---|---|---|
| <b>WALL</b> | <p>No gaps in the bricks large enough to house roosting bats.</p> <p>The wall was assessed as having <b>Negligible</b> potential.</p> | |
