# Land at Bank Top Farm, Hollingworth Road

## Existing Farm Access Appraisal Note

| Client: | Bank Top Farm | Job No | J325773 |

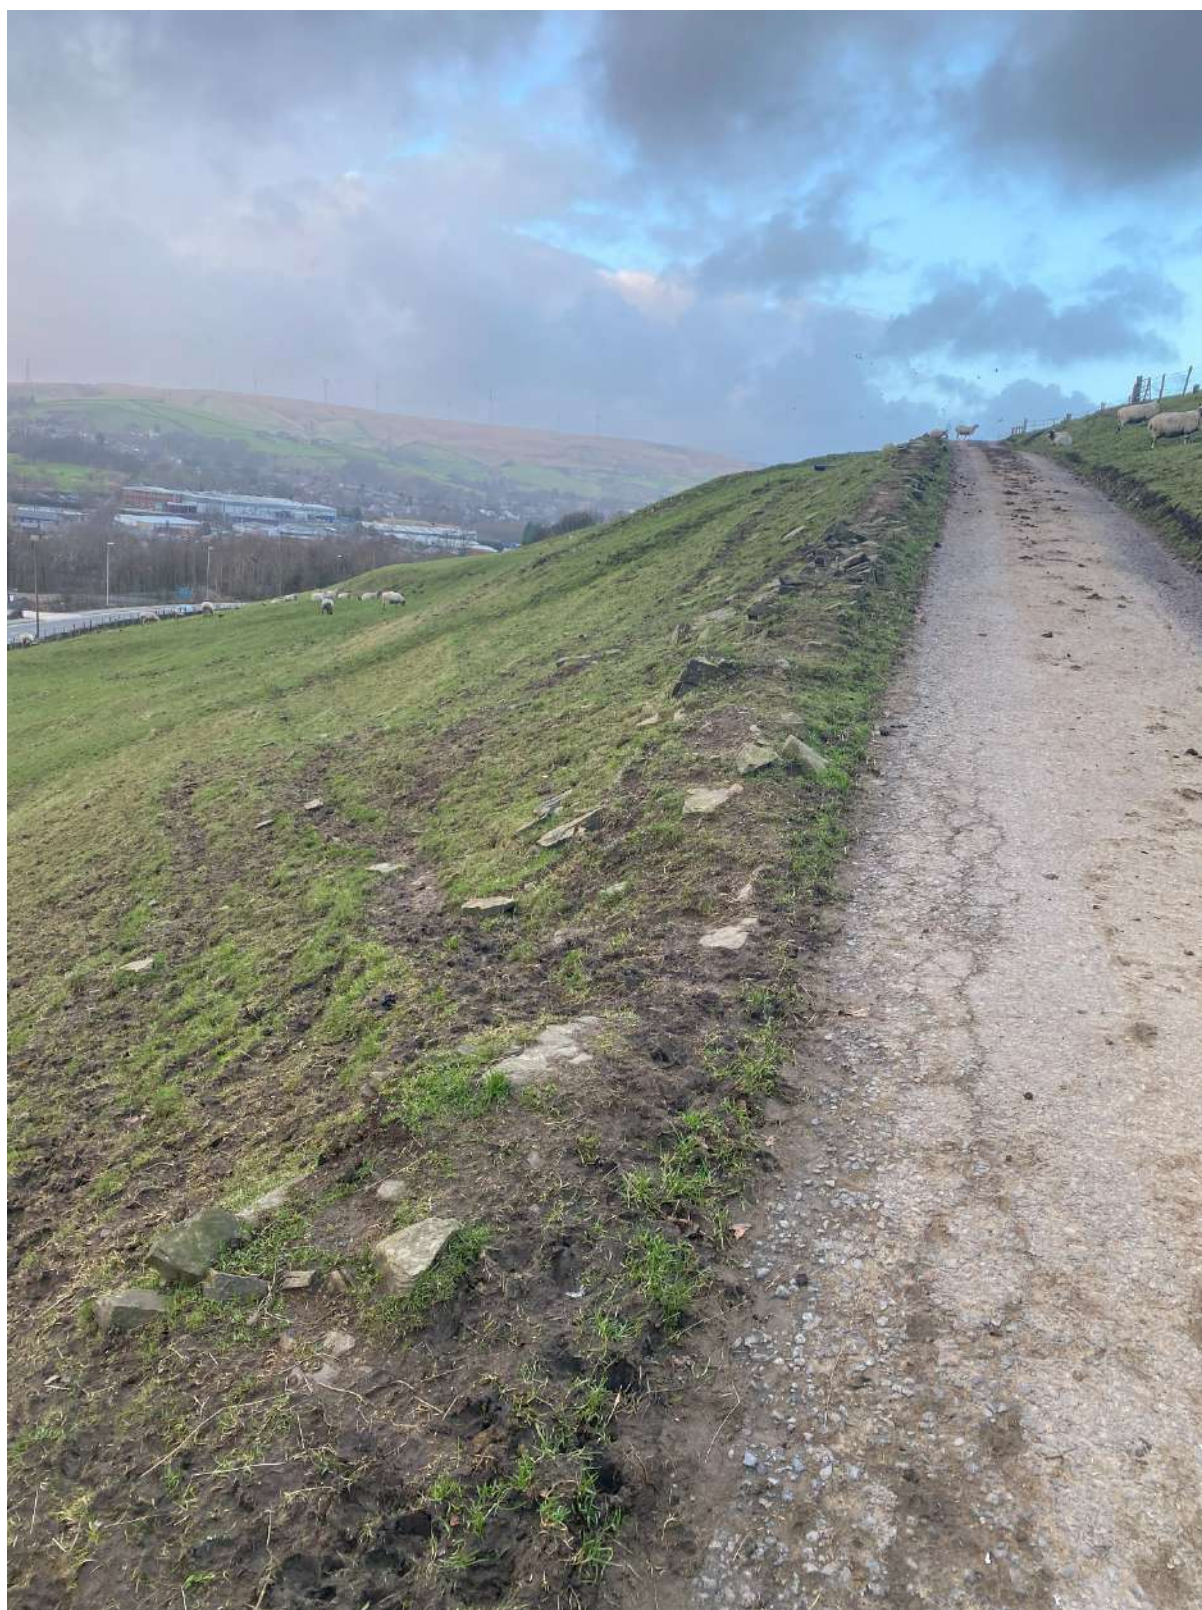
Photograph 2.1 : Existing Access

- 2.1.1 The existing farm access is a single-track lane c.2.6m wide. The gradient along the majority of the access is c.9.8%.
- 2.1.2 The land on either side of the access falls from east to west at a steep gradient of around 30%.
- 2.1.3 The existing access is not surfaced along the entire length and is particularly muddy in parts. This would ideally need resurfacing along the entire route to ensure that it is suitable for both vehicles and pedestrians.
- 2.1.4 [Photograph 2.1](#) and [Photograph 2.2](#) show the condition of the access and the gradient of the access and the surrounding land.

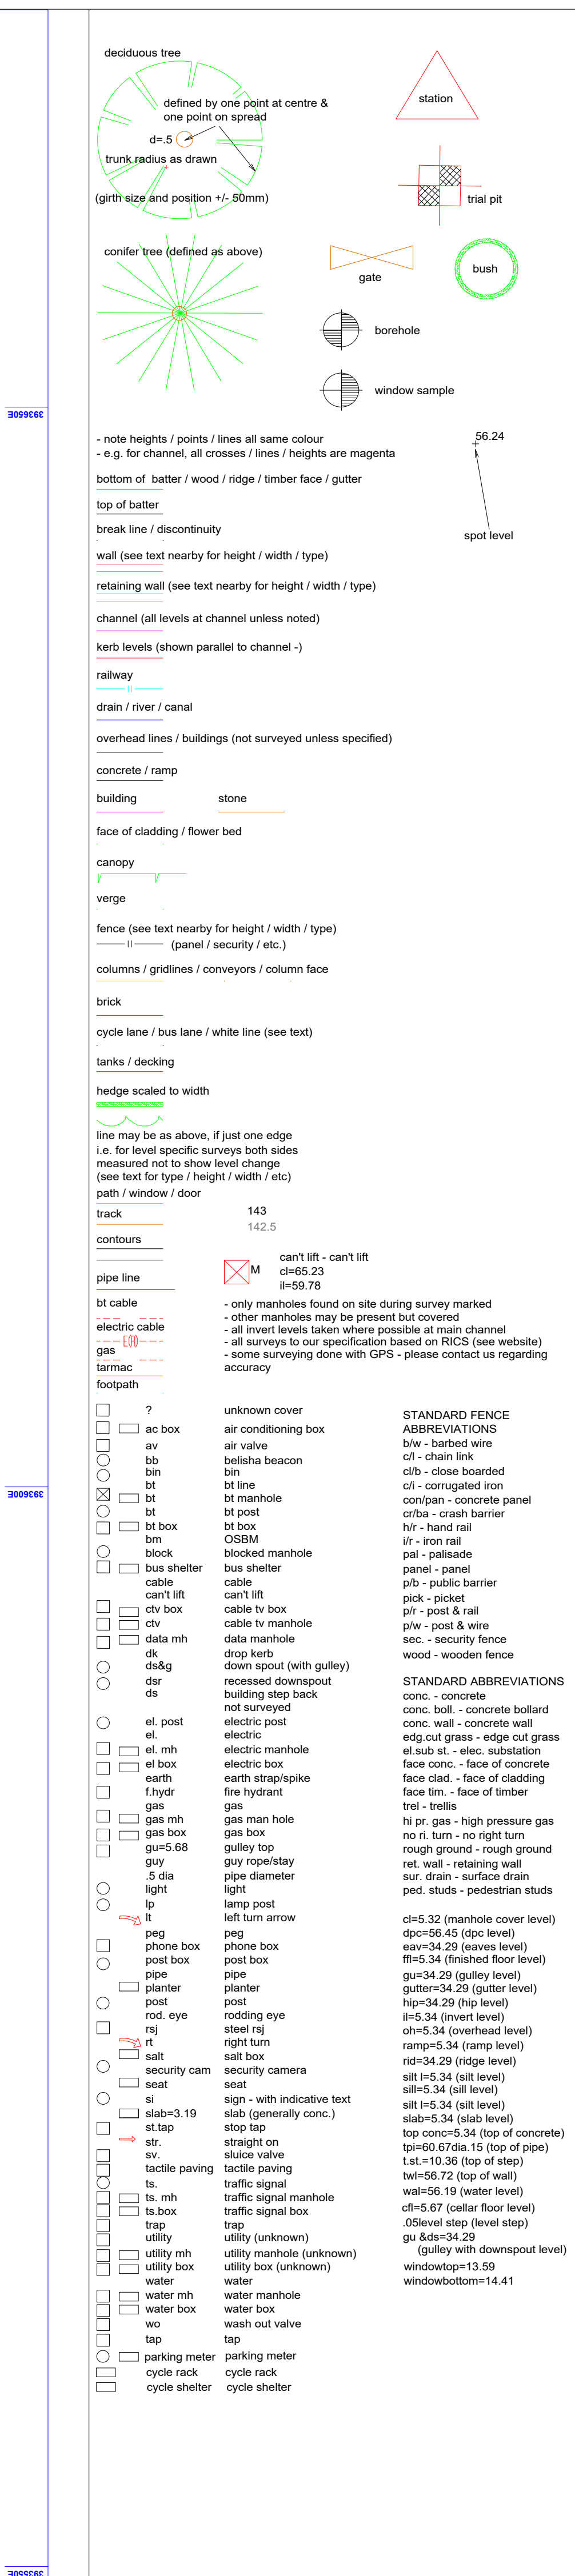
## APPENDIX A Topographical Survey Data

1.1.6 The above analysis is based on topographical survey data recorded along a c.170m section of the existing farm track, including the access junction on Hollingworth Road. The topographical survey data is attached in [Appendix A](#).
