# Dusk Survey Results

## **Hopwood Hall**

Middleton

**Hopwood Hall, Middleton, Rochdale, Greater Manchester, M24 6XH**  
**Dusk Survey Results**

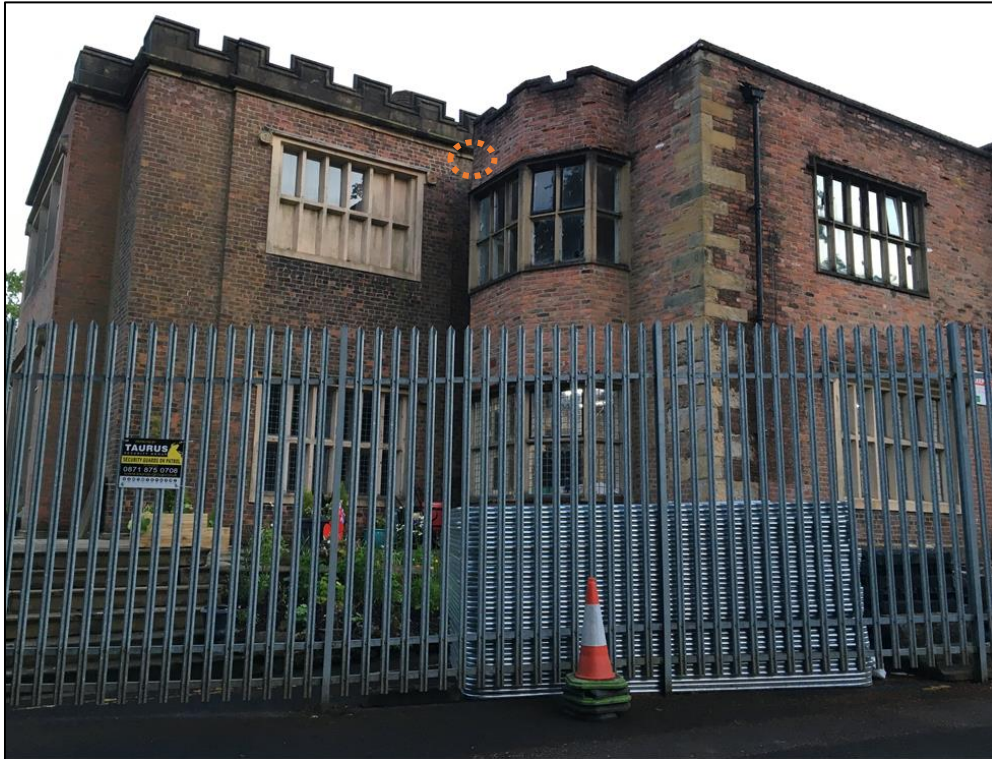
**Figure 5.1** - *Dusk Survey 1 & Dusk Survey 2 - Visual Aid* - Emergence locations on the northern elevation; where a single Common Pipistrelle emerged from below the coping stone of the parapet wall and a single Common Pipistrelle emerged at the join of the second storey canted bay window meets the brickwork.

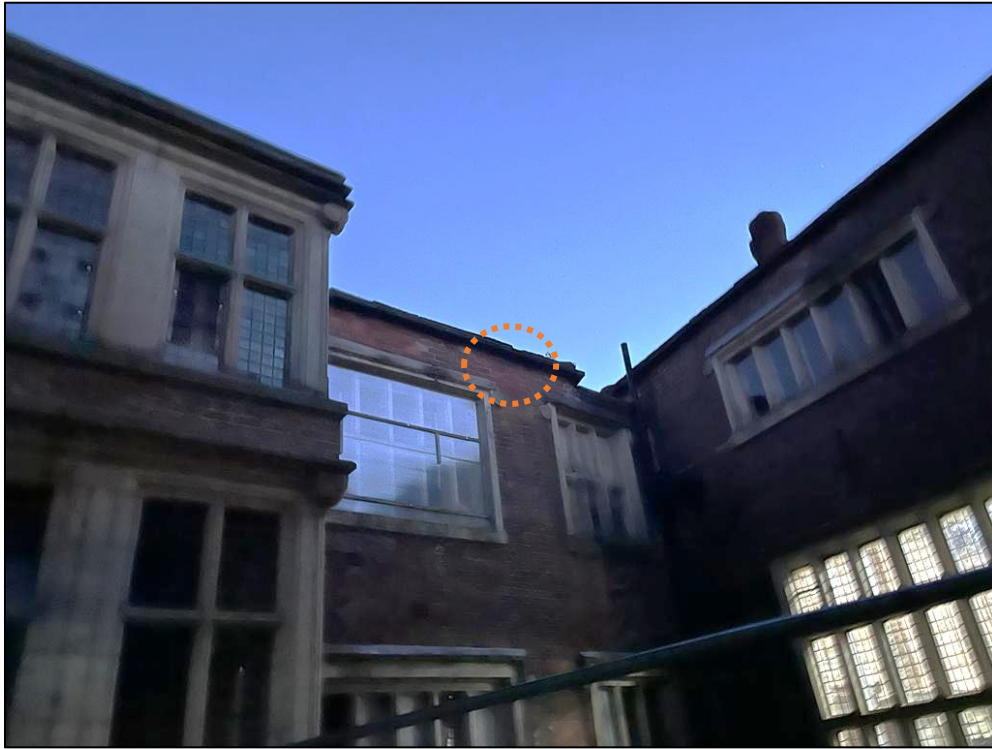
**Figure 5.3** *Dusk Survey 1 - Visual Aid – Emergence location from wall plate level of a single Common Pipistrelle.*

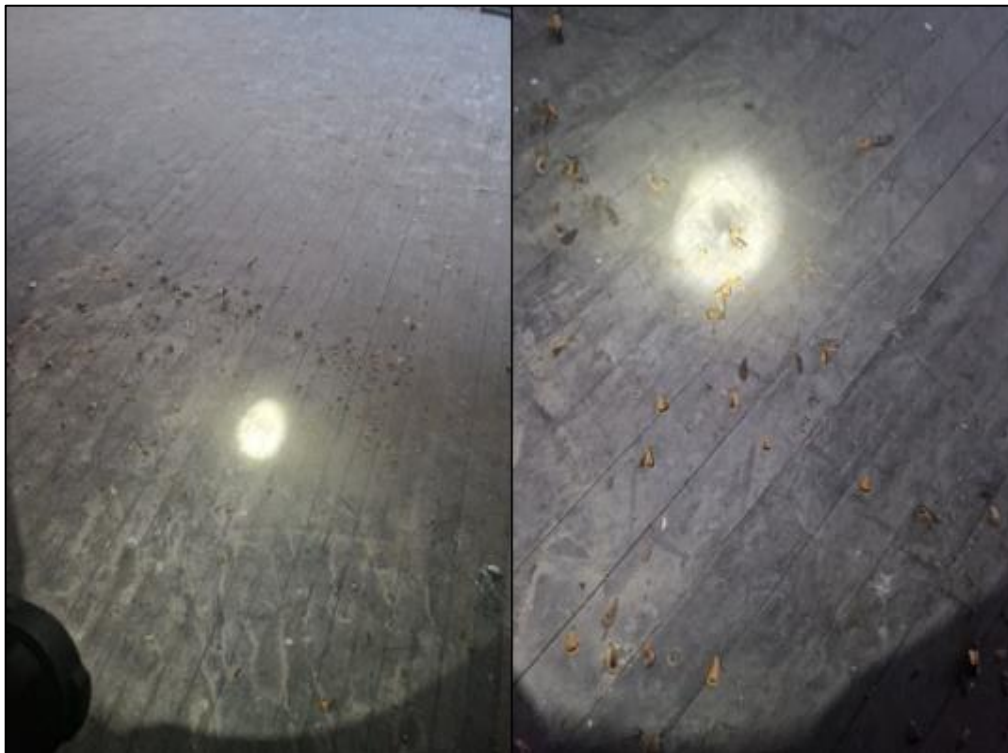
- 5.1 During the pre-dusk survey on 15<sup>th</sup> August 2023 20+ bat droppings attributed to brown long-eared bat (*Plecotus auratus*) were located within the previously identified feeding roost underneath 'Roof B' along with an increase in yellow underwing remains observed from the previous surveys a secondary feeding roost was observed within the hall way, with a limited number of wings and droppings recorded, this hall is accessible from the roof void below 'Roof B'.
- 5.2 The surveys took place on the 15<sup>th</sup> August and 29<sup>th</sup> August from a combination of 8 surveyors listed below; surveyor credentials have been given within **Table 5.1. Tables 5.2-5.3** alongside **Figures 5.1-5.2** document the results of the dusk surveys. This section of the report should be read in conjunction with **Appendix III**.

**Figure 5.4** *Pre-dusk inspection survey 1- Visual Aid – increased evidence of use by BLE, with feeding remains, dropping and splashing observed throughout the room.*

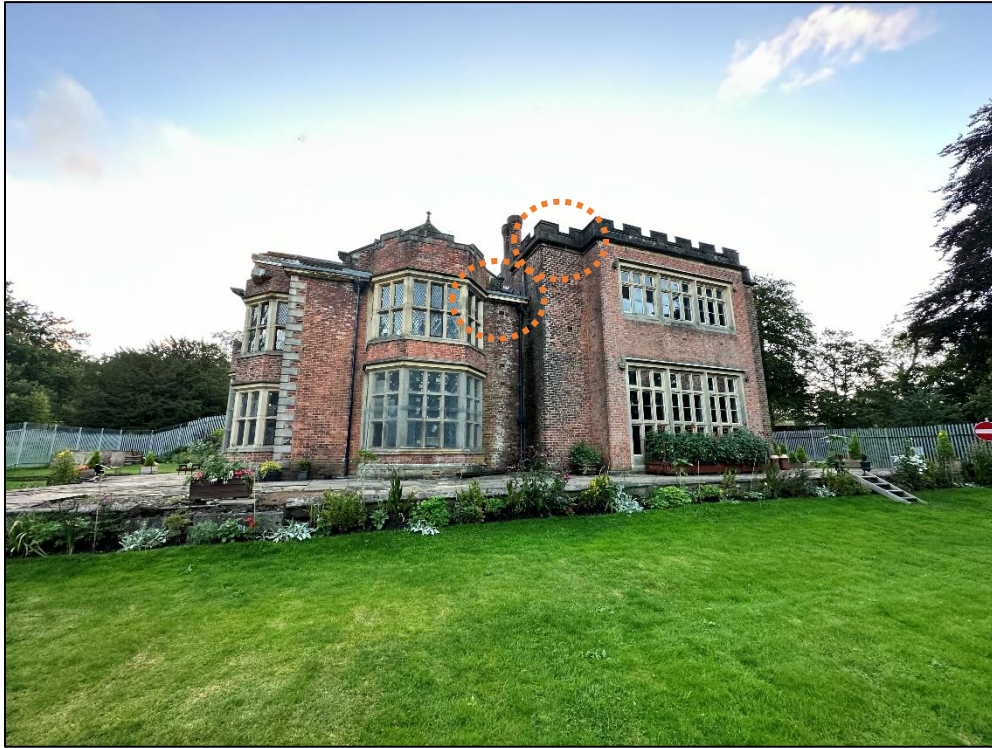
**Figure 5.5** *Dusk Survey 1 - Visual Aid – Emergence locations for 5 x BLE, 3 from over the parapet wall and 2 from the soffit.*

The area to the east of the building (red) hosts 5 roosts occupied by three species of bat, and thus any works which would result in the destruction/modification/damage of multiple bat roosts will therefore need to be addressed from both a conservation and legal perspective along with the application of appropriate mitigation. A European Protected Species Mitigation Licence (EPSML) will be required to legally destroy places that are actively used for breeding, rest or shelter (roost) by bats (see section 6.2).

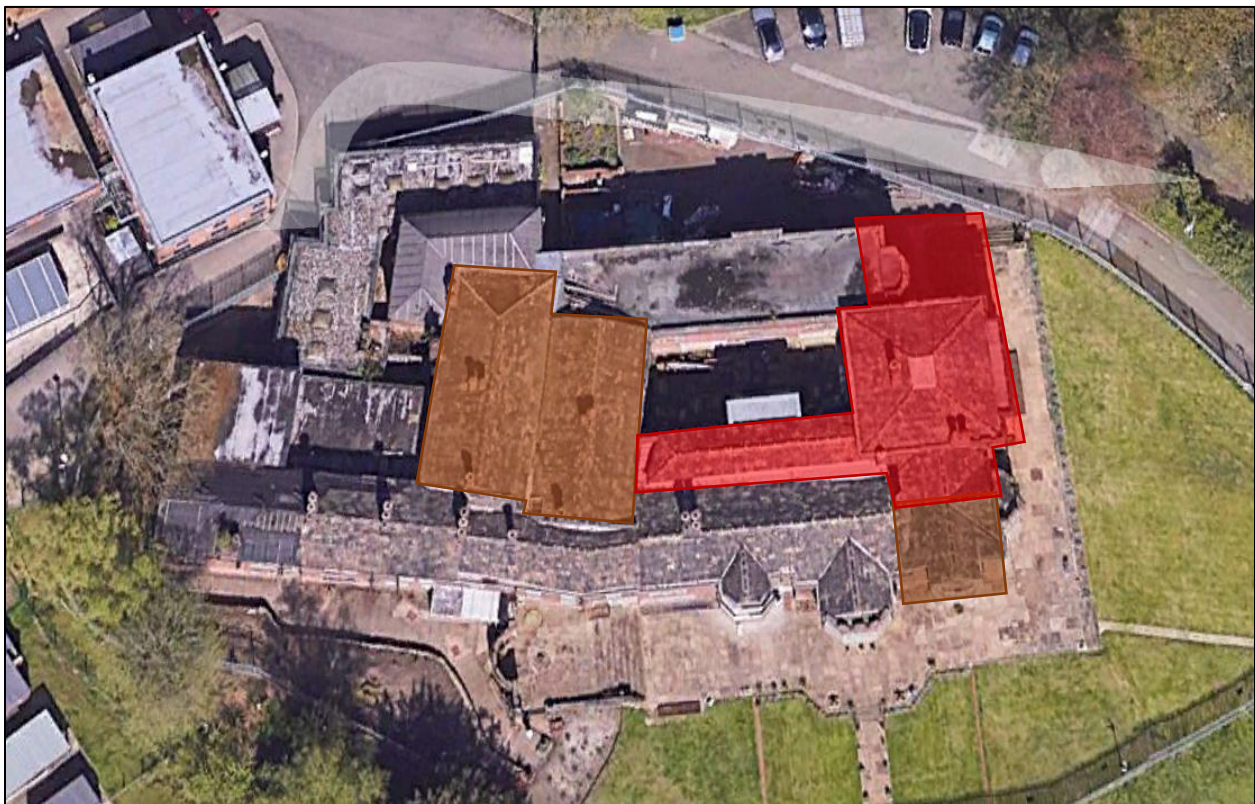
On the completion of the further two emergence surveys, no emergences / potential emergences were observed at the area to the centre of the building (orange) K and J. However, the roof, soffits, facias and barge boards all hold potential to host roosting bats. Thus, a precautionary approach is recommended during the proposed works to this section of the building whereby prior to work being undertaken a bat licenced ecologist should be provided with access to inspect the slates, gaps beneath barge boards, facias, any open cavity walls and all other areas identified as hosting bat roost potential at the ecologist's discretion; this inspection should be undertaken with the aid of torch light and endoscope.

**Figure 6.1:** Depicting areas of Hopwood Hall which require ecological clerk of works (ECow) and an EPSML. Orange (ECow) Red (EPSML)

If current evidence/bat presence is absent these areas will be carefully stripped by hand or sealed as appropriate immediately after the inspection; however, should recent evidence or bat/s be observed during this time the area will be retained and an EPSML applied for to legally allow the works to commence.

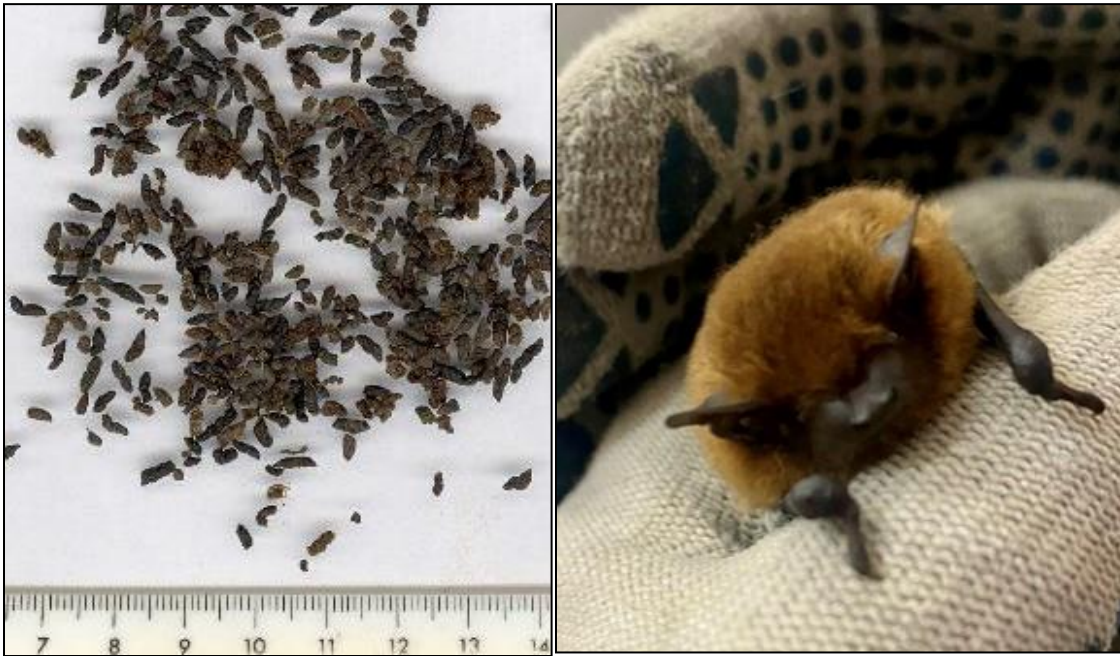
**Figure 7.2 – Evidence of bats – droppings on the left / a Common Pipistrelle bat on the right - indicative**

Bats are a transient species and will utilise different roosts throughout the year based on the climatic conditions provided within the individual roosts. In the highly unlikely event that bat(s), or recent evidence of bat(s), are found during proposed works then as a legal requirement the work at the site should immediately cease. If bat(s) or their roost(s) will be affected, then an EPSML may be required to legally commence with the works. See Figure 7.2 for indicative evidence of bats.

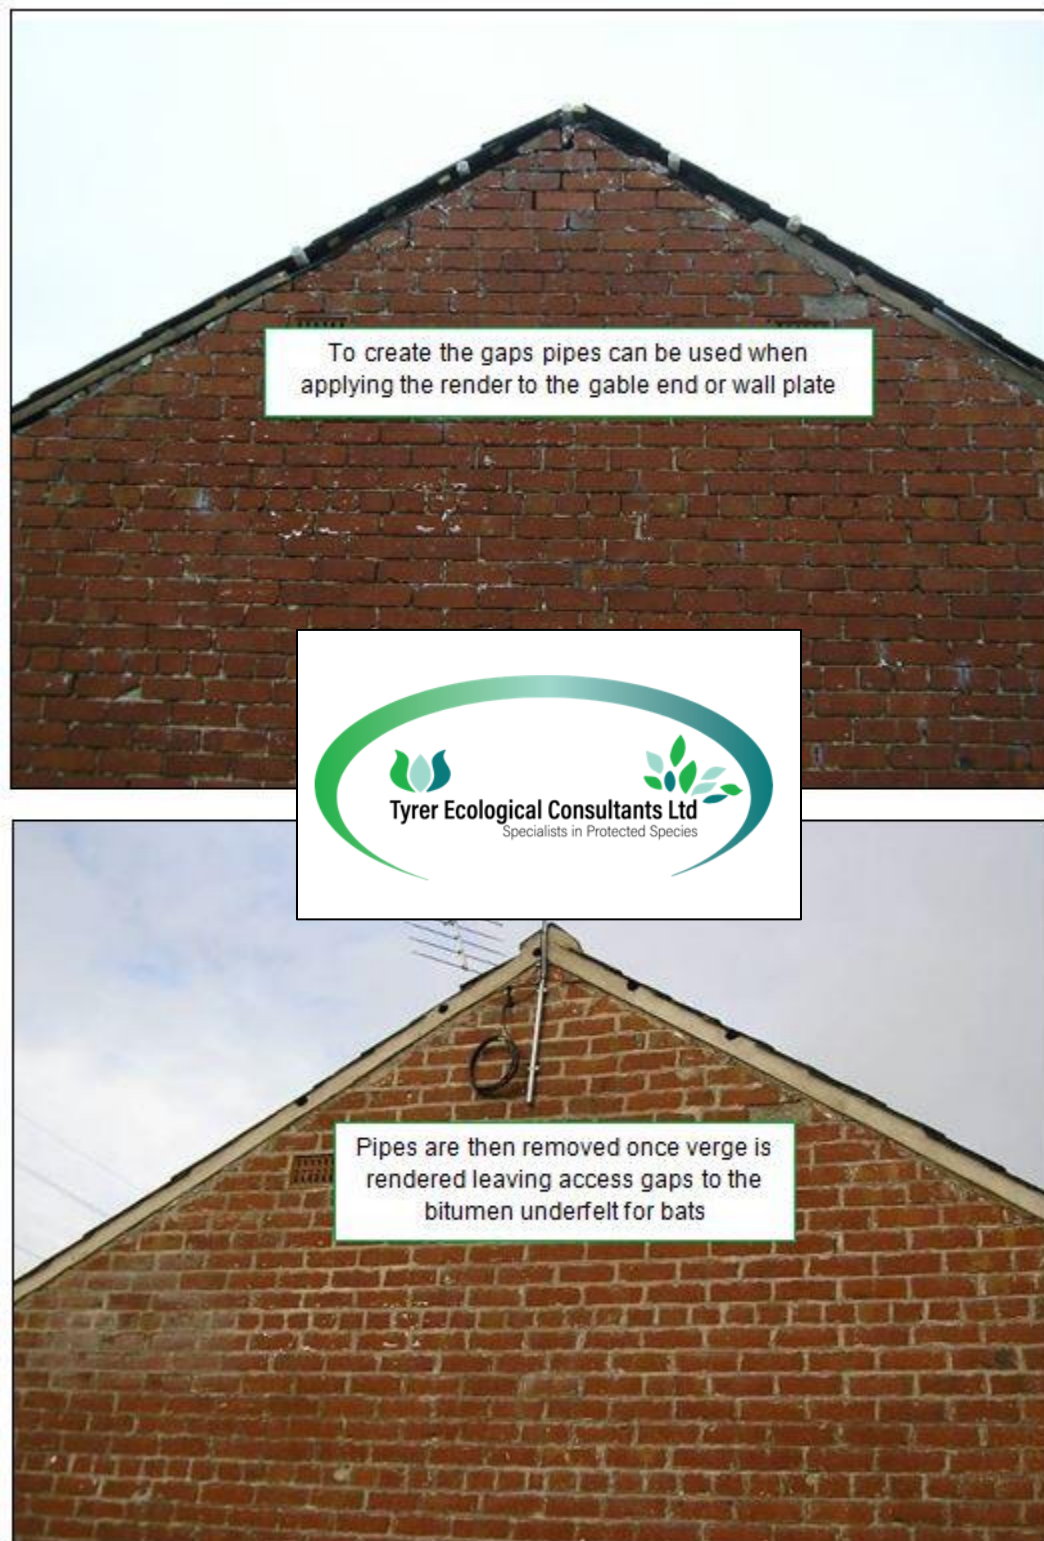
See Figures below for illustrative aids.

- As part of this roost creation process it is imperative that traditional bitumen 1F roofing felt will be used as the chosen as the underfelt/roof lining throughout the slate roof, as opposed to any breathable roofing membrane (BRM). Modern breathable roofing membranes (BRM) entrap bats through wear and tear in the synthetic polymers used to protect the breathable membrane causing bats harm, injury and death, therefore any BRM within the building should be removed and replaced within the traditional bitumen 1F.

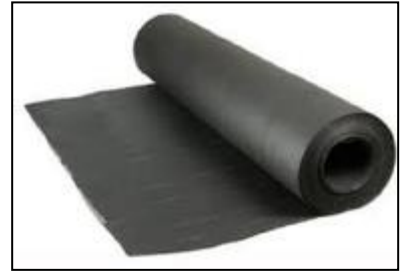
Breathable Roofing Membranes (BRMs) can trap the feet of bats, resulting in death or injury. It is therefore essential that any ingress points lead to areas lined with traditional bitumen 1F underfelt which is bat safe. It is also essential that there is no access to areas lined with BRM from the ingress point; therefore, sections of timber baton must be laid vertically between the horizontal roofing batons, effectively preventing movement between areas.

This areas of Bitumen 1F underfelt should be incorporated during the roofing of the dwelling, directly adjacent to the barge board/fascia and ridge access.
