**Syke Farm,  
Syke Road, Littleborough, Rochdale,  
Manchester.  
OL15 0AH**

**Preliminary Ecology Survey & Assessment  
in respect of Bat Species and Nesting Birds.**

**13<sup>th</sup> July 2023**

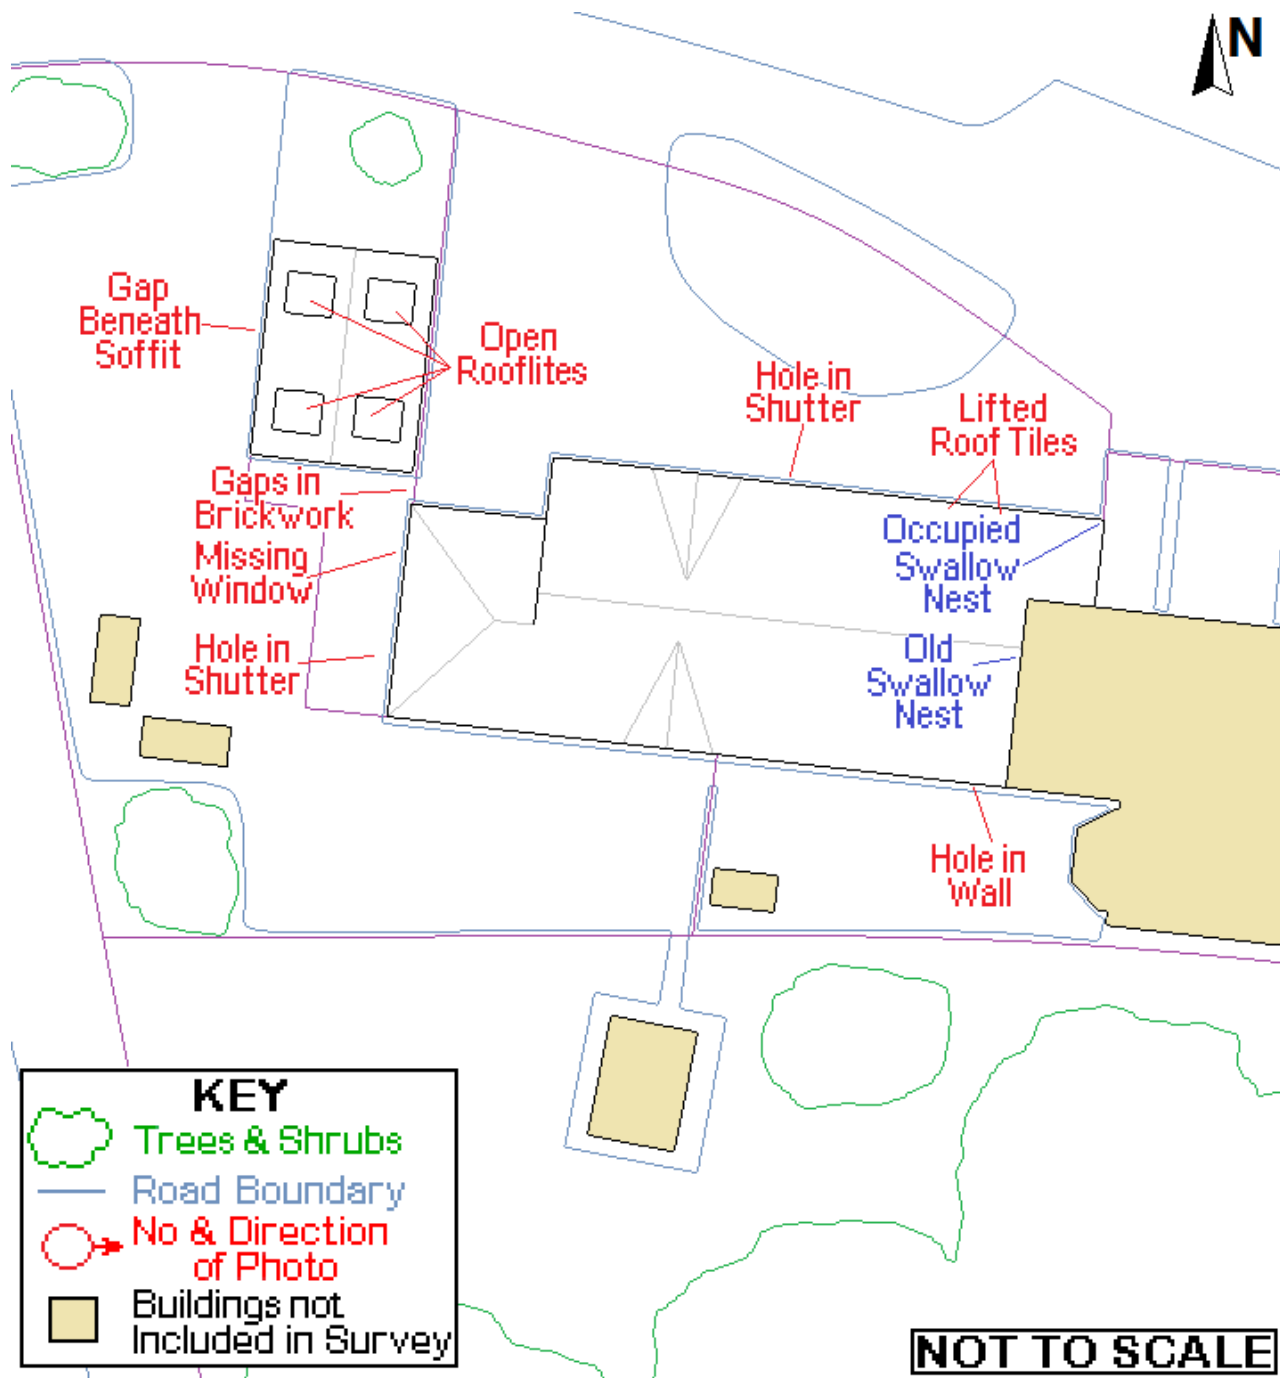
**Fig 5 – Plan Showing Results of Preliminary Daylight Evidence and Opportunity Survey and Assessment.**

- There was a hole in upper south-eastern wall, also holes in two shutters, one centrally in the upper northern elevation, and the other positioned at the upper north-eastern corner of the western elevation, whilst a window was also missing at the south-western corner of the western elevation. All of these potential bat access opportunities, the areas around them and the walls and floor beneath them, were carefully surveyed, both internally and externally, but neither bat droppings, invertebrate prey remains, nor any fur or urine stains, were found, and all of these locations were judged to be of low roosting suitability, (refer to **figs 3, 4, 5 and 6, and photos 1, 6, 7, and 18**).

- There were several lifted tiles with gaps below them, along the northern edge of the northern roof, but a survey of the gaps themselves, and the areas around them, using close-focus binoculars found no bat droppings, nor any staining, or any other evidence of bat usage, and therefore the gaps was deemed to offer very low bat suitability, (refer to **figs 3, 4, 5 and 6, and photos 1, 6, 7, and 18**).

- Mounted upon a roof beam at the inside north-eastern part of the roof stable block, was an occupied swallow nest, (*Hirundo rustica*), and as a parent bird was evident, and noisily flying around in the building, the bird was not disturbed further. However, another unoccupied swallow nest was seen attached to a part of the eastern roof, and this one was deemed not to have been used for some time. It was therefore concluded that this nesting potential would both be lost if the building is developed, (refer to **figs 3, 4 and 5, and photos 35 and 36**).

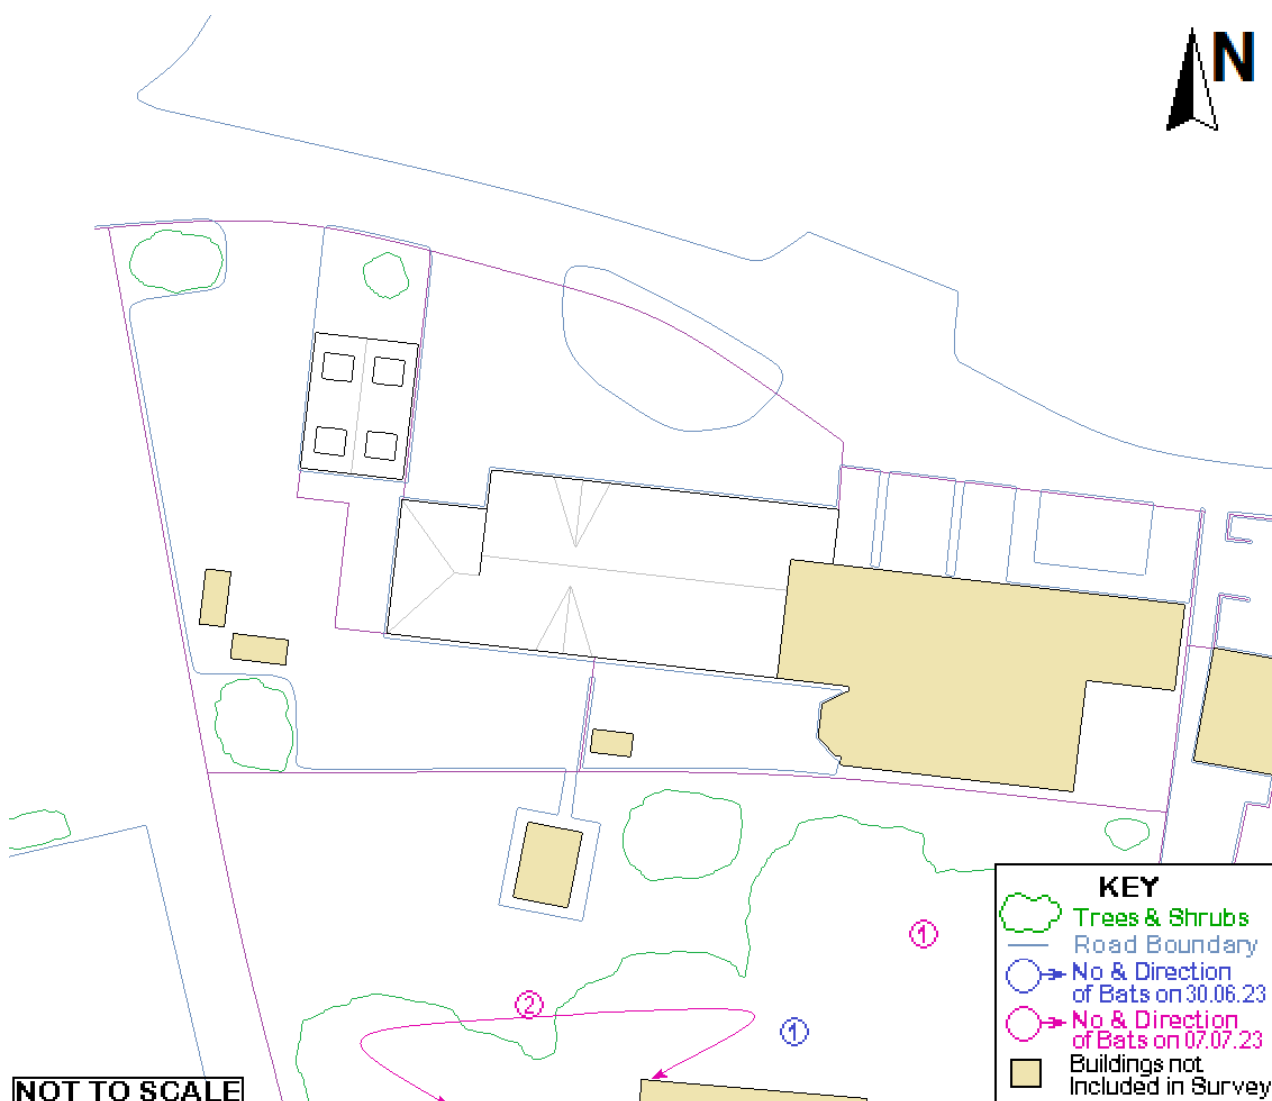
**Fig 6 – Plan of Evening Bat Emergence Survey Results**

Shortly afterwards, at 22.08 hrs, a pipistrelle was observed foraging in a continuous loop amongst and over the trees, some distance to the south of the site. This behaviour was observed intermittently until the survey ended, during which time some feeding buzzes were heard. It was thought that this was the same bat observed earlier in the survey, (refer to **pink arrow 2** on **fig 6**).

No other bat activity was observed around the site, and at no time were bats seen to have emerged from any part of the targeted buildings, or from any of the trees and shrubs around the site, nor from any of the other nearby buildings.

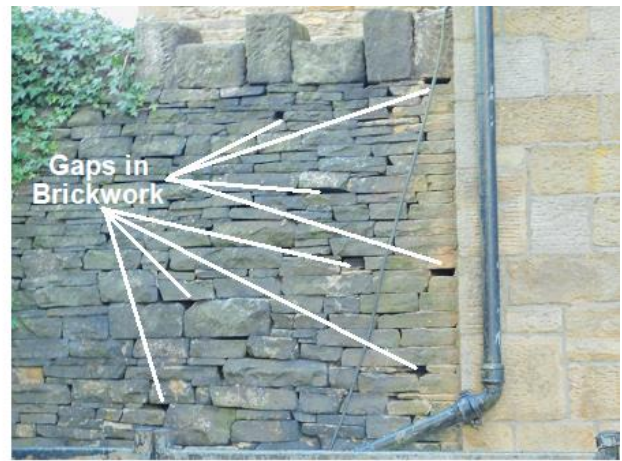
**PHOTO 8**  
**Western Elevation of Wall**

- A stone wall ran from the north-western corner of the barn in a northerly direction, lying adjacent to the eastern elevation of the henhouse, and this had numerous holes where the stone was missing. The holes and the wall around them were all searched by eyesight, and where possible by using an endoscope. The majority were found to be either too shallow for bats to use, and some were full of either cobweb or debris, and therefore all were deemed to be of low suitability for bats, (refer to **figs 3, 4, 5 and 6, and photo 8**).

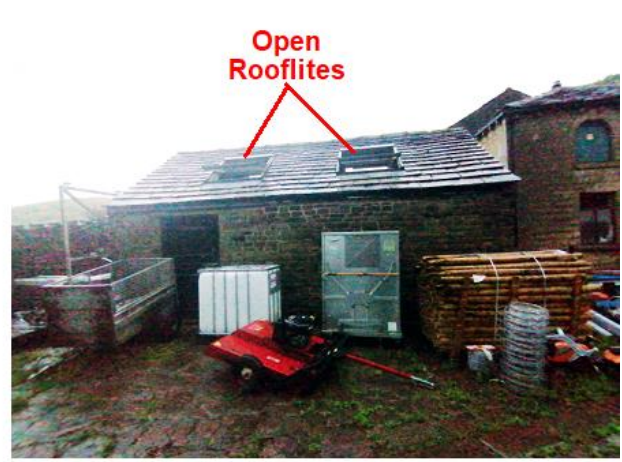
**PHOTO 10**  
**Western Elevation of Henhouse**

- There were four rooflights within the roof, and these were permanently open, but a search around the gaps and the roof and inside of the henhouse, found no bat droppings or invertebrate prey remains, nor either any fur or urine staining, and therefore the roof lites were deemed to be of very low suitability and have not been used by bats, (refer to **figs 3, 4, 5 and 6, and photos 10, 11 13 and 14**).

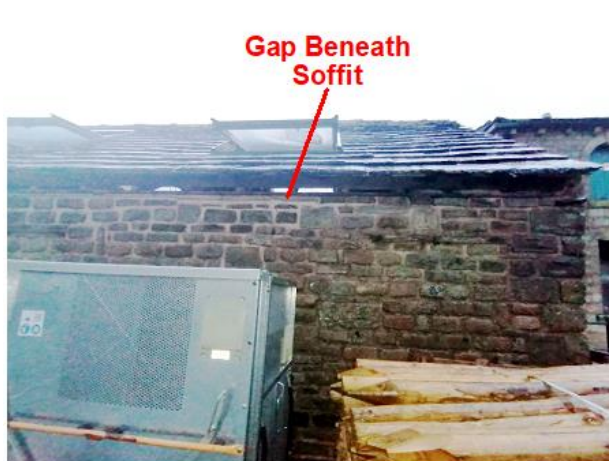
**PHOTO 11**  
**Western Henhouse Roof**

- There was a gap between the top of the western wall and the underside of the roof, but a careful examination of the gap, the wall and floor beneath it, and the interior of the henhouse found neither bat droppings of any other sign of bat usage and therefore the gap was of low suitability for bats, (refer to **figs 3, 4, 5 and 6, and photo 11**).
