Phase I Geoenvironmental Site Assessment  
Brassey Street, Middleton  
Reference:16-124-R1  
Date: September 2022

# PHASE I GEOENVIRONMENTAL SITE ASSESSMENT

Brassey Street  
Middleton  
Manchester  
M24 6AR

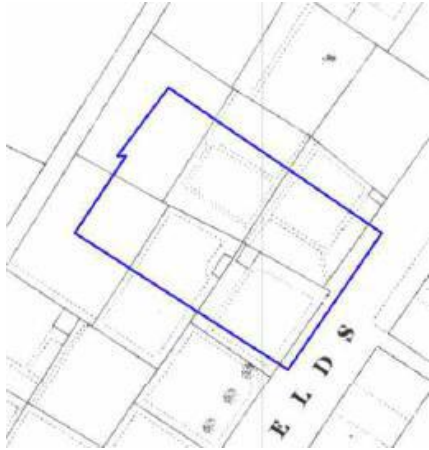
| MAP EDITION | HISTORICAL LAND USE | HISTORICAL MAP EXCERPT |
|---|---|---|
| <b>1851</b><br><b>1:1,056</b> | <p>The site consists of agricultural fields, separated into 6 parcels with two structures recorded in the centre-south.</p> | |

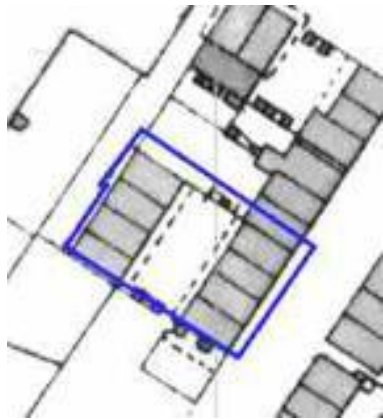
| MAP EDITION | HISTORICAL LAND USE | HISTORICAL MAP EXCERPT |
|---|---|---|
| <b>1893</b><br><b>1:2,500</b> | <p>The site is no longer recorded as agricultural fields. Rows of presumed terraced houses are present along the north west and south east boundaries.</p> | |

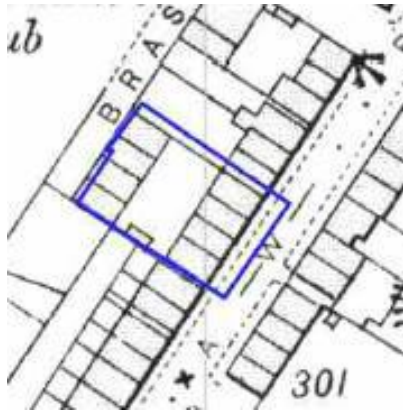
| MAP EDITION | HISTORICAL LAND USE | HISTORICAL MAP EXCERPT |
|---|---|---|
| <b>1909</b><br><b>1:2,500</b> | <p>A small outbuilding is recorded adjacent the southern site boundary.</p> | |

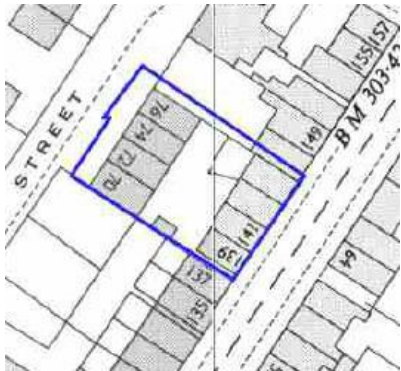
| MAP EDITION | HISTORICAL LAND USE | HISTORICAL MAP EXCERPT |
|---|---|---|
| <p><b>1954</b><br/><b>1:1,250</b></p> | <p>An additional small boundary segment is recorded belonging to the dwelling at the south eastern site boundary.</p> <p>Properties are now referenced by number.</p> | |

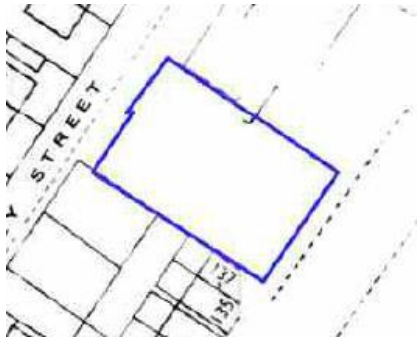
| MAP EDITION | HISTORICAL LAND USE | HISTORICAL MAP EXCERPT |
|---|---|---|
| <p><b>1975</b><br/><b>1:1,250</b></p> | <p>All structures have been removed.</p> | |

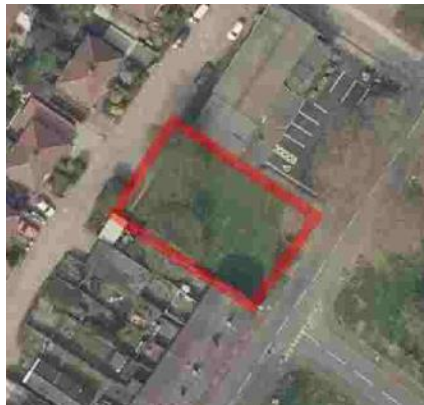
| MAP EDITION | HISTORICAL LAND USE | HISTORICAL MAP EXCERPT |
|---|---|---|
| <b>2019</b><br><b>Aerial Photograph</b> | Most recent aerial photograph depicting the sites current composition and displaying no changes since 2003 mapping. | |

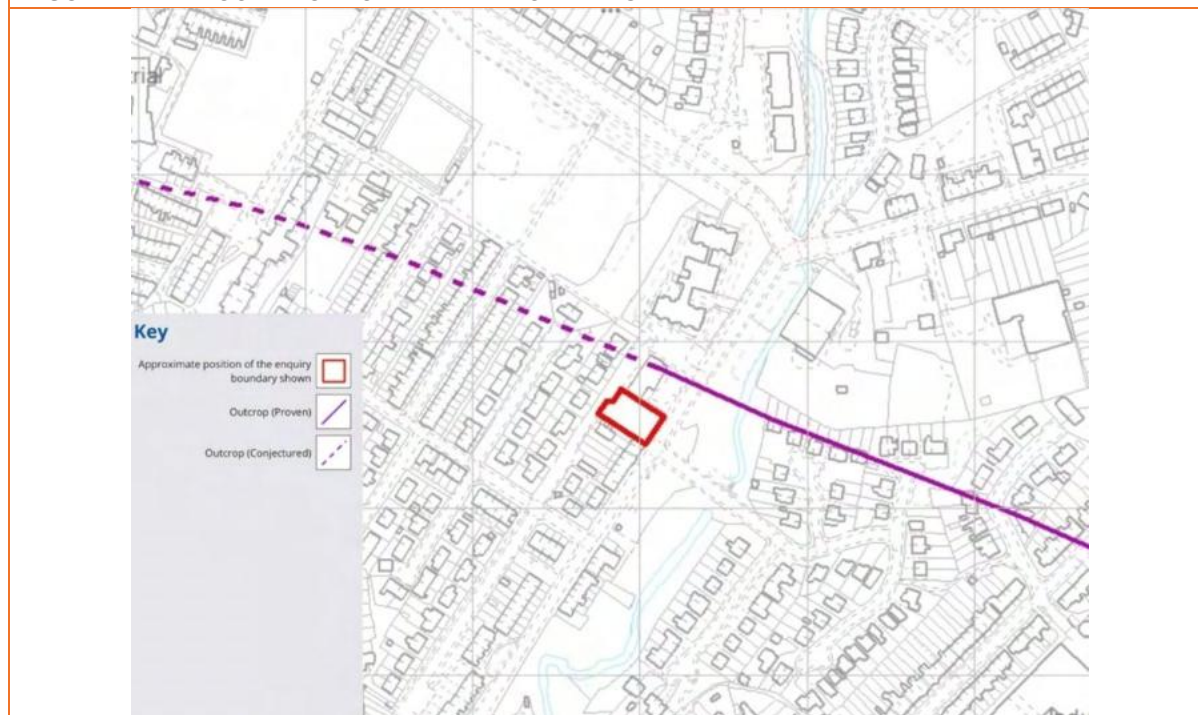
FIGURE 4.1 COAL AUTHORITY PLAN FOR THE SITE

The Coal Authority plan referenced: MR-LARGE-PLOT-51003309357001-1662388323427 shows a proven coal seam striking north west – south east immediately north of the site.

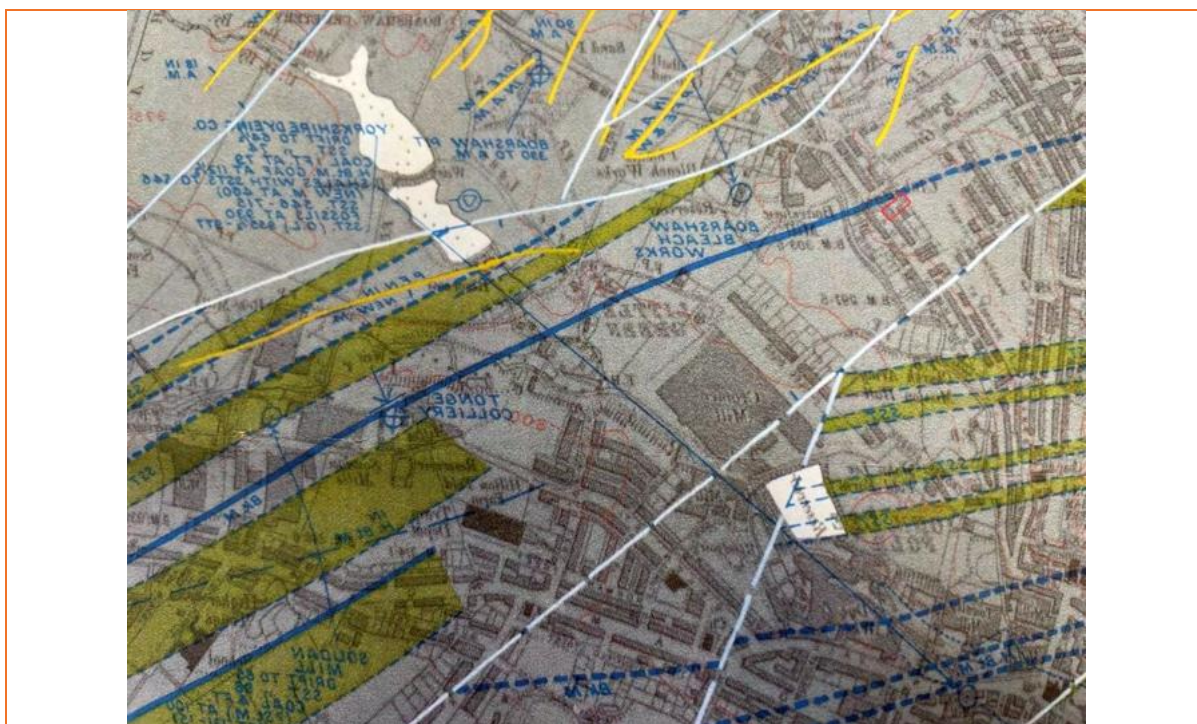
FIGURE 4.3 EXCEPT OF COUNTRY MAPS 6" LANCASHIRE 96 NE SOLID EDITION (1929)

Figure 4.2 is an extract from BGS Sheet 85, Manchester 1:50,000 Solid Edition (1974) and Figure 4.3 is an extract from Country Maps 6" Lancashire 96 NE Solid Edition (1929)

Log annotations for the mapped mine entries on the 6-inch map record drift to 64-65 ft (19.5-20 m) bgl over sandstone, with coal at 79 and 96 ft (22.5 and 29 m).
