Phase I & II Geoenvironmental Site Assessment  
Buxton Street, Heywood

Reference: 16-060-R1-1  
Date: September 2022

# PHASE I & II GEOENVIRONMENTAL SITE ASSESSMENT

Buxton Street  
Heywood  
Greater Manchester  
OL10 1BS

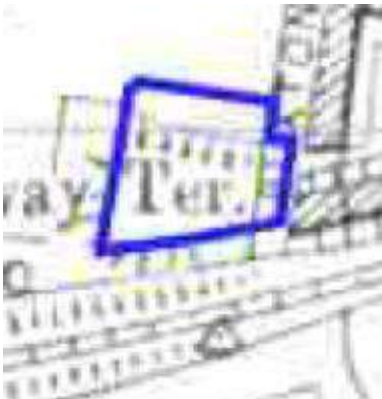
| MAP EDITION | HISTORICAL LAND USE | HISTORICAL MAP EXCERPT |
|---|---|---|
| <b>1928</b><br><b>1:10,560</b> | <p>The field boundary in the north of the site has been removed and the site has been upfilled to form a railway terrace. Steep sloping sides are noted along the north, south and east of the terrace.</p> <p>There are no other significant changes recorded.</p> | |

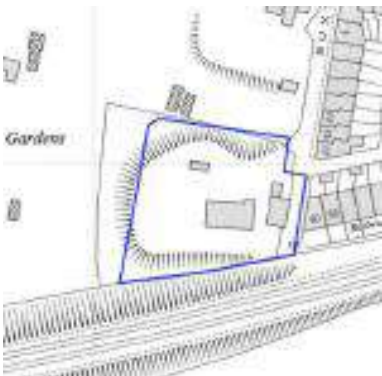
| MAP EDITION | HISTORICAL LAND USE | HISTORICAL MAP EXCERPT |
|---|---|---|
| <p><b>1956</b><br/><b>1:1,250</b></p> | <p>Three structures have been constructed onsite.</p> <p>There are no other significant changes recorded.</p> | |

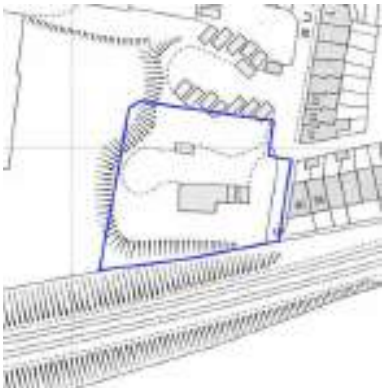
| MAP EDITION | HISTORICAL LAND USE | HISTORICAL MAP EXCERPT |
|---|---|---|
| <p><b>1965</b><br/><b>1:1,250</b></p> | <p>The easternmost structure has been removed with the central structure being extended.</p> <p>Between the structures, a hardstanding yard has been constructed.</p> <p>There are no other significant changes recorded.</p> | |

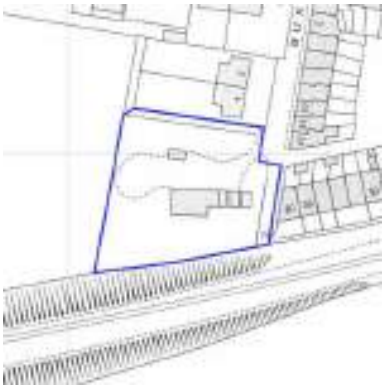
| MAP EDITION | HISTORICAL LAND USE | HISTORICAL MAP EXCERPT |
|---|---|---|
| <p><b>1971-1975</b><br/><b>1:1,250</b></p> | <p>The sloped sides of the terrace are no longer indicated, however, given that the structures remain in place it is unlikely this feature has been removed.</p> <p>There are no other significant changes recorded.</p> | |

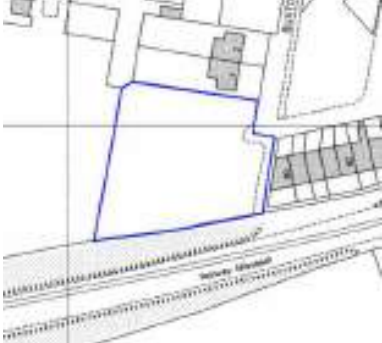
| MAP EDITION | HISTORICAL LAND USE | HISTORICAL MAP EXCERPT |
|---|---|---|
| <p><b>1988-1992</b><br/><b>1:1,250</b></p> | <p>All of the structures onsite have been removed and are no longer mapped.</p> <p>There are no other significant changes recorded.</p> | |

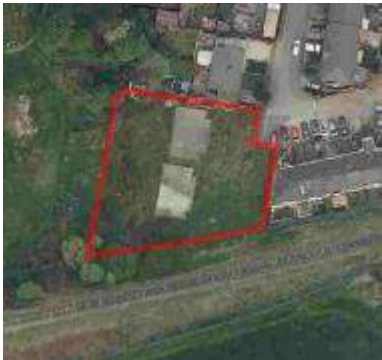
| MAP EDITION | HISTORICAL LAND USE | HISTORICAL MAP EXCERPT |
|---|---|---|
| <b>2022</b><br><b>Google Earth</b> | <p>Two raft foundations are visible in the centre of the site.</p> | |

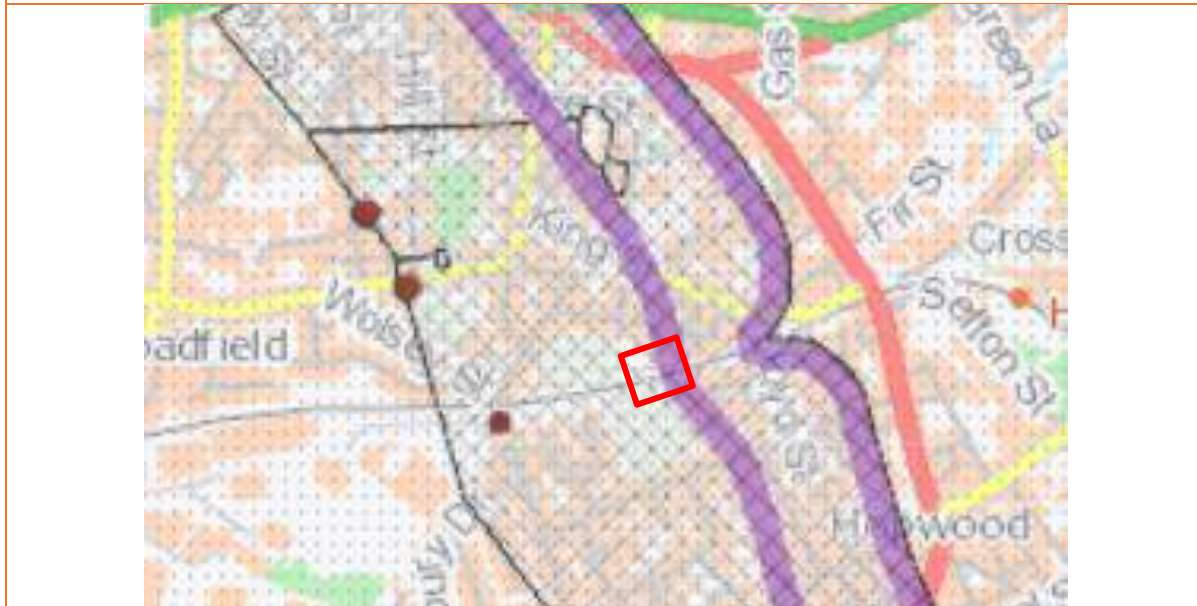
FIGURE 4.3 EXCERPT OF THE COAL AUTHORITY ONLINE VIEWER

In the first instance, E3P has reviewed the Coal Authority Online Viewer and an excerpt of this is presented as Figure 4.3. This map shows that the site lies within a development high risk area. Furthermore, there are coal seams to the Thin Coal (Seam Code: ZZ004C) appears to dip below the site. The map also indicates that there is the potential for shallow workings beneath the site and there are no mine shafts on the site.

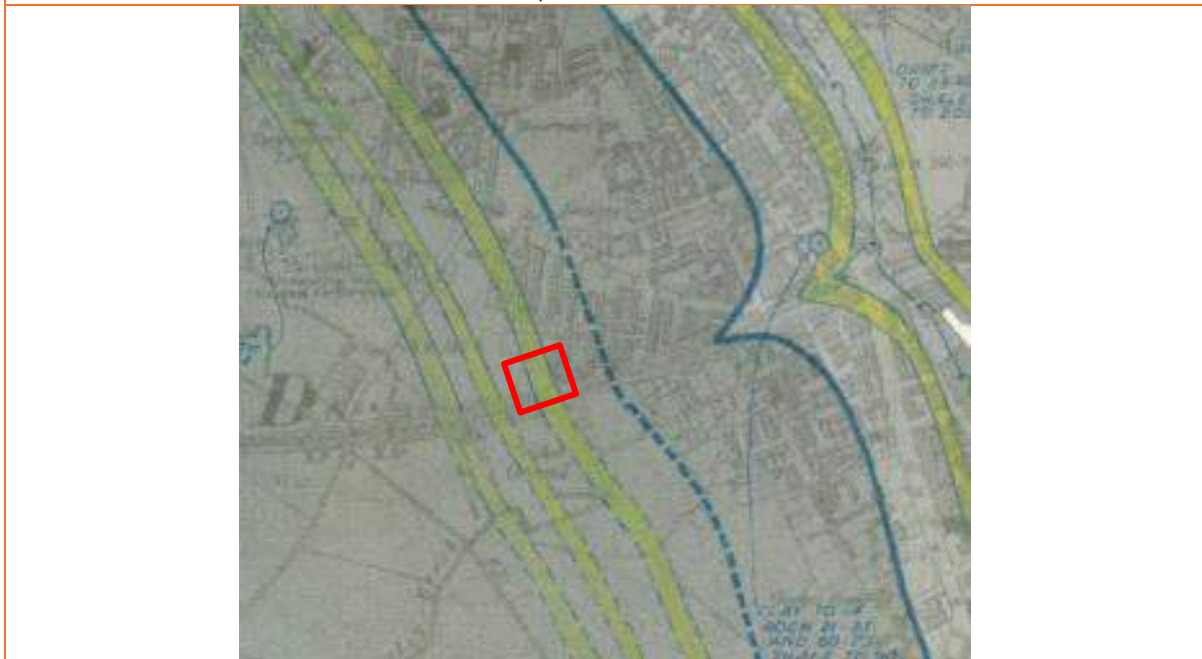
**FIGURE 4.5 PHOTOGRAPH OF THE 1:10,000 PLAN FOR THE SITE**

Figure 4.5 is a photograph of the 1:1200 plan for the site which shows the Thin Coal outcrop, trending NW/SE, potentially can be found 57 m to the east, however, this is inferred and no outcrop has been marked.

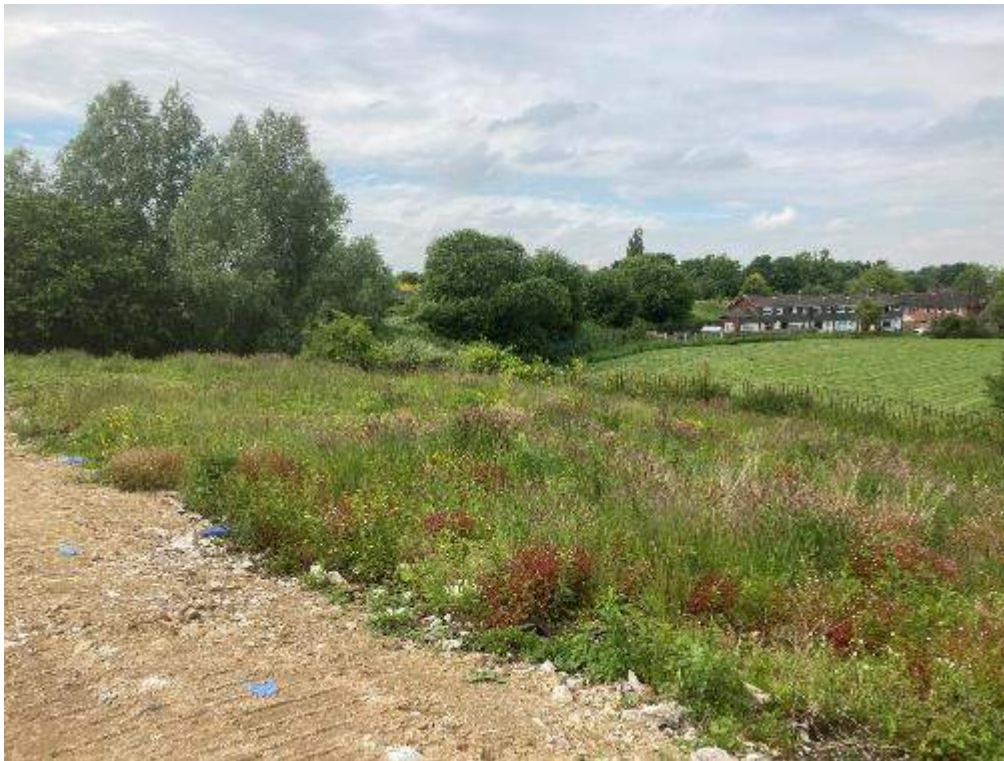
PLATE 3 SLOPE IN THE WESTERN SECTOR OF THE SITE

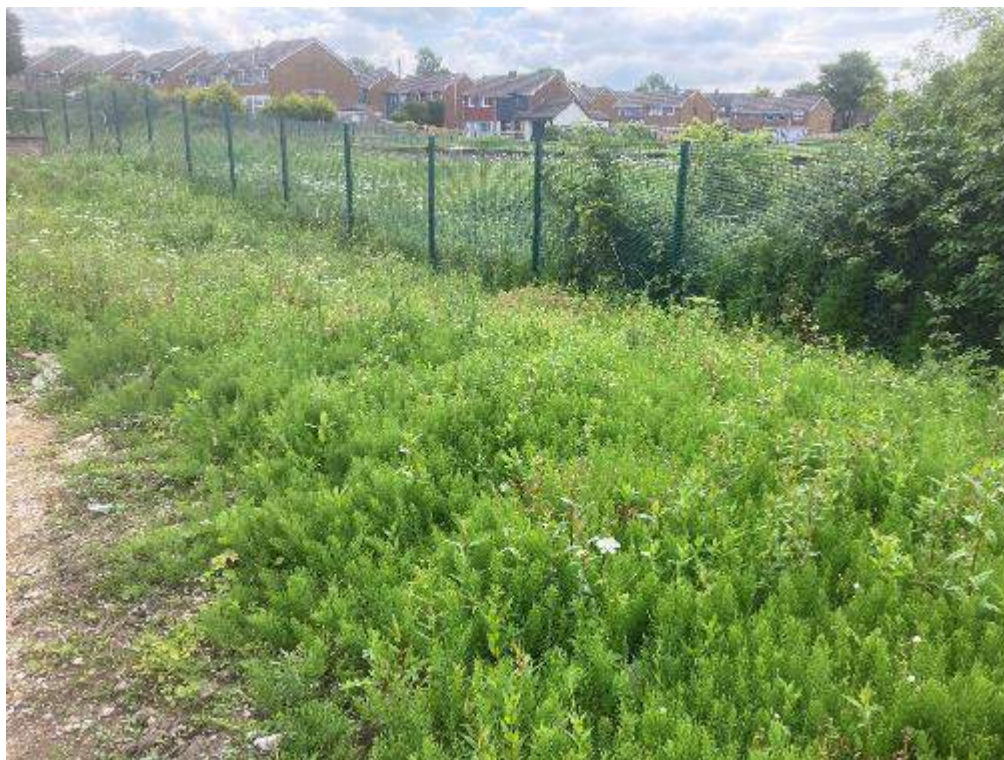
PLATE 4 RAILWAY ALONG THE SOUTHERN BOUNDARY

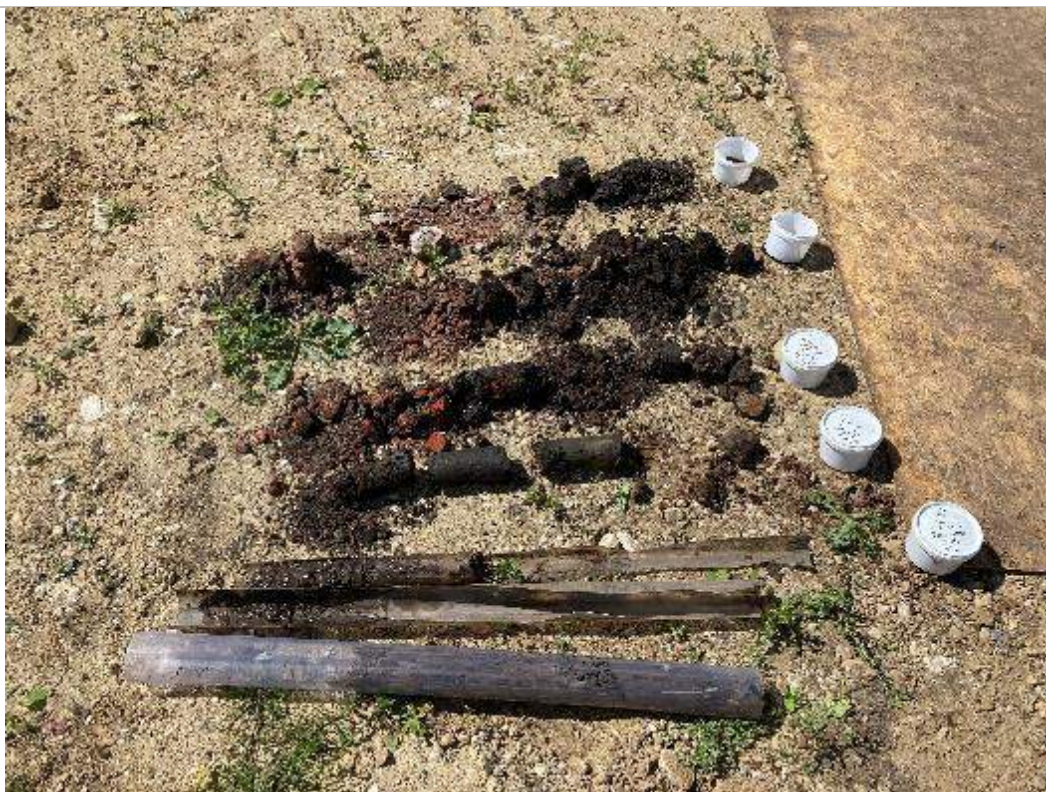
The Made Ground on site is generally comprised of very loose (WS102 and WS104) to medium dense black slightly clayey slightly sandy gravel. Gravel is fine to medium subangular of sandstone with frequent fragments of brick, clinker, concrete, glass and ash with clay clods of sandy clay 0.15 m in size throughout.

PLATE 5 GROUND CONDITIONS WS102

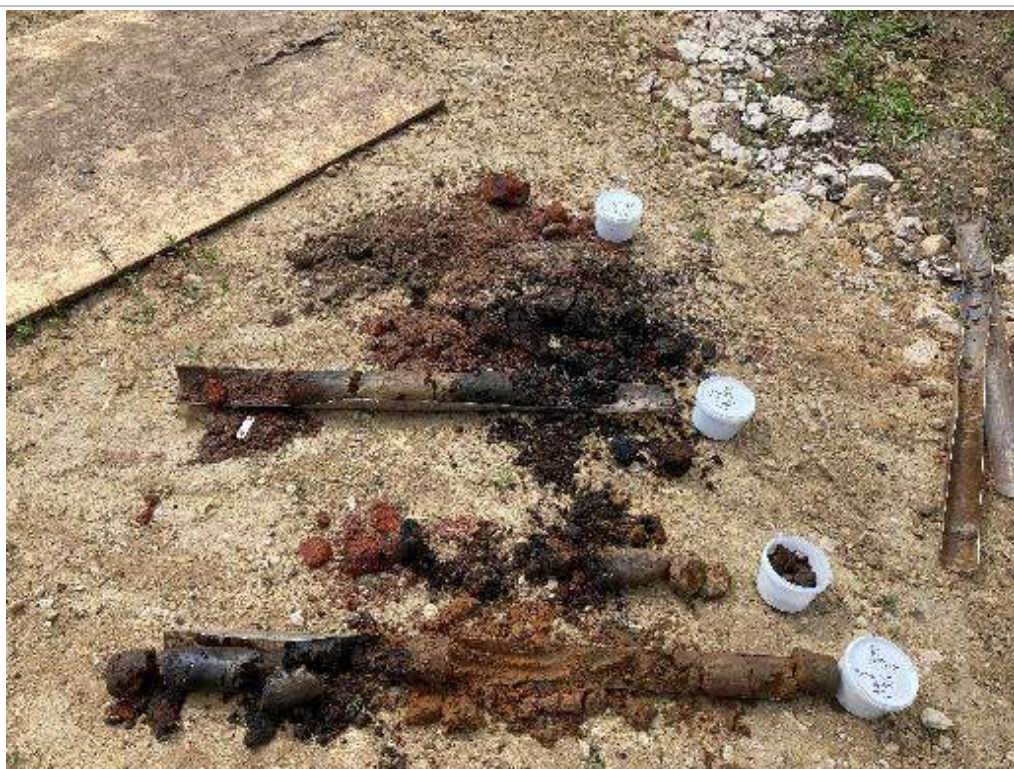
PLATE 6 GROUND CONDITIONS WS105

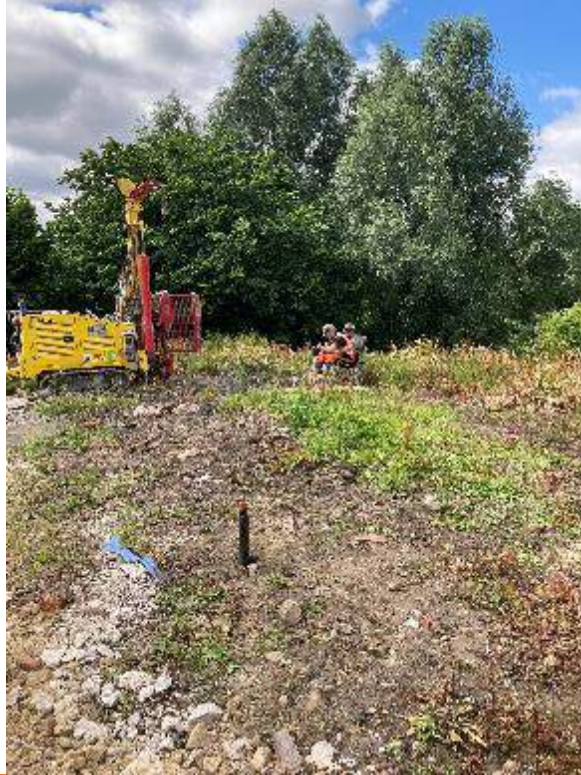
PLATE 7      MONITORING WELL INSTALL

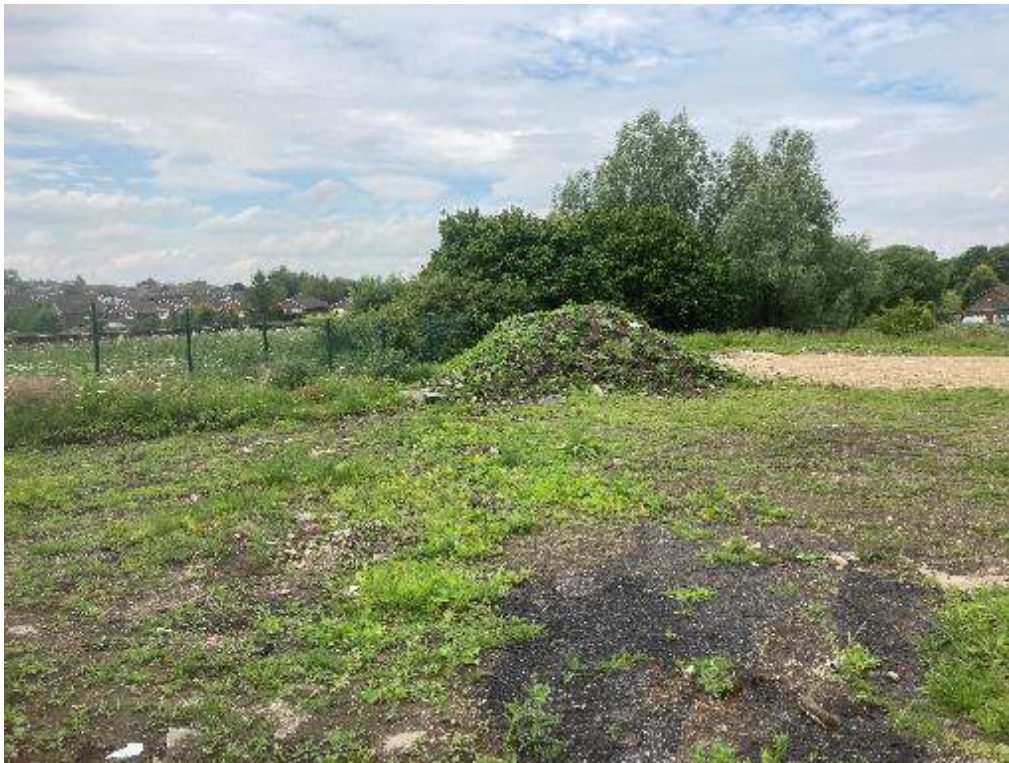
PLATE 8      STOCKPILE IN THE SOUTH OF THE SITE

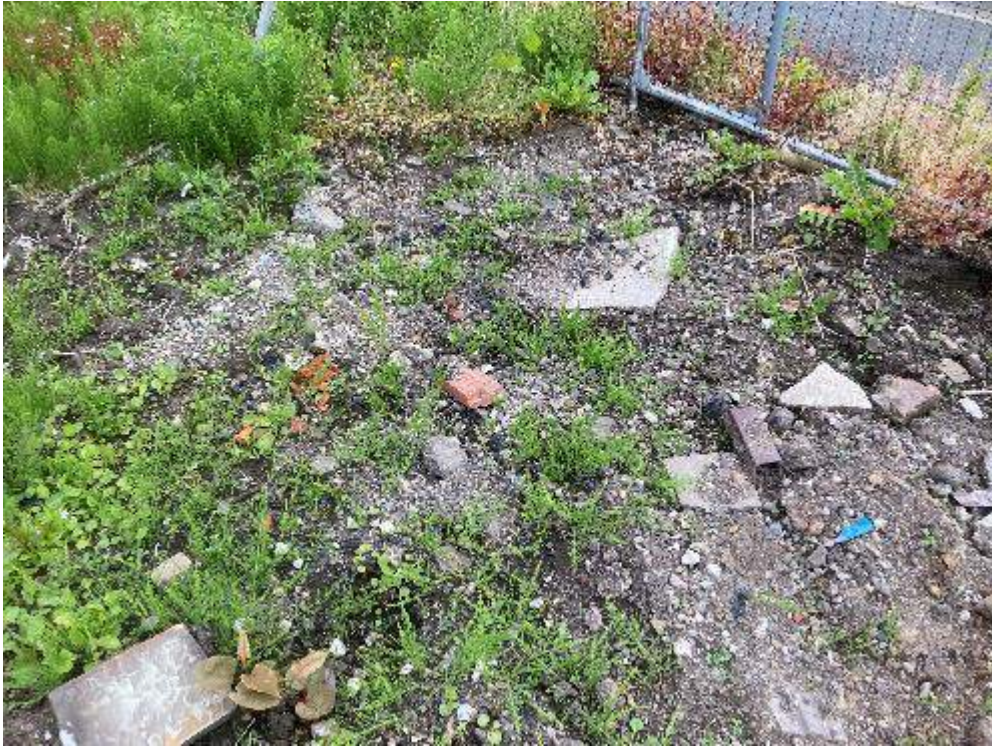
| <b>Invasive Plant Species</b> | E3P has been made aware that invasive species have been noted and treated by a third party onsite. | |

PLATE 9      SPROUTING INVASIVE SPECIES ON SITE
